Contract No. DC/2018/08
Inter-reservoirs Transfer Scheme -
Water Tunnel between Kowloon Byewash Reservoir and Lower Shing Mun Reservoir
Monthly Environmental Monitoring and Audit (EM&A) Report
(October 2021)

28th Monthly EM&A Report (Rev. 1)

- E2. This is the 28th Monthly Environmental Monitoring and Audit (EM&A) Report presents EM&A works undertaken in the period from 1 to 31 October 2021. EM&A works were performed in accordance with the approved EM&A Manual and conditions stipulated in the amended Environmental Permit EP-345/2009/A.

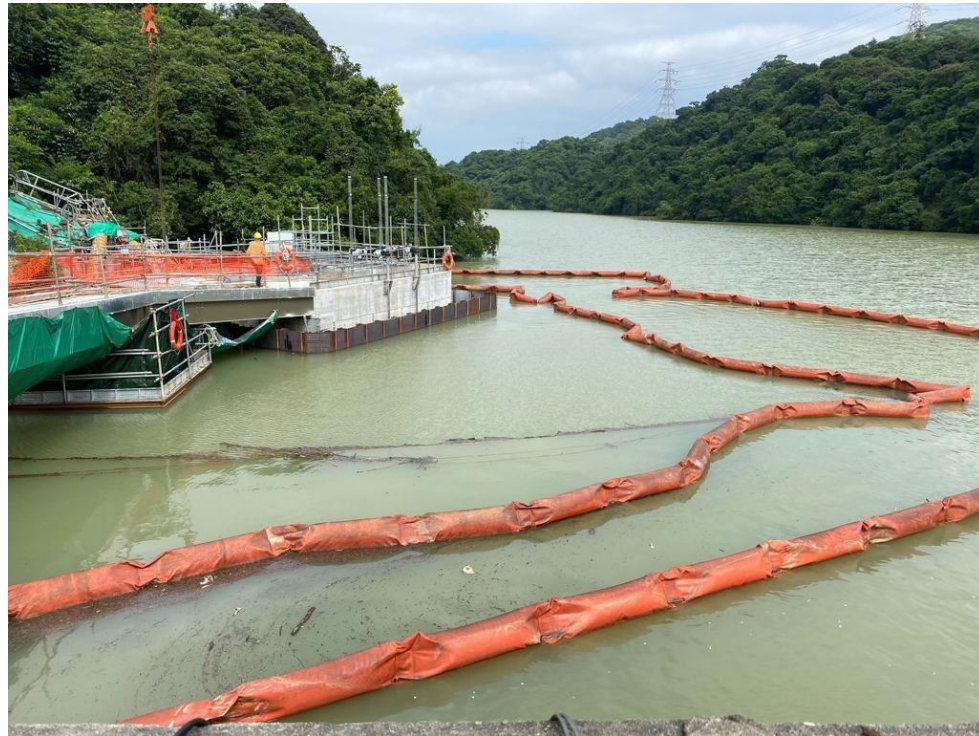
Figure 1 – Site Photo of KBR Works area taken on 19 October 2021

Date	C1b	D1b	Action Level	Limit Level
15/10	12.4	8.1	14.88	16.12
17/10	14.6	11.0	17.52	18.98
19/10	2.5	11.4	9.0	13.0
21/10	5.1	5.7	9.0	13.0
23/10	20.1	17.7	24.12	26.13
26/10	5.2	3.0	9.0	13.0
28/10	7.2	4.8	9.0	13.0

The exceedance is considered not related to the construction works of IRTS. No further action is required.
