Contract No. DC/2018/08
Inter-reservoirs Transfer Scheme –
Water Tunnel between Kowloon Byewash Reservoir and Lower Shing Mun Reservoir
Monthly Environmental Monitoring and Audit (EM&A) Report
(January 2022)

31st Monthly EM&A Report (Rev. 0)

- E2. This is the 31st Monthly Environmental Monitoring and Audit (EM&A) Report presents EM&A works undertaken in the period from 1 to 31 January 2022. EM&A works were performed in accordance with the approved EM&A Manual and conditions stipulated in the amended Environmental Permit EP-345/2009/A.

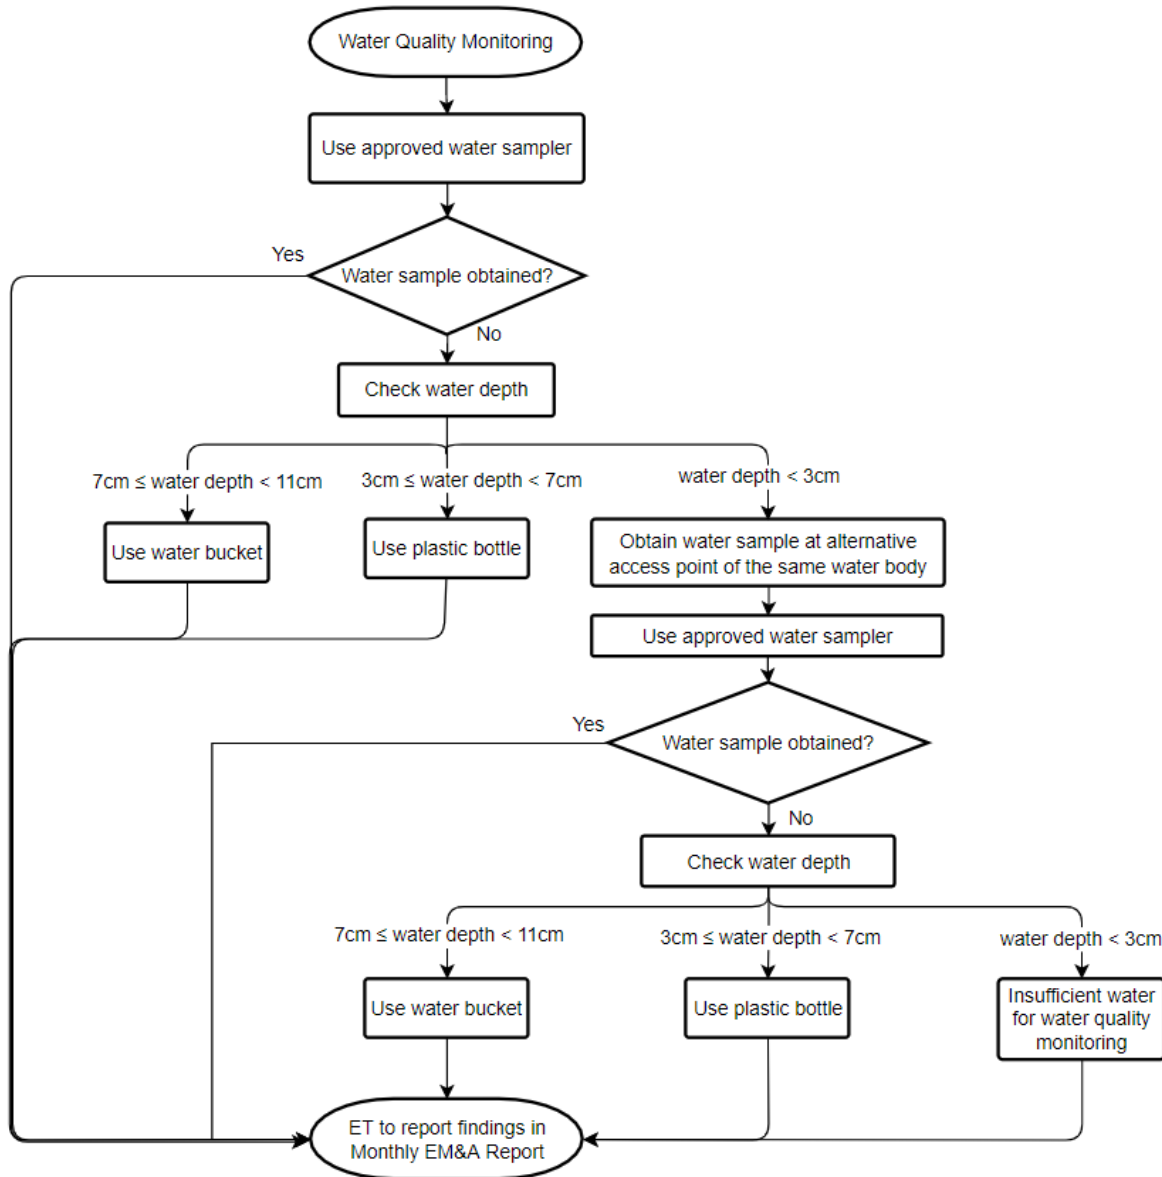
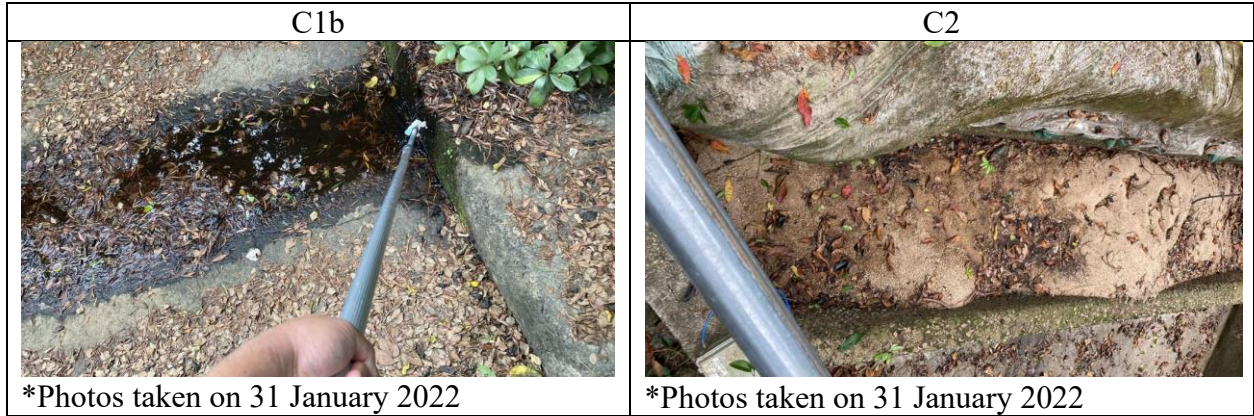
- 3.16 The water level at Lower Shing Mun Reservoir (i.e., monitoring location D2a) changes in time. Due to the access constraint, water sampling could only be done at the boundary of the water body. Hence, the actual sampling location of D2a is subject to the actual water level of the reservoir and was determined on-site at locations close to the site.
- 3.17 After the joint water sampling inspection with the ER, the IEC representative, the Contractor and the ET on 15 October 2021, on days when very shallow flow (<11cm of water depth) were observed at the control points, actions will be taken to collect samples at the sampling locations. At the control point C1b, a small plastic bottle was used to collect

samples according to the flow chart below. At the control point C2, samples were collected from another access to the water body.

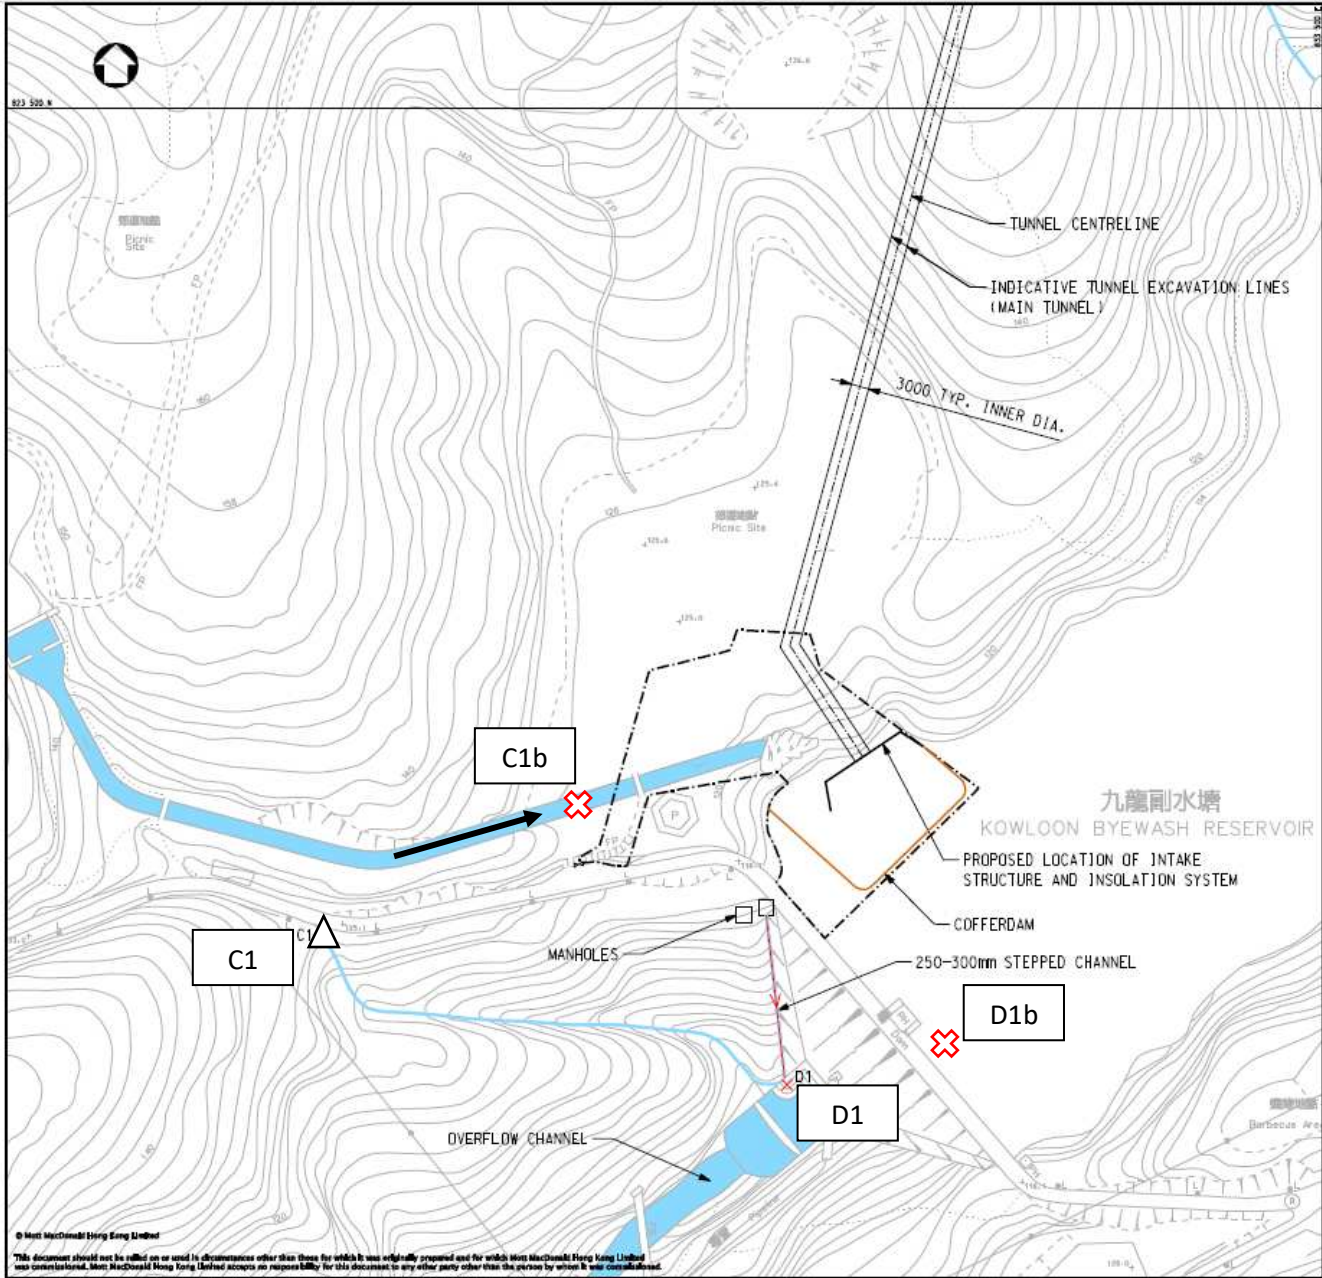
Scale: 1:5000A1
Project No: 240564
Sheet No: 2/2
Drawing No: FIGURE 5-1
Page No: P3

NOTE:
DESIGN DETAILS OF THE COFFERDAM WILL BE DETERMINED BY THE CONTRACTOR.

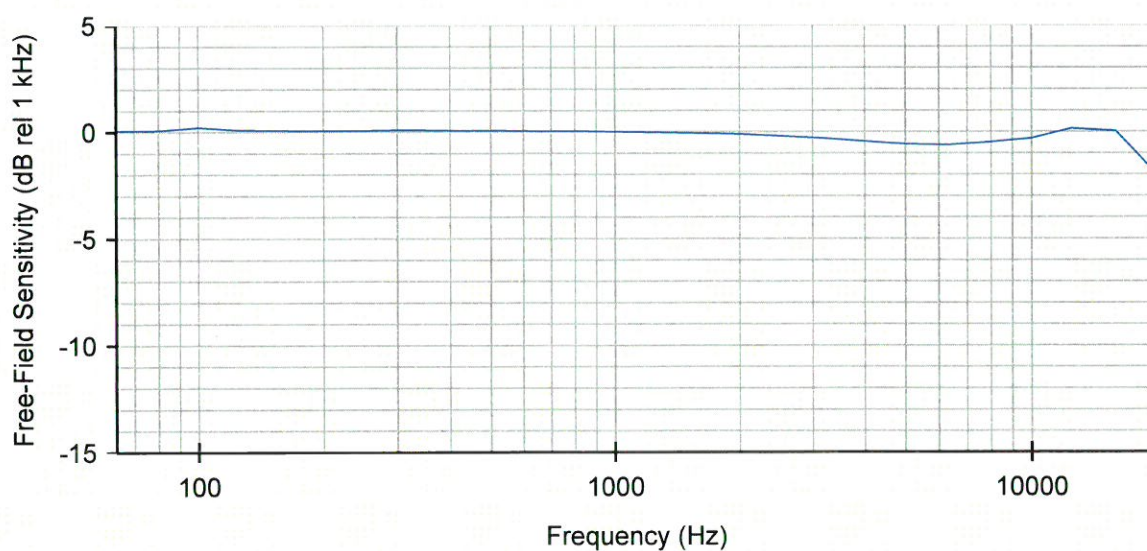
Free-Field Frequency Response : Graphical

The frequency response was measured using an electrostatic actuator in accordance with BS EN 61094-6:2005 with the free-field response derived via standard correction data traceable to a National Measurement Institute.

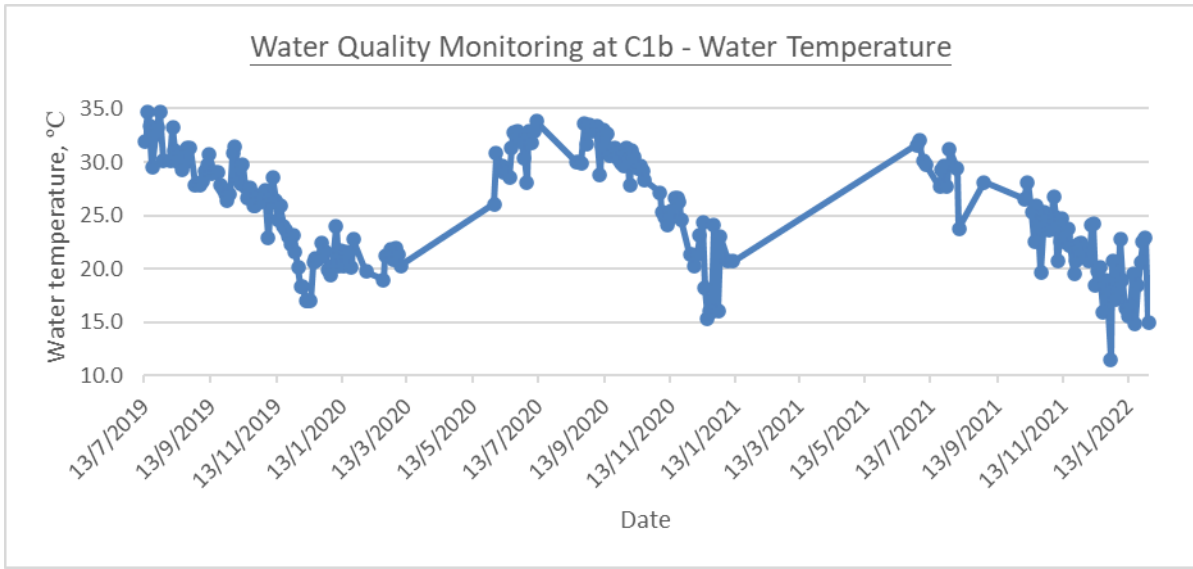
Note 1: Period without data implied that water in location C1b was dried up, insufficient water was available for sample collection

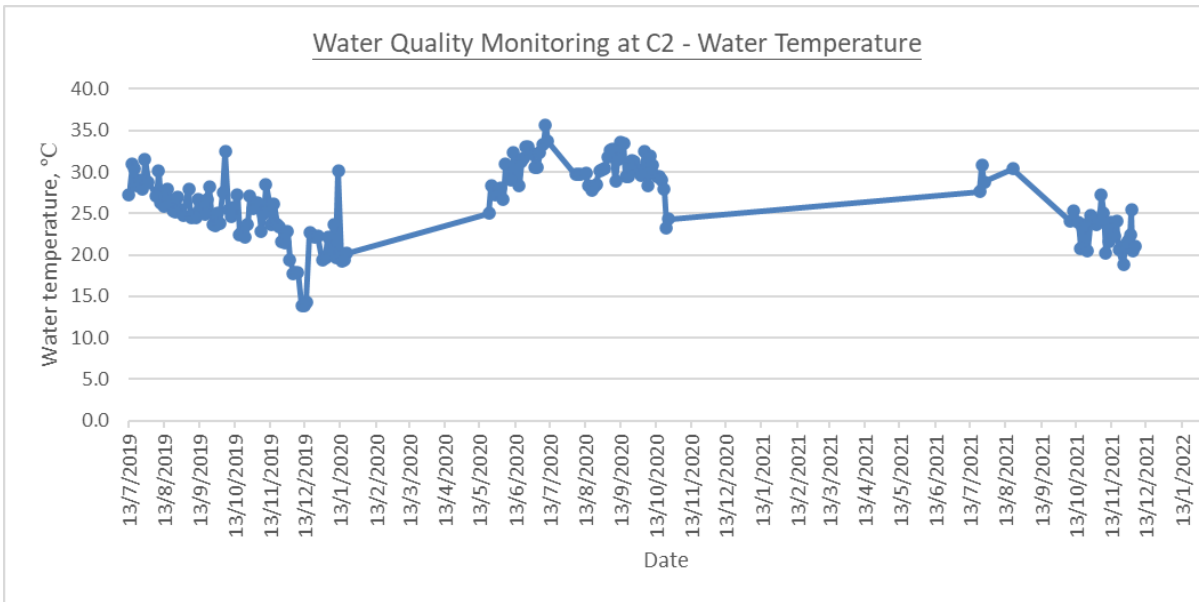
Note 1: Period without data implied that water in location C2 was dried up, insufficient water was available for sample collection
