Contract No. DC/2018/08
Inter-reservoirs Transfer Scheme –
Water Tunnel between Kowloon Byewash Reservoir and Lower Shing Mun Reservoir
Monthly Environmental Monitoring and Audit (EM&A) Report
(February 2022)

32nd Monthly EM&A Report (Rev. 1)

- E2. This is the 32nd Monthly Environmental Monitoring and Audit (EM&A) Report presents EM&A works undertaken in the period from 1 to 28 February 2022. EM&A works were performed in accordance with the approved EM&A Manual and conditions stipulated in the amended Environmental Permit EP-345/2009/A.

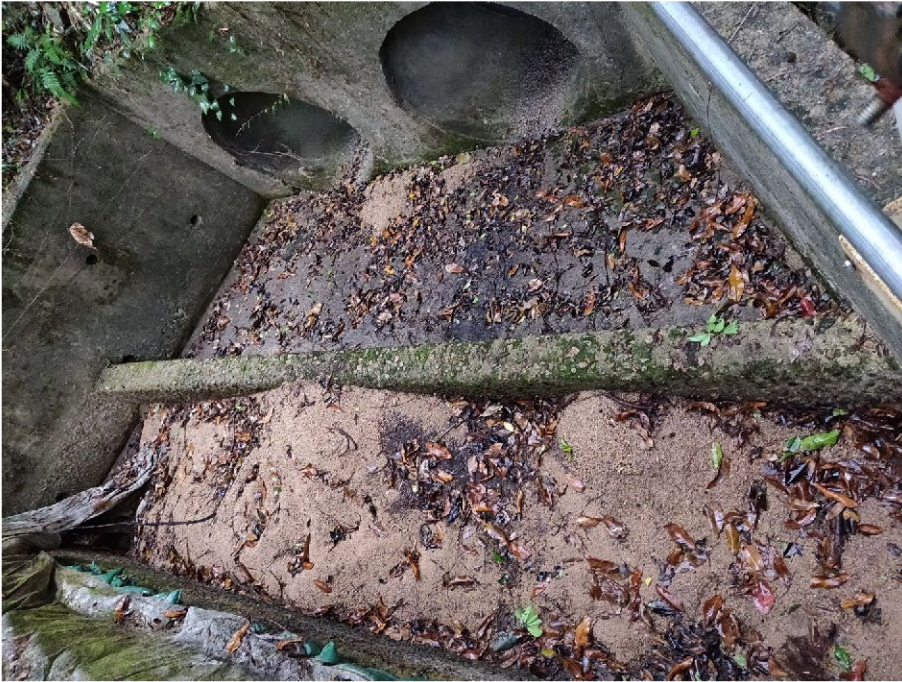
Photograph taken on 2 February 2022 at monitoring location C2. Running water from upstream is allowed via cement drainage pipe.

- Analysis of SS was not carried out with reference to the testing method and detection limit stated in Section 5.3.9 of EM&A Manual.
- Pursuant to Section 5.7.1 of EM&A Manual, water quality parameters including turbidity and suspended solids rely on the representative samples of the upstream control station of the same day to determine their action and limit levels in addition to the baseline data. Recently, IEC carried out a random site inspection and observed the blockage of drainage pipes at the monitoring location C2 (See enclosed). Two metal plates were installed at the drainage cement pipes to restrict the flow of water to the reservoir by gravity. Thus, running water is no longer available in the monitoring location C2 since 7 February 2022. Water monitoring results on 21, 23, 25 and February 2022 were obtained from stagnant water samples. The samples did not validly reflect to the upstream control station of the same day. The effectiveness of sample collected at the monitoring location C2 is also called into doubt. Surprisingly, no advanced notification is given to IEC on the human disturbance of water flow at the

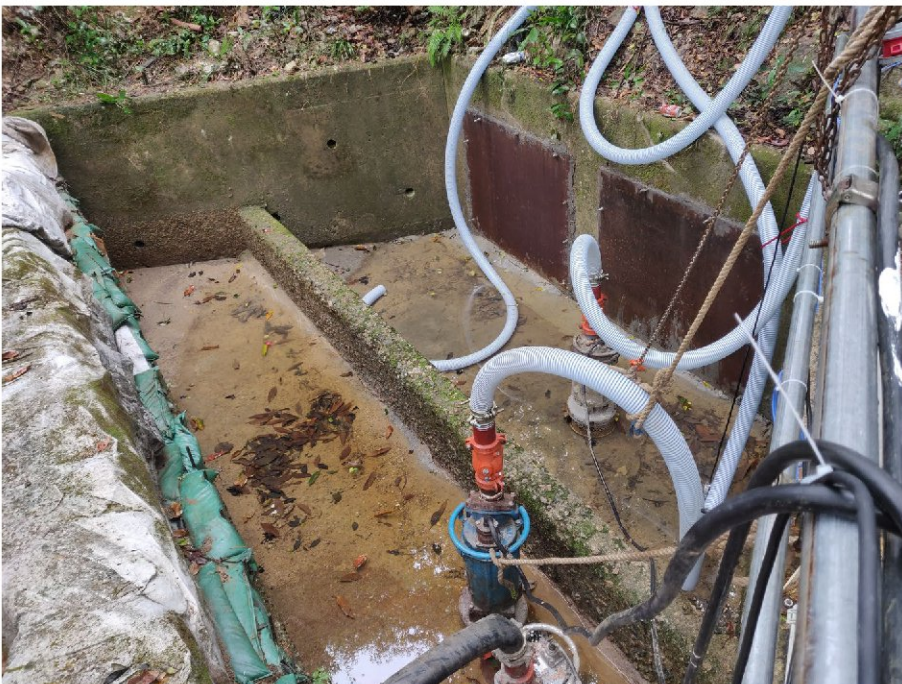
Photograph taken on 7 March 2022 at monitoring location C2. Water is accumulated because of the blockage of cement drainage pipe.

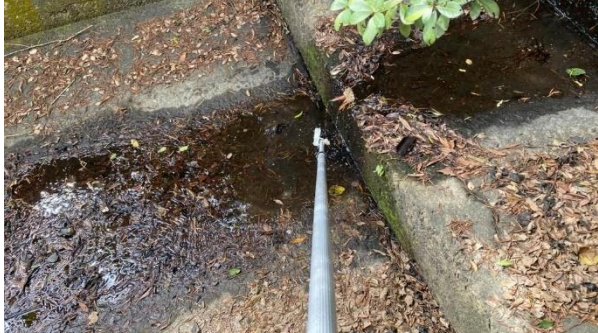
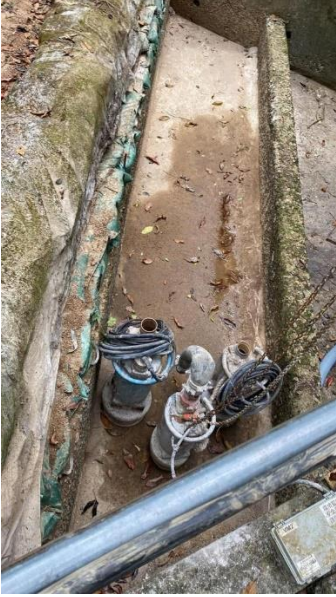
C1b	C2

3.18 After the joint water sampling inspection with the ER, the IEC representative, the Contractor and the ET on 15 October 2021, on days when very shallow flow (<11cm of water depth) were observed at the control points, actions will be taken to collect samples at the sampling locations. At the control point C1b, a small plastic bottle was used to collect samples according to the flow chart below. At the control point C2, samples were collected from another access to the water body.

<p>*Photos taken on 28 February 2022</p>

<p>*Photos taken on 16 February 2022</p>

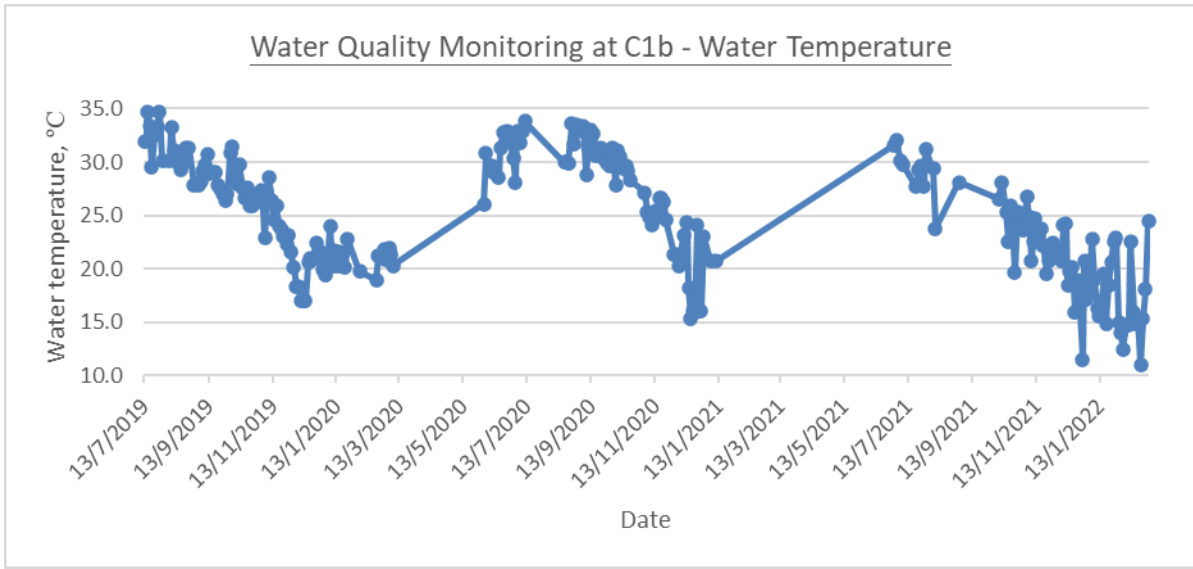
Note 1: Period without data implied that water in location C1b was dried up, insufficient water was available for sample collection
