**Contract No. DC/2018/08**  
**Inter-reservoirs Transfer Scheme -**  
**Water Tunnel between Kowloon Byewash Reservoir and Lower Shing Mun Reservoir**  
**Monthly Environmental Monitoring and Audit (EM&A) Report**  
**(March 2022)**

**Independent Environmental Checker Services for Inter-Reservoirs Transfer Scheme (IRTS) – Water Tunnel between Kowloon Byewash Reservoir and Lower Shing Mun Reservoir**

33rd Monthly EM&A Report (Rev. 1)

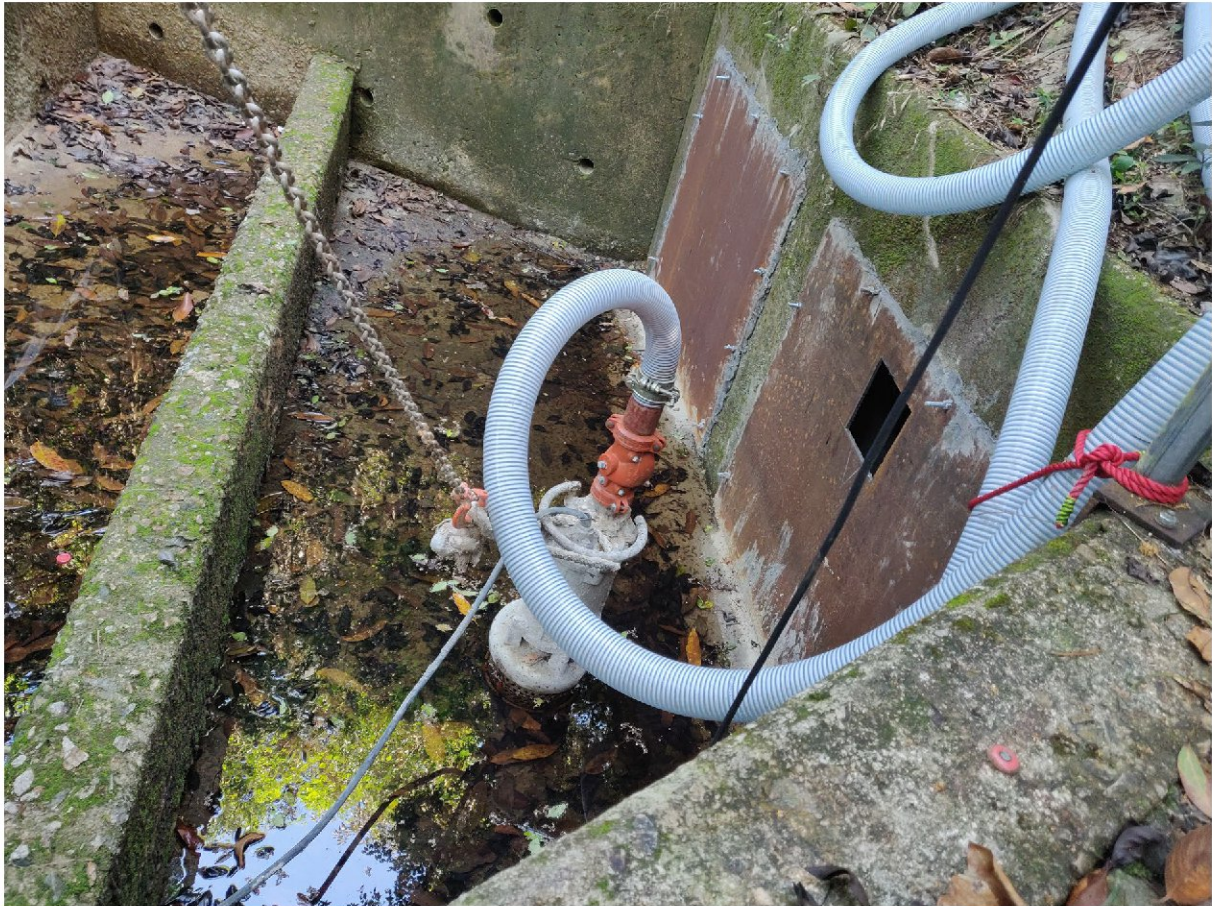
Photograph taken on 4 April 2022 at monitoring location C2. Water is accumulated because of the blockage of cement drainage pipe.

- This is the second reminder. A temporary drainage measure was introduced to influence the monitoring location C2. Monitoring location C2 is no longer a natural stream directing to Lower Shing Reservoir as described in Section 2.5 of Baseline Monitoring Report. Pursuant to Section 5.7.1 of EM&A Manual, water quality parameters including turbidity and suspended solids rely on the representative samples of the upstream control station of the same day to determine their action and limit levels in addition to the baseline data. Recently, IEC carried out a random site inspection and observed the blockage of drainage pipes at the monitoring location C2 (See enclosed). Two metal plates were installed at the drainage cement pipes to restrict the flow of water to the reservoir

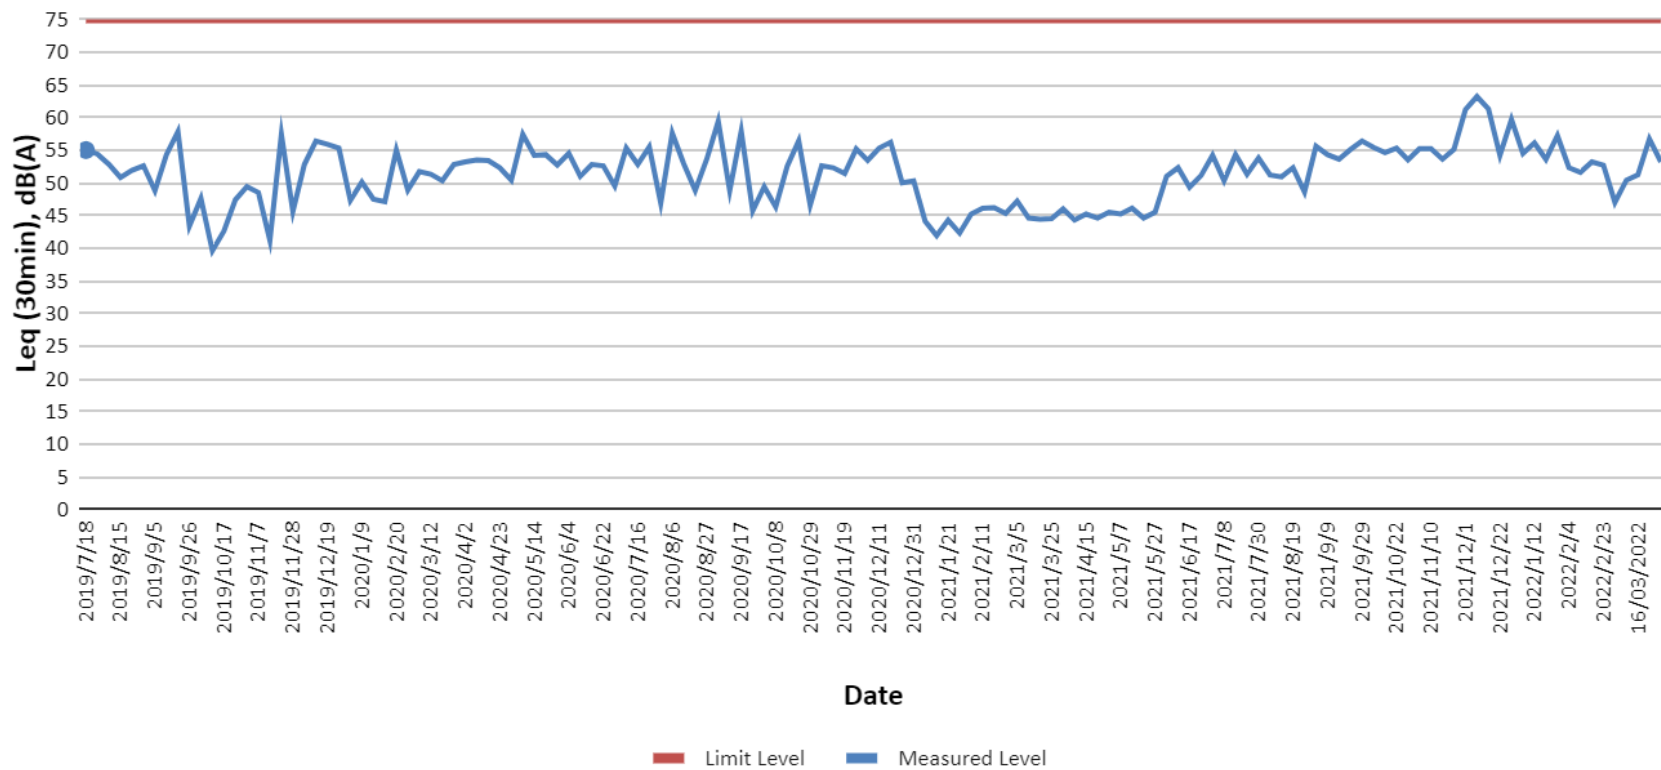
Impact Construction Noise Level at NM1 during Daytime (0700 – 1900) except general holidays and Sunday

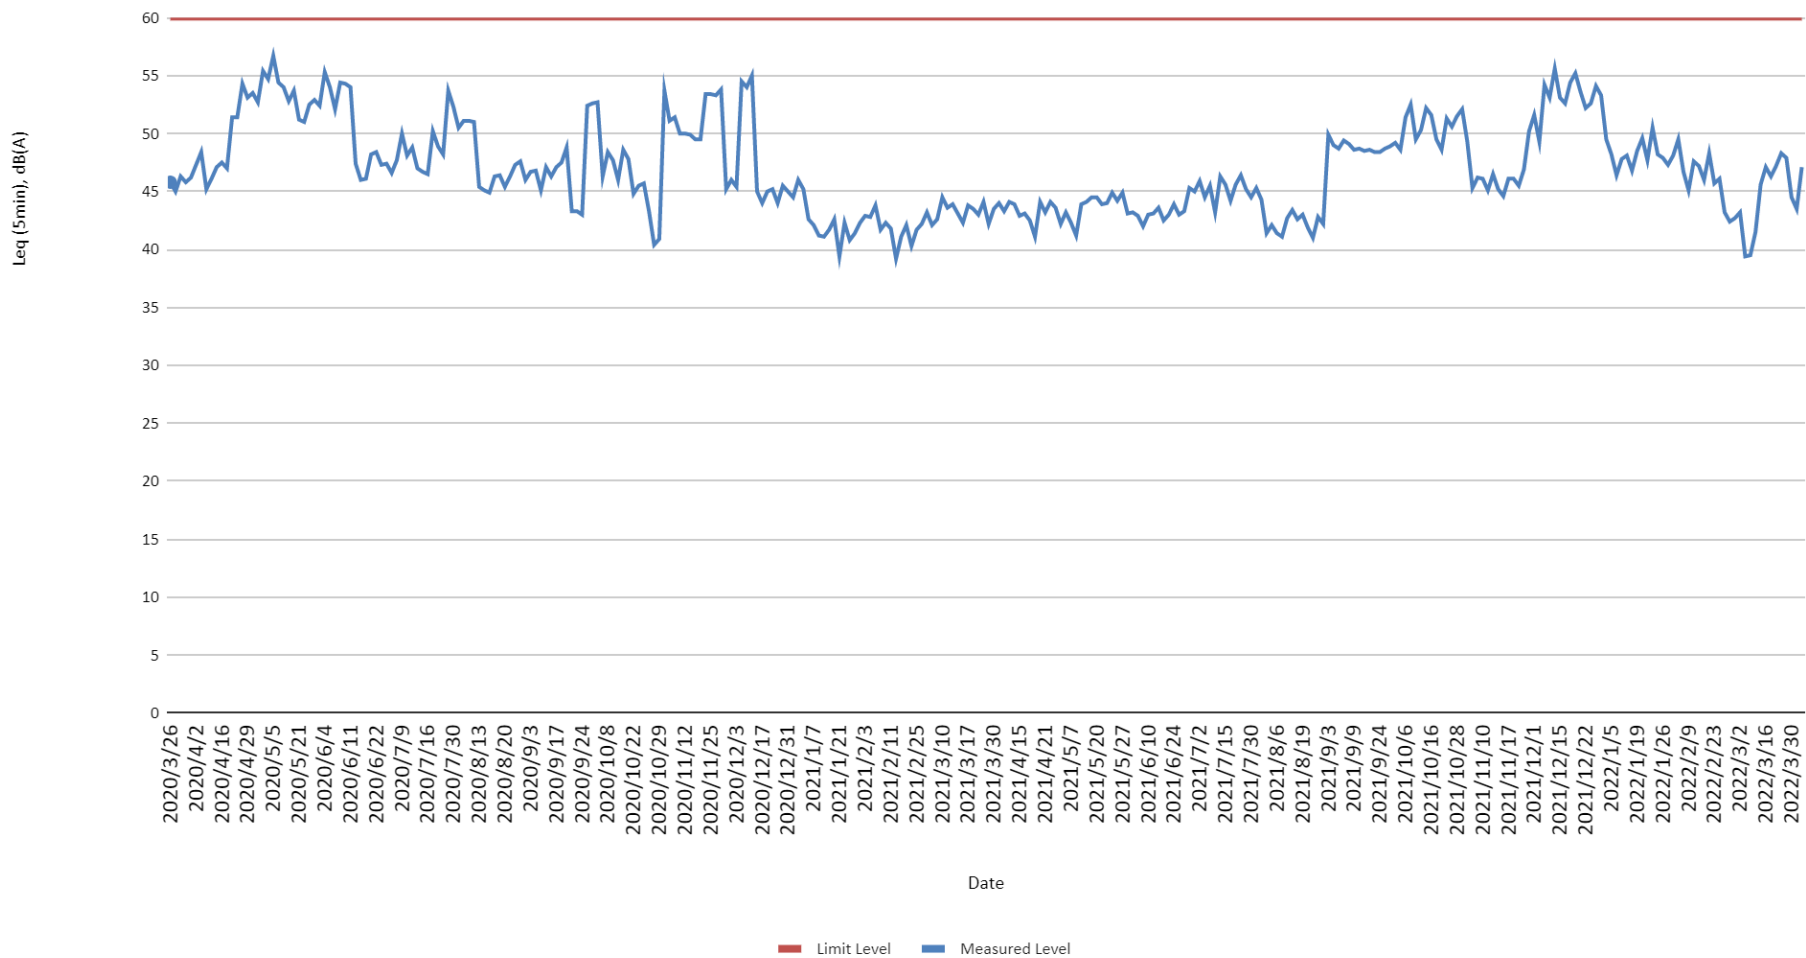
### Impact Construction Noise Level at NM1 during Evening (1900-2300)

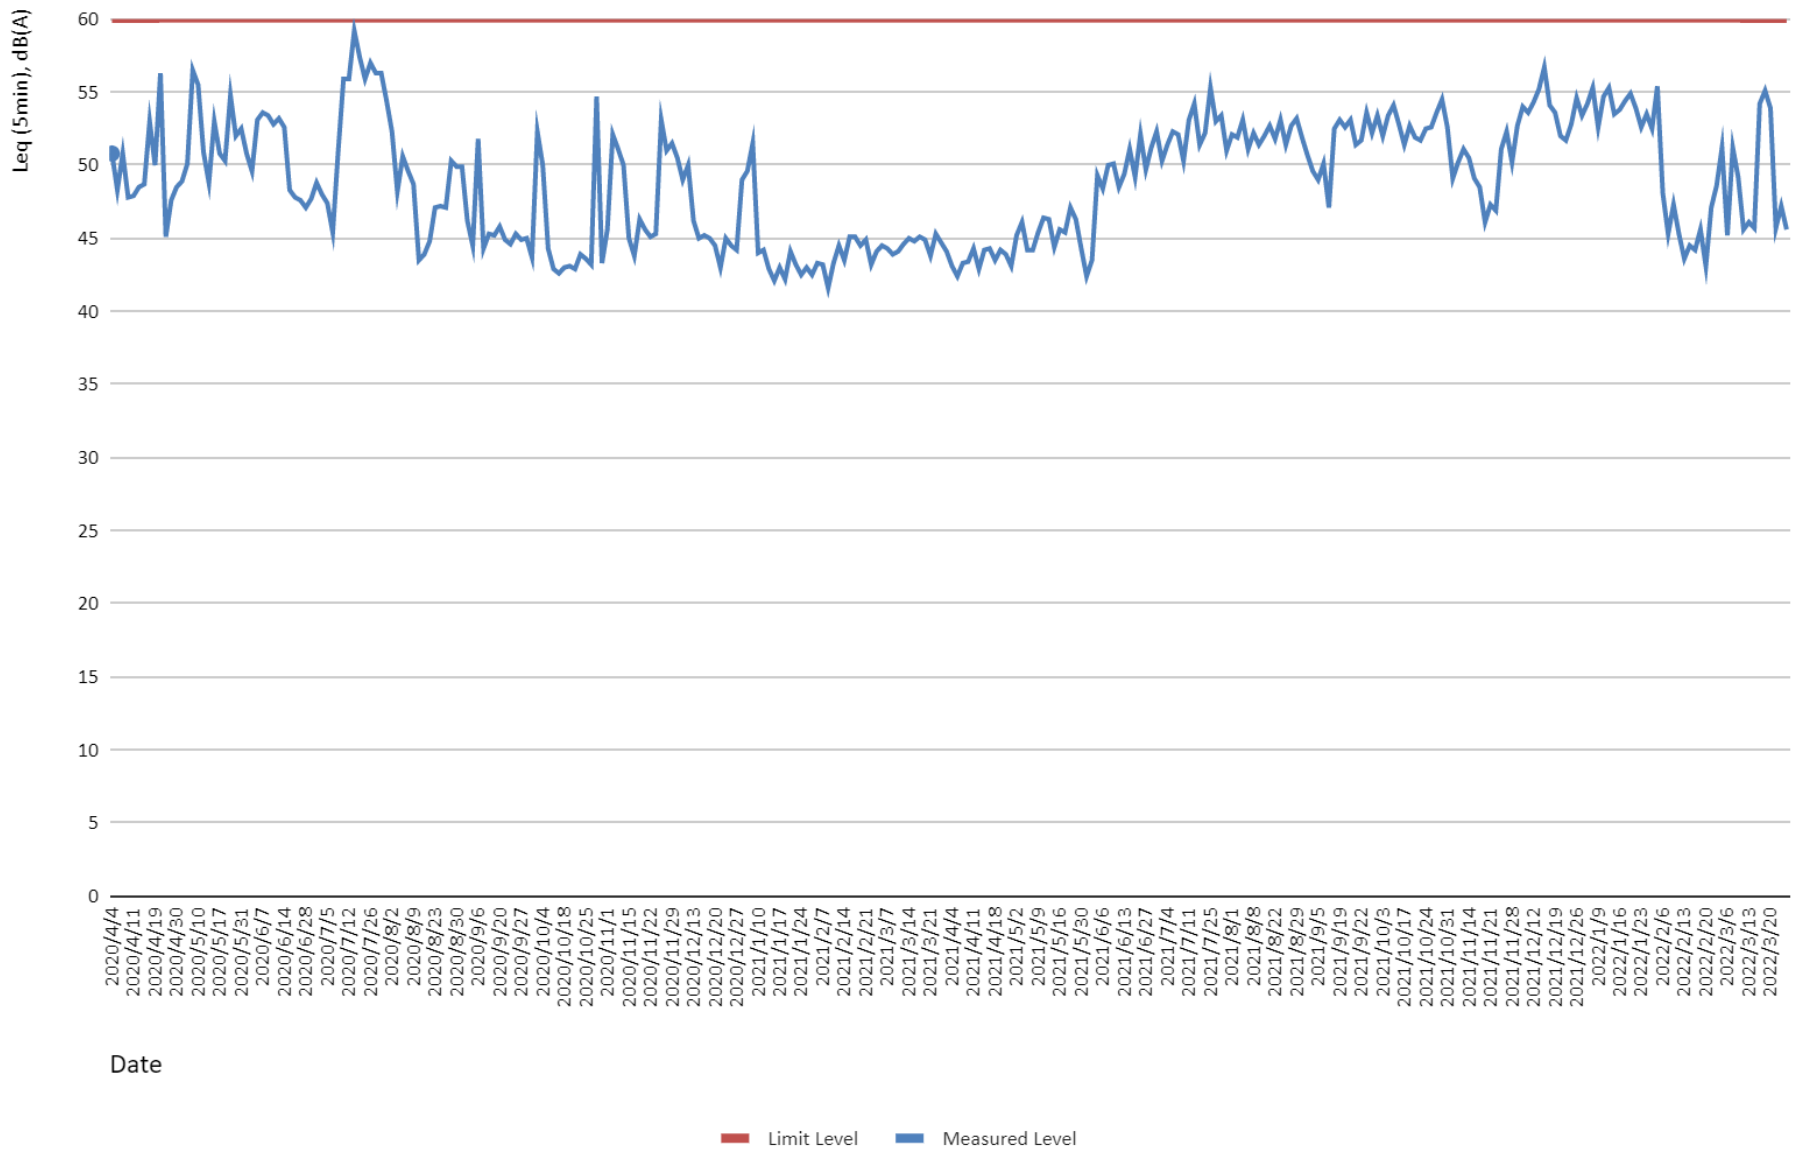
# Impact Construction Noise Level at NM1 during General Holidays and Sundays (0700-1900)

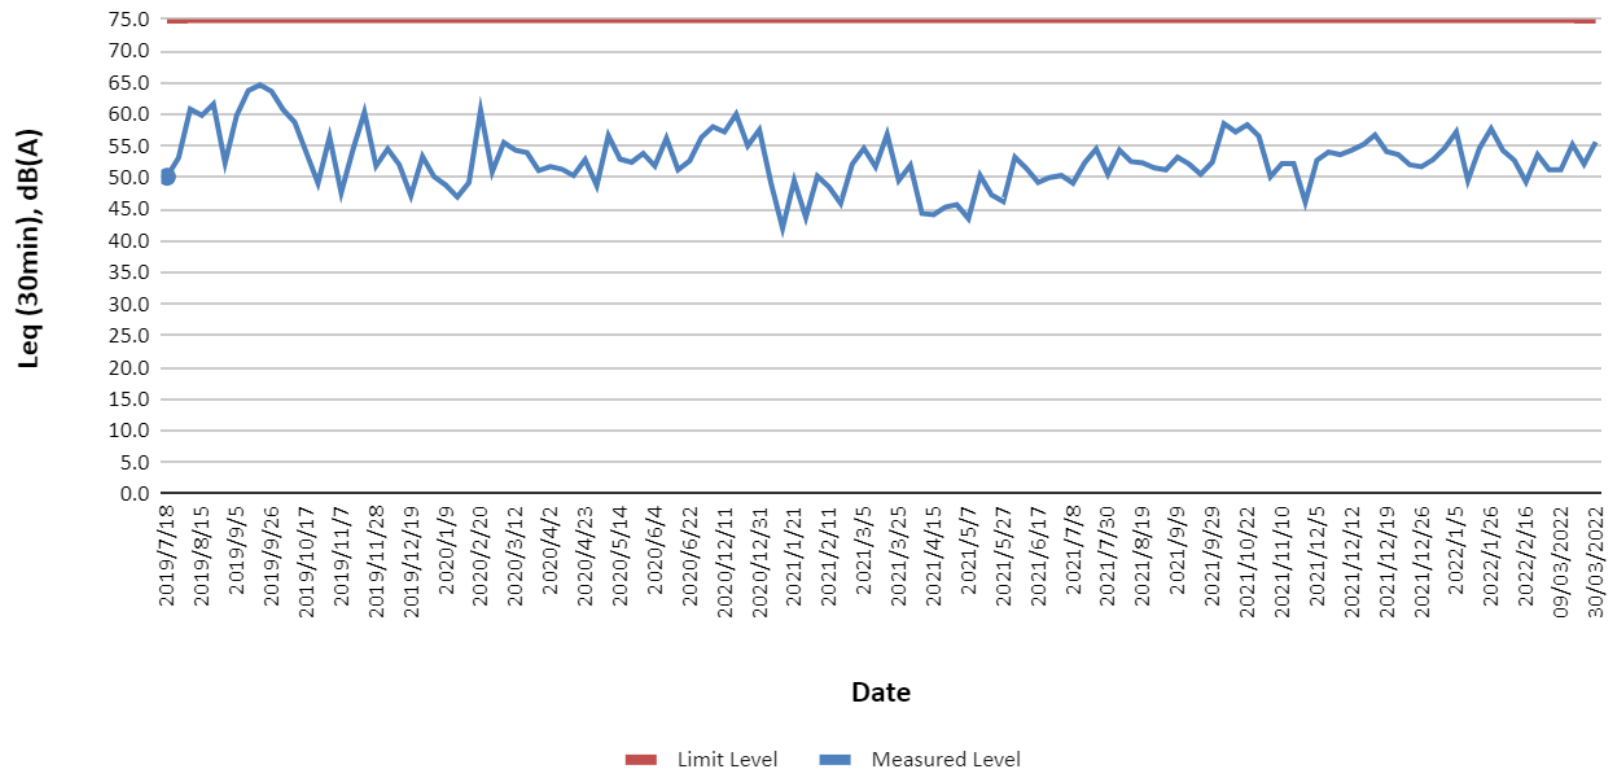
Impact Construction Noise Level at NM2 during Daytime  
(0700 – 1900) except general holidays and Sunday

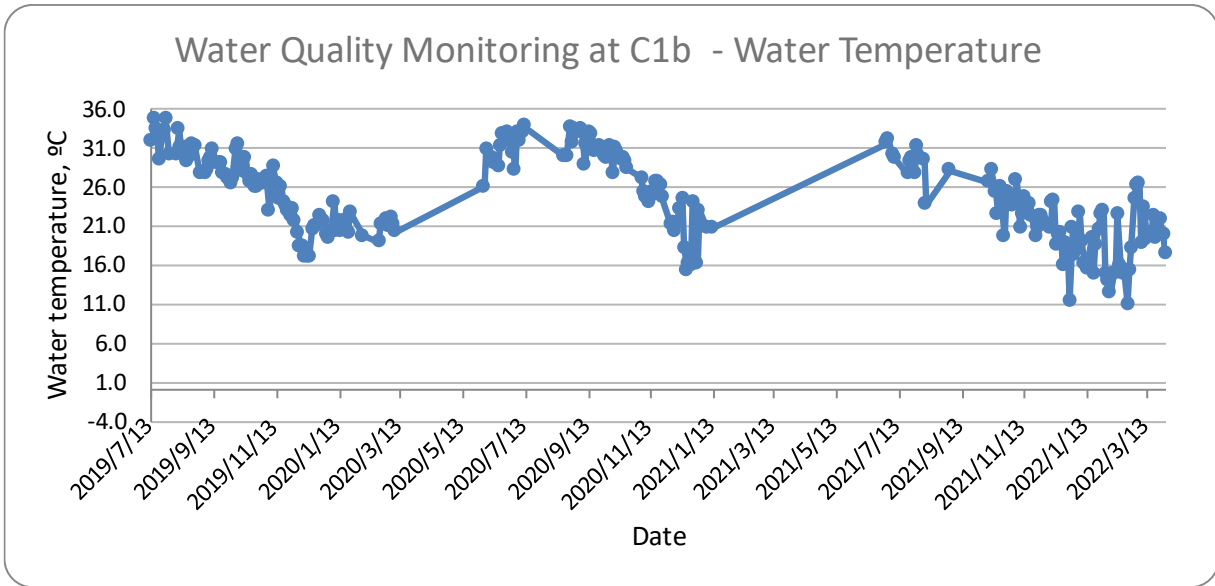
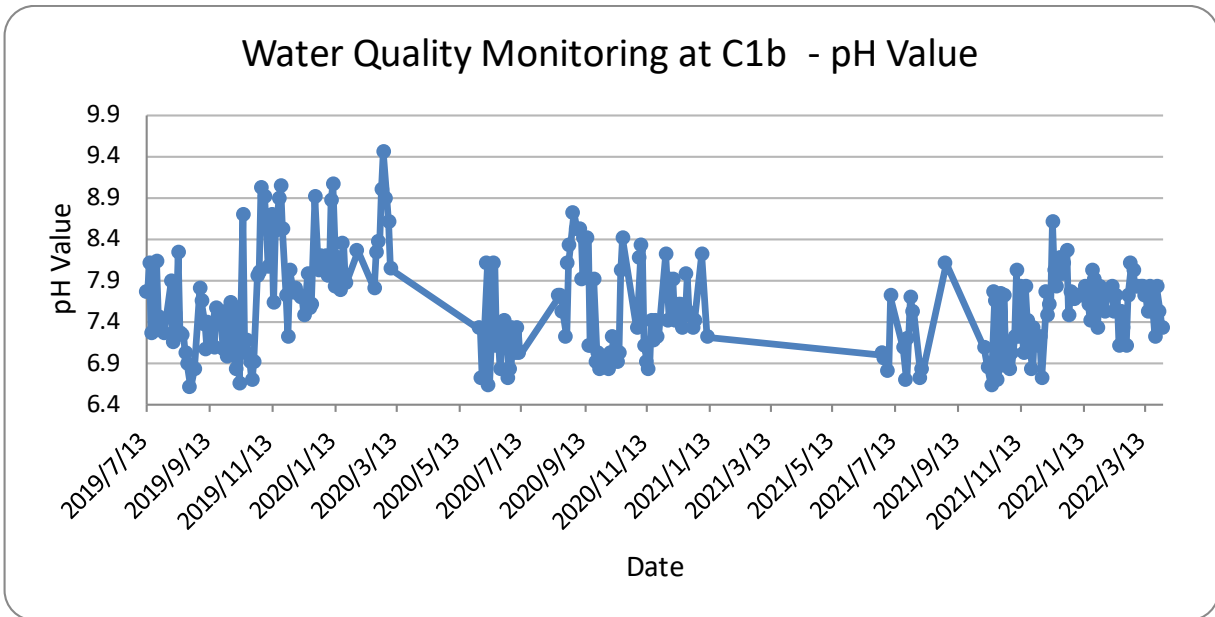
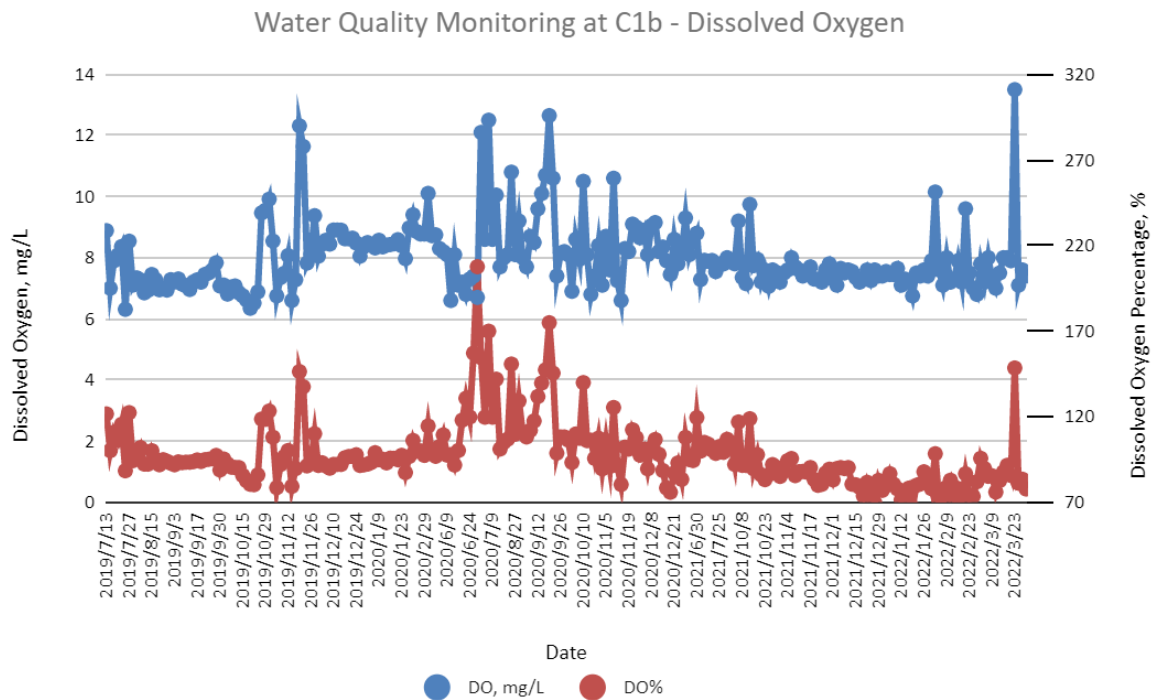
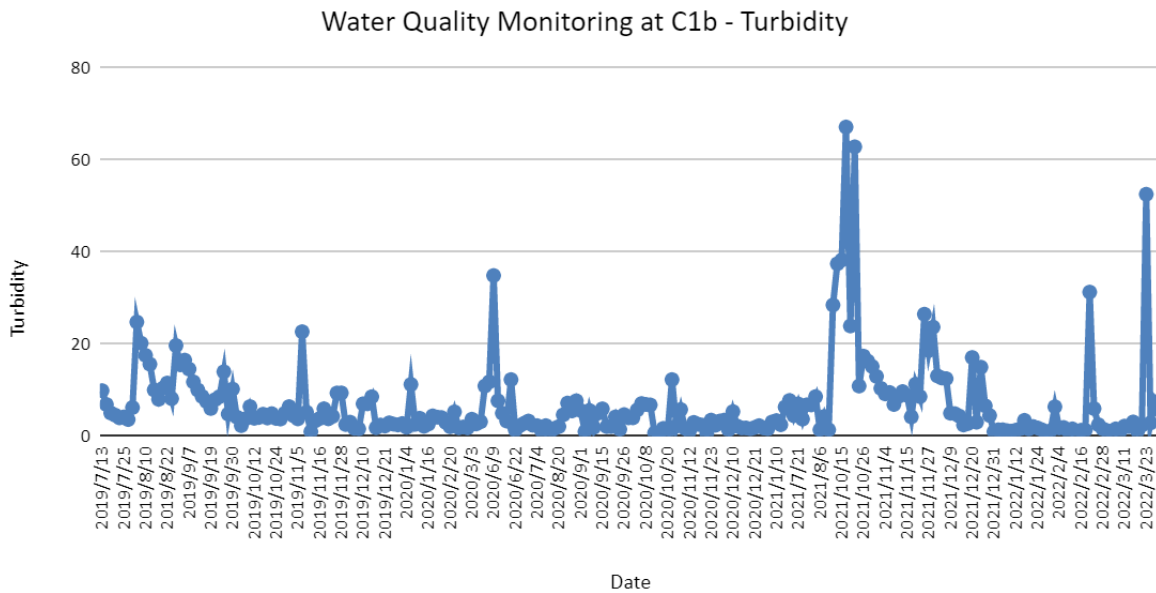
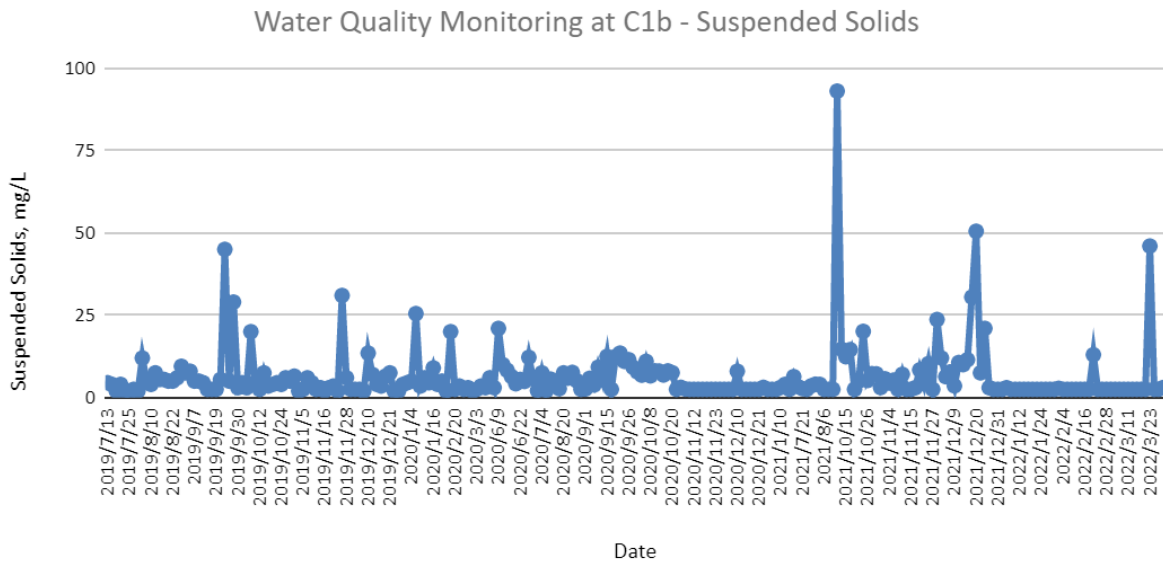
Note 1: Period without data implied that water in location C1b was dried up, insufficient water was available for sample collection

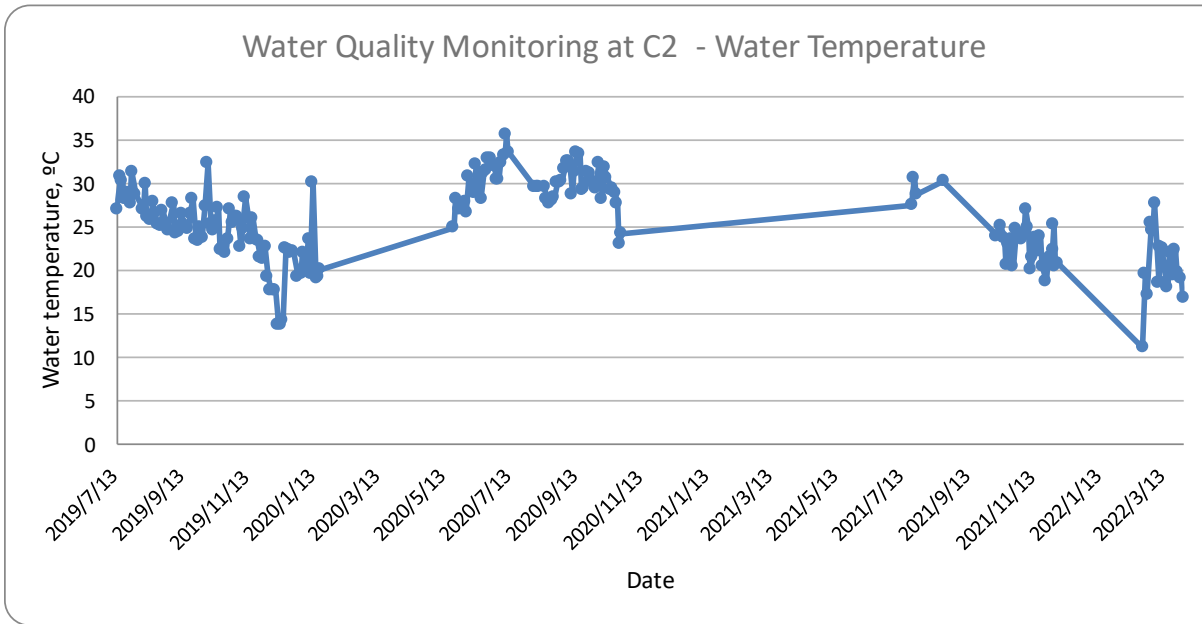
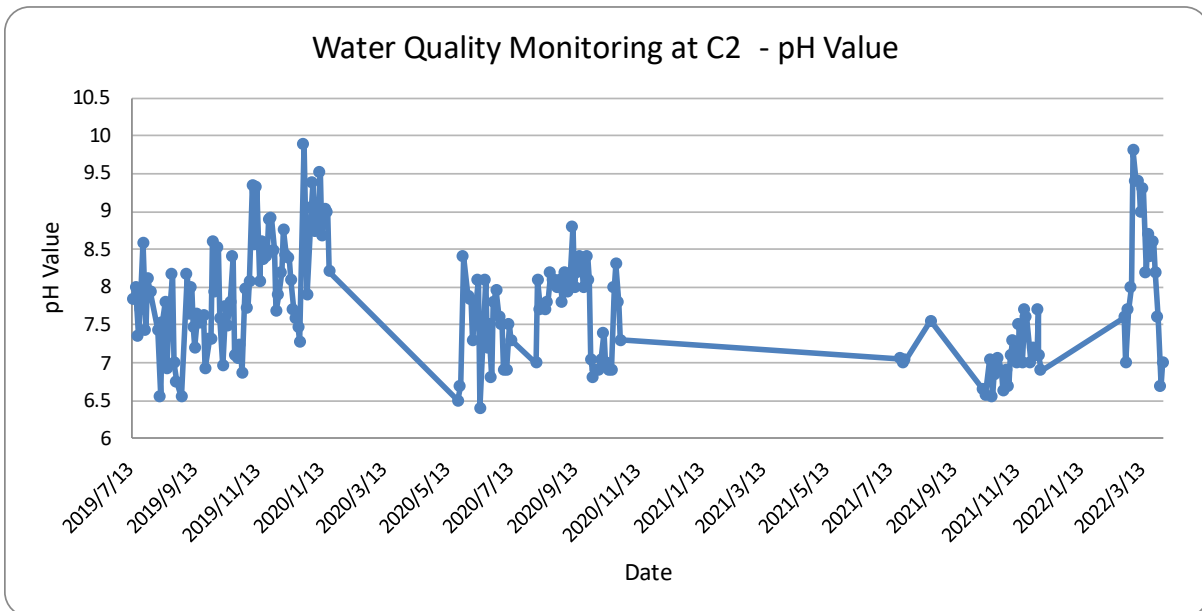
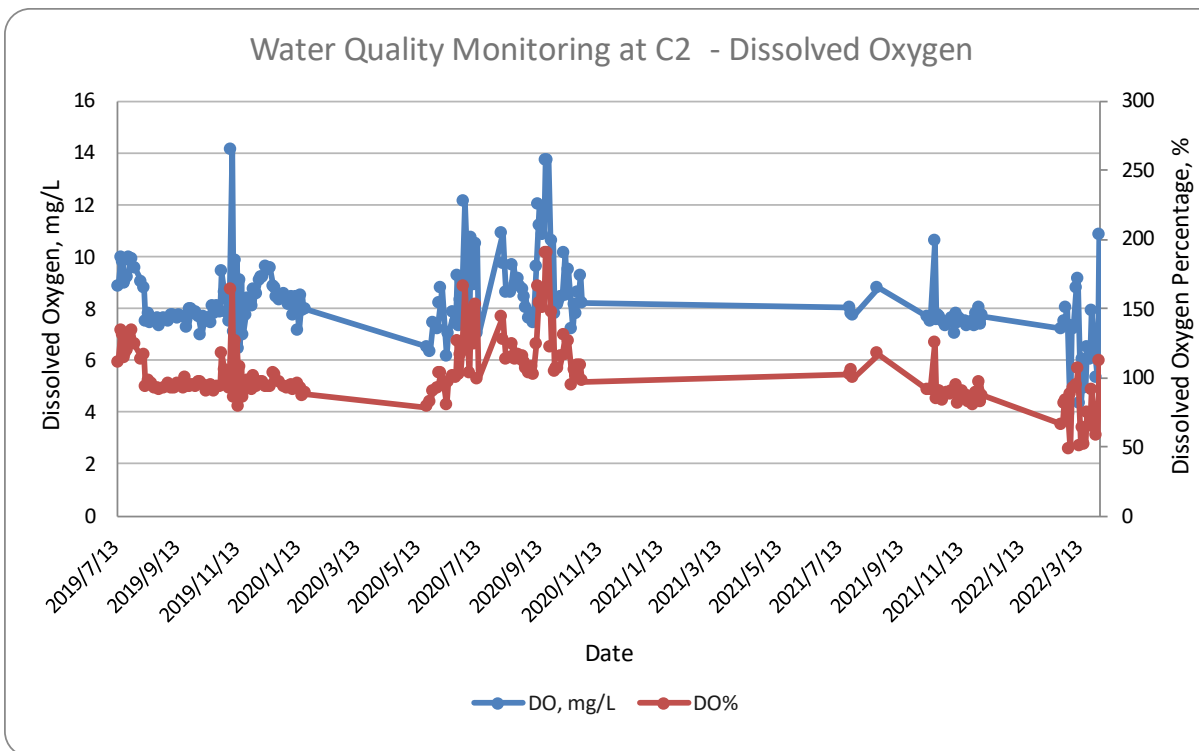
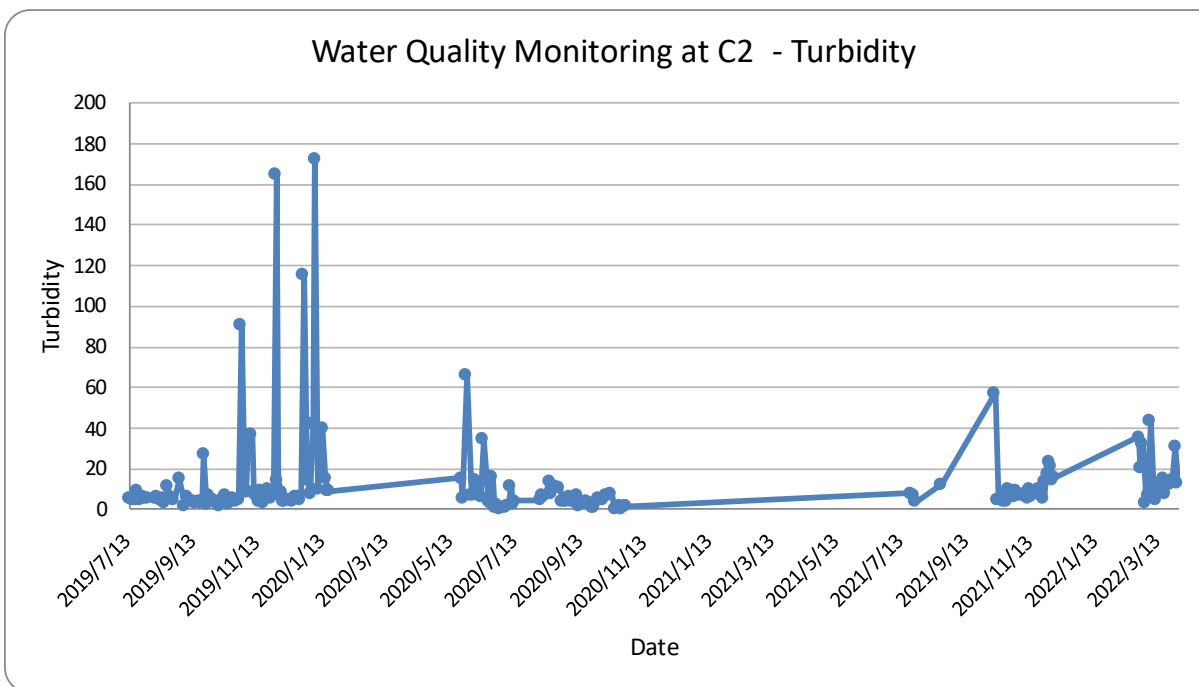
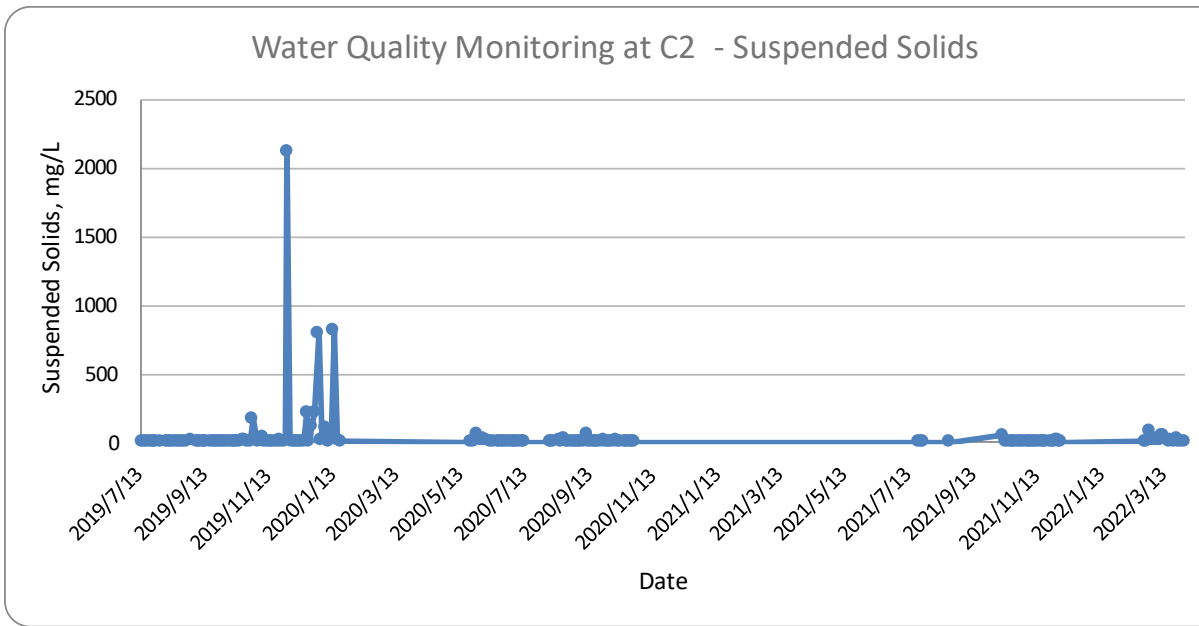
Note 1: Period without data implied that water in location C2 was dried up, insufficient water was available for sample collection
