Contract No. DC/2018/08
Inter-reservoirs Transfer Scheme –
Water Tunnel between Kowloon Byewash Reservoir and Lower Shing Mun Reservoir
Monthly Environmental Monitoring and Audit (EM&A) Report
(September 2022)

Independent Environmental Checker Services for Inter-Reservoirs Transfer Scheme (IRTS) – Water Tunnel between Kowloon Byewash Reservoir and Lower Shing Mun Reservoir
39th Monthly EM&A Report (Rev. 1)

- E2. This is the 39th Monthly Environmental Monitoring and Audit (EM&A) Report presents EM&A works undertaken in the period from 1 to 30 September 2022. EM&A works were performed in accordance with the approved EM&A Manual and conditions stipulated in the amended Environmental Permit EP-345/2009/A.

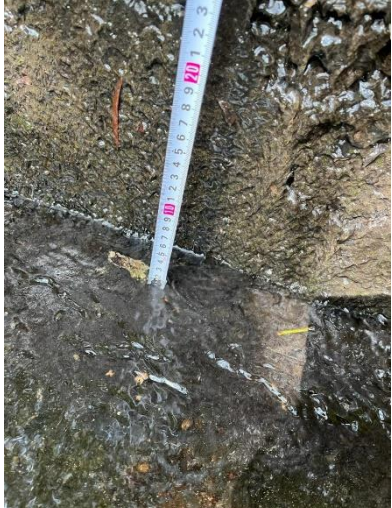
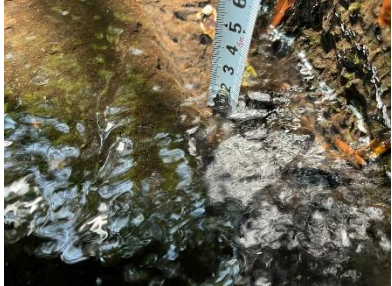
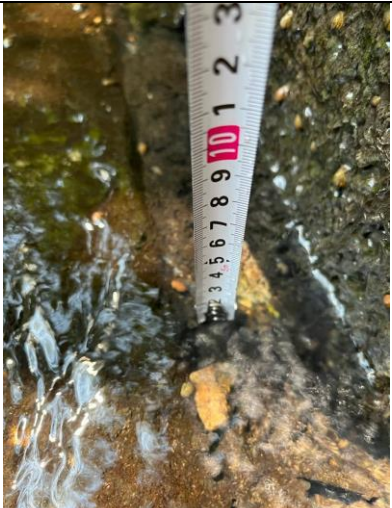
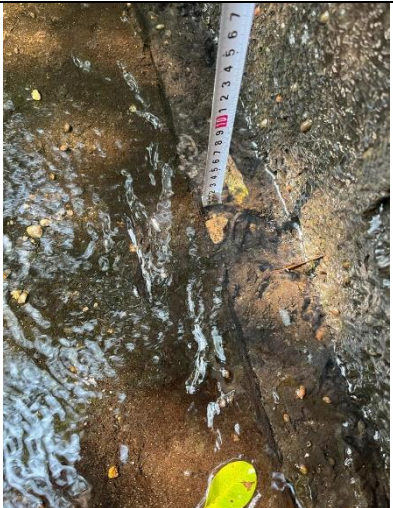
C1b on Days with Insufficient Water Available for Water Sampler at Original Access		
2/9/2022	5/9/2022	7/9/2022

3.19 After the joint water sampling inspection with the ER, the IEC representative, the Contractor and the ET on 15 October 2021, on days when very shallow flow (<11cm of water depth) were observed at the control points, actions will be taken to collect samples at the sampling locations. At the control point C1b, a small plastic bottle was used to collect samples according to the flow chart below. At the control point C2, samples were collected from another access to the water body.

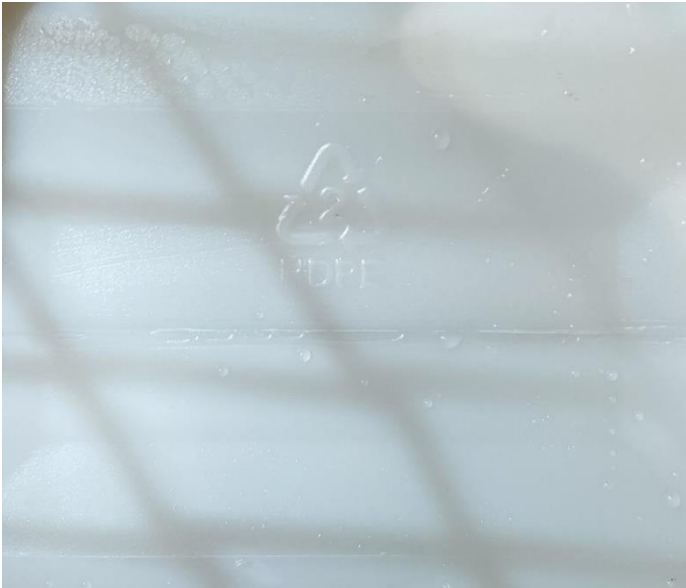
4.	Section 5.3.6 of the EM&A Manual mentions that water samples for SS measurement should be collected in high density polythene bottles. The ET stated that "the sampling bottles are made from plastic" However, there are no documents provided showing that bottles for storing the water samples are made of high density polythene bottles. Please consider the ET response made as mentioned, whether the ET and the ET Leader shall be responsible for the implementation of the EM&A programme.	As per the confirmation from laboratory, the 5-L sampling bottles are made from HDPE. The icon of HDPE is printed on the bottom of the sampling bottles, please refer to the photo below:

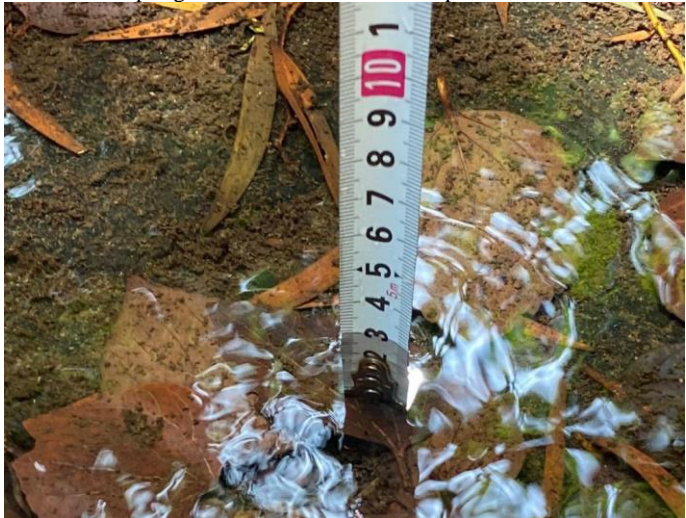
ITEM NO.	IEC'S COMMENT	ET'S RESPONSE	CLOSE DATE
6.	<p>Section 5.3.5 of the EM&A Manual stipulates that a water sampler should be used. The ET reported that "same water sampler was used for impact water quality monitoring at all monitoring locations" However, water samples at monitoring location C1b were not collected with the same water sampler under EO and IEC witnesses during monthly random site inspection on 28 September 2022. Please consider the ET response made as mentioned, that the ET and the ET Leader shall be responsible for the implementation of the EM&A programme.</p>	<p>At monitoring location C1b, shallow water level is often observed and the water sample could not be obtained by using the approved water sampler. Since the water monitoring methodology of the Project has no designated water sampling depths (i.e., surface/ middle/ bottom), depending on the water depth, a water bucket or a small plastic bottle are proposed to be used to collect water samples in shallow water at the designated locations to facilitate the water sampling of this location.</p> <p>If the measured water depth is between 7 cm and 11 cm (i.e. $7 \text{ cm} \leq \text{water depth} < 11 \text{ cm}$), a water bucket shall be used to obtain the water sample. If the measured water depth is between 3 cm and 7 cm (i.e. $3 \text{ cm} \leq \text{water depth} < 7 \text{ cm}$), a small plastic bottle shall be used to obtain the water sample.</p> <p>The water depth at C1b on 28 September 2022 was 3cm, thus, small plastic bottle was used for water sampling at C1b. Please refer to the photo record below:</p>
