21st Monthly EM&A Report (Rev. 1)

March 2021

Inter-Reservoir Transfer Scheme – Water Tunnel Between Kowloon Byewash Reservoir and Lower Shing Mun Reservoir (Contract No.: DC/2018/08)

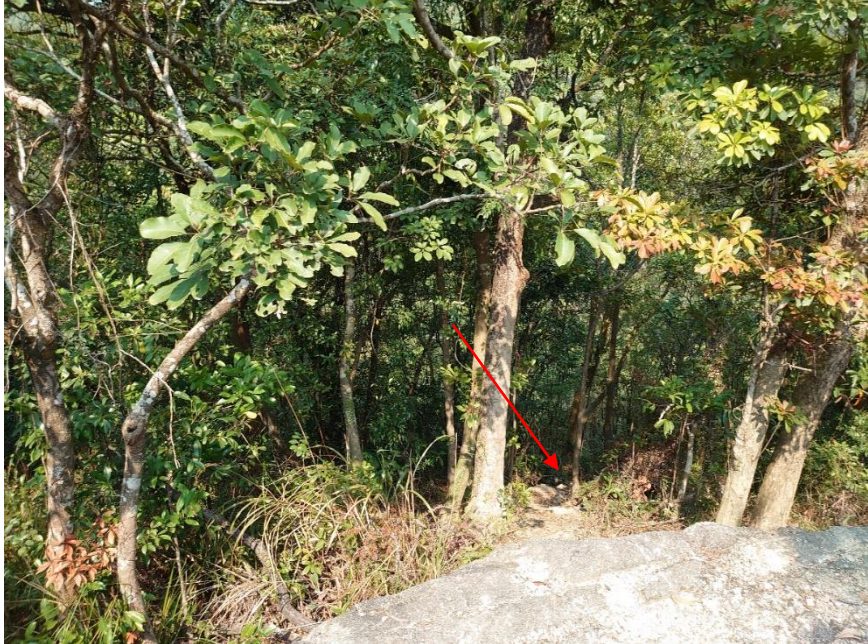
Parameter	Works within Country Park
Investigation finding	<p>The ET approached the Contractor to obtain the details of the site works at the location of complaint. The ET was informed that the Contractor was carrying out preparation works and erection of scaffolding platform for ground investigation (GI) works at Borehole No. RDH3 during the concerned period.</p> <p>Joined with the Contractor and the Supervisor's representatives, the ET conducted a site visit to the concerned area on 12 Mar 2021 but the concerned area was considered not accessible due to safety consideration. A photograph showing the entrance of sole access leading to the compliant location was taken on that day as shown below:</p>

<p>Based on the Pre-Construction Site Check Report for RDH3 provided by the Contractor, pre-construction site checking was conducted by a certified arborist on 21 January 2021, in which the trees and plant species of conservation importance specified under EP No. EP-345/2009/A were identified, photo recorded and demarcated for preservation on site. Vegetation clearance works was carried out but no trees and plant species of conservation importance were cut down.</p> <p>At the concerned location, a scaffolding platform was erected and helicopters were used to transported the materials.</p> <p>In view of several considerations including the progress of TBM tunneling works and the additional time requiring for any conservation measures for the freshwater turtle, the Contractor considered that there would not be sufficient time to complete the planned GI fieldworks and the associated laboratory tests for Borehole No. RDH3 before arrival of Tunneling Boring Machine at about 120m below the existing ground level. The Contractor decided to suspend immediately.</p>

<p>Actions taken / to be taken</p>	<p>The planned GI works the concerned area were ceased before carrying out. The temporary scaffolding platform for GI works and the wooden boards forming the site access to the platform were dismantled shortly after. All plants, machines and most of the materials were removed off site by aerial lifting right after Chinese New Year.</p>
<p>Remarks</p>	<p>N/A</p>
