**Service Contract No. WD/04/2020
Development of Lok Ma Chau Loop:
Main Works Package 1 –
Environmental Team**

**Environmental Permit No.: EP-477/2013/A –
Development of Lok Ma Chau Loop**

**Quarterly Environmental Monitoring and
Audit Report for July to September 2023
(Version 1.0)**

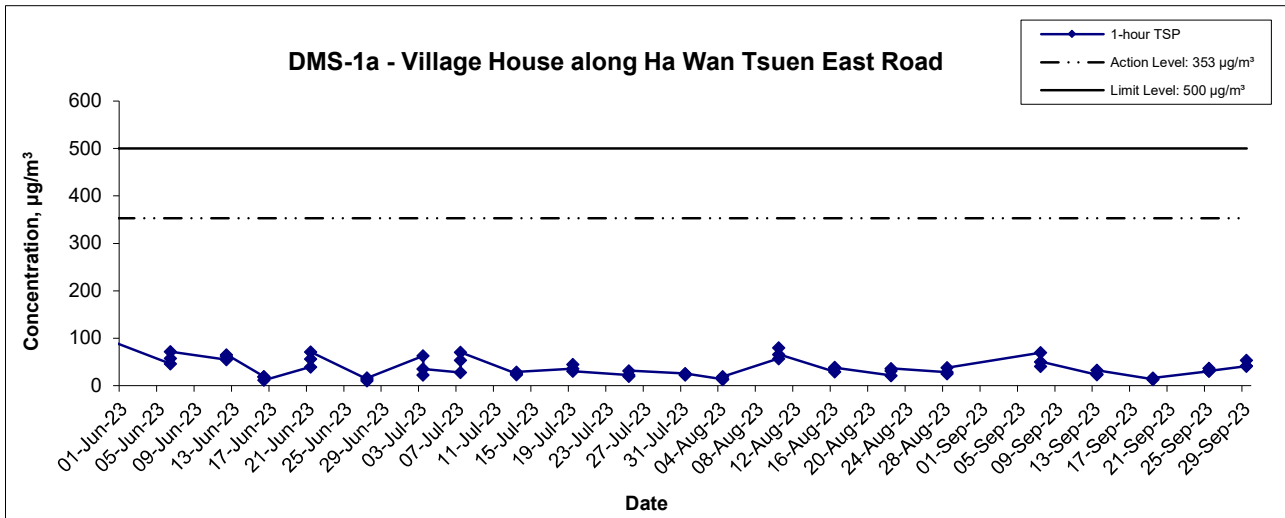
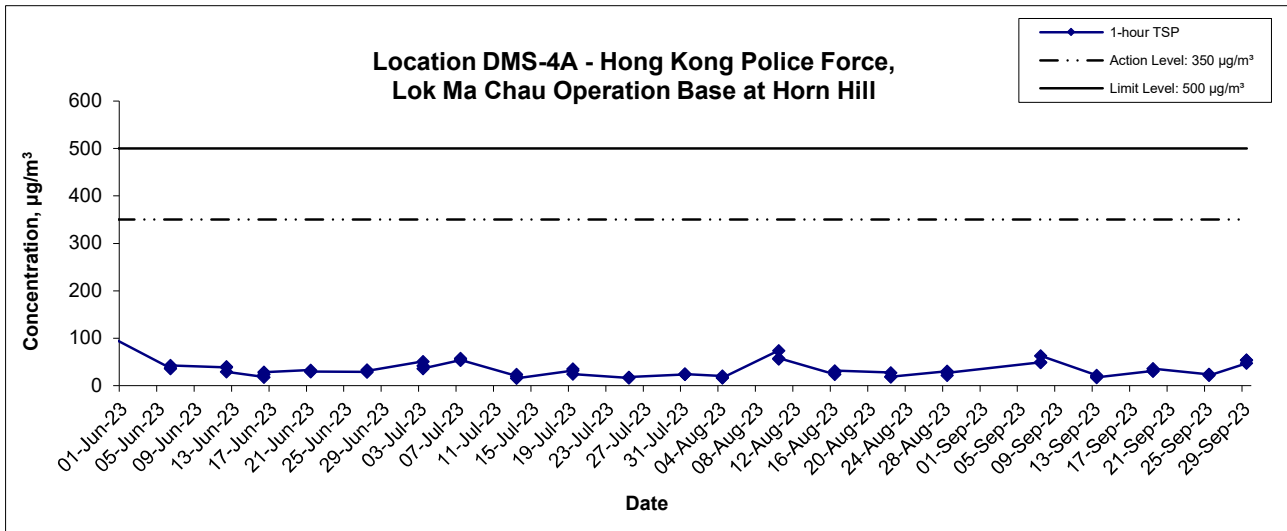
1-hour TSP Concentration Levels

Title Service Contract No. WD/04/2020 Development of Lok Ma Chau Loop: Main Works Package 1 - Environmental Team Graphical Presentation of 1-hour TSP Monitoring Results	Scale N.T.S	Project No. WMA21009

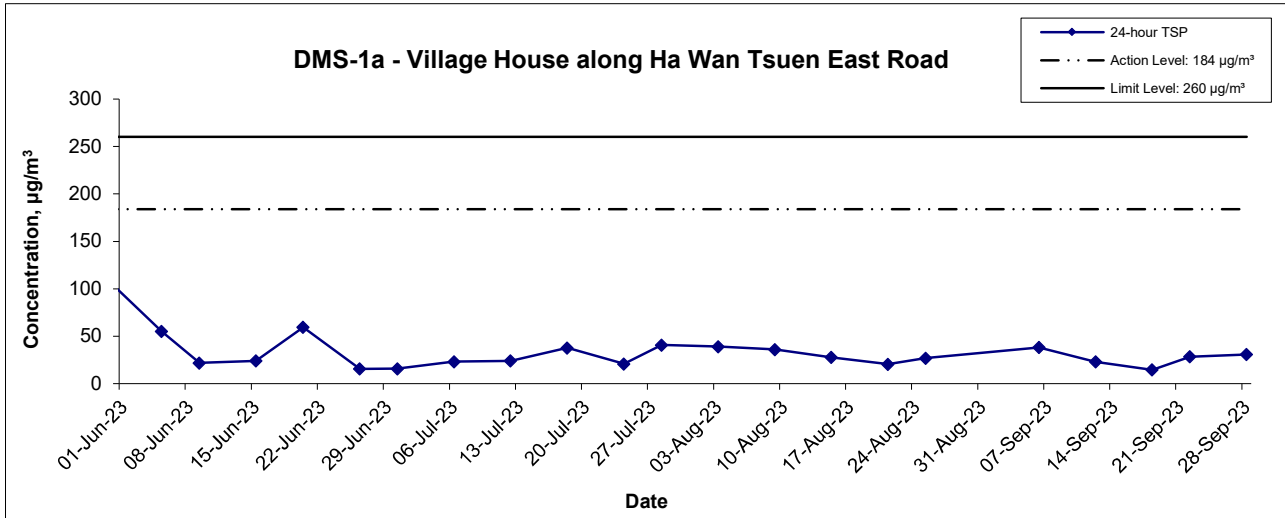
24-hour TSP Concentration Levels

Title Service Contract No. WD/04/2020 Development of Lok Ma Chau Loop: Main Works Package 1 - Environmental Team Graphical Presentation of 24-hour TSP Monitoring Results	Scale	N.T.S	Project No.	WMA21009	consulting . testing . research
	Date	Sept 23	Appendix	C

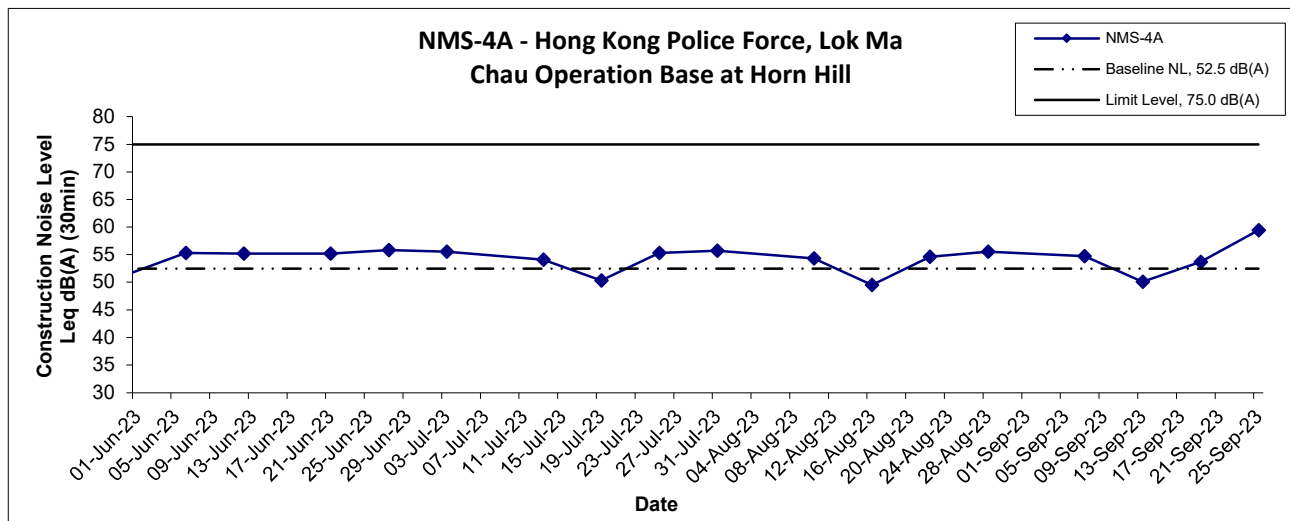
Noise Levels

Title Service Contract No. WD/04/2020 Development of Lok Ma Chau Loop: Main Works Package 1 - Environmental Team Graphical Presentation of Construction Noise Monitoring Results	Scale	N.T.S	Project No.	WMA21009
	Date	Sept 23	Appendix	D

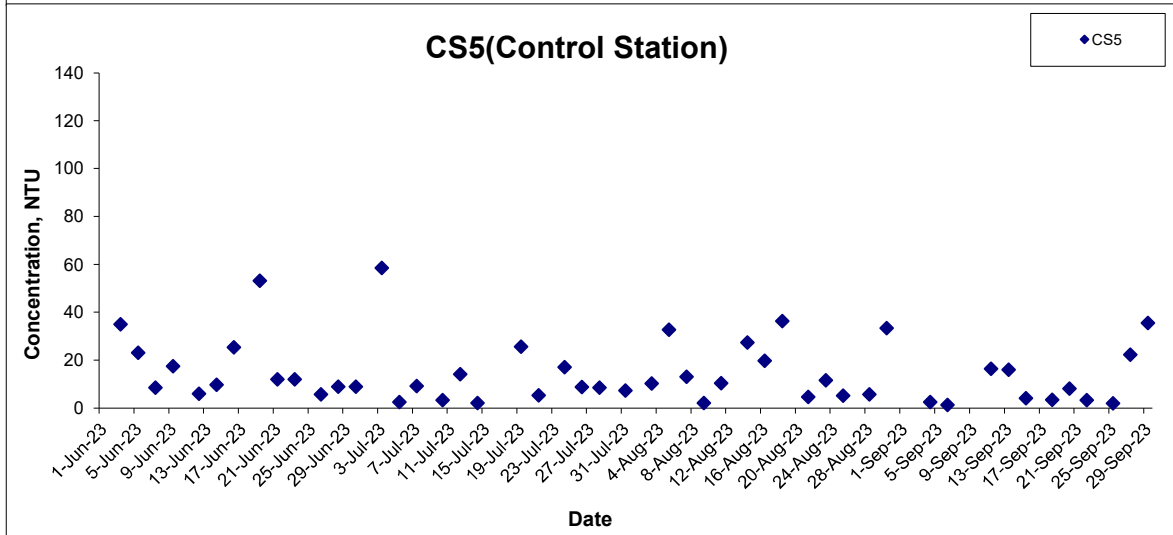
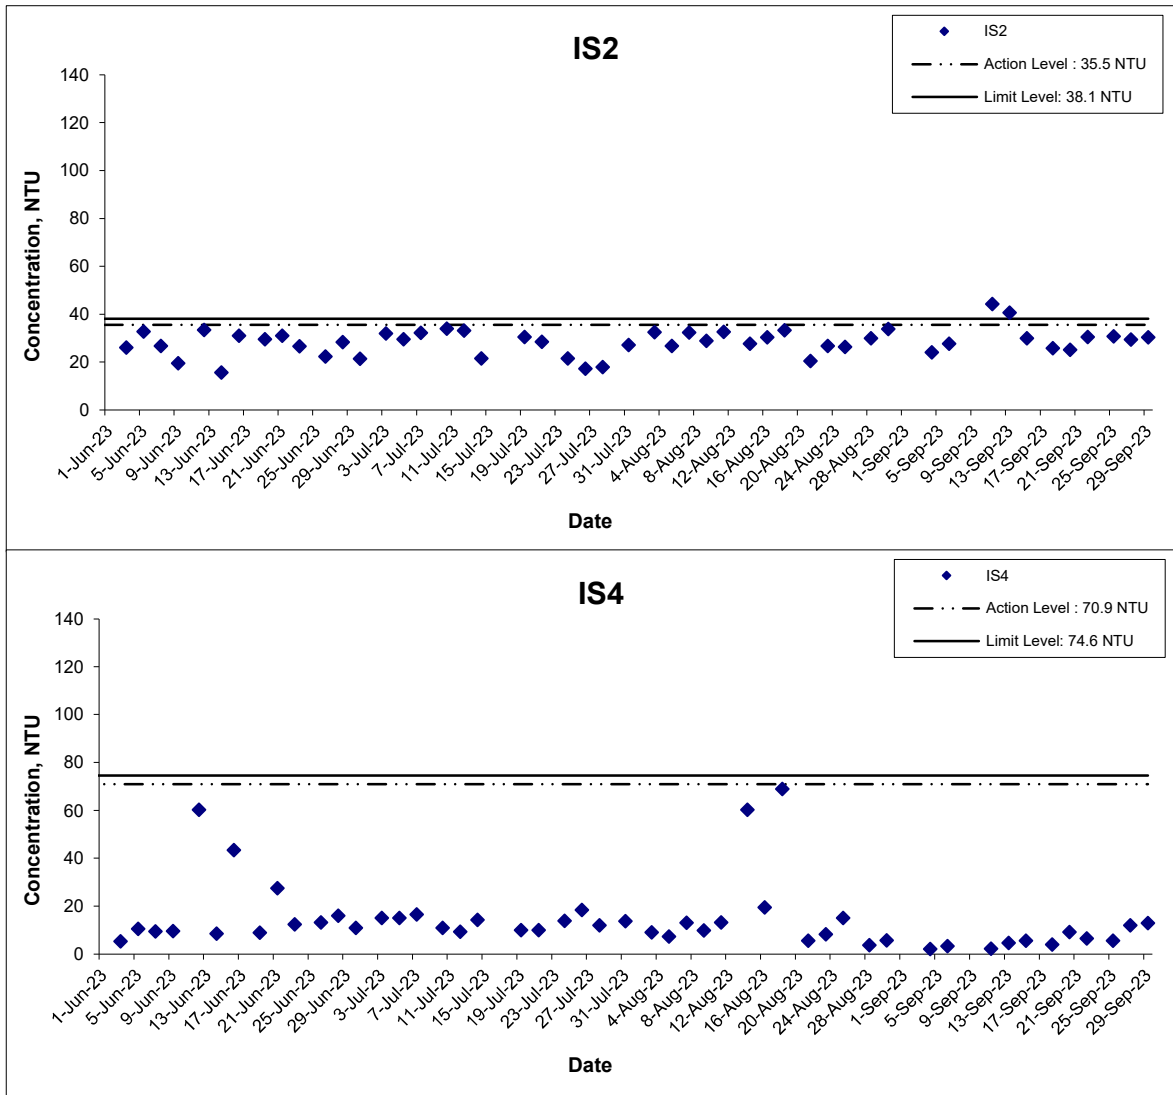
Turbidity

Title Service Contract No. WD/04/2020
 Development of Lok Ma Chau Loop:
 Main Works Package 1 - Environmental Team
 Graphical Presentation of Water Quality Monitoring
 Results

- (b) Amber rainstorm warning signals were recorded on 10th September 2023, in the period between 06:25 and 08:55. Rainfall in Northern District was also recorded before and during the water quality monitoring. Influx of turbid water was observed on 11th September 2023 from Shenzhen River to the old Shenzhen River meander as well as the monitoring station, IS2 during the monitoring.

- (c) Influx of turbid water was observed on 13th September from Shenzhen River to the old Shenzhen River meander as well as the monitoring station, IS2 during the monitoring.
