**Monthly EM&A Report
(July 2022)**

Contract No. : DPW 01/2020
Contract Name : Environmental Team for Drainage
Improvement Works at Ngong Ping
(Contract No. DC/2019/06)
Report No. : 0118/20/ED/0506A
EP No. : EP-456/2013/B

**Drainage Improvement Works at Ngong Ping
Monthly EM&A Report for July 2022**

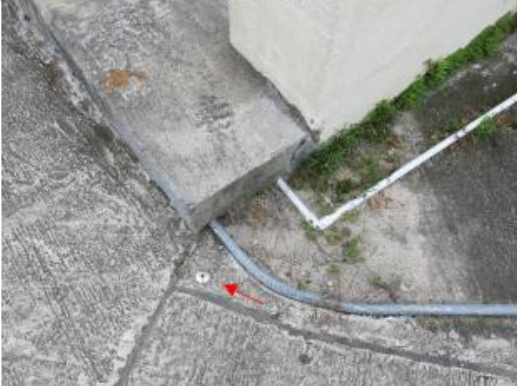
<p>Photo 4: General View of NP-11</p>	<p>Photo 5: Ground settlement marker for settlement monitoring was installed at the entrance of NP-11.</p>	<p>Photo 6: Tell-tale for crack monitoring was installed at NP-11.</p>

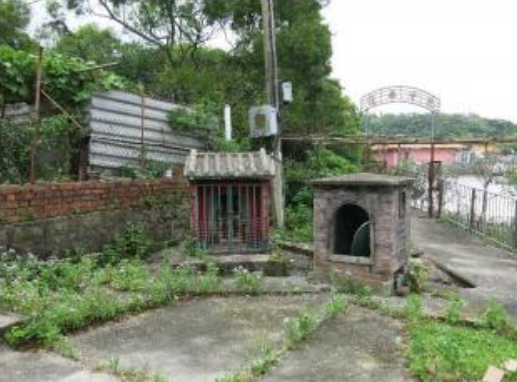
<p>Photo 10: Access to NP-20 & NP-21 has been fenced off in accordance to EM&A Manual.</p>	<p>Photo 11: No temporary fence has been erected around NP-26 in mutual agreement with the villagers.</p>	<p>Photo 12: A warning notice was placed near NP-26.</p>
