**Monthly EM&A Report
(August 2022)**

Contract No. : DPW 01/2020
Contract Name : Environmental Team for Drainage
Improvement Works at Ngong Ping
(Contract No. DC/2019/06)
Report No. : 0118/20/ED/0515A
EP No. : EP-456/2013/B

**Drainage Improvement Works at Ngong Ping
Monthly EM&A Report for August 2022**

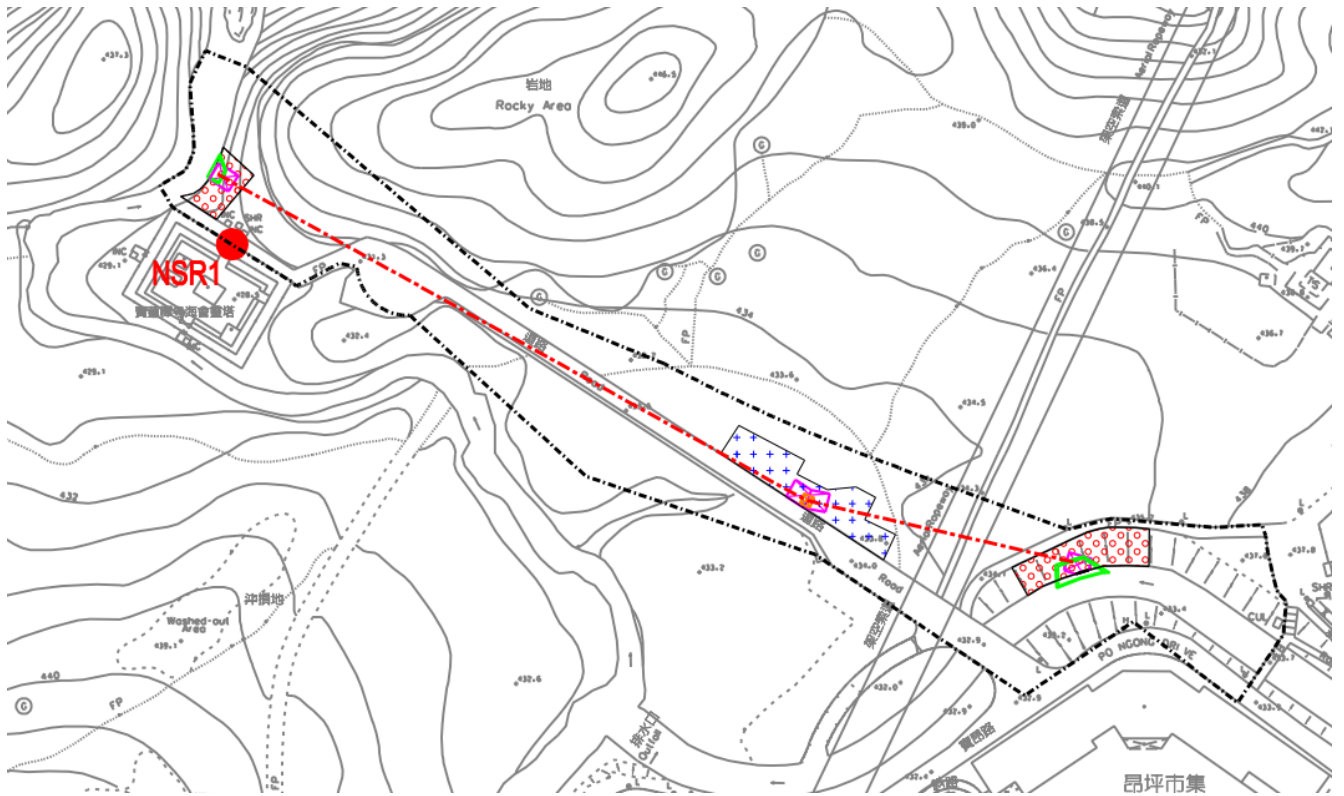
Figure 2a Noise Monitoring Locations (Part 1)

NSRs*	Monitoring Location	Type of Measurement#
NSR1	Columbarium of Po Lin Monastery	Free-field
NSR5	Village House No. 49A	Free-field
NSR8	Village House No. 34	Façade

For Free-field measurement, +3dB(A) should be added to the measured results.

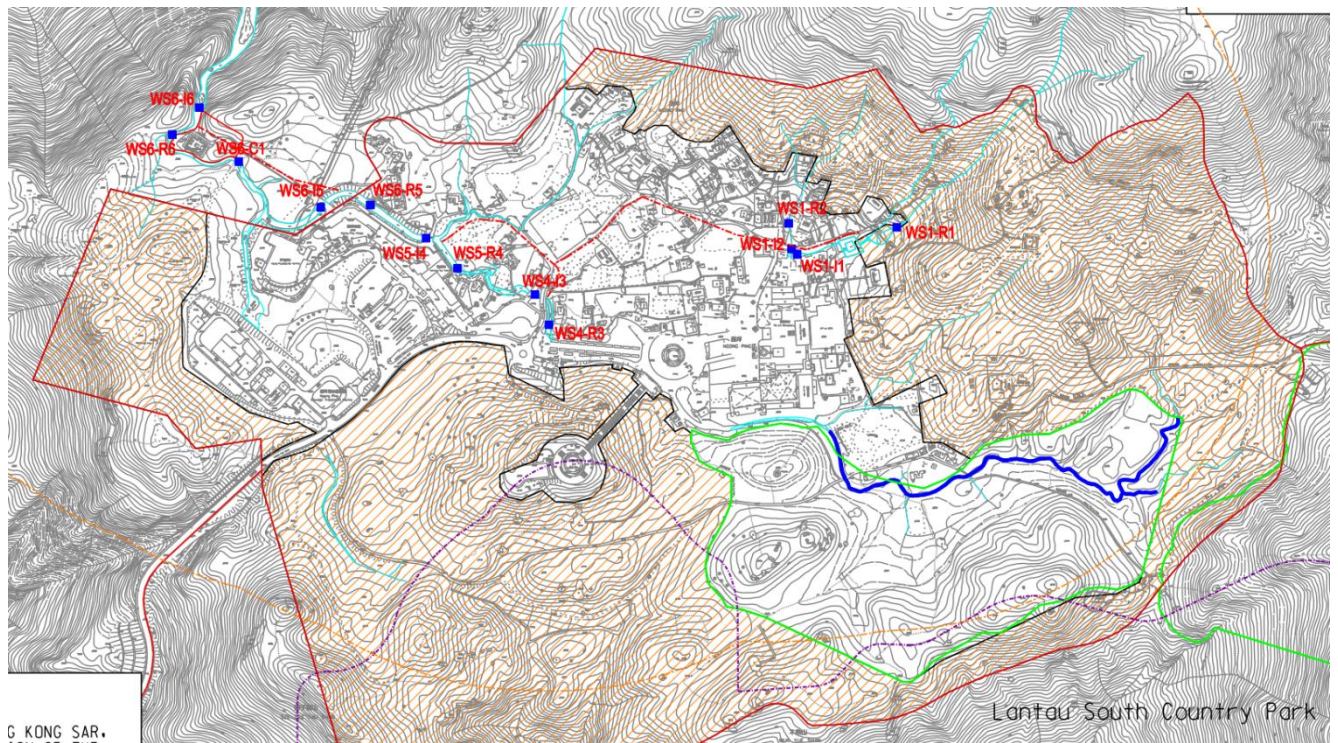
Figure 2c Water Quality Monitoring Locations

Station	Type
WS1-R1	Upstream reference
WS1-I1	Downstream impact
WS1-R2	Upstream reference
WS1-I2	Downstream impact
WS4-R3	Upstream reference
WS4-I3	Downstream impact
WS5-R4	Upstream reference
WS5-I4	Downstream impact
WS6-R5	Upstream reference
WS6-I5	Downstream impact
WS6-C1	Intermediate Control
WS6-R6	Upstream reference
WS6-I6	Downstream impact

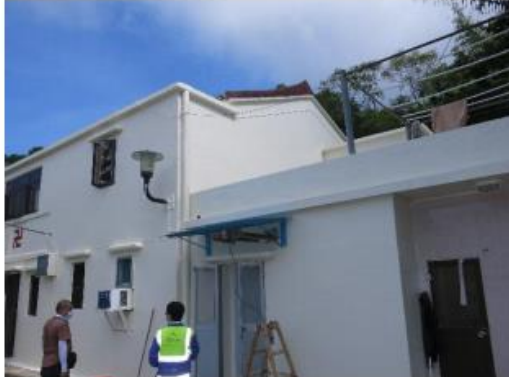
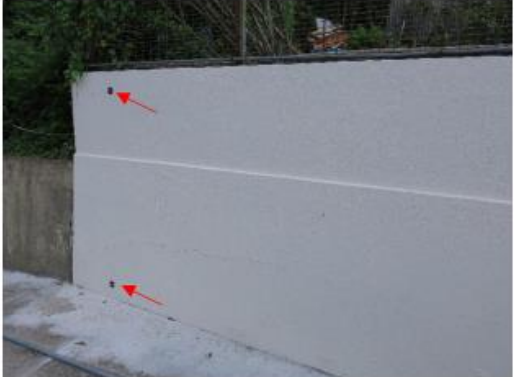
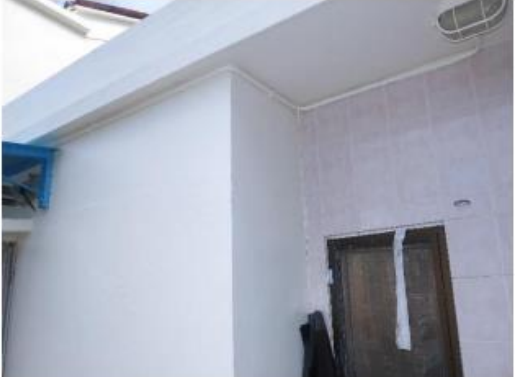
Photo Record (30/08/2022)

- 1) Renovation works have been done at NP-10
- 2) Tell-tales (TT1 & TT2) for crack monitoring were removed by the owner at NP-10 due to renovation works

<p>Photo 1: General View of NP-10; Renovation works were done at NP-10.</p>	<p>Photo 2: Reflective targets for settlement monitoring were installed on the fence wall at NP-10.</p>	<p>Photo 3: Tell-tales (TT1 & TT2) for crack monitoring were removed by the owner at NP-10 due to renovation works; Crack was repaired.</p>

- 1) Follow-up action to the crack monitoring at NP-10 will be subjected to discussion between owner and DSD.

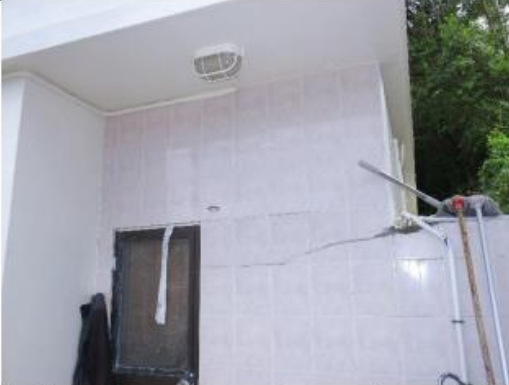
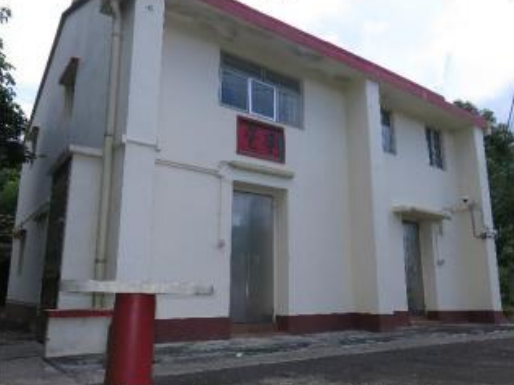
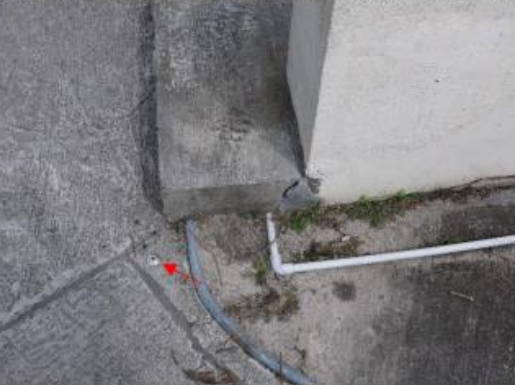
<p>Photo 4: Renovation works were done at NP-10 except for the walls in Kitchen & Lavatory at the time of inspection.</p>	<p>Photo 5: General View of NP-11</p>	<p>Photo 6: Ground settlement marker for settlement monitoring was installed at the entrance of NP-11.</p>

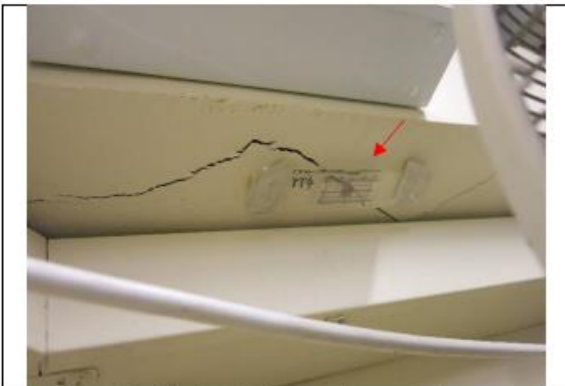
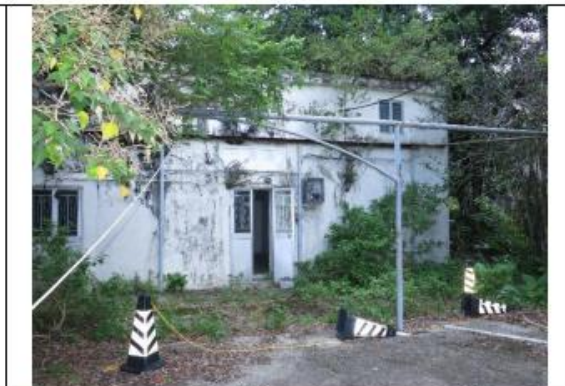
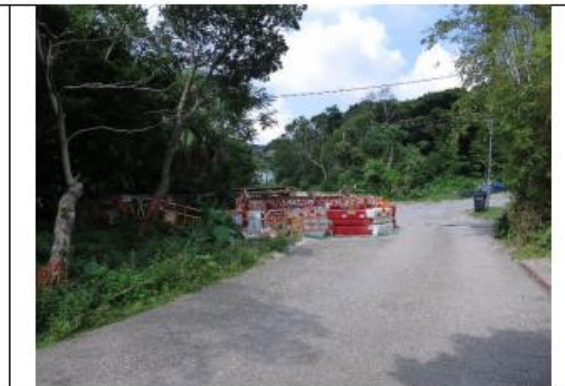
Photo Record (30/08/2022)

<p>Photo 7: Tell-tale for crack monitoring was installed at NP-11.</p>	<p>Photo 8: NP-19 has been fenced off in accordance to EM&A Manual.</p>	<p>Photo 9: Construction works in close proximity of NP-19.</p>

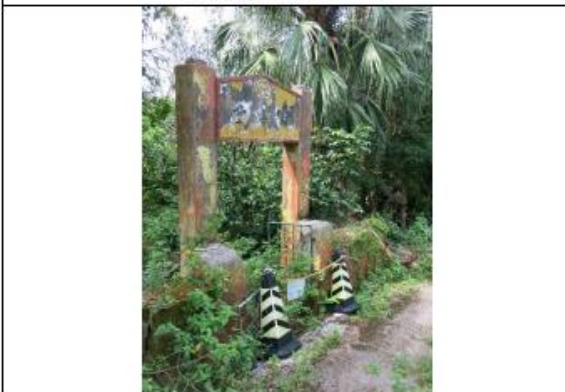
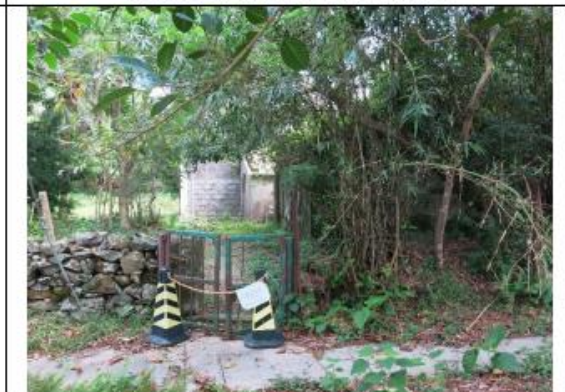
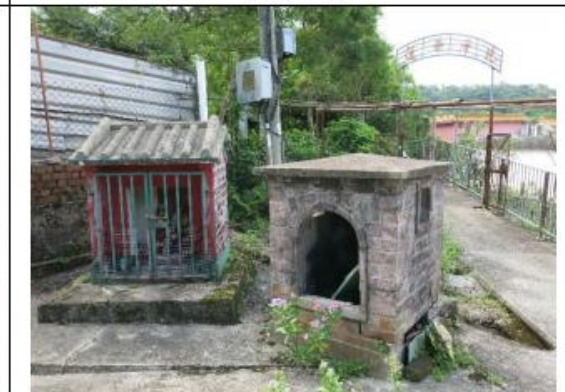
<p>Photo 10: Access to NP-20 & NP-21 has been fenced off in accordance to EM&A Manual.</p>	<p>Photo 11: Access to NP-20 & NP-21 has been fenced off in accordance to EM&A Manual.</p>	<p>Photo 12: No temporary fence has been erected around NP-26 in mutual agreement with the villagers.</p>
