**ENVIRONMENTAL TEAM FOR RELOCATION OF SHA TIN  
SEWAGE TREATMENT WORKS TO CAVERNS –  
MAIN CAVERNS CONSTRUCTION**

**QUARTERLY ENVIRONMENTAL MONITORING & AUDIT  
SUMMARY REPORT**

**- DECEMBER 2022 TO FEBRUARY 2023 -**

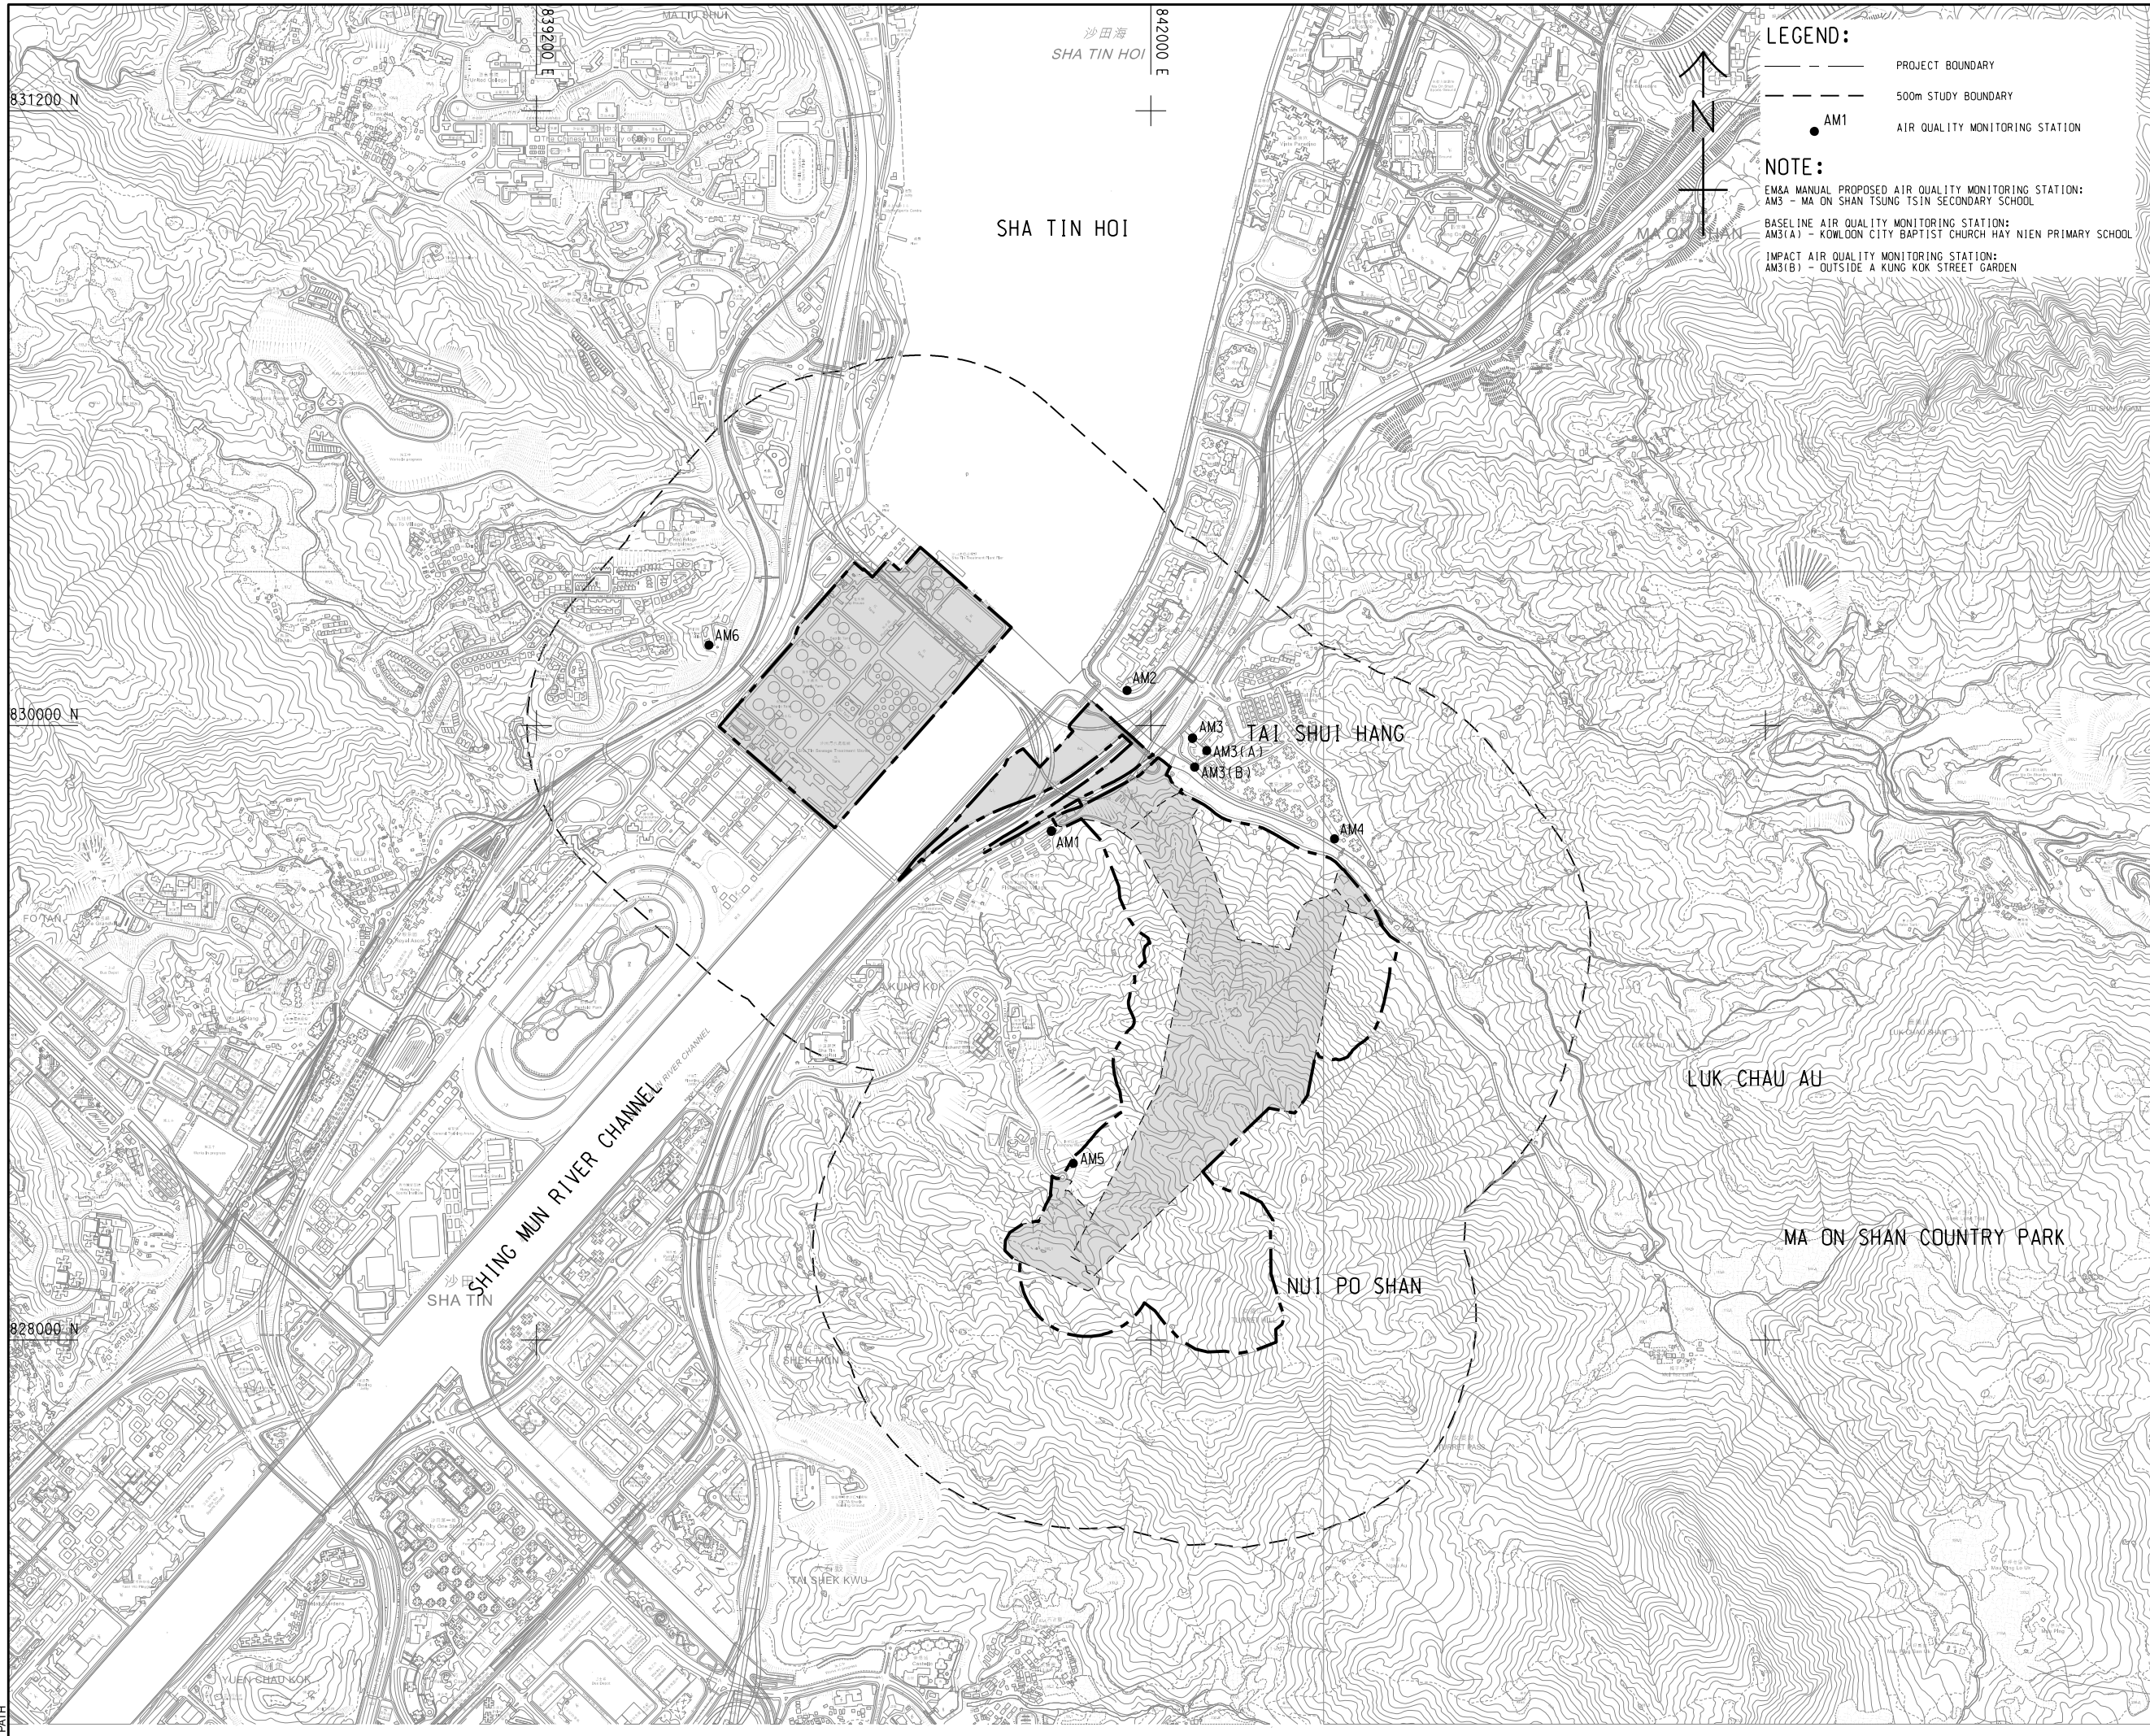
***Locations of Environmental Monitoring Station***

- PROJECT BOUNDARY
- · - 500m STUDY BOUNDARY
- AM1 AIR QUALITY MONITORING STATION

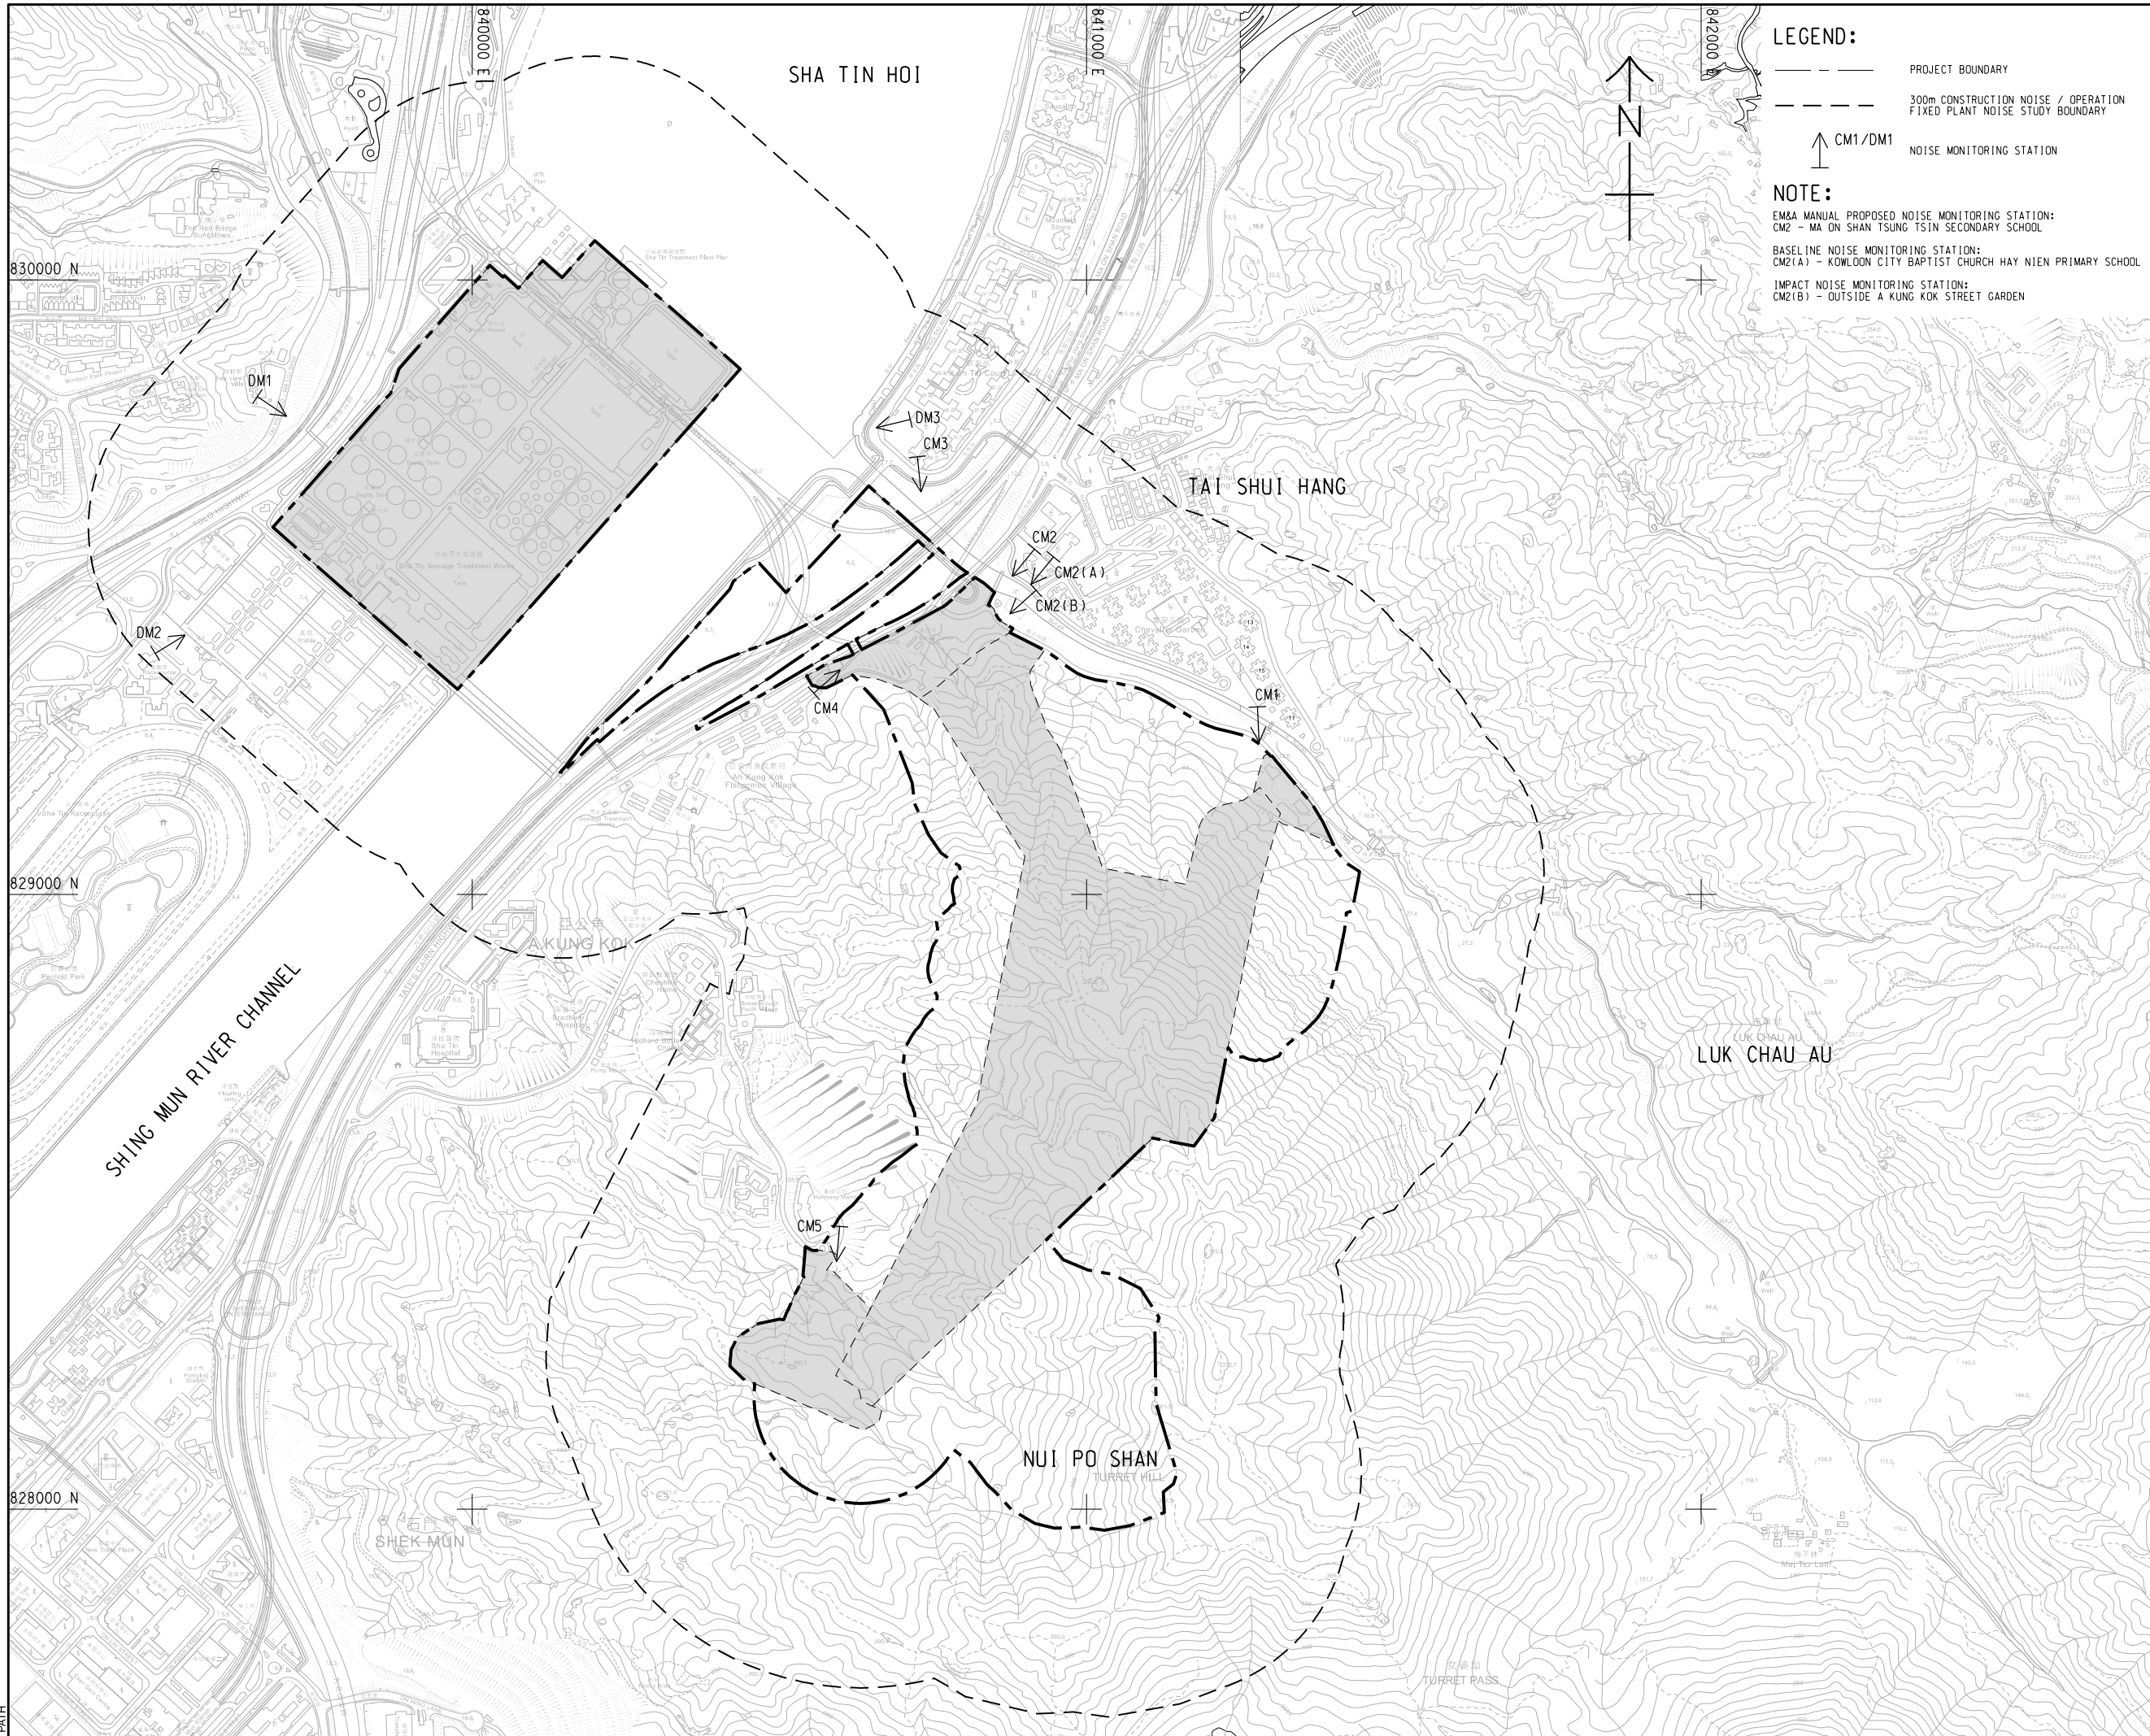
**LEGEND:**  
 - - - - - PROJECT BOUNDARY  
 - - - - - 300m CONSTRUCTION NOISE / OPERATION FIXED PLANT NOISE STUDY BOUNDARY  
 ↑ CM1/DM1 NOISE MONITORING STATION

**NOTE:**  
 EM&A MANUAL PROPOSED NOISE MONITORING STATION:  
 CM2 - MA ON SHAN TSUNG TSIN SECONDARY SCHOOL  
 BASELINE NOISE MONITORING STATION:  
 CM2(A) - KOWLOON CITY BAPTIST CHURCH HAY NIEN PRIMARY SCHOOL  
 IMPACT NOISE MONITORING STATION:  
 CM2(B) - OUTSIDE A KUNG KOK STREET GARDEN

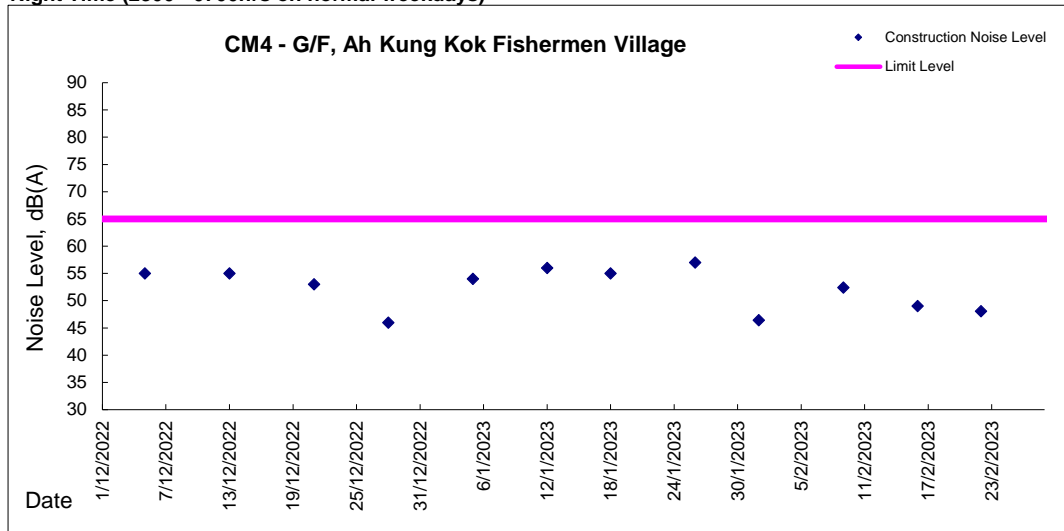
**Graphic Presentation of Noise Monitoring Result**

**Night Time (2300 - 0700hrs on normal weekdays)**
