**ENVIRONMENTAL TEAM FOR RELOCATION OF
SHA TIN SEWAGE TREATMENT WORKS TO CAVERNS –
SITE PREPARATION AND ACCESS TUNNEL CONSTRUCTION**

MONTHLY ENVIRONMENTAL MONITORING & AUDIT REPORT

JANUARY 2023

**Relocation of Sha Tin Sewage Treatment Works to Cavern – Main Caverns
Construction**

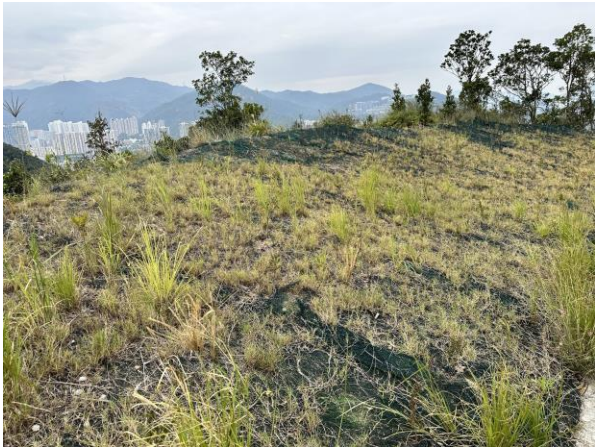
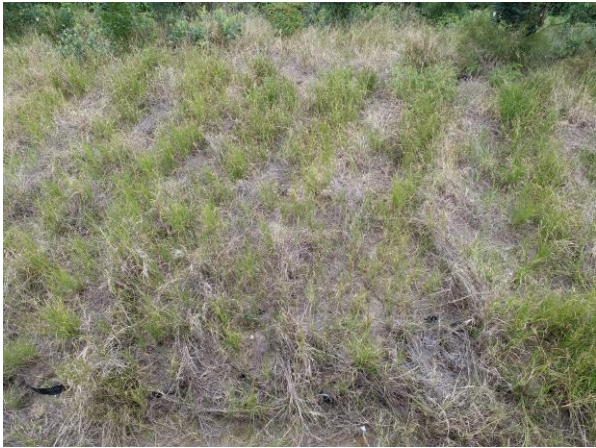
- 2.2.9. The status of the Compensatory Planting were shown in **Table 4**.
- 2.2.10. Monthly monitoring for the on-going Compensatory Planting was conducted on 17 January 2023. The seedlings of *Diospyros vaccinioides* were generally in fair condition under dry season. Photo records of *Diospyros vaccinioides* are illustrated in **Appendix 1**.

<p>Seedlings of <i>Diospyros vaccinioides</i> in nursery</p>	<p>Seedlings of <i>Diospyros vaccinioides</i> planted in receptor site observed on 17 Jan 2023</p>

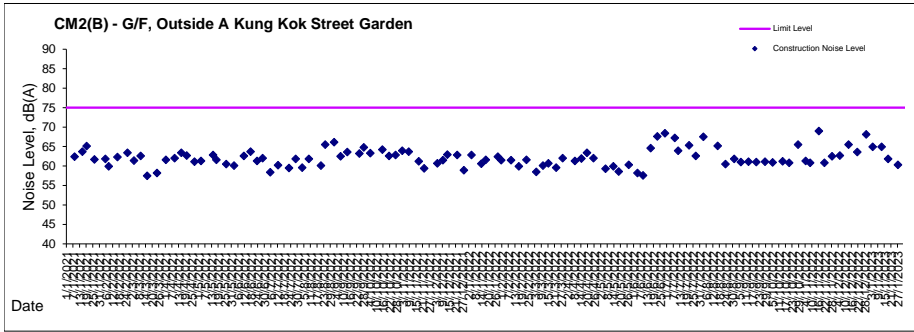
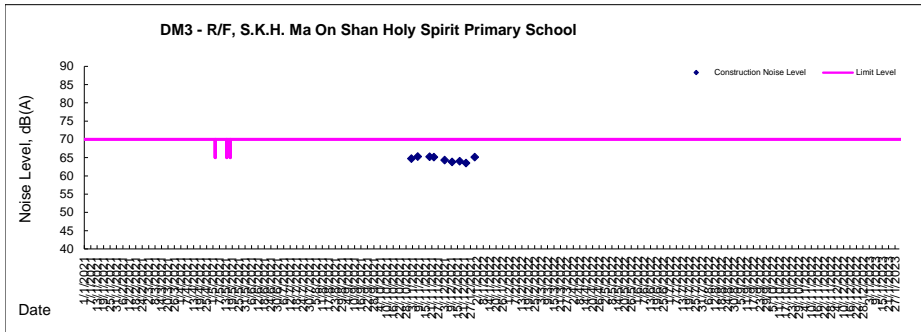
Graphic Presentation of Noise Monitoring Result

Day Time (0700 - 1900hrs on normal weekdays)
