Monthly Environmental Monitoring & Audit Report – March 2024

Contract No. CPW 01/2023 Environmental Team for Relocation of Sha Tin Sewage Treatment Works to Caverns

Contract No. CPW 02/2023
Independent Environmental Checker Services for
Relocation of Sha Tin Sewage Treatment Works to Caverns
Verification of Monthly EM&A Report (March 2024)

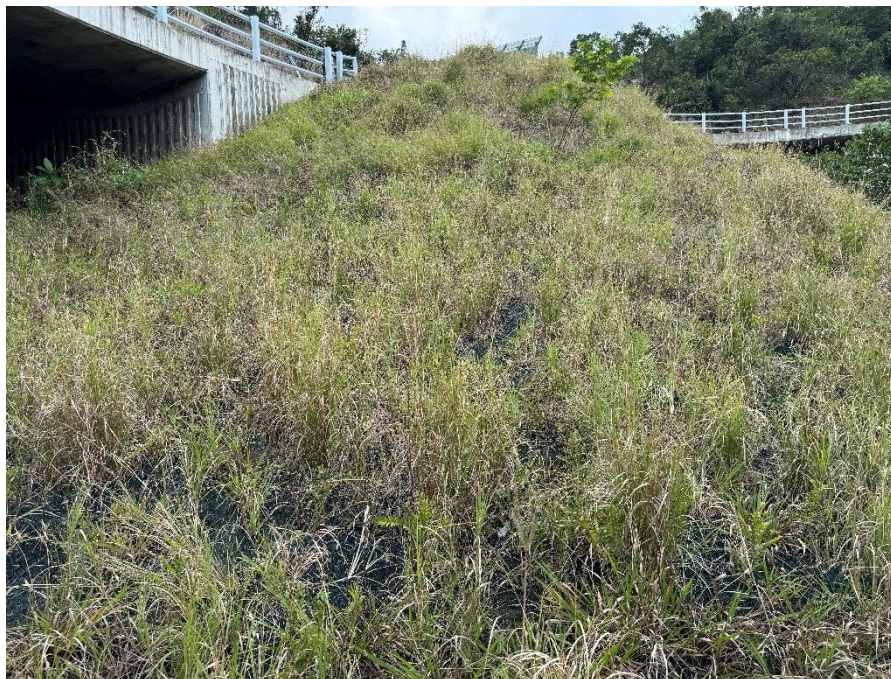
2.3.4 Monthly monitoring for the on-going compensatory planting was conducted on 05 March 2024. Health and growth condition of the transplanted second batch of *D. vaccinioides* seedlings are generally fair in condition. It was also noted that there were no construction activities adjacent to the receptor site; hence, there are no adverse impacts on the transplanted seedlings. Photo records of *D. vaccinioides* and site observations are shown in **Appendix B**.

Photo B.6: Seedlings of *Diospyros vaccinioides* planted in receptor site observed on 05 March 2024

- 3.1.2 During the current monitoring period, it was noted that the growth and health condition of the transplanted second batch of *D. vaccinioides* seedlings were generally fair in condition. There were no construction activities adjacent to the receptor; hence, no adverse impacts are expected on the transplanted seedlings of *D. vaccinioides* in the receptor site. Moreover, the contractor was reminded to remove tall weeds growing near the *D. vaccinioides* seedlings.

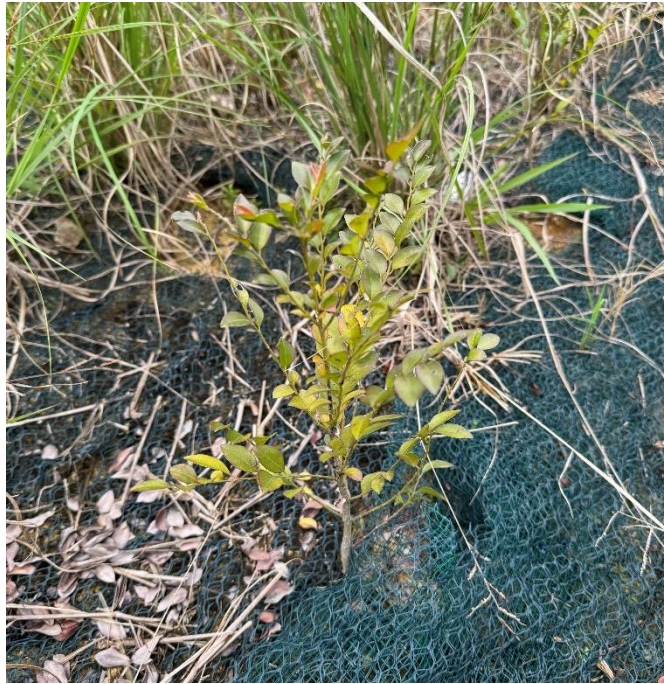
Photo B.7: Seedlings of *Diospyros vaccinioides* planted in receptor site observed on 05 March 2024

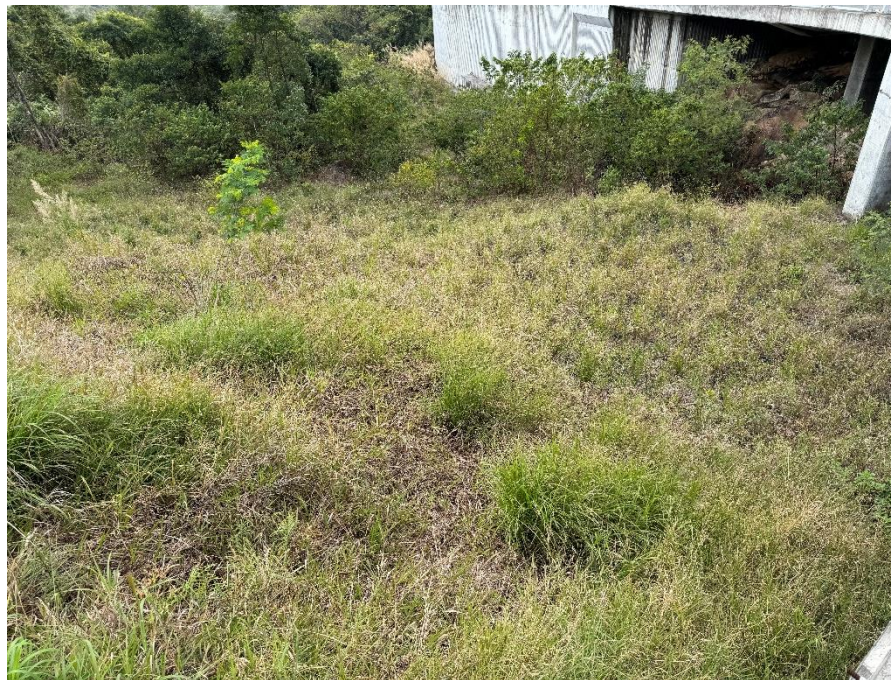
Photo B.8: Seedlings of *Diospyros vaccinioides* planted in receptor site observed on 05 March 2024

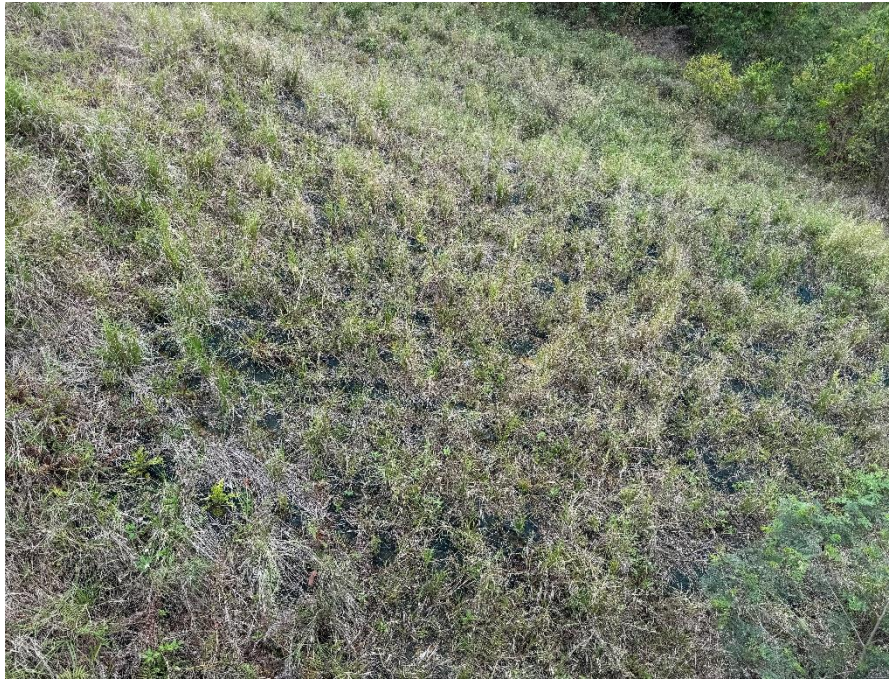
Photo B.9: Seedlings of *Diospyros vaccinioides* planted in receptor site observed on 05 March 2024

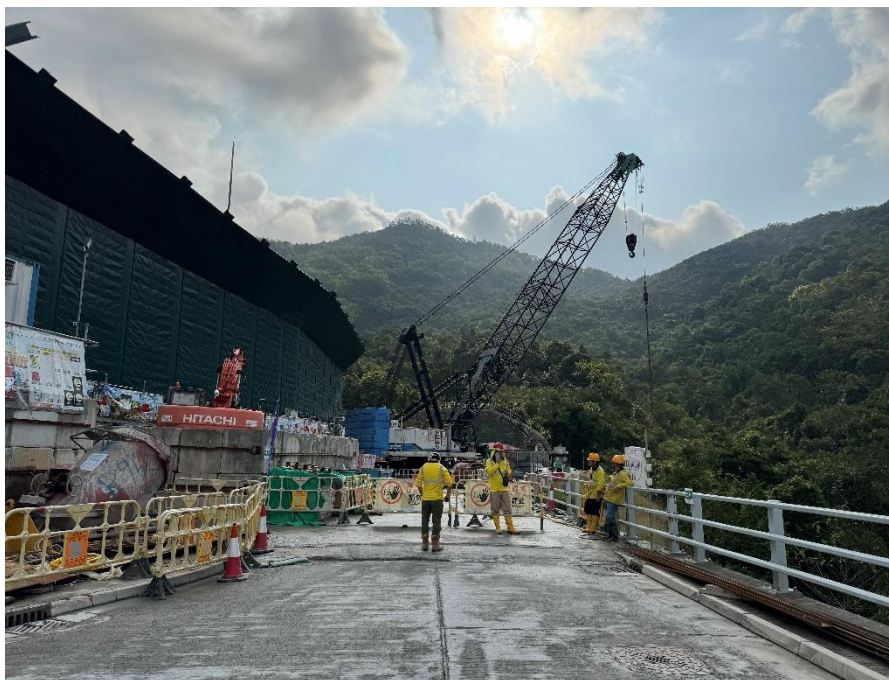
Photo B.10: Construction activities observed during the monitoring on 05 March 2024 but not adjacent to the receptor site.
