Figure 5 - Construction Sequence of HKBCF

(Plan originated from Figure 25308/041/304A of Appendix 9F of Approved EIA Report reference: AEIAR-145/2009)

Environmental Permit No.: EP-353/2009
 環境許可證編號: EP-353/2009

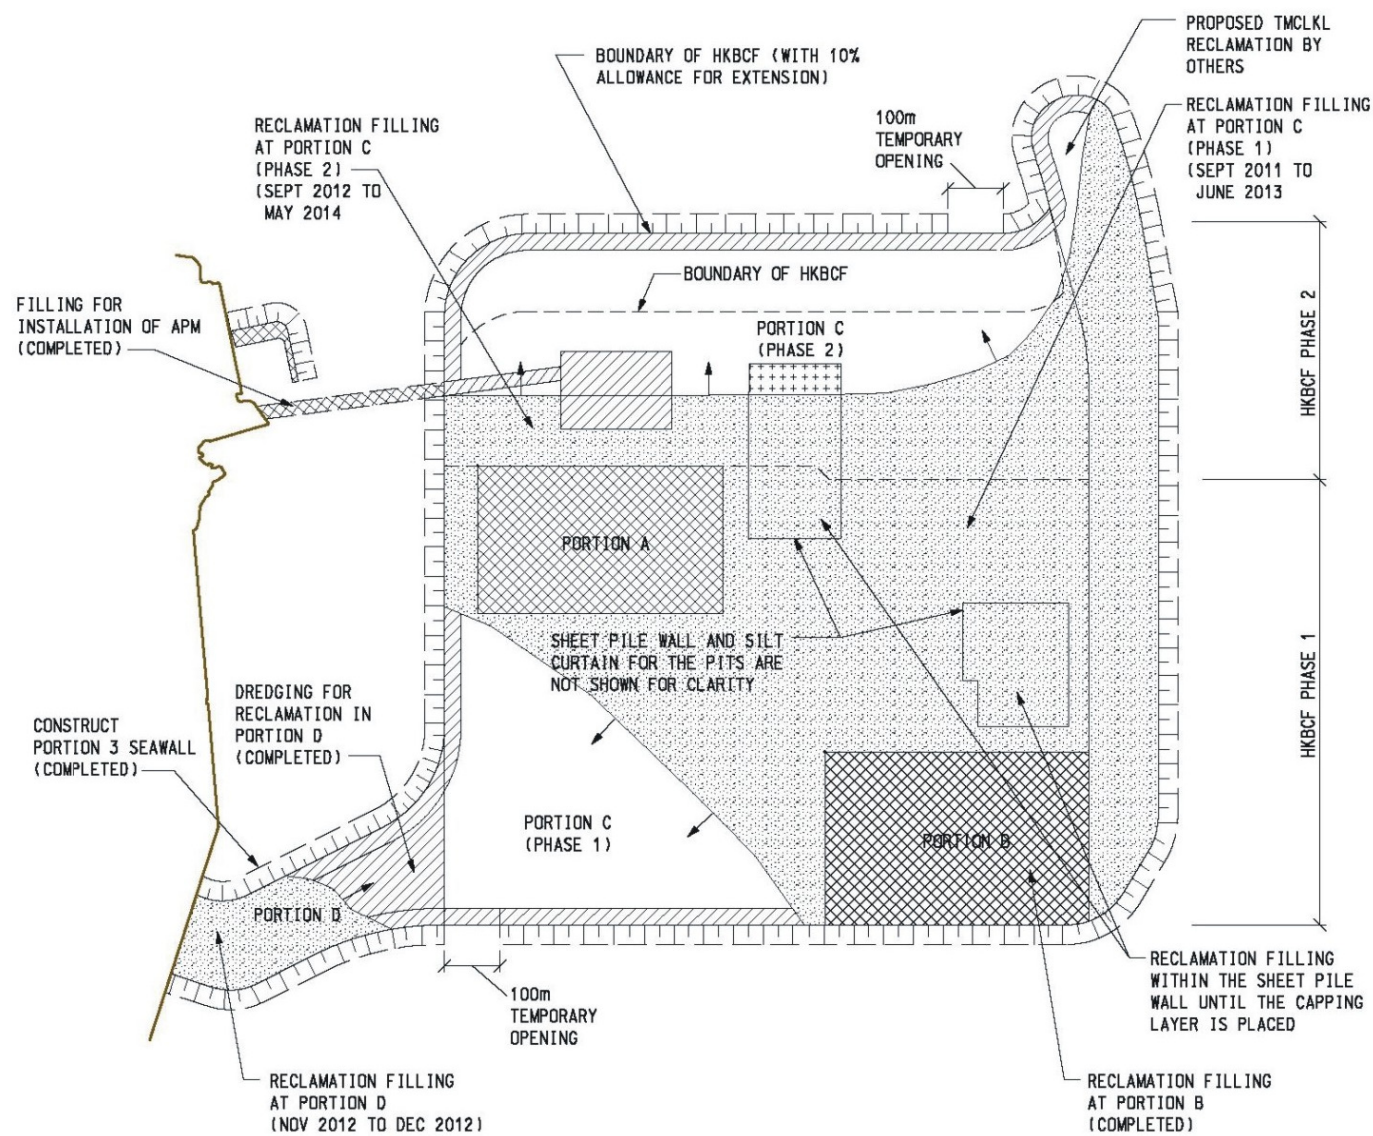
STAGE 7 (ON DEC 2012)

NOTE:
 FIRST MEASURE: CAGE TYPE SILT CURTAIN FOR ALL GRAB DREDGERS (SEE TYPICAL SECTION ATTACHED)
 SECOND MEASURE: SINGLE SILT CURTAIN AROUND THE SITE (SEE TYPICAL SECTION ATTACHED)

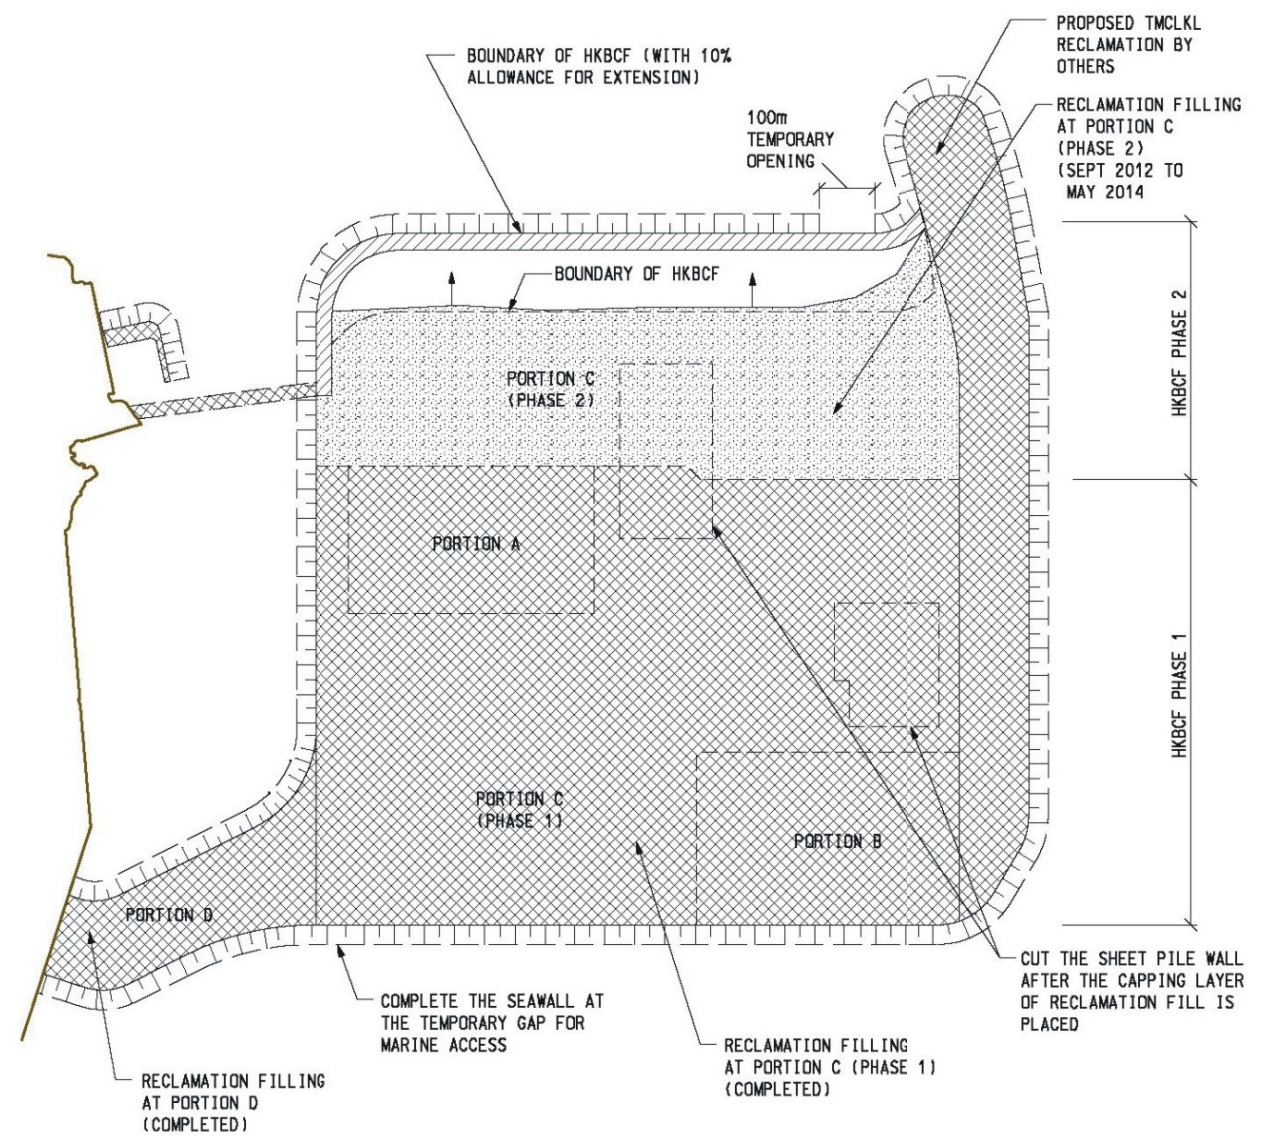
STAGE 8 (ON DEC 2013)

NOTE:
 FIRST MEASURE: CAGE TYPE SILT CURTAIN FOR ALL GRAB DREDGERS (SEE TYPICAL SECTION ATTACHED)
 SECOND MEASURE: SINGLE SILT CURTAIN AROUND THE SITE (SEE TYPICAL SECTION ATTACHED)
