Figure 1.7
Emergency Discharge Scenarios
for the Future San Wai STW
and Ha Tsuen PS

Agreement No. CE62/2000
EIA Study for the Upgrading and
Expansion of San Wai Sewage
Treatment Works and the Expansion
of Ha Tsuen Pumping Station

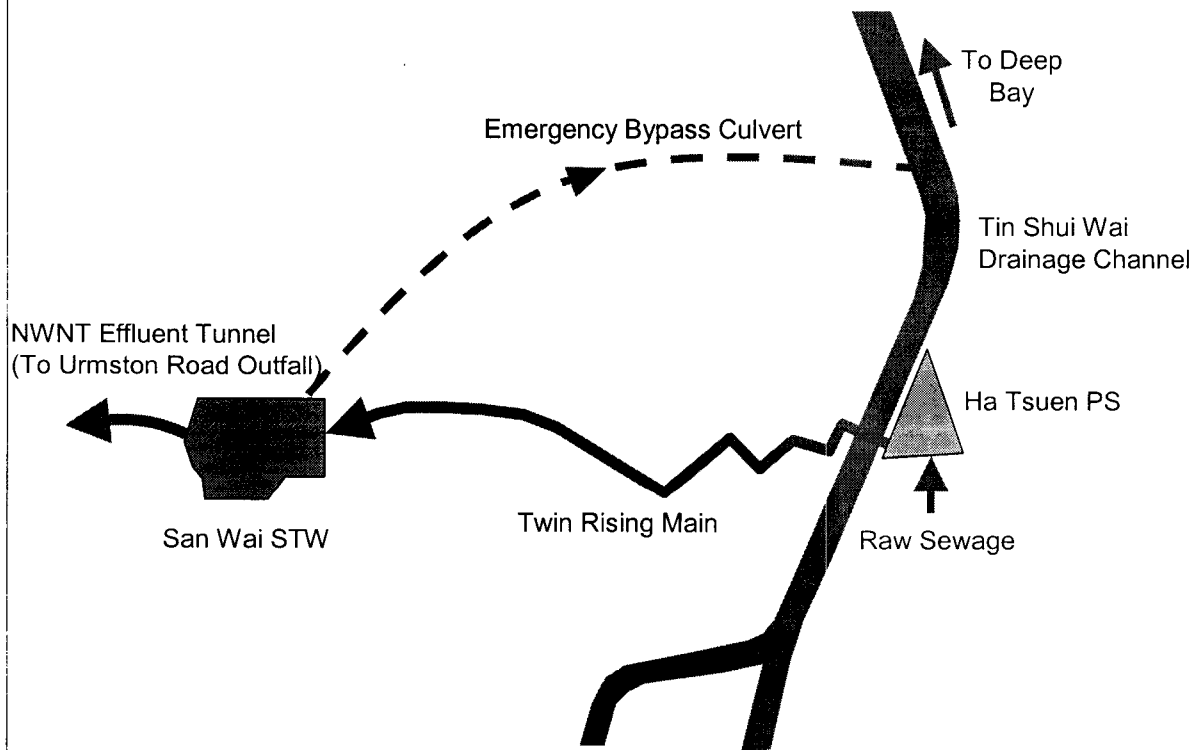
Future Condition (With Emergency Bypass Culvert)

Status of Facilities (✓ = Normal Operation, x = Totally Out of Operation)			Effluent	Discharge Location
San Wai STW	Ha Tsuen PS	NWNT Tunnel		
✓	✓	✓	Treated Effluent	Urmston Road Outfall
✓	✓	x	Treated Effluent	TSW Drainage Channel/Deep Bay
x	✓	✓	Raw Sewage	Urmston Road Outfall
✓	x	✓	Raw Sewage	TSW Drainage Channel/Deep Bay
