Location:	Fan Tin Tsuen, San Tin		
Ref:	AAHB - 403	Construction Date:	c. 100 years
Recorded on:	02.01.03	Condition:	Good
Updated on:		Orientation:	North west
Type:	Courtyard style units (4 mid and 1 end)	Map Ref.:	# 217 - 221
		Present Use:	Residential
		Past Uses:	Residential
		Historical Associations:	None

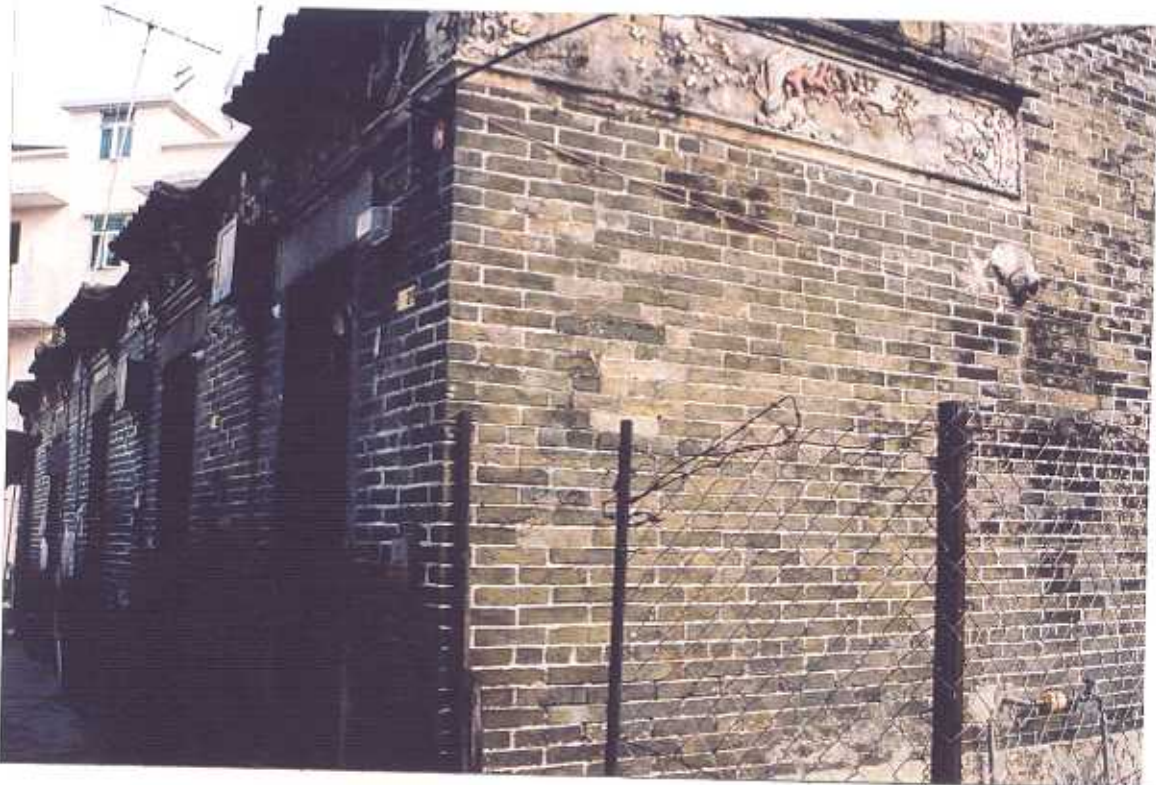
General Description: Tile and concrete roof. Green brick walls. Granite lintels and threshold stones.

Decorative Features: Canopies over all entrances. Floral and landscape designs. Frieze panels on façade and side wall, landscape floral. All in very good condition. Plaster fish drain opening on side wall.

Renovations: Concrete around foundation. Electrical outlets and lighting added.

Additional Notes: A good example of complete row of traditional houses.
