Photomontage 1 -View South from Parking Lot on Castle Peak Road
- San Tin (with Landscape Works at Year 10)

SCALE	N.T.S.	DATE	NOV 2003	
CHECK	-	DRAWN	-	
JOB No.	95102	FIGURE No.	10.44	REV

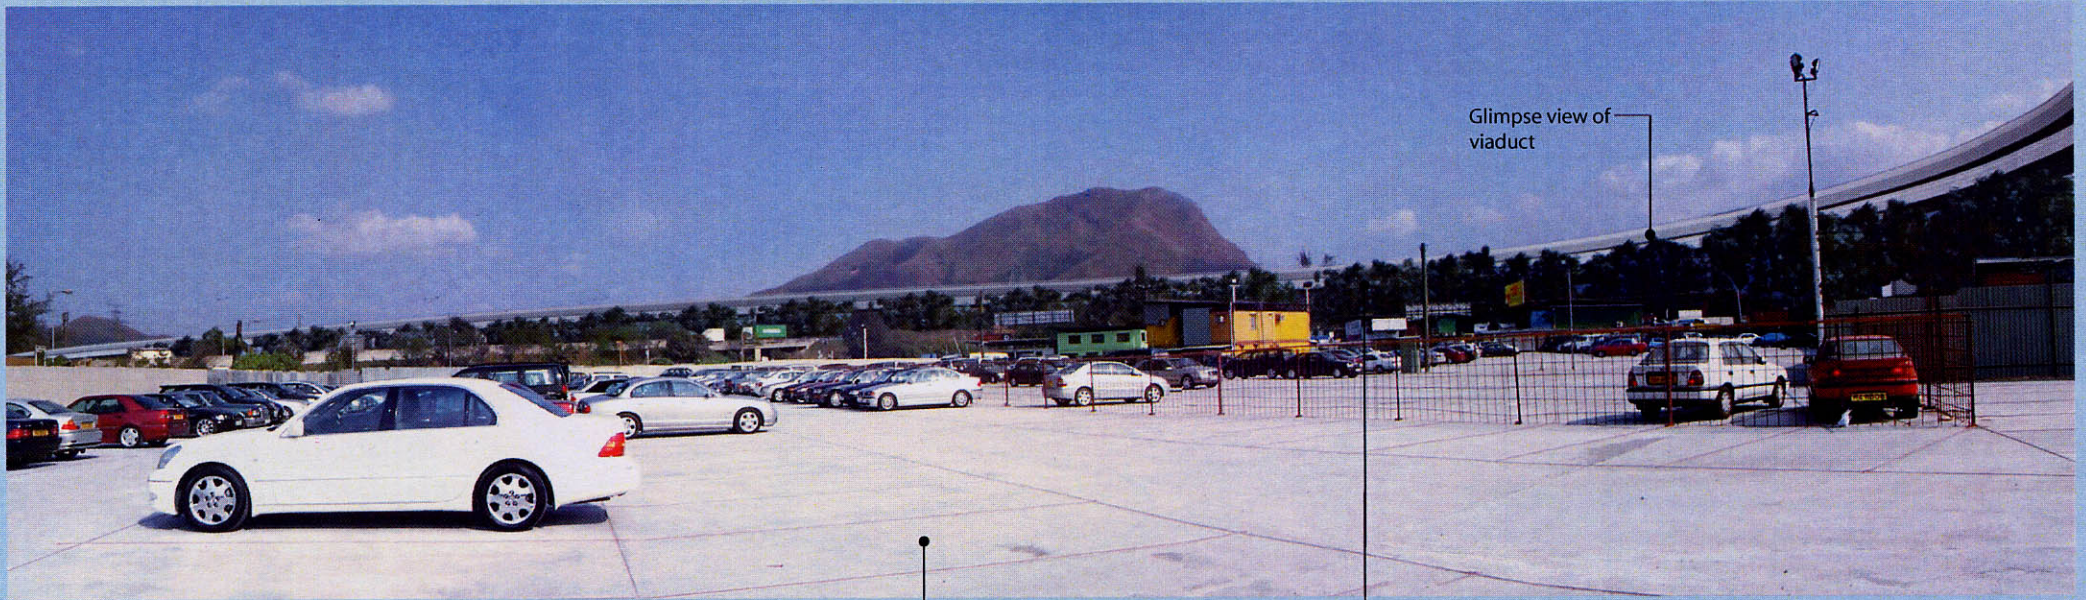
Glimpse view of viaduct

Existing parking lot

Tall canopy trees to screen viaduct from view
