**APPENDIX 4.6**

**FIGURES FOR OVERFLOW DISCHARGES**

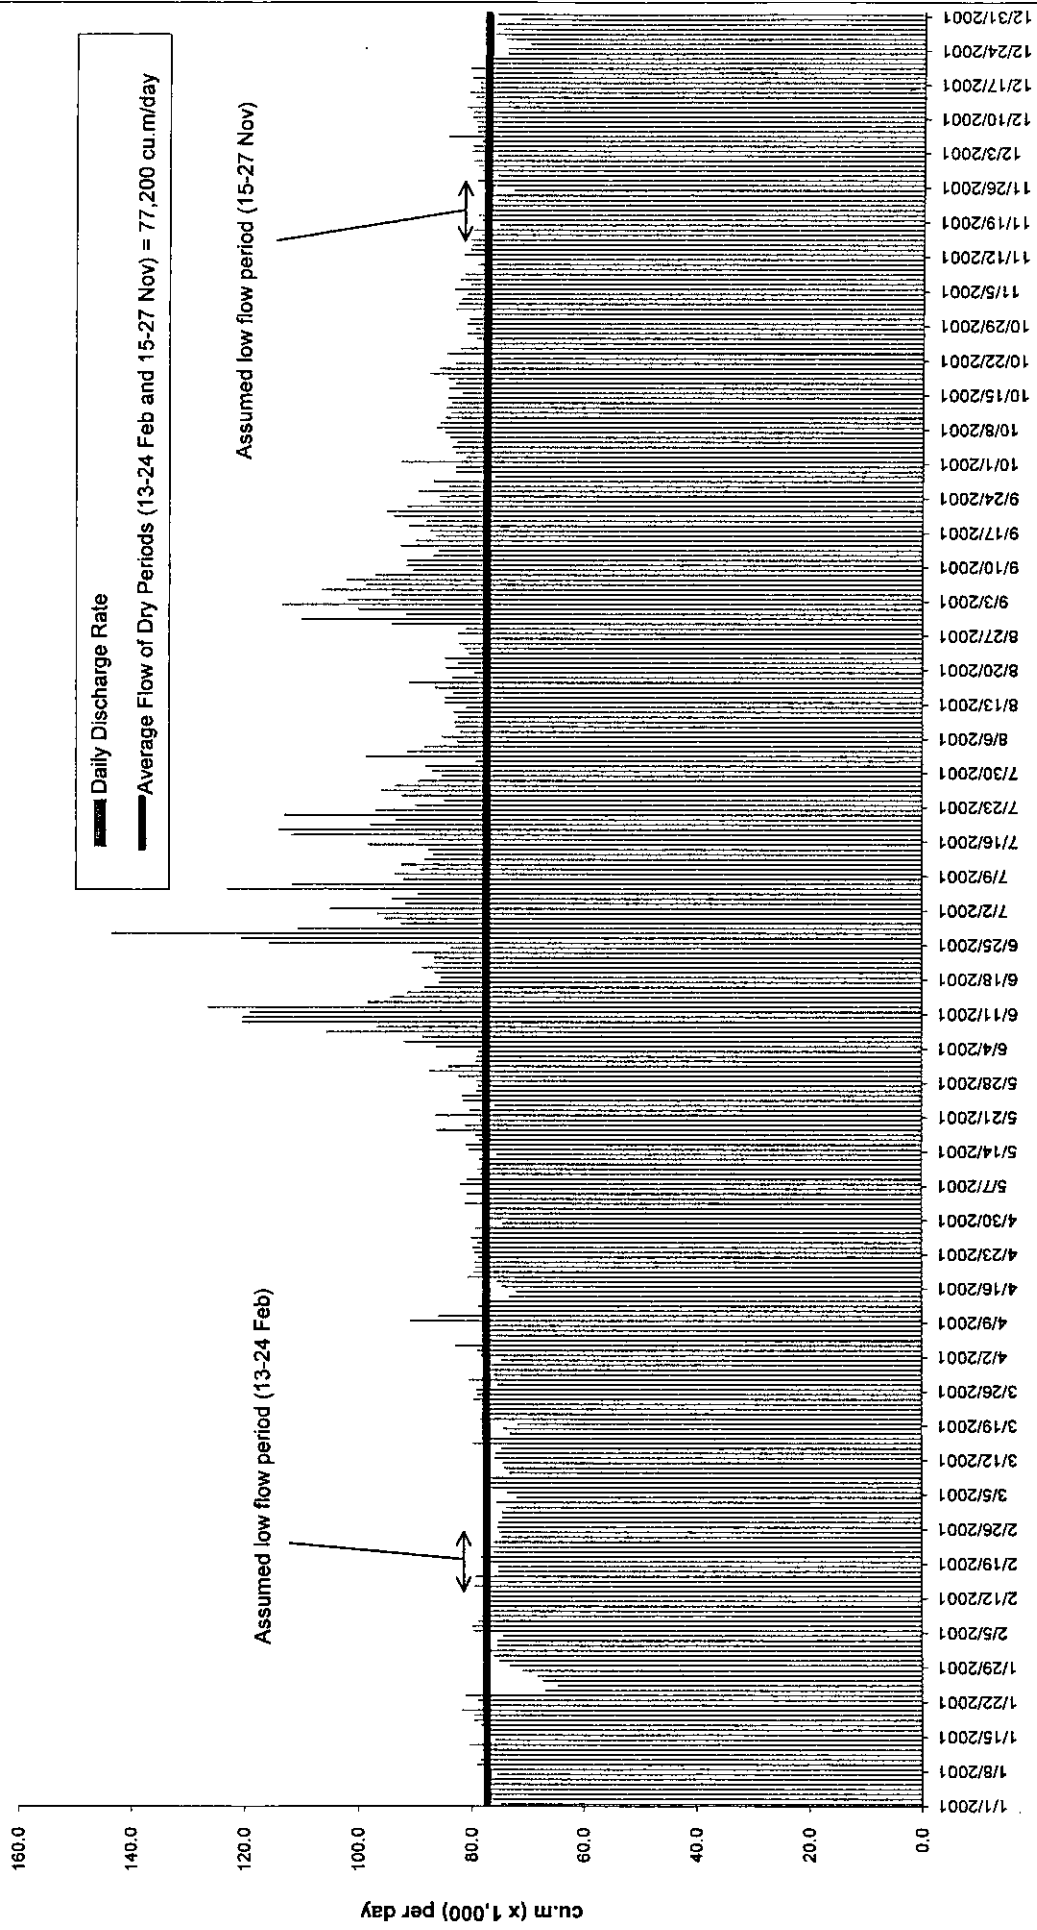
Figure 1 Past Discharge Record of Tai Po STW Year 2001

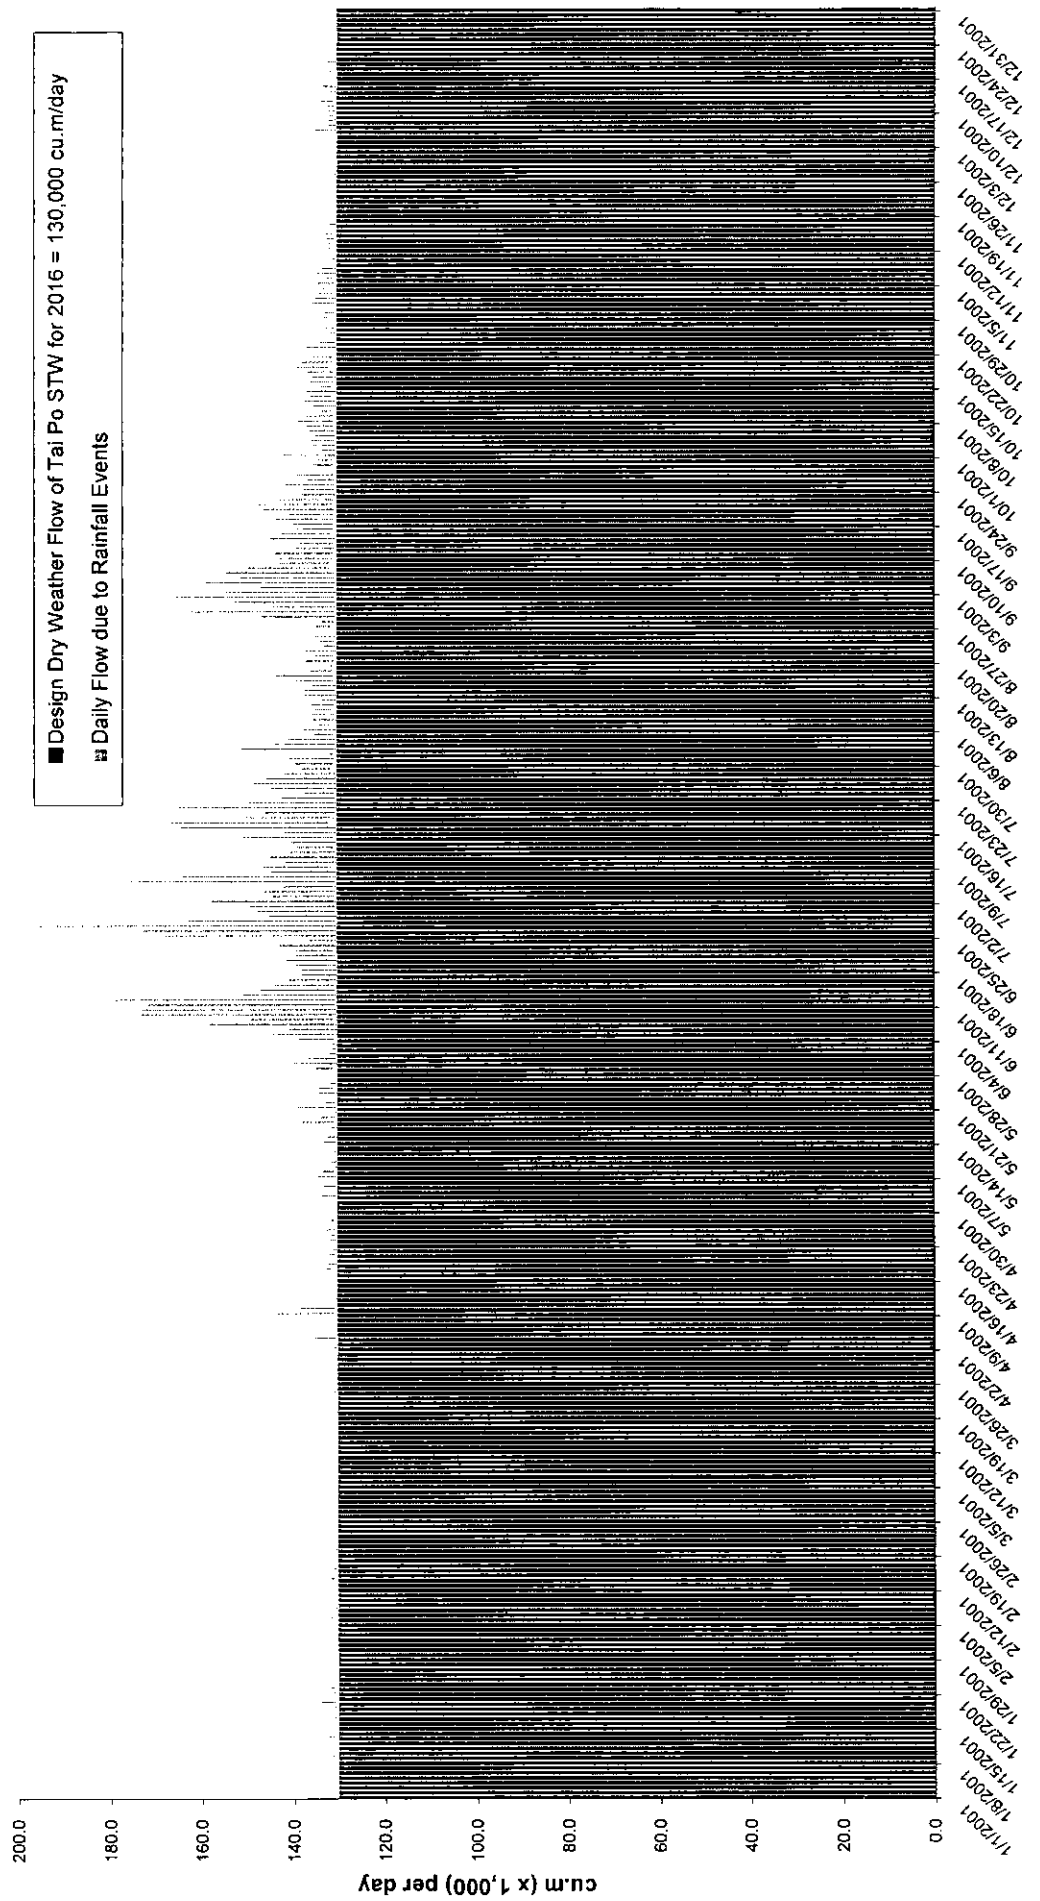
Figure 3 Projected Daily Discharge Rate (Storm + Dry Weather Flow) of Tai Po STW Year 2016

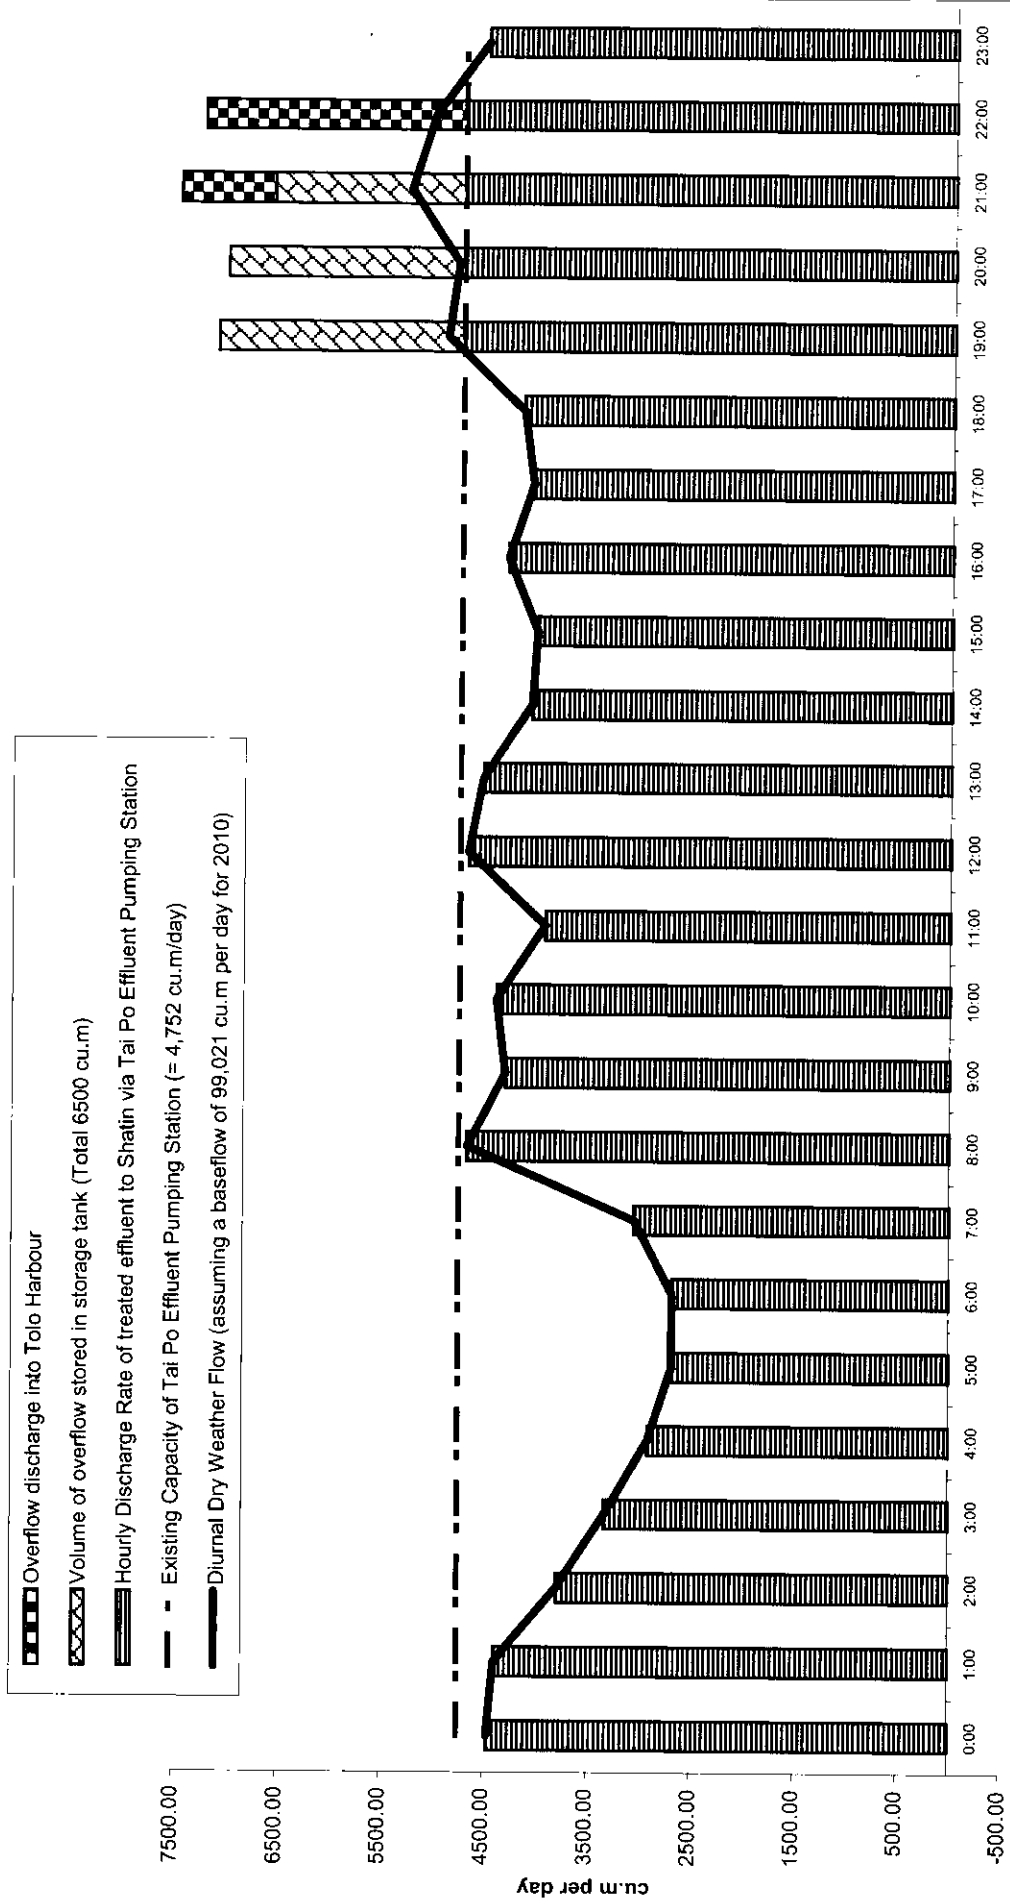
**Figure 4 Sample Plot of Diurnal Overflow at Tai Po Effluent Pumping Station for 2010**
