Summary of Disturbance to Landscape Character Units

Table 10.7 Summary of Disturbance to Landscape Resources

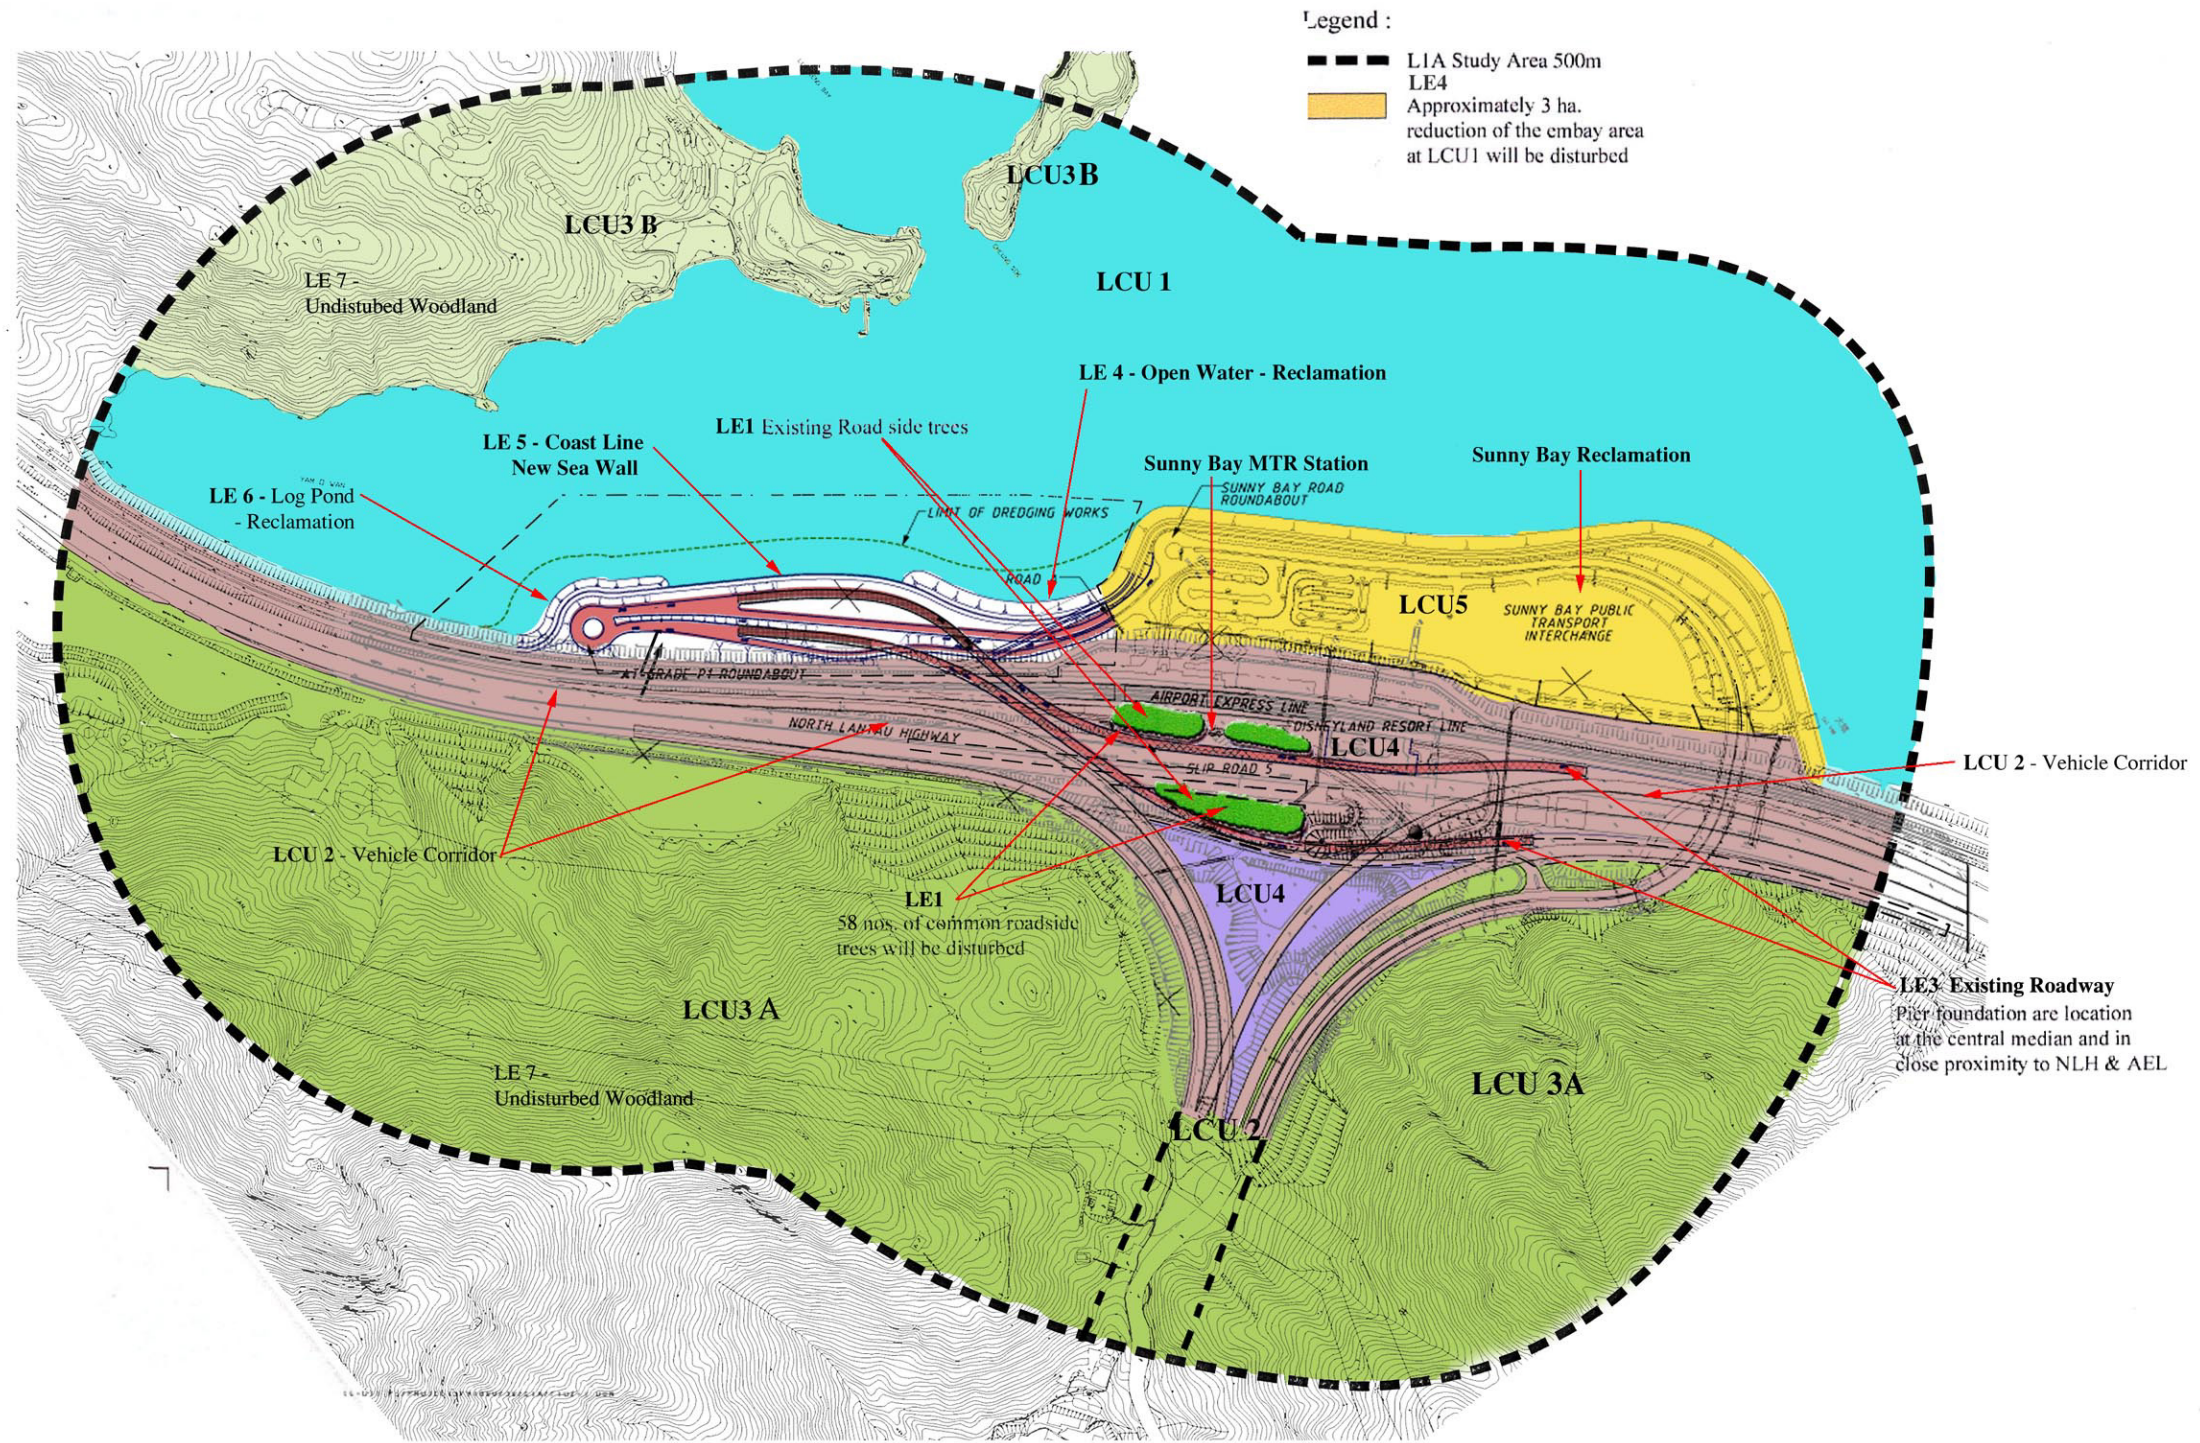
- LIA Study Area 500m
- LE4
- Approximately 3 ha. reduction of the embay area at LCU1 will be disturbed

Description	Disturbance
LCU1 - Yam O Wan	Approximately 3 ha. reduction of the embay area of Yam O Wan
LCU2 - Existing Transport Corridor	Pier foundations are located at the central median and in close proximity to NLH and AEL and existing vegetation need to be removed.
LCU3A - Green Belt of Tai Shan and Tai Yam Teng	No interaction
LCU3B - Conservation area of Luk Keng Headland and Cheng Sok Island	No interaction
LCU4 - Existing Utility Facilities	No interaction
LCU5 - Temporary Sunny Bay PTI/Future Tourism Area Gateway	Temporary construction arrangement
