<b>ENSR   AECOM</b>		AGREEMENT NO. CE 43/2005 (EP)		SCALE	N.T.S.	DATE	FEB 2008
		HARBOUR AREA TREATMENT SCHEME (HATS) STAGE 2A ENVIRONMENTAL IMPACT ASSESSMENT STUDY - INVESTIGATION		CHECK	AKYC	DRAWN	WCM
		<b>DEPTH-AVERAGED DISSOLVED OXYGEN - SCENARIO B, DRY SEASON, SPRING TIDE MID-EBB - BEACHES AND FISH CULTURE ZONES</b>		JOB NO.	60017198	DRAWING No.	6.63
				Rev			
				Rev	-

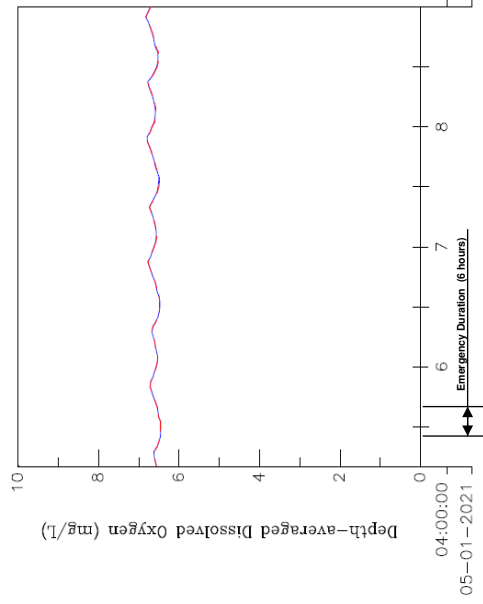
B7 – Anglers' Beach

Scenario 2b - 2021 HATS Stage 2A under Normal Operation  
 Scenario B - 2021 HATS Stage 2A under Emergency Situation (Power / Equipment Failure at SCISTW)
