AGREEMENT NO. CE 43/2005 (EP)
 HARBOUR AREA TREATMENT SCHEME (HATS) STAGE 2A ENVIRONMENTAL IMPACT ASSESSMENT STUDY - INVESTIGATION
DEPTH-AVERAGED DISSOLVED OXYGEN - SCENARIO B, DRY SEASON, NEAR TIDE LOW WATER - BEACHES AND FISH CULTURE ZONES

SCALE	N.T.S.	DATE	FEB 2008
CHECK	AKYC	DRAWN	WCM
JOB NO.	60017198	DRAWING No.	6.64
Rev			-

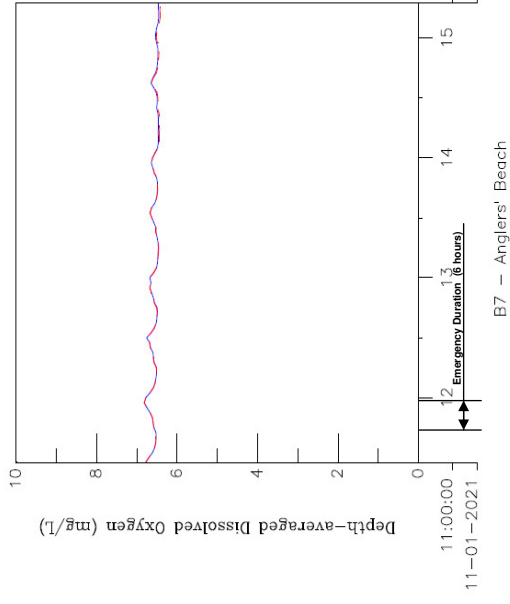
B7 - Anglers' Beach

Scenario 2b - 2021 HATS Stage 2A under Normal Operation
 Scenario B - 2021 HATS Stage 2A under Emergency Situation (Power / Equipment Failure at SCISTW)
