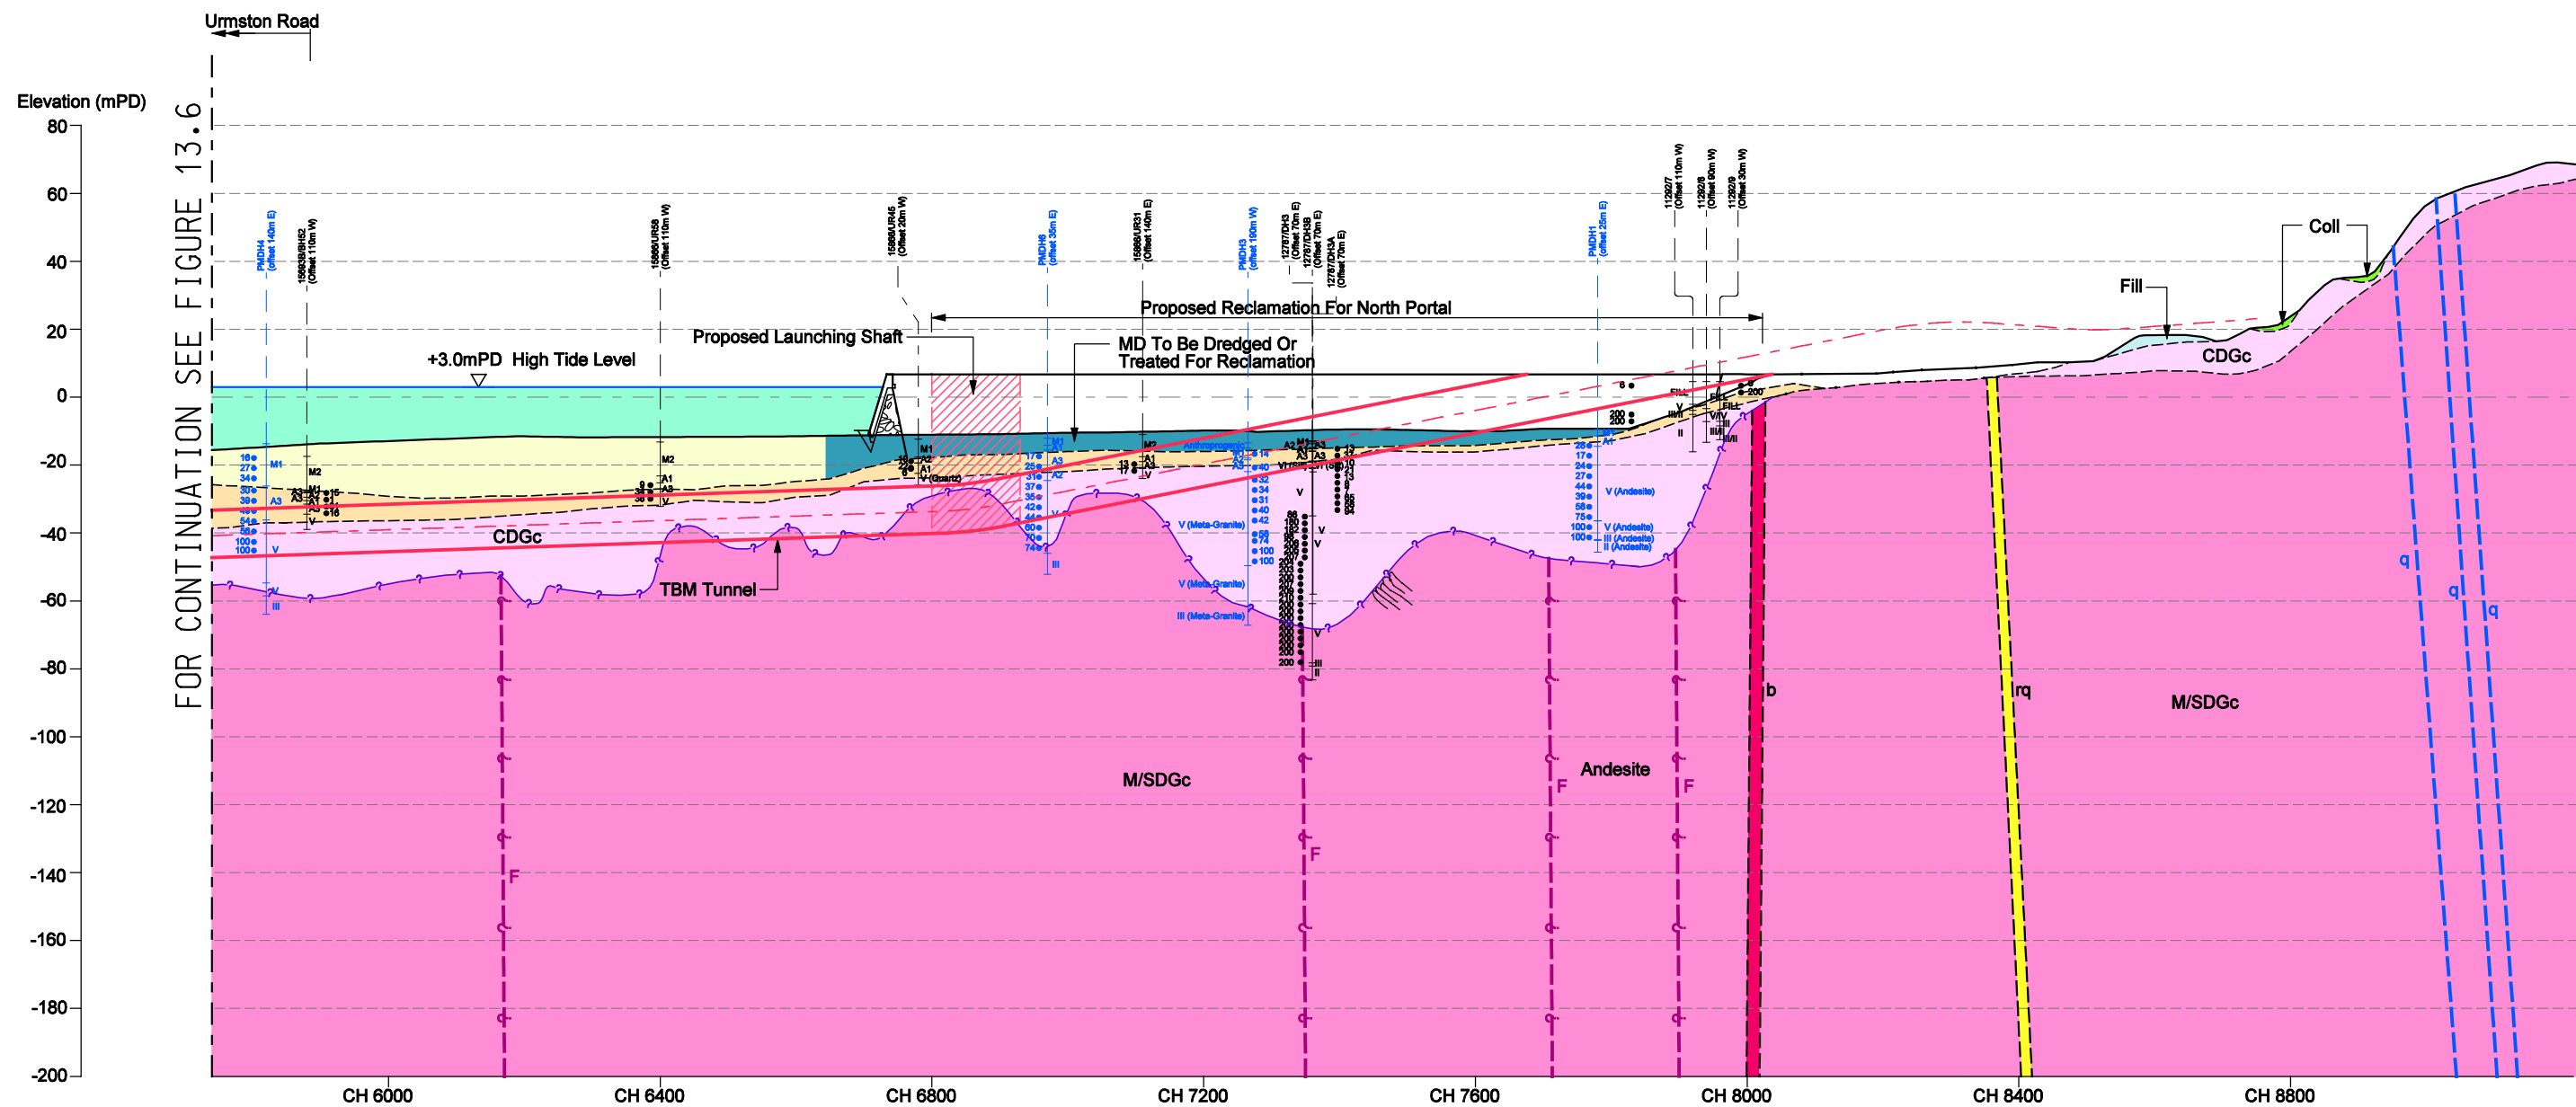
CHAINAGE	6325	6673	6910	6938	6988	7106	7297
GROUND CONDITION AT TUNNEL LEVEL	ALL	ALL	CDG	ALL/MD (Dredged/Treated)			
	CDG	M/SDG	M/SDG	CDG	M/SDG	CDG

**Note:**  
 Rockhead Level & Material Profiles Are Referred From Adjacent Drillholes & Geophysical Survey Results
