Comparison of current at HATS outfall before and after dredging
 Upper plot: Current magnitude; Lower plot: Current direction
 Red: Before dredging at KTCB; Green: After dredging at KTCB

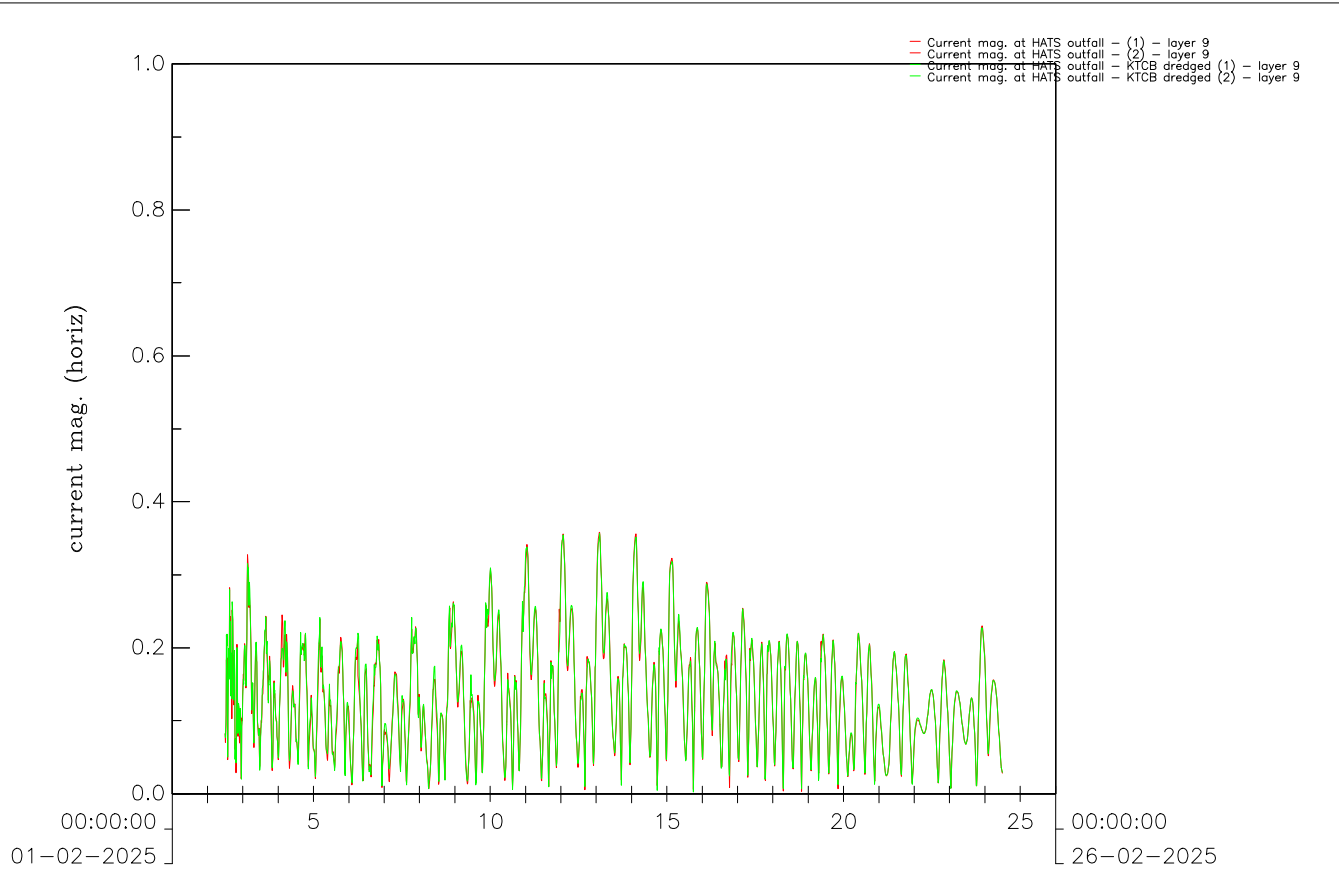
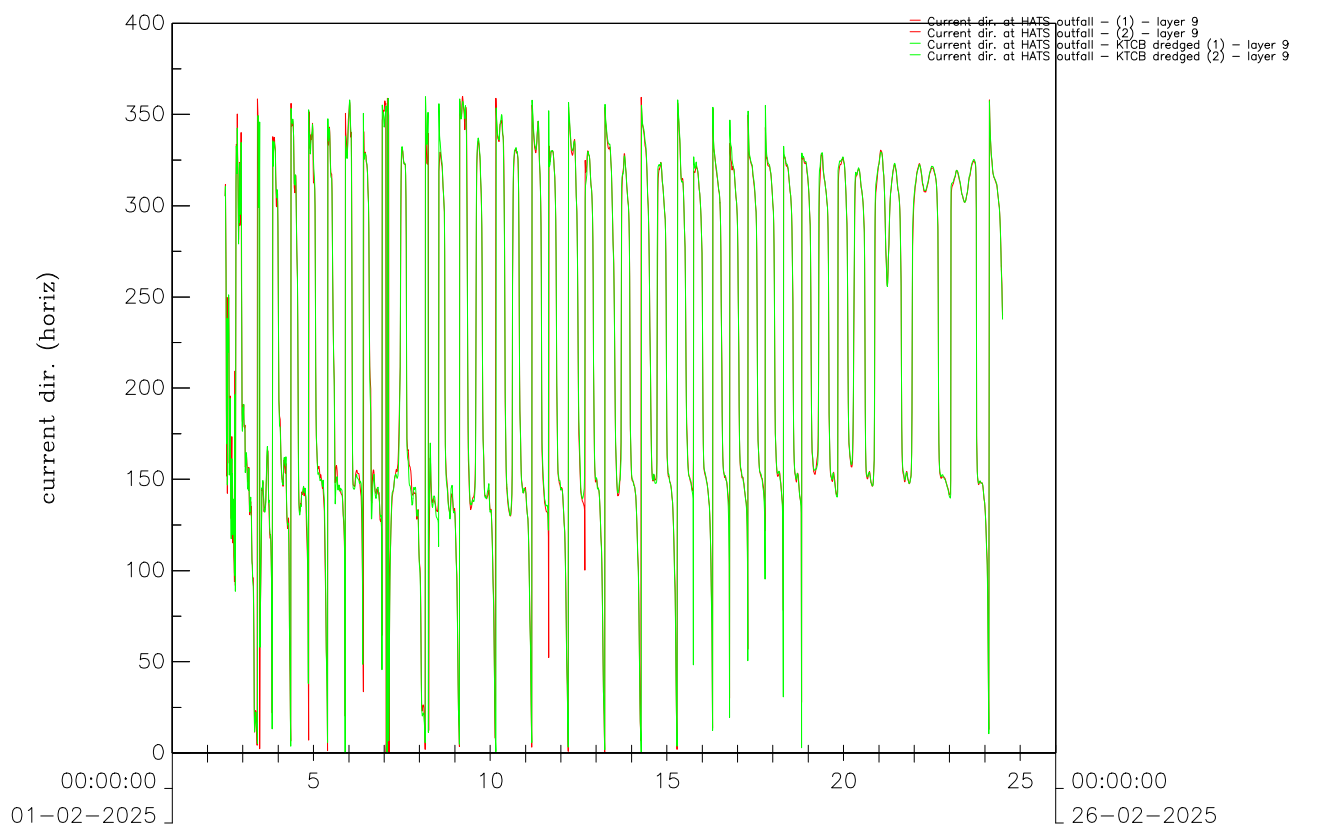
Bottom Layer

dry

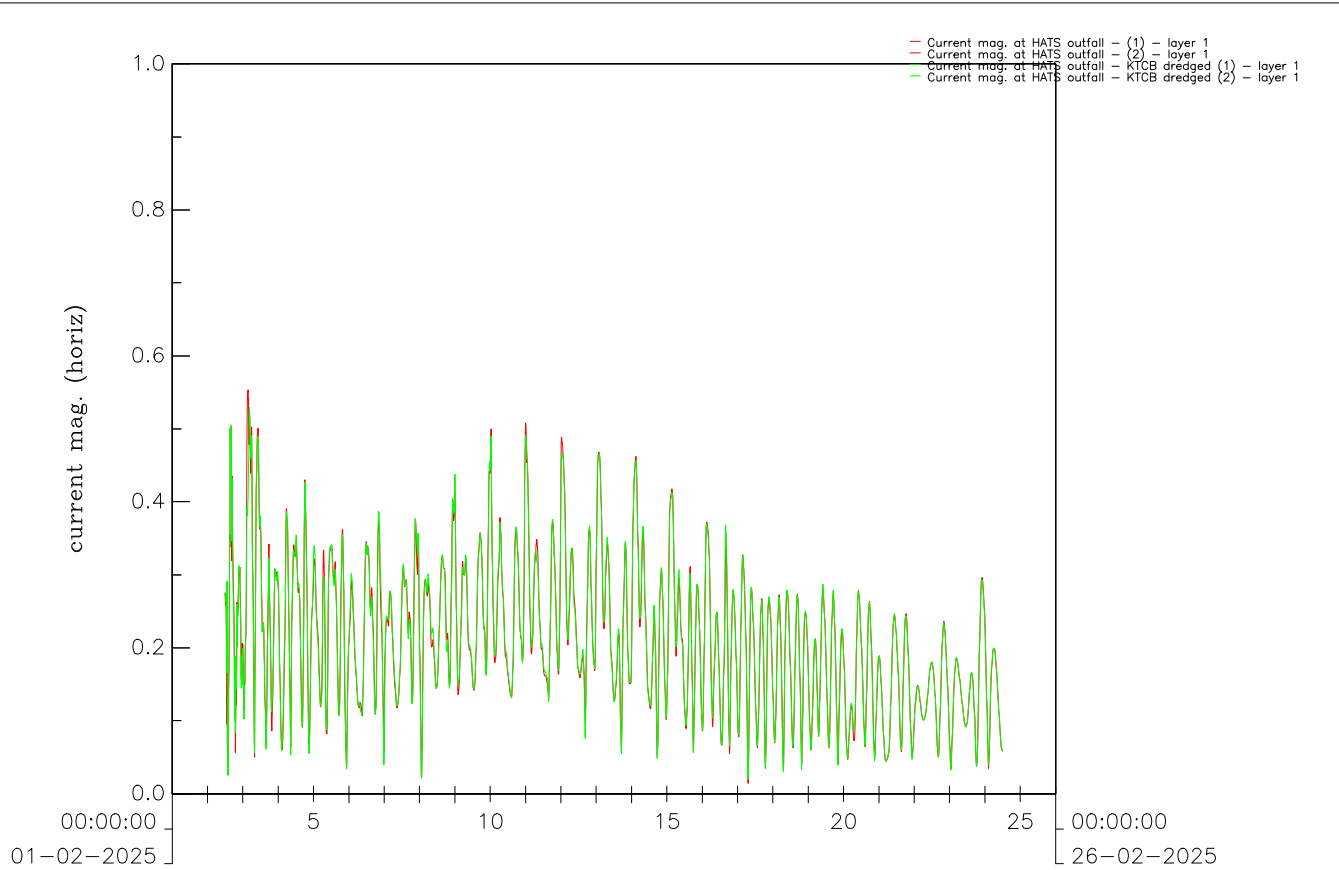
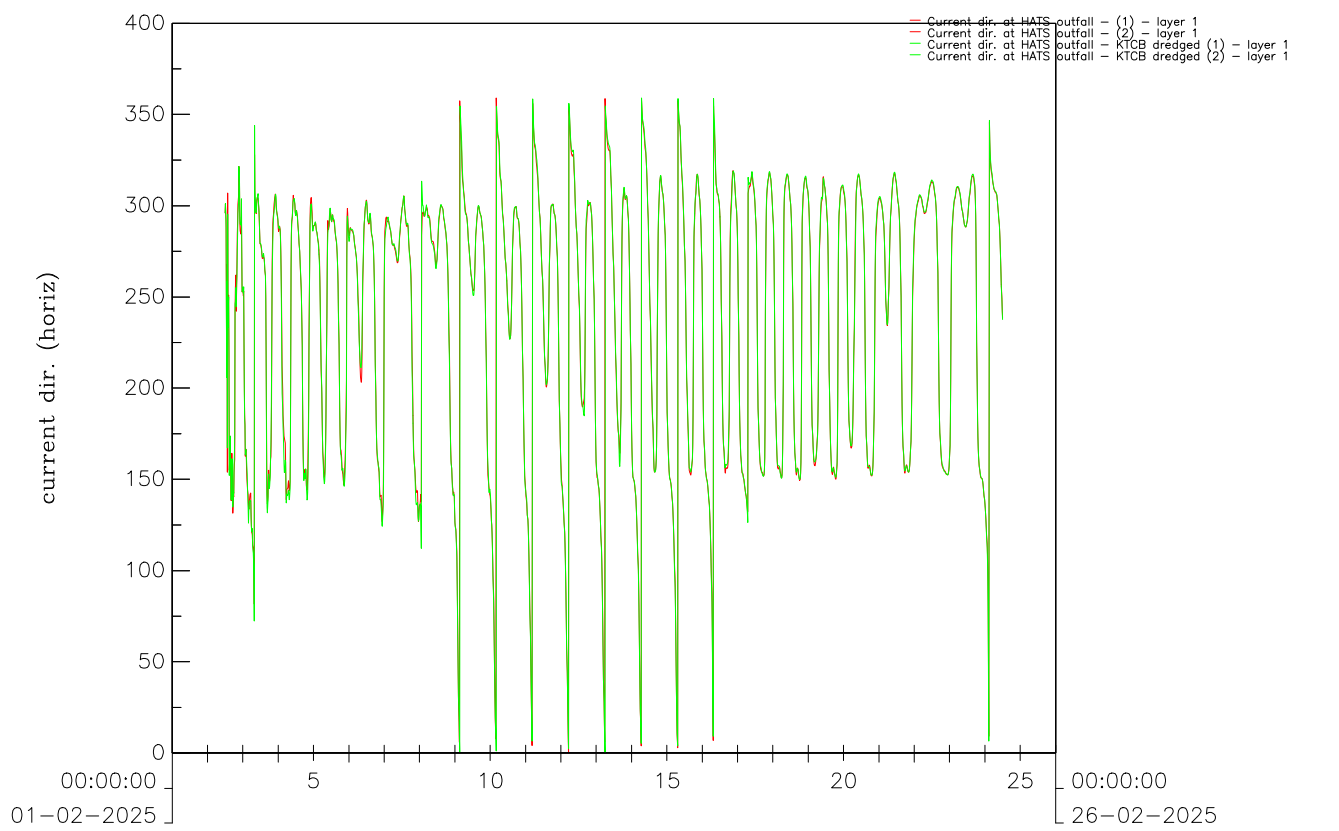
Surface Layer

Comparison of current at HATS outfall before and after dredging
 Upper plot: Current magnitude; Lower plot: Current direction
 Red: Before dredging at KTCB; Green: After dredging at KTCB

dry

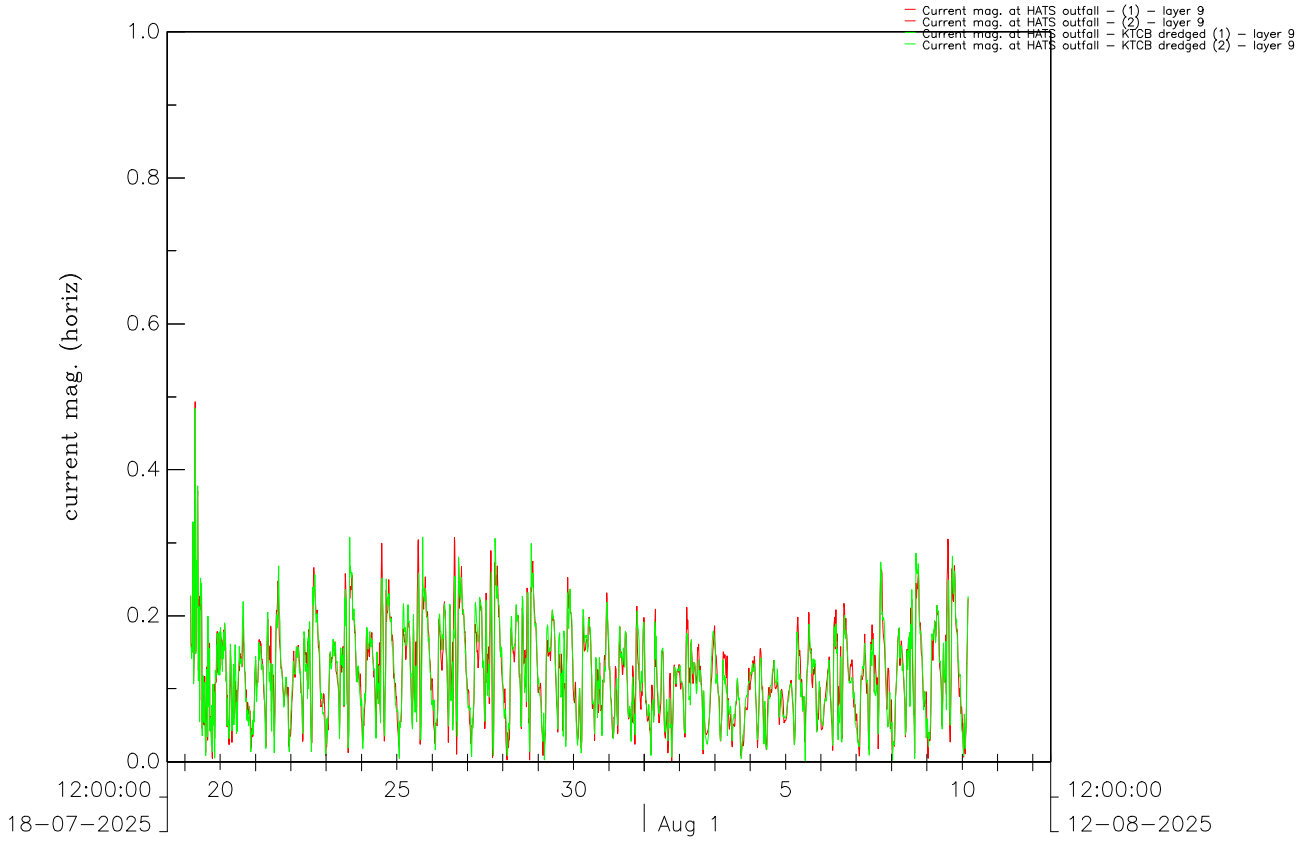
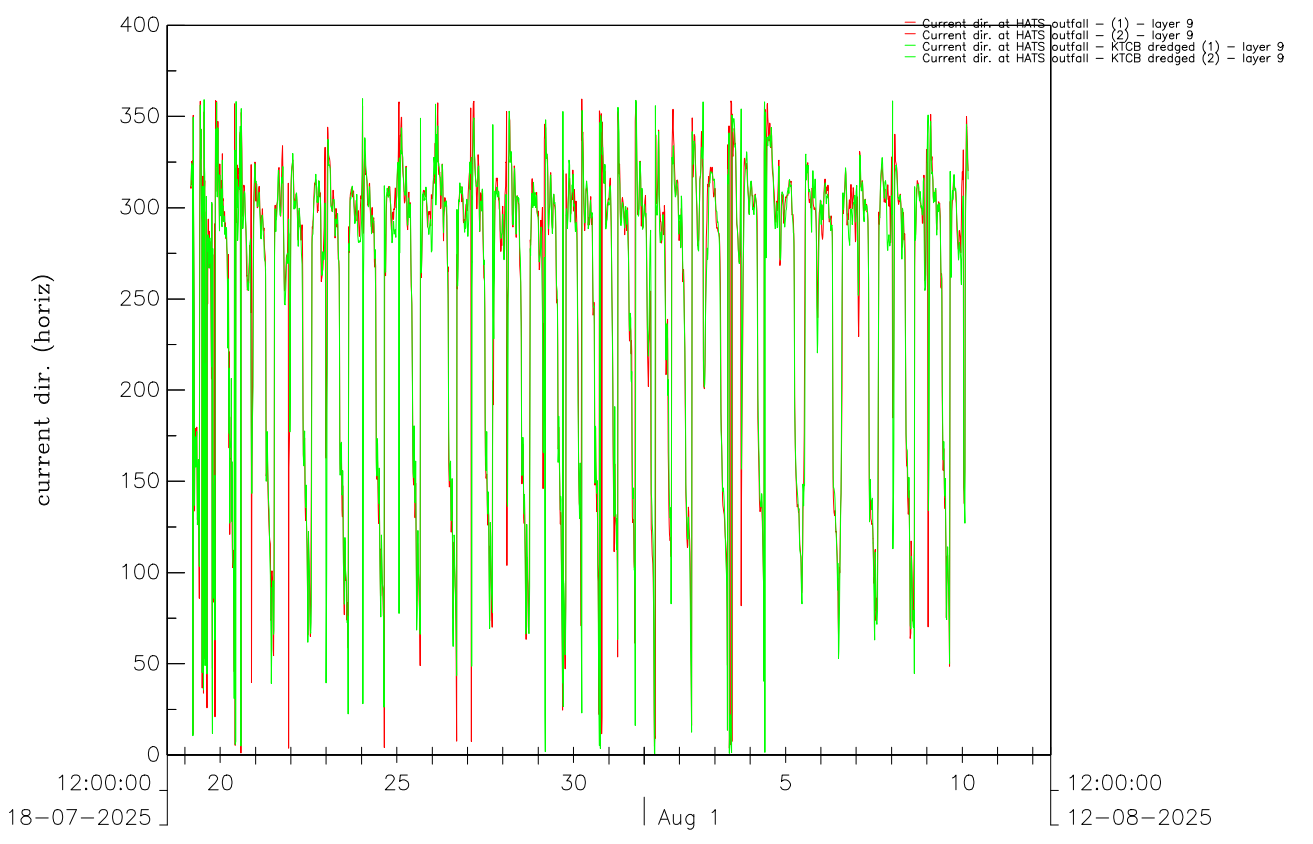
Comparison of current at HATS outfall before and after dredging Upper plot: Current magnitude; Lower plot: Current direction Red: Before dredging at KTCB; Green: After dredging at KTCB	wet	Bottom Layer
Mott MacDonald Hong Kong Ltd.

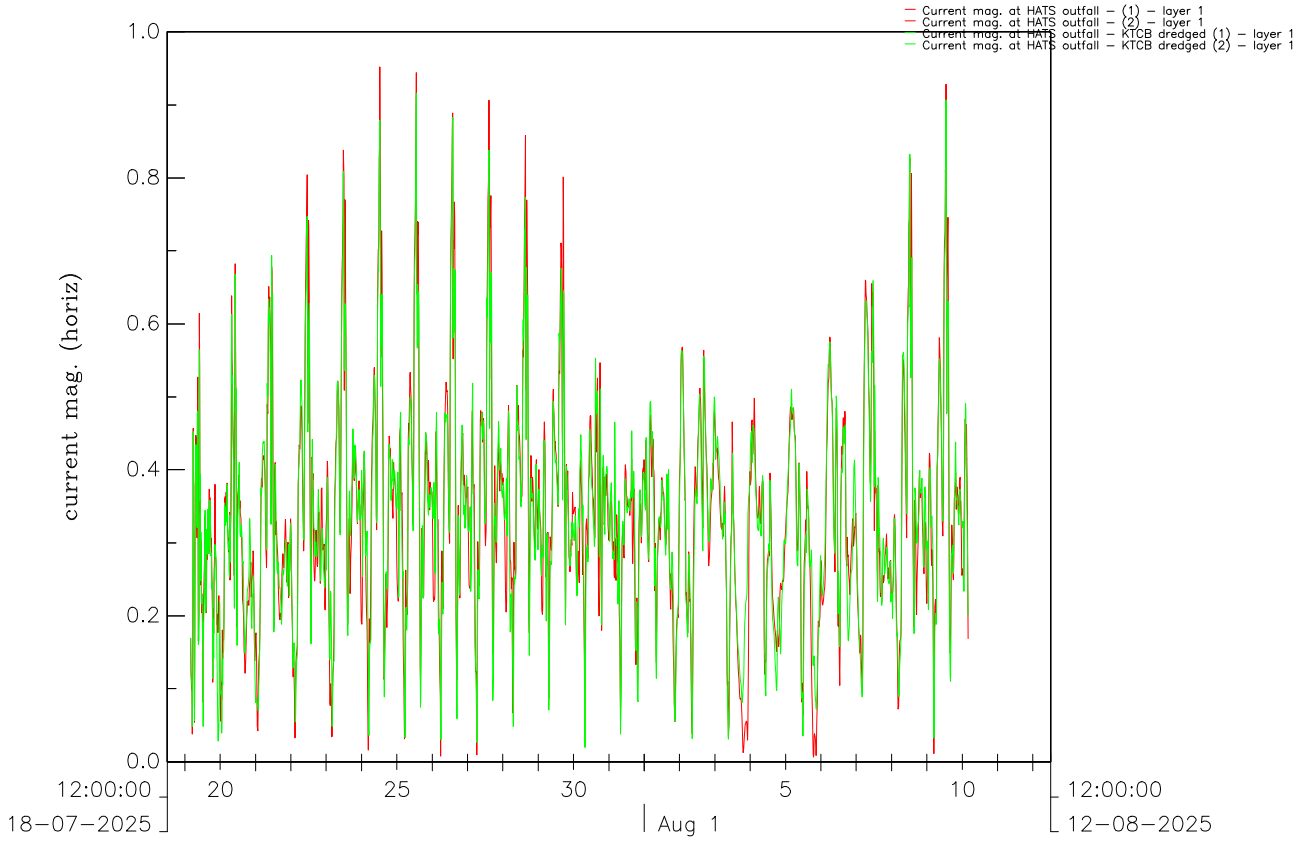
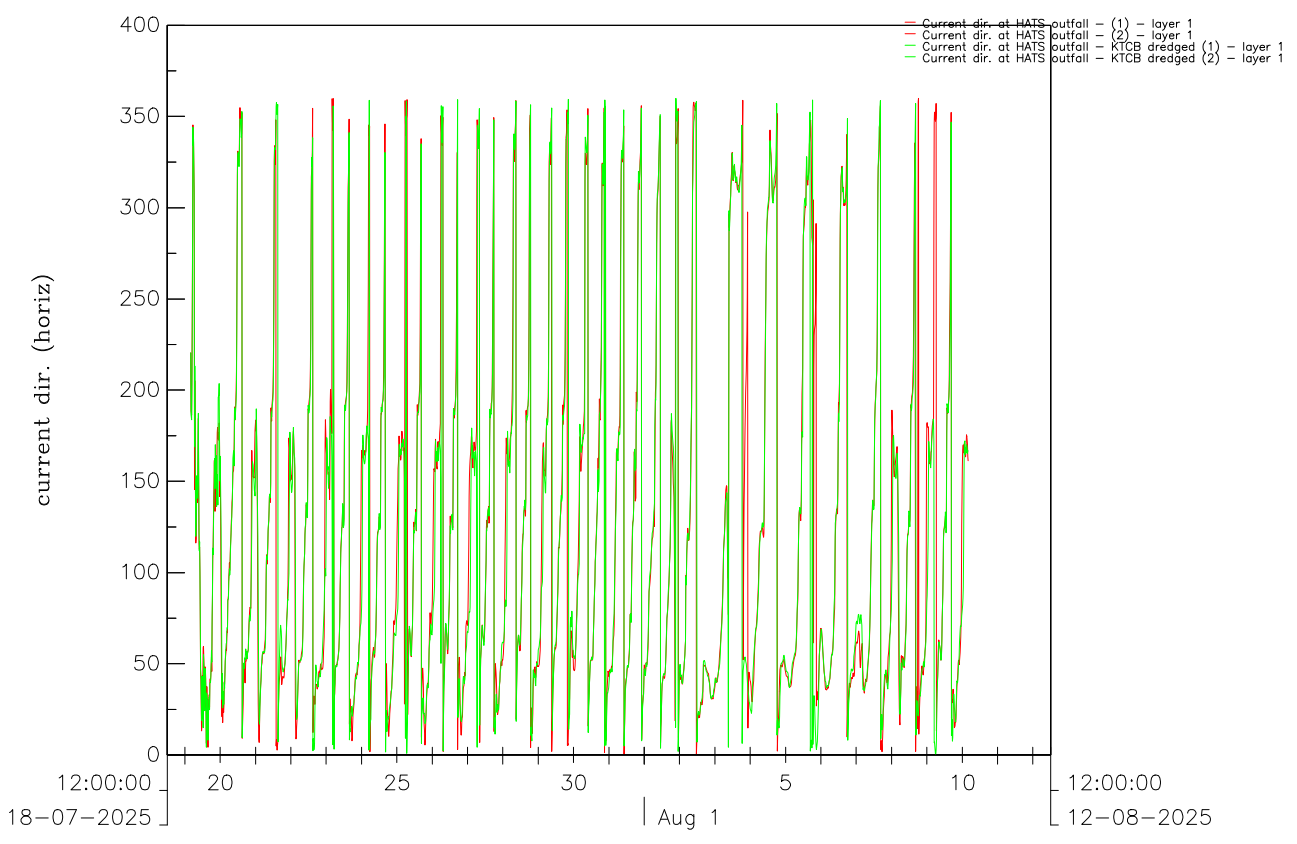
Surface Layer

Comparison of current at HATS outfall before and after dredging
 Upper plot: Current magnitude; Lower plot: Current direction
 Red: Before dredging at KTCB; Green: After dredging at KTCB

wet
