Project
CONSULTANCY AGREEMENT NO. NEX/2301
SOUTH ISLAND LINE (EAST)
ENVIRONMENTAL IMPACT ASSESSMENT

Title
Visual Impacts
Sheet 1 of 4

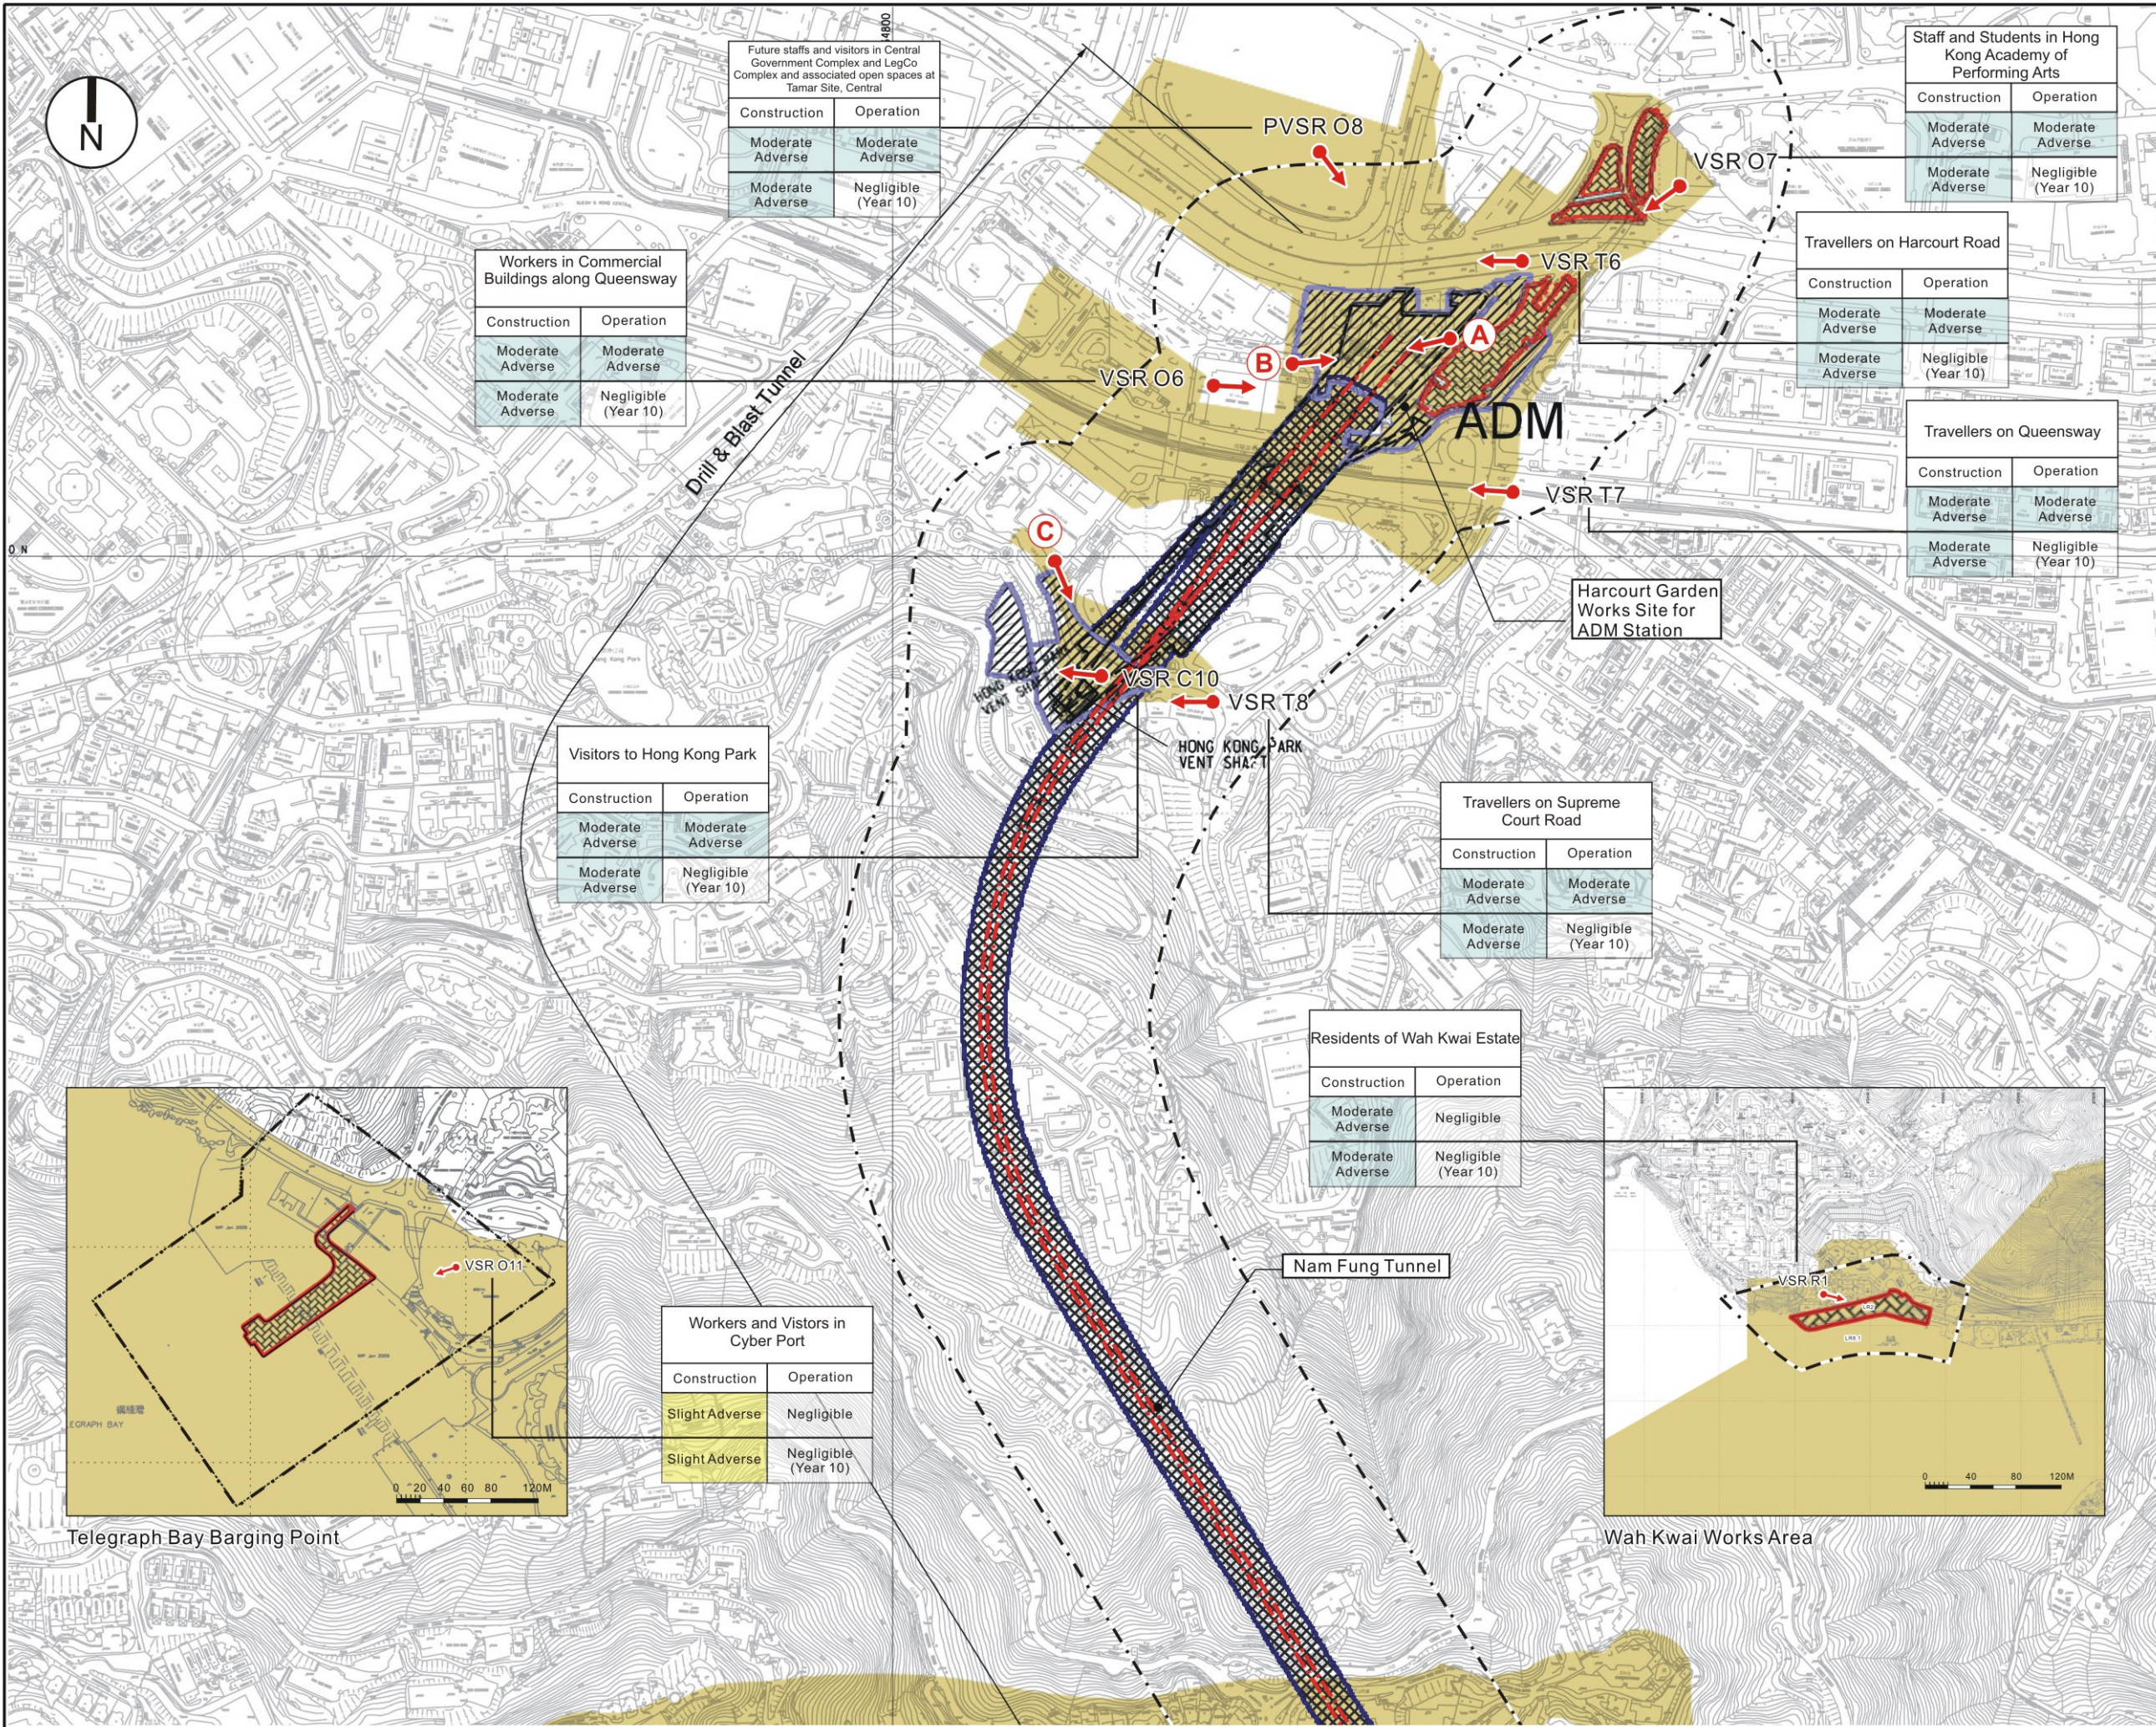
Designed	EIK	07/10	Eng.Chk.	
Drawn	EIK	07/10	Coordination	
Dwg.Chk.	ELK	07/10	Approved	CJF 07/10
Scale	As Shown	Project	CAD File	Status
Drawing No.	Figure 6.8.1			Rev

Visual Impact	Residents of estates in eastern Wah Fu	
	Construction	Operation
Unmitigated	Significant Adverse	Slight Adverse
Mitigated	Moderate Adverse	Negligible (Year 10)

Future staffs and visitors in Central Government Complex and LegCo Complex and associated open spaces at Tamar Site, Central	
Construction	Operation
Moderate Adverse	Moderate Adverse
Moderate Adverse	Negligible (Year 10)

Workers in Commercial Buildings along Queensway	
Construction	Operation
Moderate Adverse	Moderate Adverse
Moderate Adverse	Negligible (Year 10)

Visitors to Hong Kong Park	
Construction	Operation
Moderate Adverse	Moderate Adverse
Moderate Adverse	Negligible (Year 10)

Travellers on Supreme Court Road	
Construction	Operation
Moderate Adverse	Moderate Adverse
Moderate Adverse	Negligible (Year 10)

Residents of Wah Kwai Estate	
Construction	Operation
Moderate Adverse	Negligible
Moderate Adverse	Negligible (Year 10)

Workers and Visitors in Cyber Port	
Construction	Operation
Slight Adverse	Negligible
Slight Adverse	Negligible (Year 10)
