Annex G5

Detailed Records of Identified Built Heritage Features within CHIA Study Area

Graded/Proposed Graded Historic Building

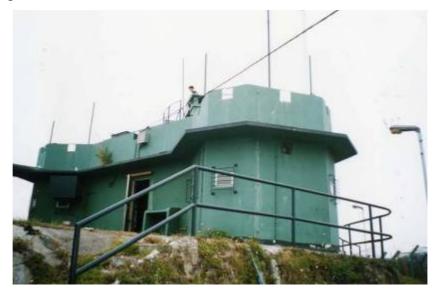
This fort at Pak Fu Shan is two-storey high and was constructed with a rounded central portion and two side wings on the ground floor. One wing was generally used for sleeping quarters for up to eight people and the other for cooking. The ground floor of the central area served as communication or command room and the second floor as an observation tower. Both floors are constructed with ramparts and gun-slot iron openings. There are double iron doors at the entrance of the fort

Existing Condition: Good

General view (Source: Antiquities and Monuments Office Website)

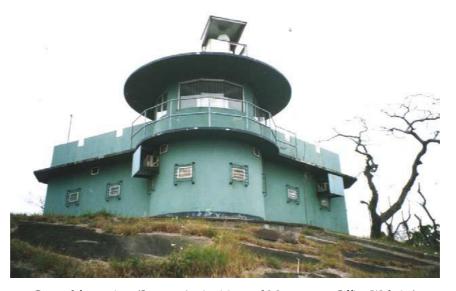
Site Code: G202 Site Name: MacIntosh Fort (Ngau Yiu)

Similar to MacIntosh Fort at Pak Fu Shan, this fort at Ngau Yiu is two-storey high and was constructed with a rounded central portion and two single-storey side wings on the ground floor. One wing was generally used for sleeping quarters for up to eight people and the other for cooking. The ground floor of the central area served as communication or command room and the second floor as an observation tower. Both floors are constructed with ramparts and gunslot iron openings. There are double iron doors at the entrance of the fort. The major difference of this fort from other MacIntosh Forts is that this fort has a circular shaped flat roof, instead of an octagonal shaped roof adopted by other forts.

Existing Condition: Good

General front view (Source: Antiquities and Monuments Office Website)

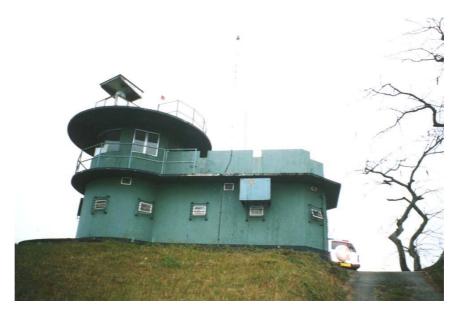
Right elevation (Source: Antiquities and Monuments Office Website)

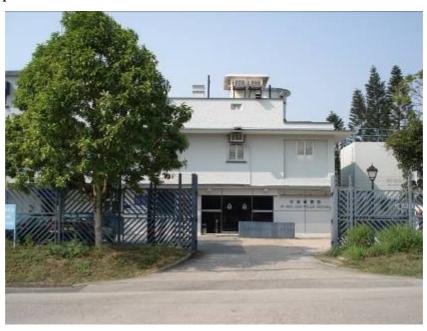
Site Code: G301

The police station is built to a T-shaped plan situated in a large compound opposite the Fire Station in Ta Kwu Ling Village. The architectural style of the buildings is International Modern which was a popular style in the 1930s when it was built. Characteristic features of this style are the long rectangular shape, white walls, regularly spaced windows, projecting horizontal typhoon canopies running the length of the facades, and the absence of any superfluous ornamentation or decoration. The colour scheme is white and dark blue which are the distinctive livery colours chosen for all police stations some years ago by local architect Tao Ho (何爱) who was commissioned to produce a colour scheme that would give a corporate identity. A distinctive feature on the roof is the round watch tower which is only found on police stations and is something of a trademark. The interior of the building is simple and functional as befits police operational requirements.

Existing Condition: Excellent

General View of the Front Gate of the Police Station

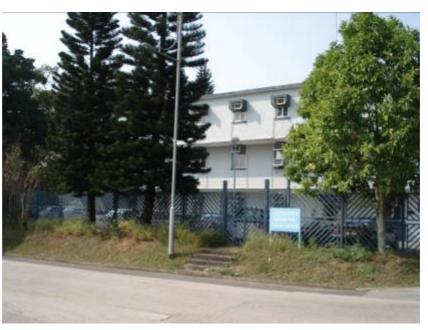
Side View of the Police Station

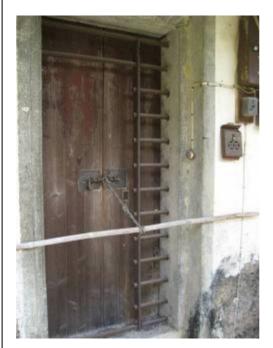
These buildings are one hall and three bays in layout. It is two storeys high and has a balcony in front supported by granite pillars. The balcony on the second floor has iron railings and there are three doors on the second floor giving access to the balcony. On the ground floor, there are three granite doorways with timber doors. There are arched external doorways through the side walls, one of which is now blocked. The side walls have small window openings.

Existing Condition: Poor

Granite Doorways with Iron Bars and Blocked Arch Opening at Side Wall

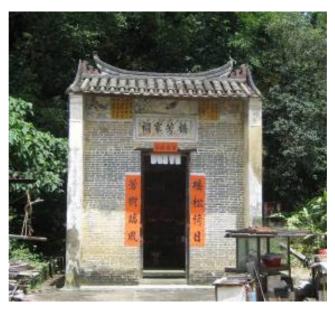
Site Code: G303 Site Name: Kiu Fong Ancestral Hall

The building is two hall and one bay in layout. The building was constructed with grey bricks and rammed earth. The entrance door is located in the middle of the façade and the name of the ancestral hall "橋芳家祠" (Kiu Fong Family Hall) is inscribed above the lintel. According to the inscription above the lintel, the hall was constructed in 1931. The façade wall frieze is decorated with paintings and calligraphy. The roof ridge is decorated with a boat shape. The altar is placed in the rear hall. Kiu Fong was probably one of the ancestors of a branch of the Ho clan.

Existing Condition: Fair

General Front View

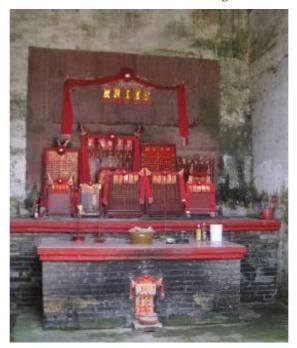
Altar in the Rear Hall

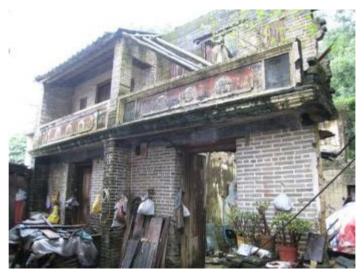
These buildings were originally two halls and two bays in layout. The southern section is now in a ruined condition. The building is two storeys high and has a balcony in the front supported grey brick built pillars. There is a doorway and two windows on the second floor of the façade connecting to the balcony. A timber-framed entrance door is located in the middle of the façade on the ground floor. The building was constructed with grey bricks and has a pitched roof. The north side wall frieze is decorated with plaster features. There is no courtyard between the front hall and rear hall. The rear hall is only one storey high and has a chimney stack indicating that it was probably used as a kitchen. Window openings are found on the side walls and rear wall.

Existing Condition: Poor

General Front View

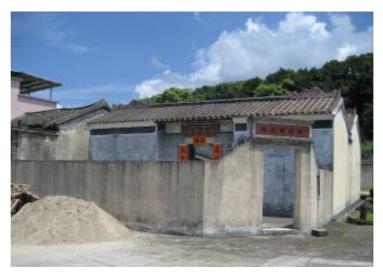
It is a two halls building with an open courtyard in between and an enclosed frontyard. The halls comprise three bays. The ancestors' soul tablets are place on the altar in the rear hall of the middle bay for ancestral worship.

Existing Condition: Well maintained

General Front View

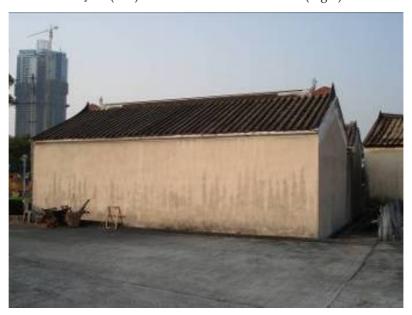
Back View

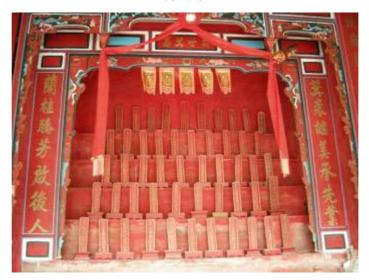
Altar with Soul Tablets in the Middle Bay Rear Hall

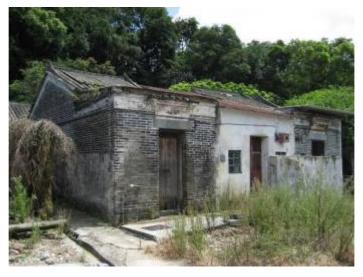
Site Code: BS02 Site Name: Nos 48 to 50 Tsung Yuen Ha

The buildings are two halls and three bays in layout. The middle bay may have been modified with modern materials. The side bays were constructed with grey bricks. An entrance door is located in the middle of each bay with and each has a granite lintel. Wall friezes with decorative features were also observed.

Existing Condition: Poor

General Front View

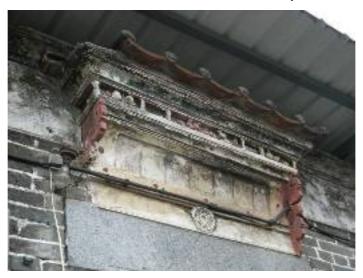
Wall Frieze Decorative Features of West Bay

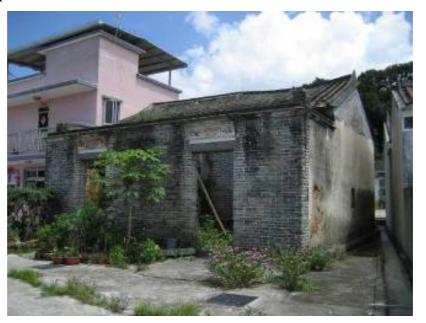
Site Code: BS03

It is two-hall and two-bay in layout. The building was constructed with grey bricks and rammed earth. An entrance door opned in the middle of façade at each of the two bays. The lintel was granite made and decorative features were found on wall frieze. Small window openings are found on the side and rear walls. The building is in a ruined condition and the east bay roof has collapsed.

Existing Condition: Poor and dilapidated

General Front View

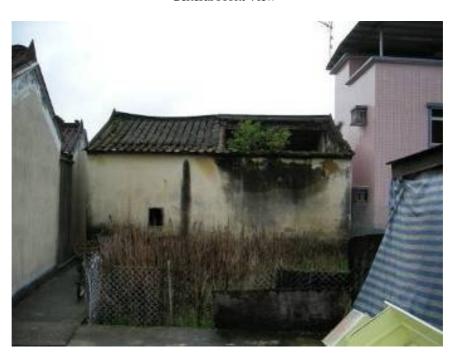
Back view (collapsed roof)

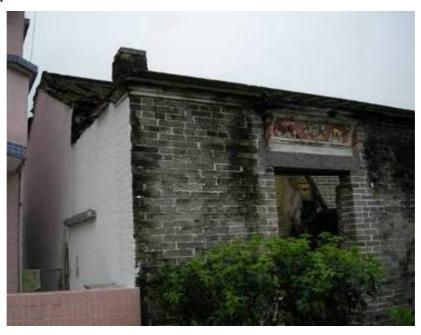
It is two-hall and one-bay in layout and is constructed with grey bricks and rammed earth. The entrance door opened in the middle of façade. Decorative features were found above the lintel. Small window openings are found on the side and rear walls. The building is now ruined.

Existing Condition: Poor and abandoned

General Front View of East Bay

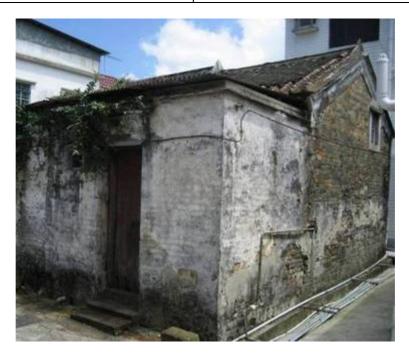
Site Name: House between Nos 7 and 9, Tsung Yuen Ha

General Front View of West Bay and West Side Wall

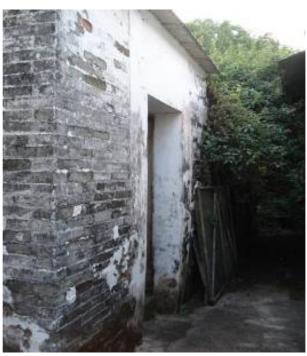
Site Code: BS07 Site Name: No. 43 Tsung Yuen Ha

Existing Condition: Dilapidated

Front View

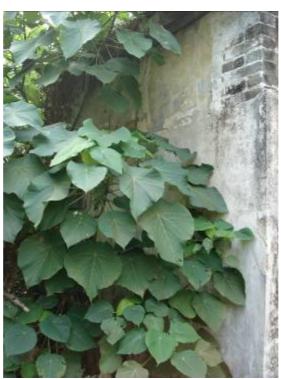
Back View

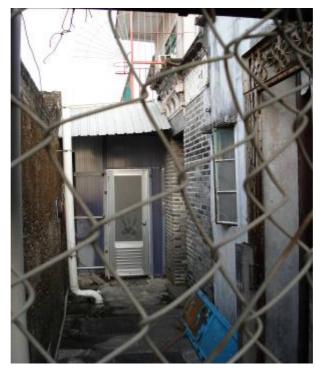
Site Code: BS08 Site Name: No. 40 Tsung Yuen Ha

Existing Condition: Fair

General Front View

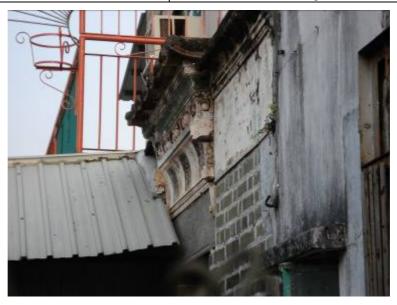
Decoration above Lintel of No. 40 Tsung Yuen Ha

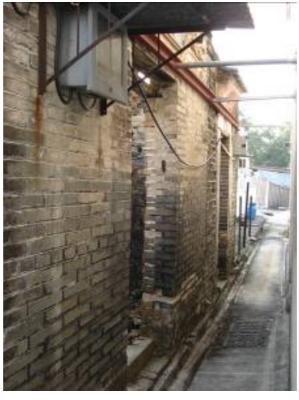
These two rectangular residential houses constructed with shared party wall, pitched tile roofs and enclosed frontyard. Wall frieze decorations are identified on facade. The buildings were constructed with stone and rammed earth and grey bricks. These buildings are in such a dilapidated condition that some of the walls/roofs have been collapsed.

Existing Condition: Poor and dilapidated

General Front View

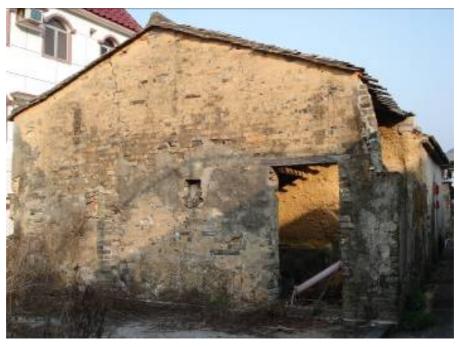
Existing Condition: Poor and structurally unstable

General Front View

Notes on any Modifications: Require external structural support

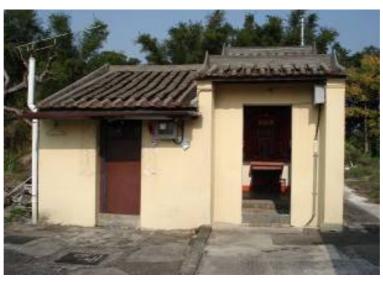
Site Code: BS11 Site Name: Fuk Tak Temple

Existing Condition: Good

Notes on any Modifications: Recently renovated; Surfaced with cement and painted walls

Front View

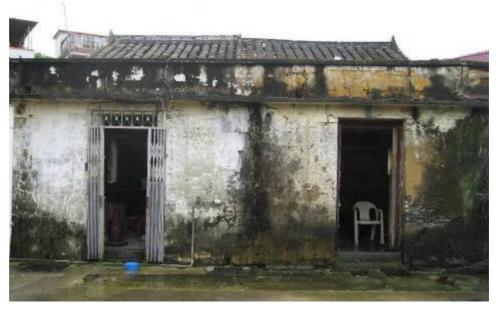
Site Code: BS13 Site Name: No. 14 Kan Tau Wai

This building is two halls and two bays in layout. The building was constructed with rammed earth and grey bricks. An entrance door is located in the middle of the façade of each bay. Window openings are found on the side and rear walls. No decorative features were identified.

Existing Condition: Poor and dilapidated

Front View

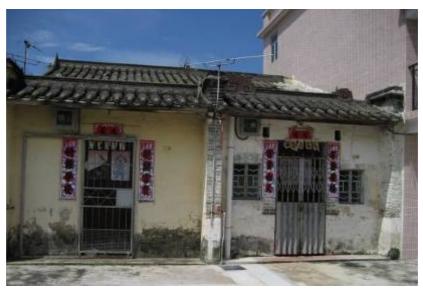
These buildings are two halls and two bays in layout. The building was constructed with grey bricks and rammed earth and lime plastered. An entrance door is located in the middle of each bay. Window openings are found above and beside the entrance door of No 2. Other windows were observed on the north western side wall and rear wall.

Existing Condition: Fair

Front View of Nos. 1 (Left) and 2 (Right) Kan Tau Wai

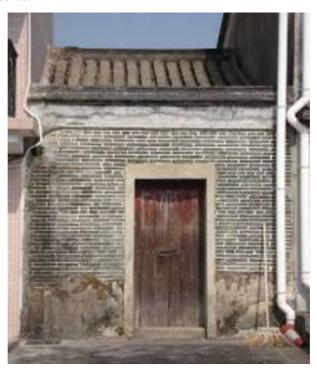
Site Code: BS15 Site Name: No. 4A Kan Tau Wai

This building is two halls and two bays in layout. The building was constructed with stone block foundations and grey bricks and rammed earth on top of the walls. An entrance door is located in the middle of the façade. No decorative features were identified.

Façade showing tile roof and wooden front doors

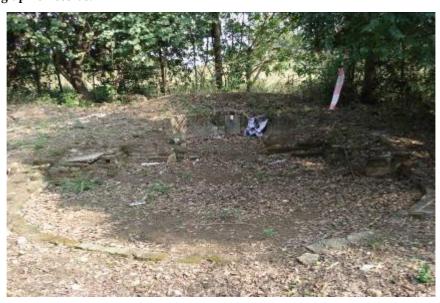
Architectural Appraisal: The three clan graves are identical in size (i.e. $6m (L) \times 3m (W) \times 0.5m (H)$). Each grave has a circular layout and was constructed of bricks with headstone erected in the middle.

Existing Condition: Poor

General View of the Clan Grave at the East

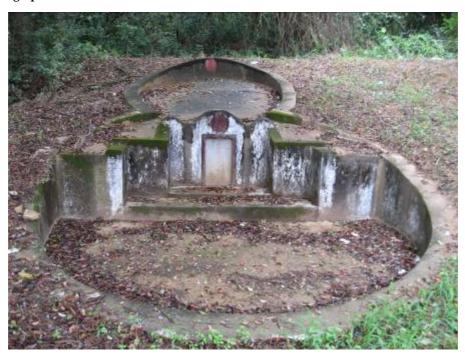
Site Code: GR07 Site Name: Yiu Grave

Existing Condition: Poor

Front View

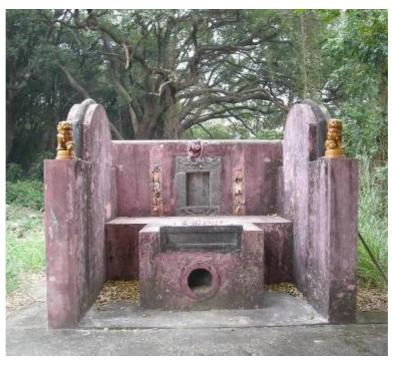
This earth shrine is armchair-shaped and finished with cement. It is worshipped by the villagers of Tsung Yuen Ha village.

Existing Condition: Fair

General Front View of the Shrine
