Figure A.2.1: Sketch of Luminaries and VSR Locations along BCP boundary (East side).

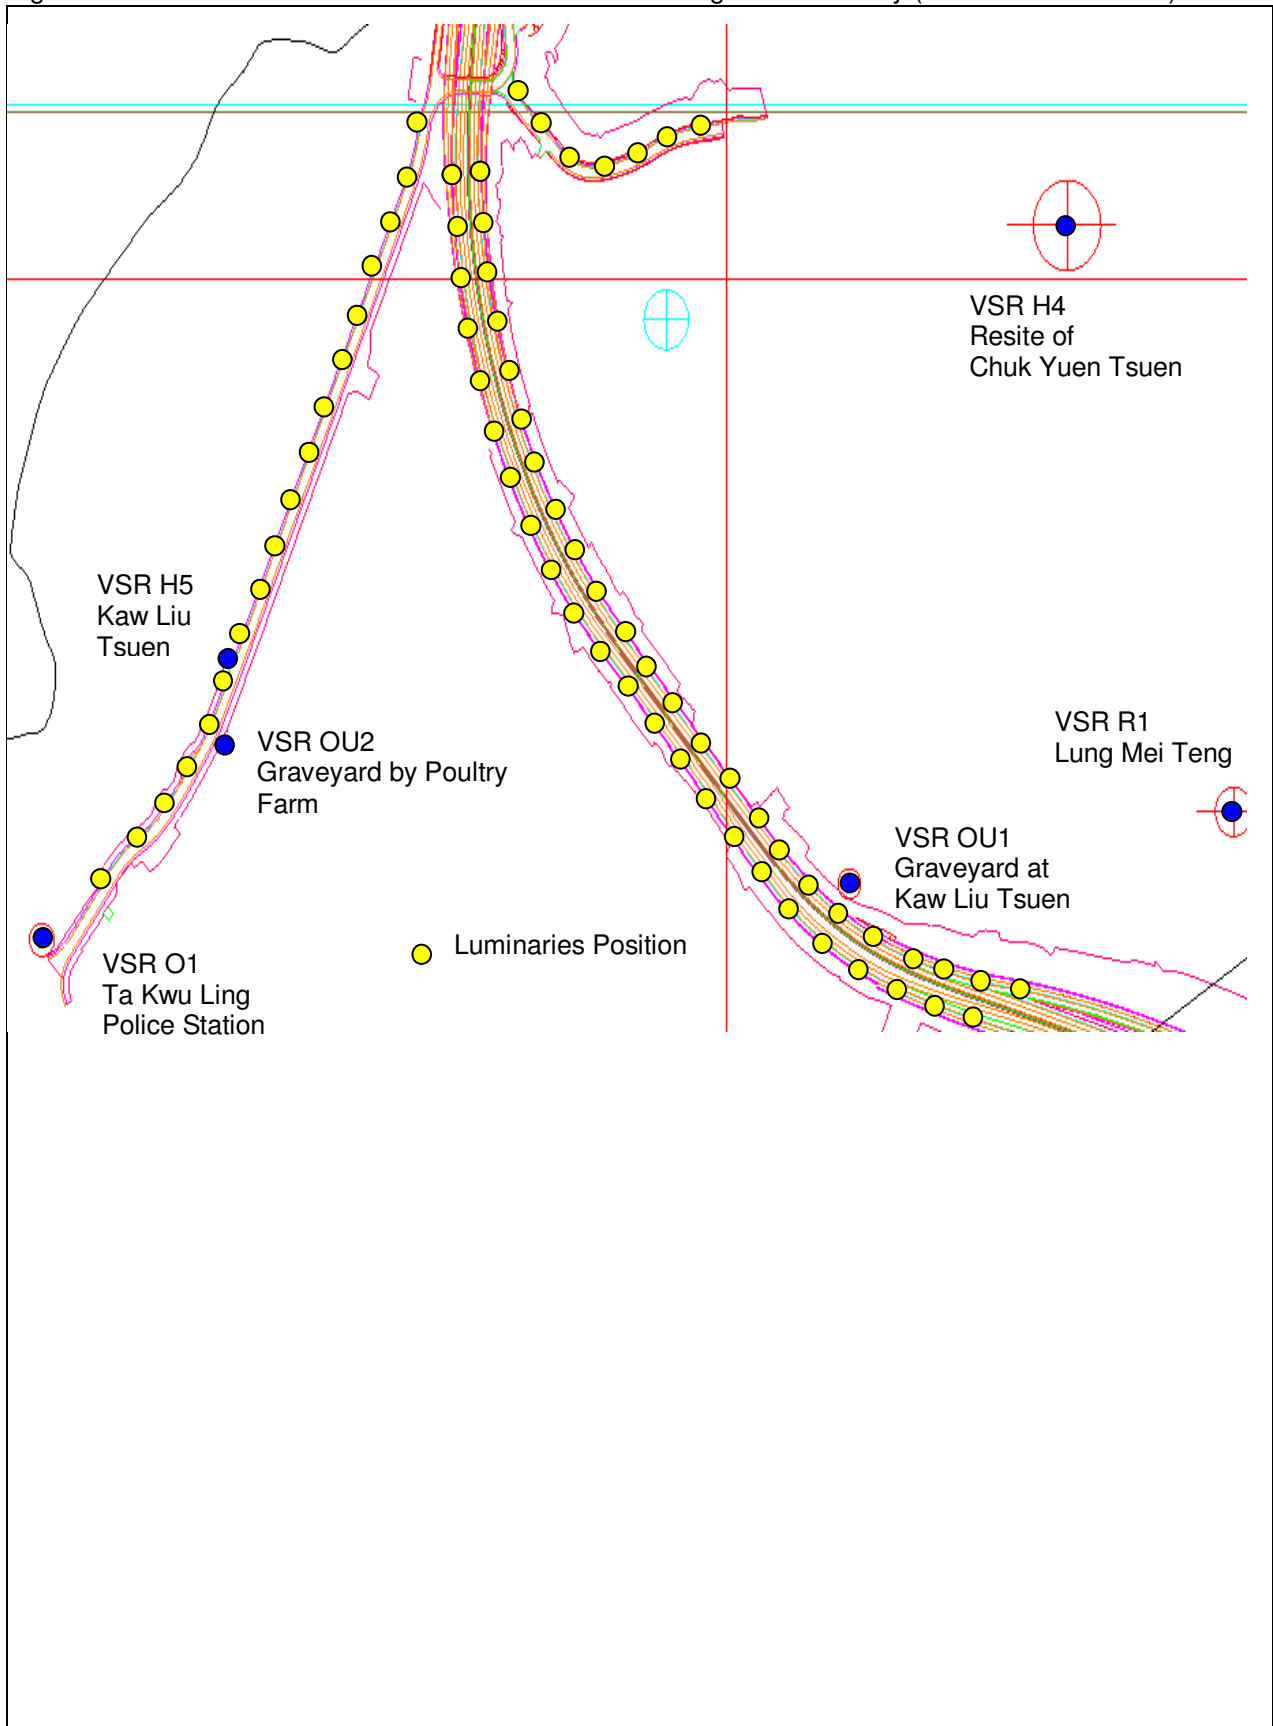
Figure A.2.2: Sketch of Luminaries and VSR Locations along BCP boundary (South and West side).

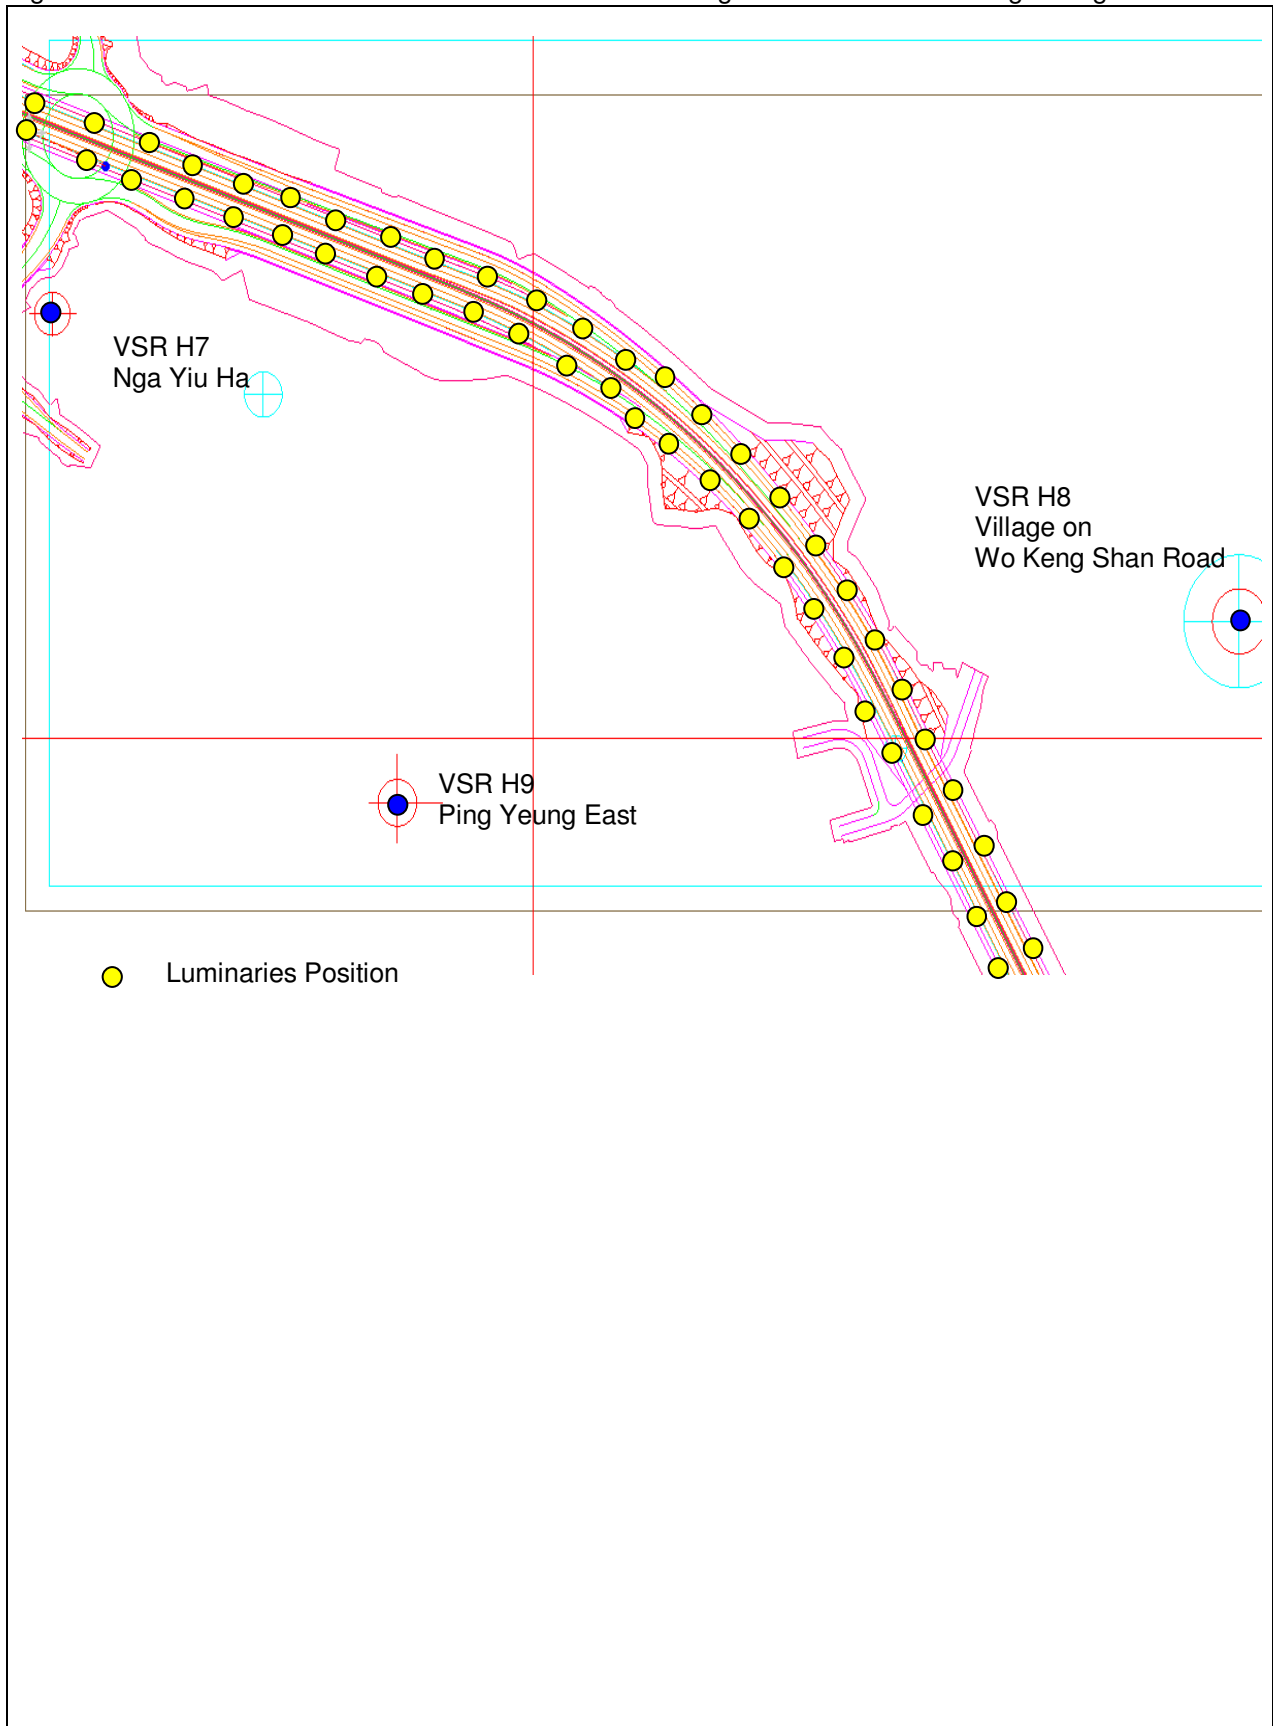
Figure A.2.3: Sketch of Luminaries and VSR Locations along elevated road near Ping Yeung.

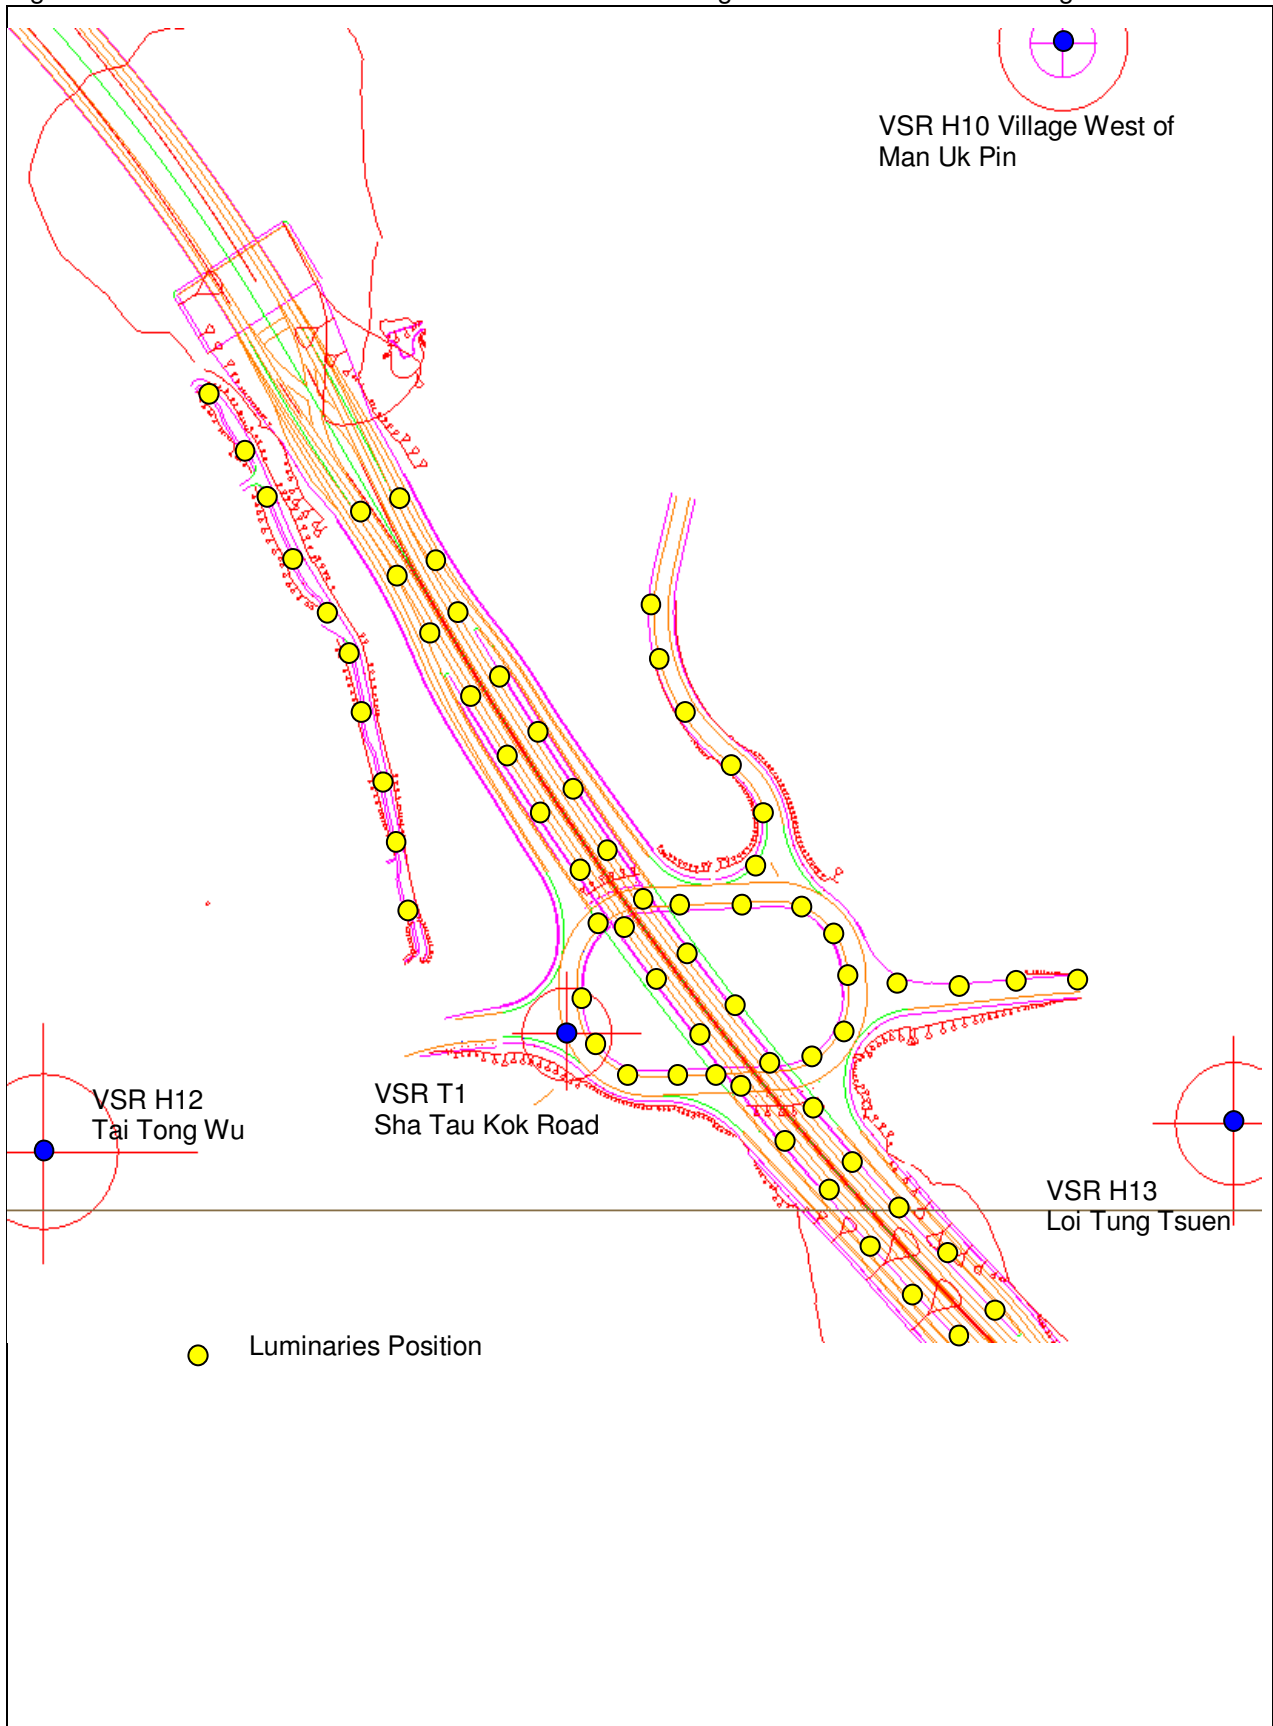
Figure A.2.4: Sketch of Luminaries and VSR Locations along elevated road near Loi Tung Tsuen.

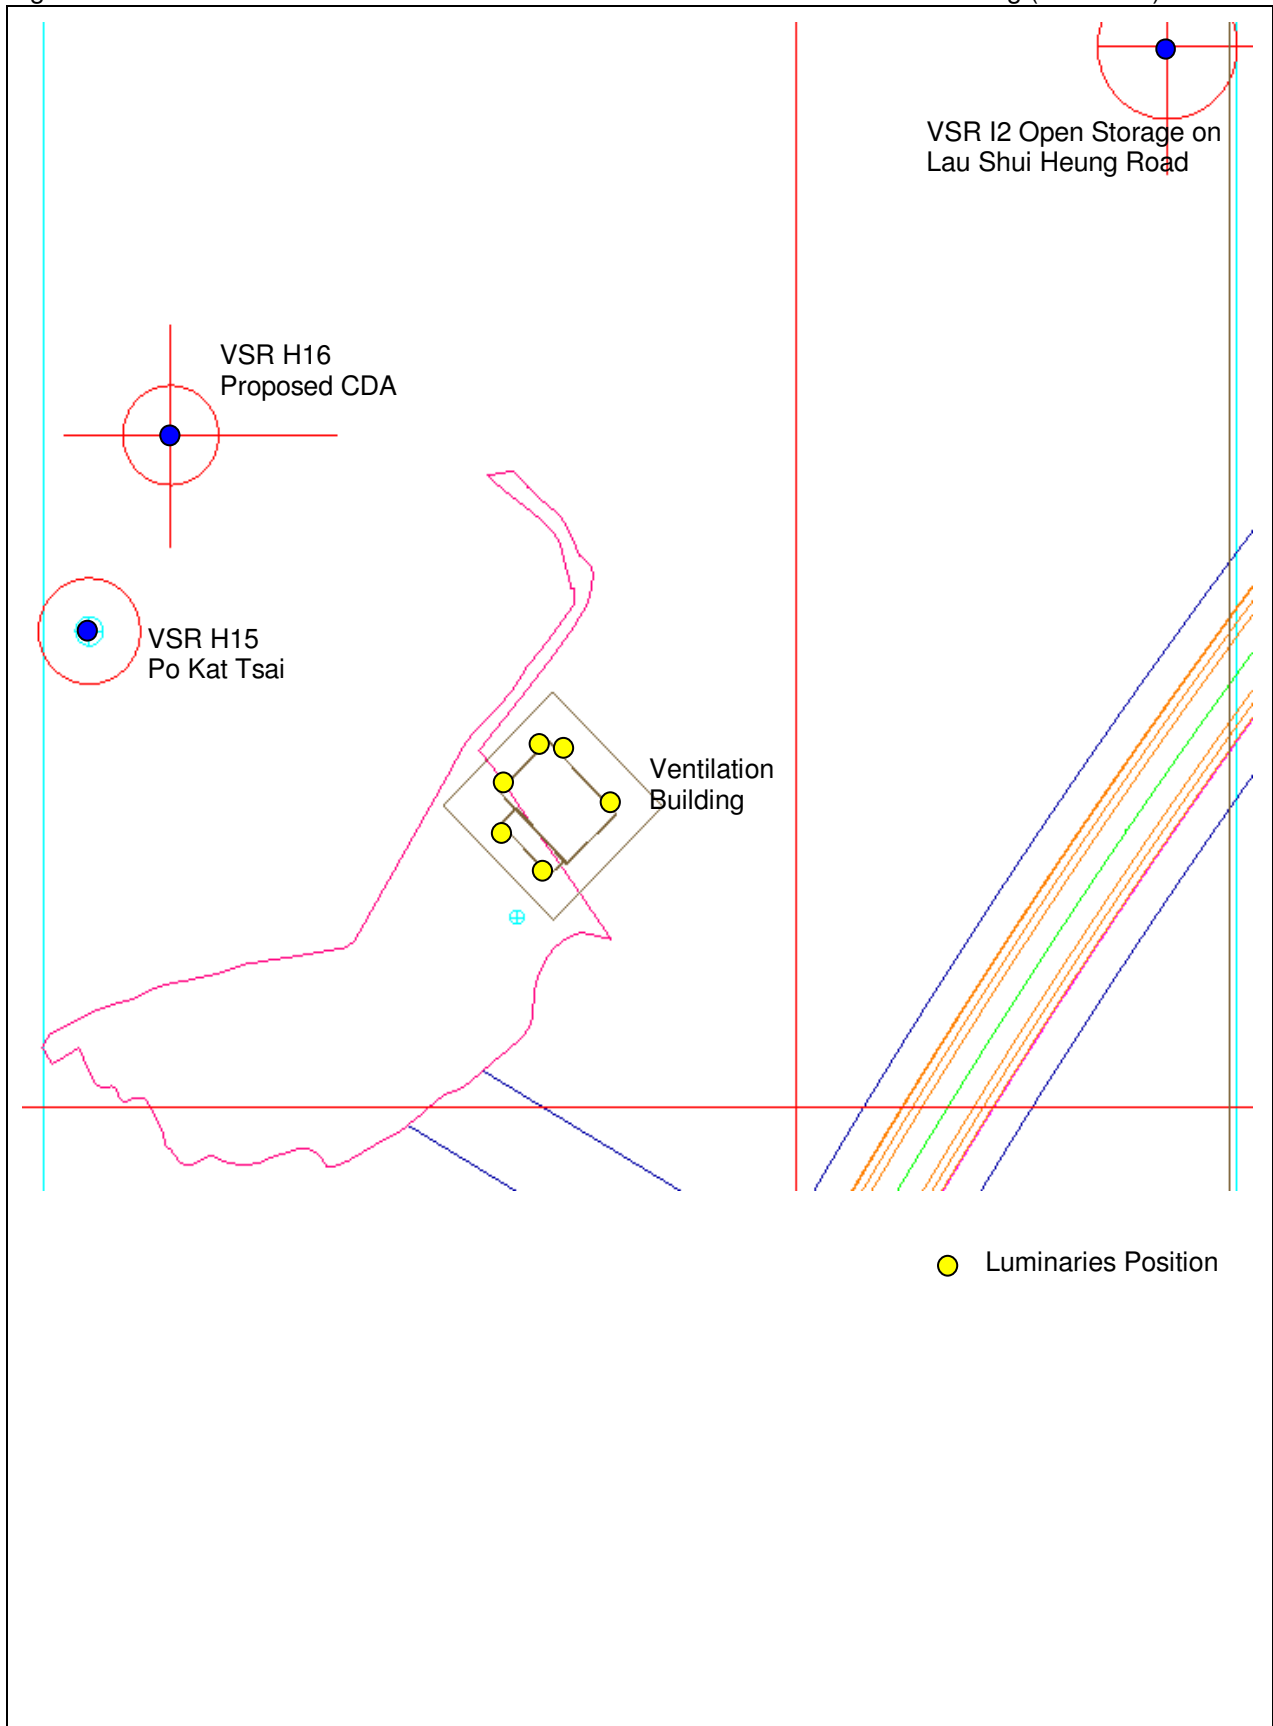
Figure A.2.5: Sketch of Luminaries and VSR Locations for Tunnel Ventilation Building (Section B).

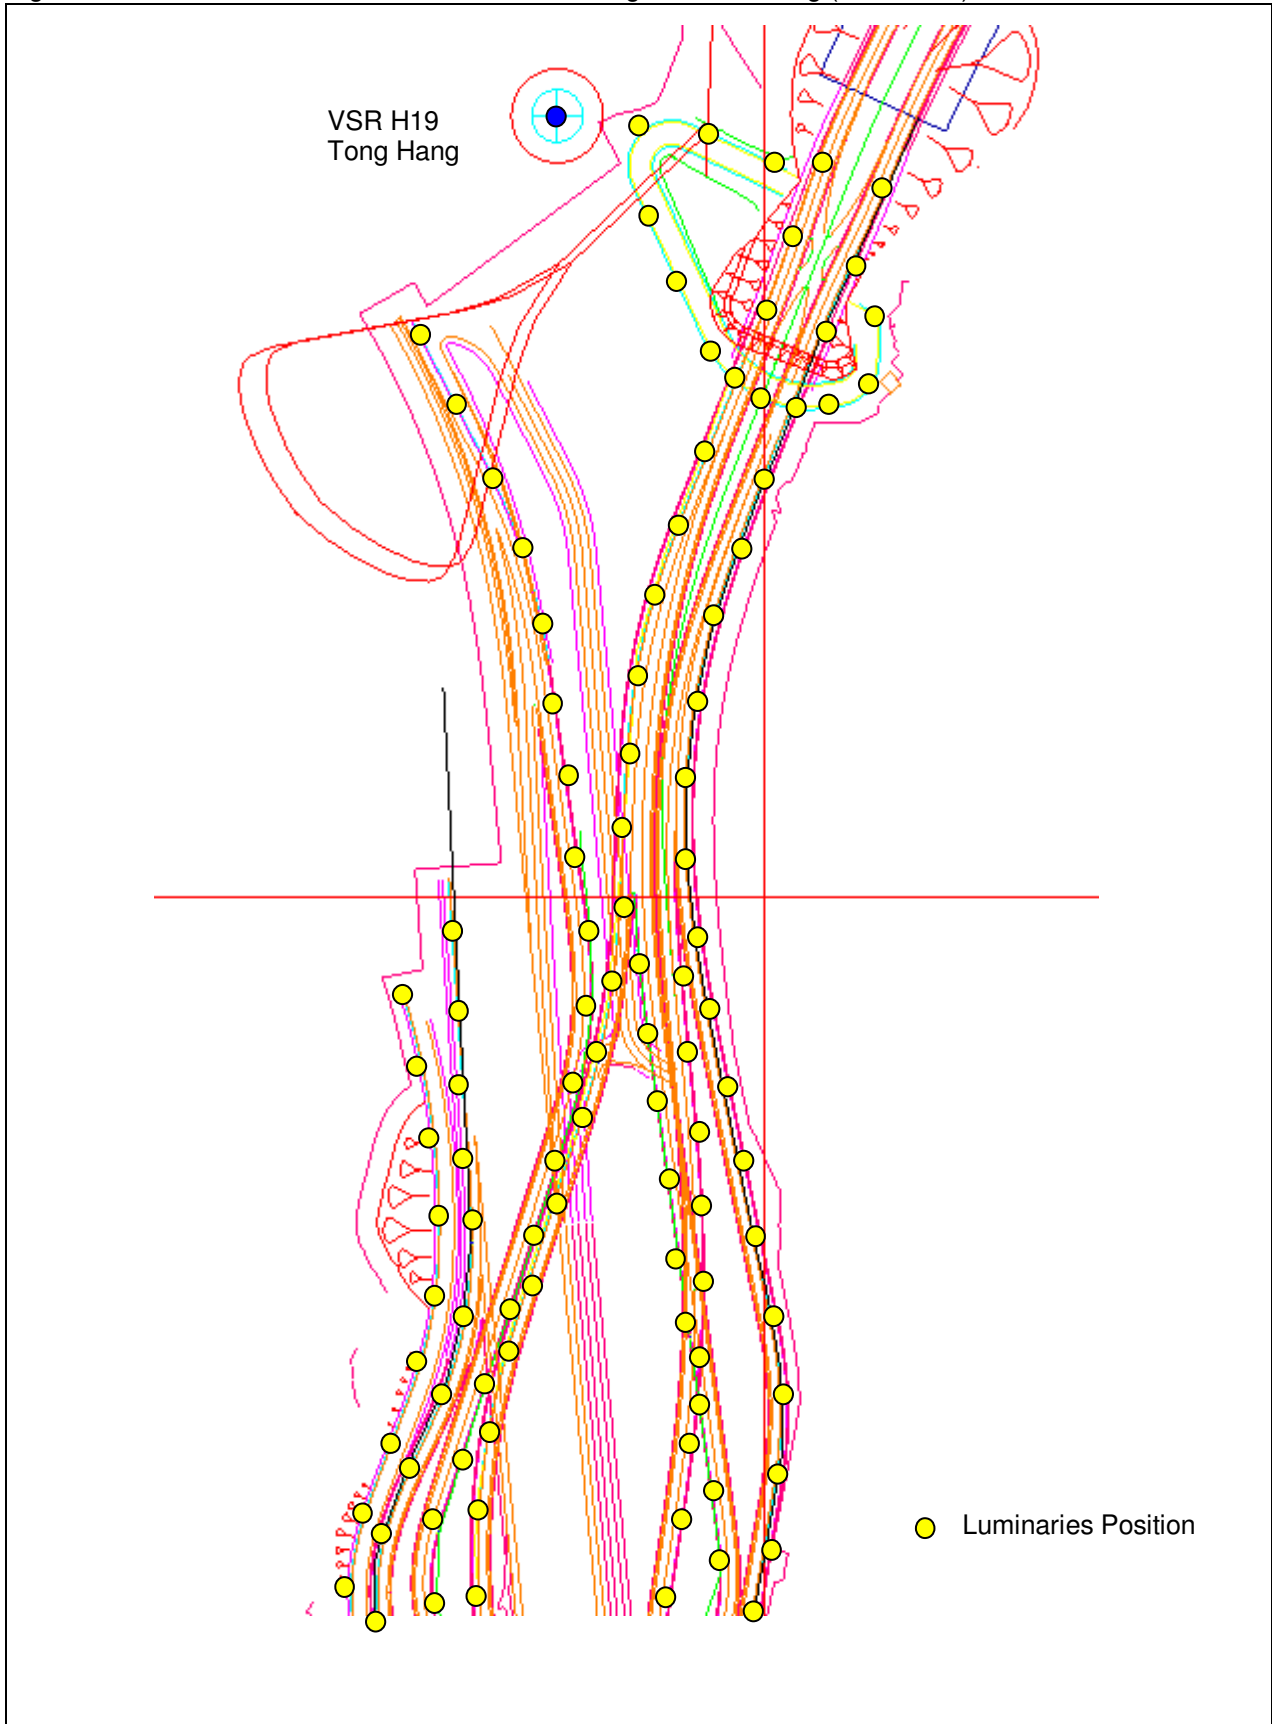
Figure A.2.6: Sketch of VSR Locations for Interchange at Yuen Leng (Part 1 of 2).

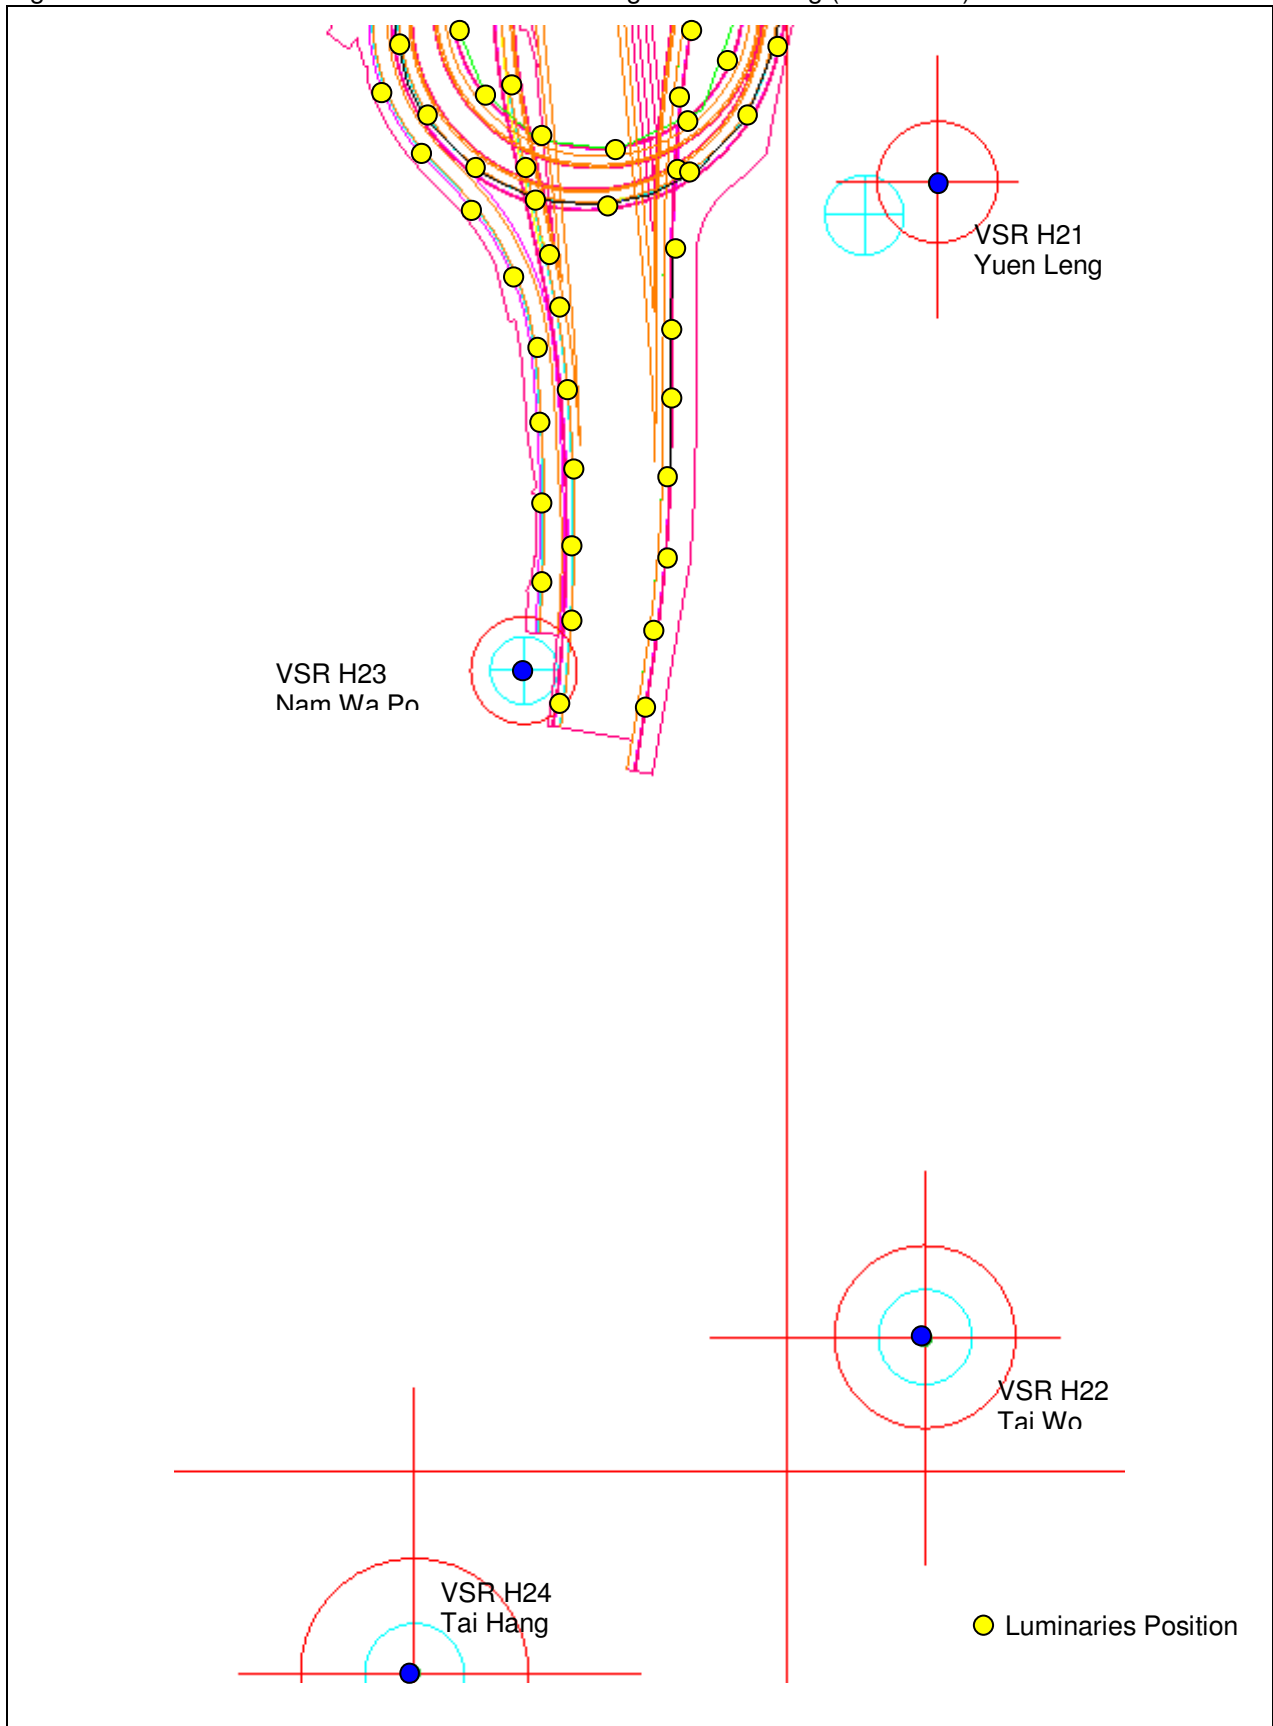
Figure A.2.7: Sketch of VSR Locations for Interchange at Yuen Leng (Part 2 of 2).

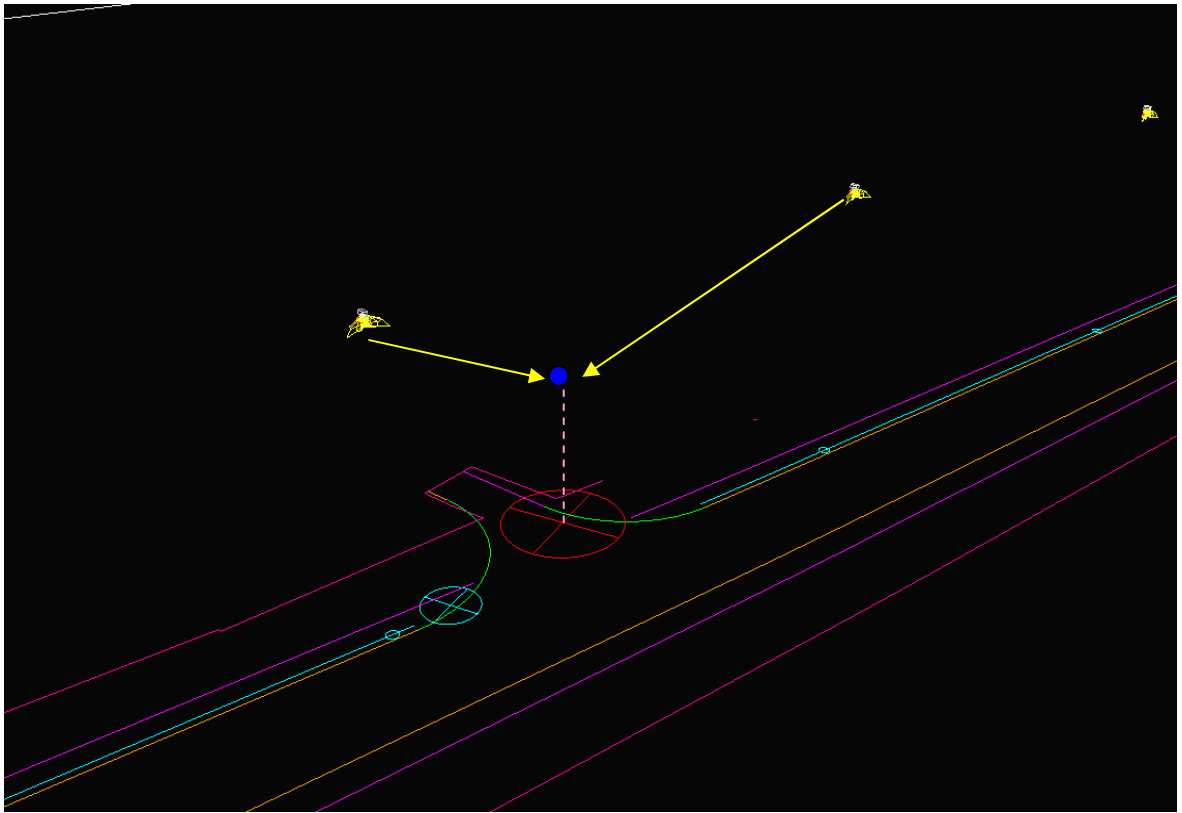
Figure A.2.8: Sketch of Luminaries and VSR Locations at Kaw Liu Tsuen. This figure shows luminous flux radiate from the side of the luminaries causes high glare rating at the visual observer.

Luminaries Position and incident light direction
-

VSR H5 at Kaw Liu Tsuen
