Project
**AGREEMENT NO. CE45/2008(CE)
 LIANTANG/HEUNG YUEN WAI BOUNDARY CONTROL POINT AND ASSOCIATED WORKS -- INVESTIGATION**

Title
LANDSCAPE AND VISUAL MITIGATION PLAN- SECTION A, ZONES 1 & 2

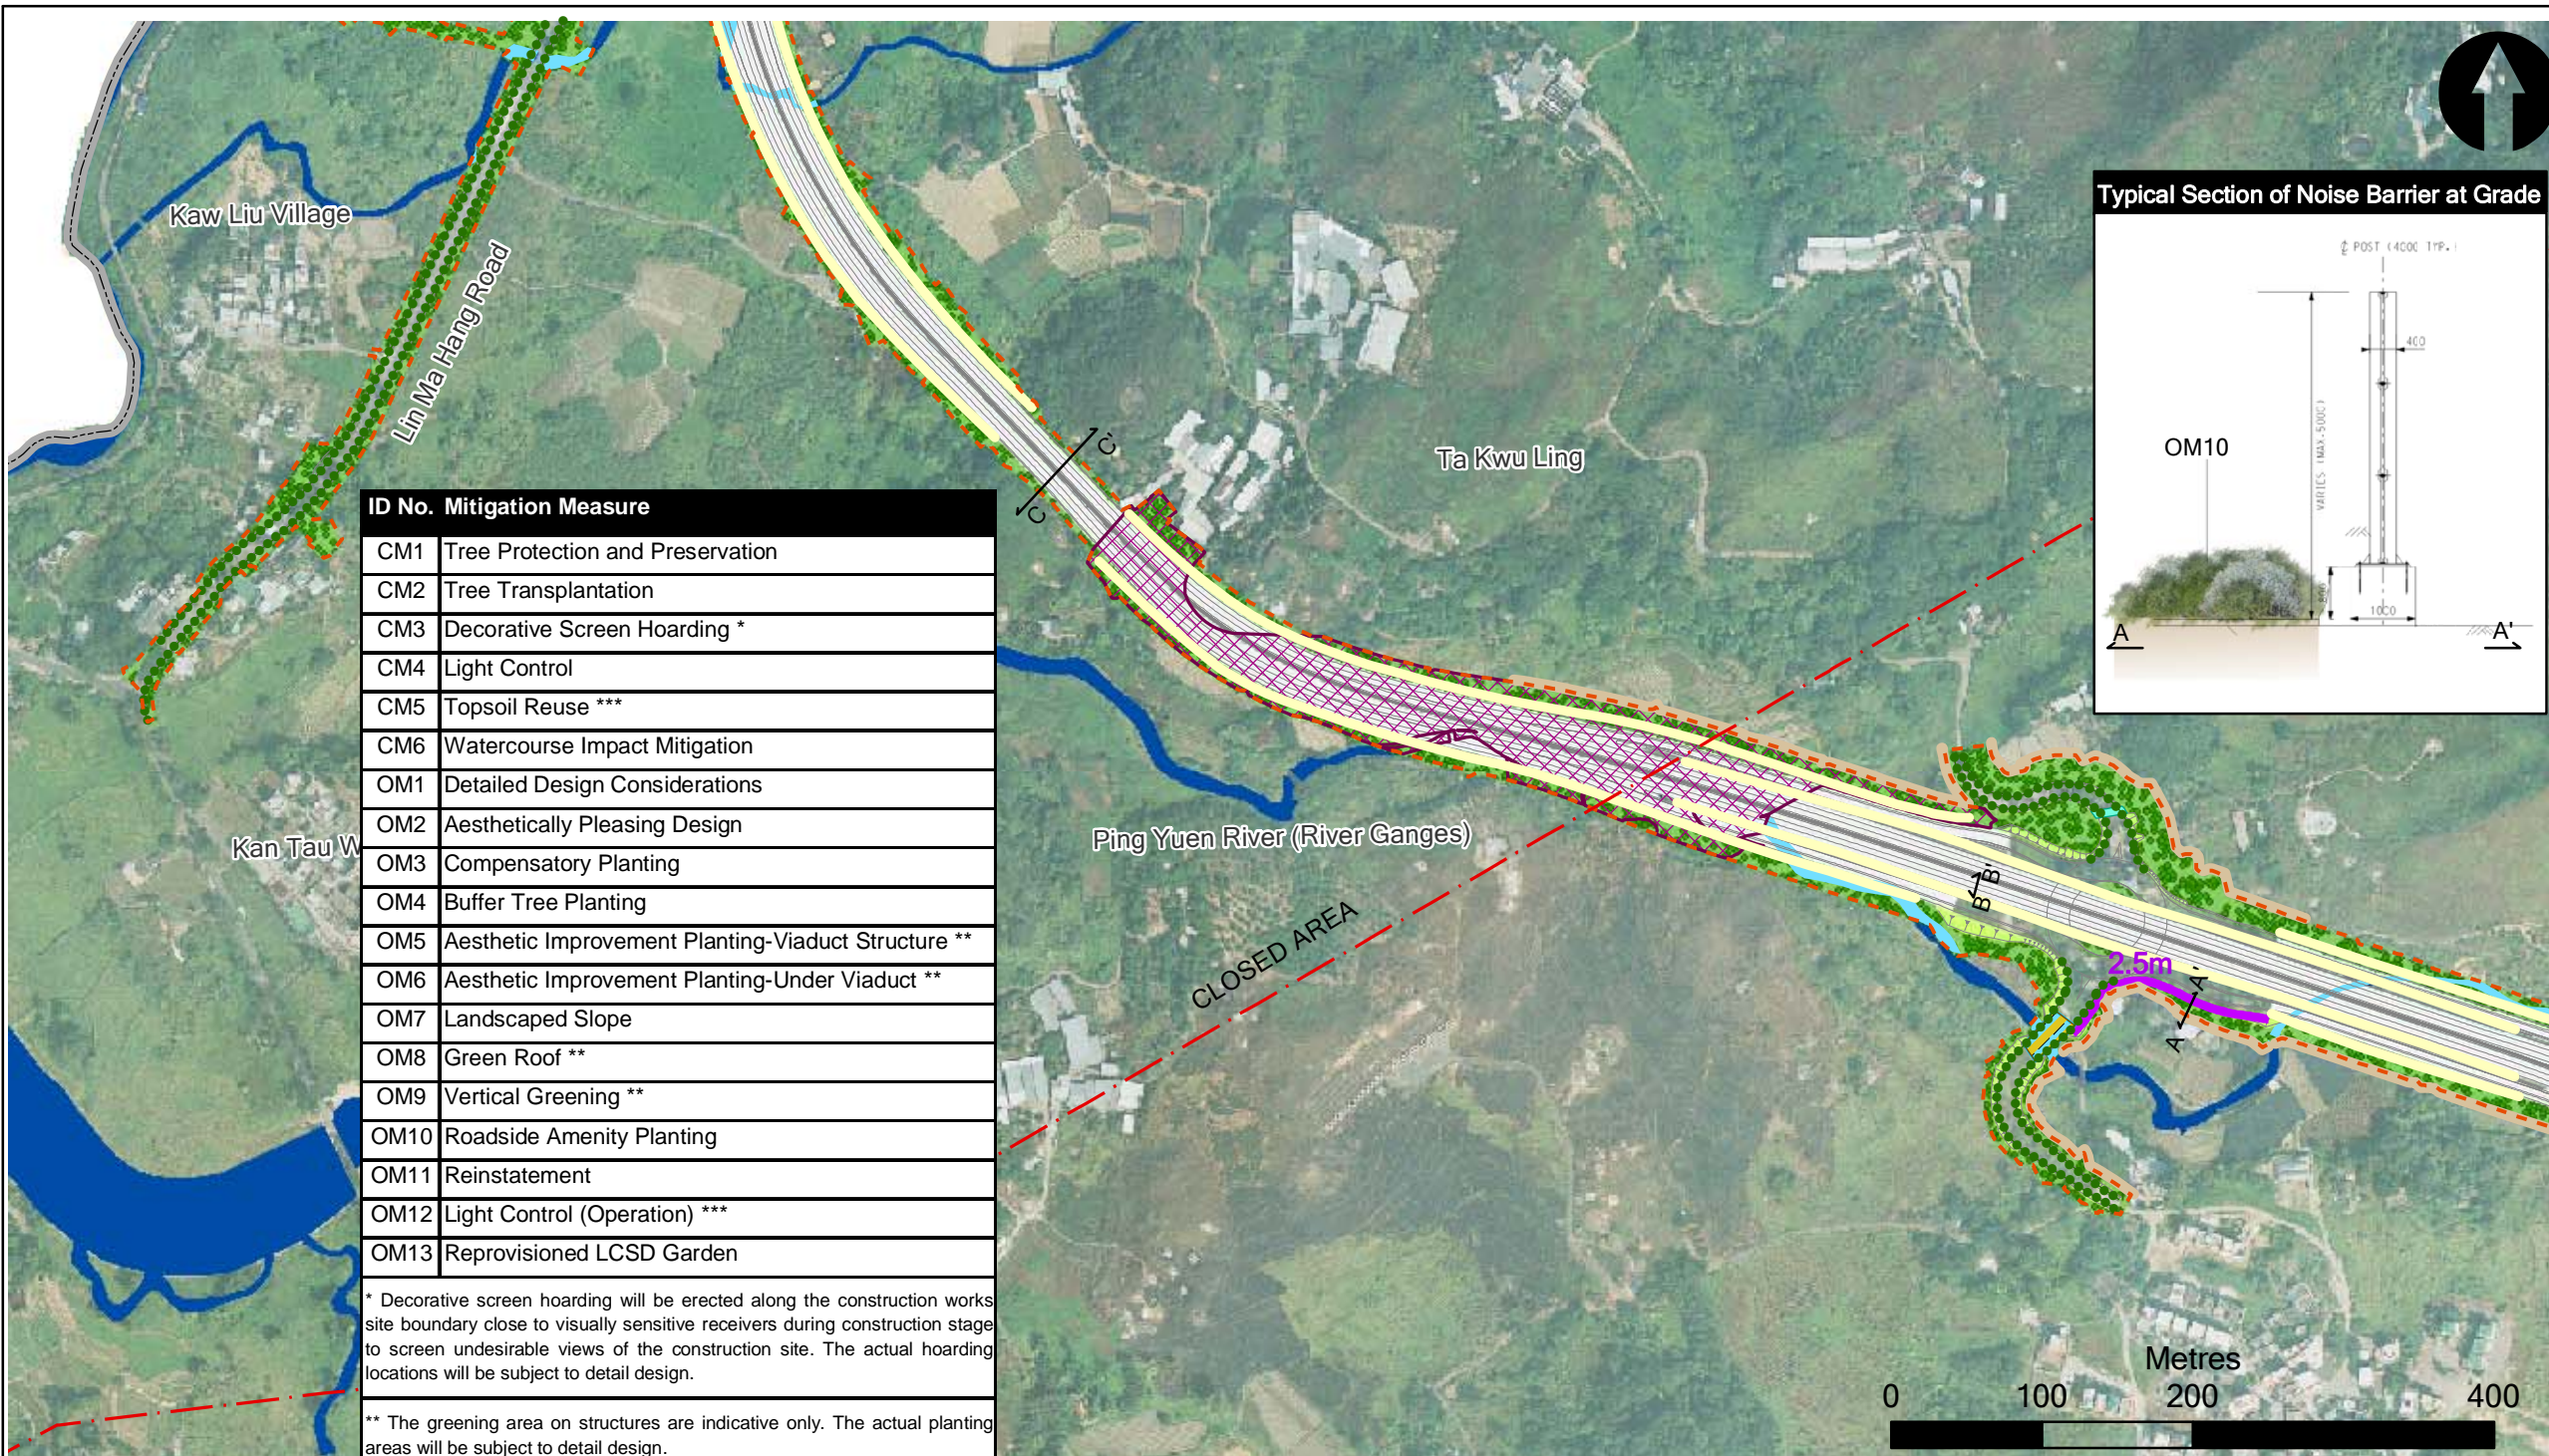
Typical Section of Noise Barrier at Grade

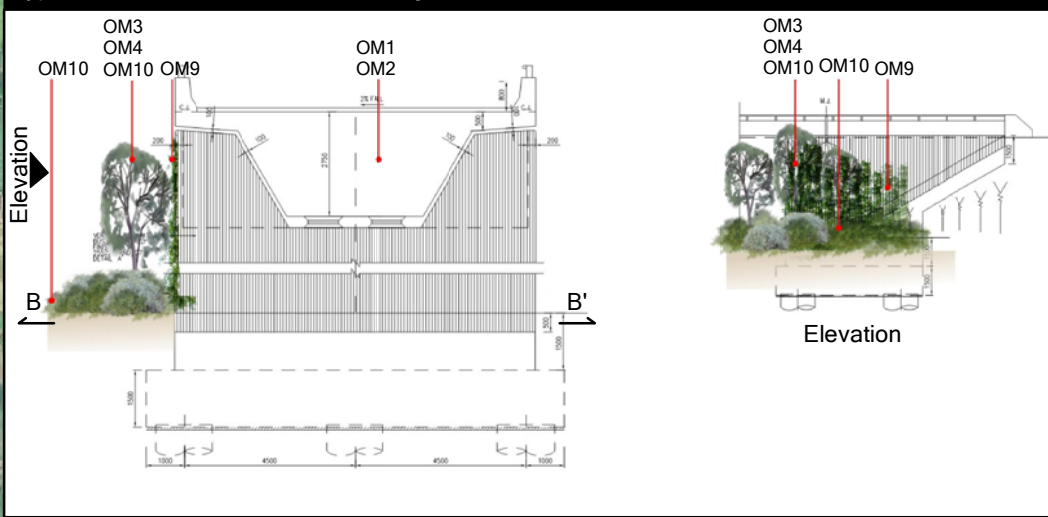
Typical Section of Abutment with Mitigation Measures
