**FIGURE 10.18
PHOTOMONTAGE
VIEW POINT 1
CLOUDY PEAK**

**FIGURE 10.19
PHOTOMONTAGE
VIEWPOINT 2
WILSON TRAIL**

FIGURE 10.26
SECTIONS
THROUGH THE DEVELOPMENT SITE
TO THE EAST

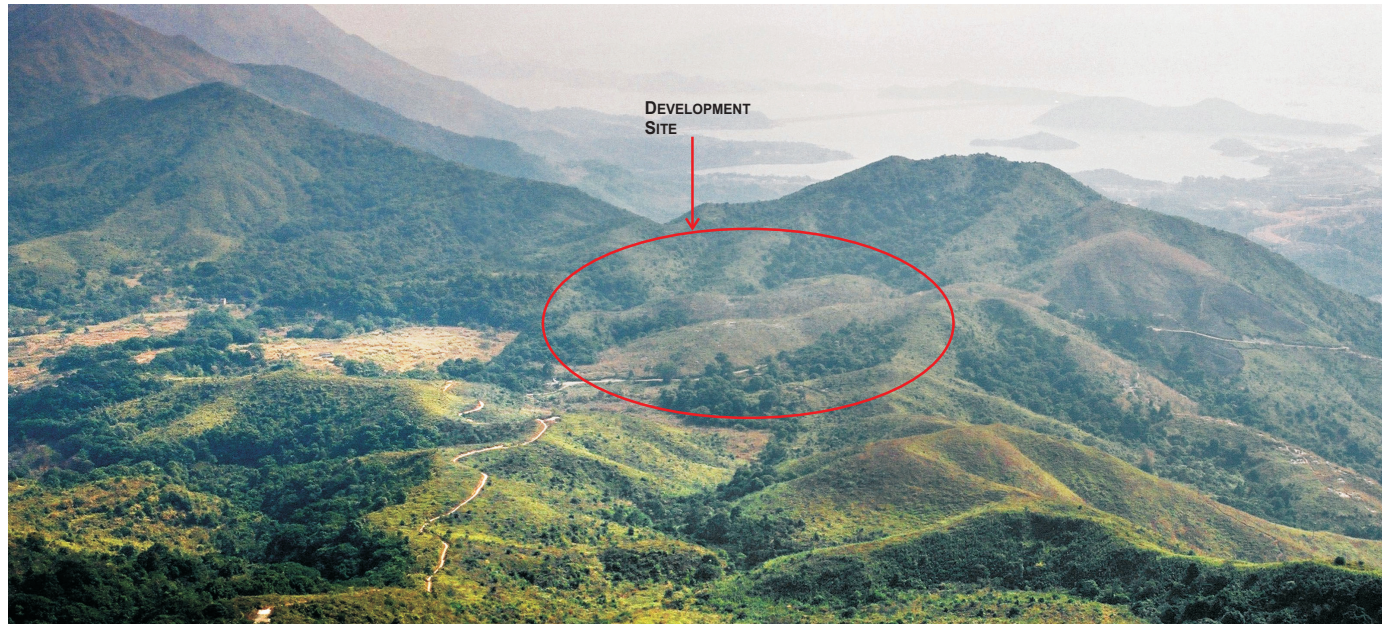
VIEWPOINT 1- LOOKING EAST FROM CLOUDY PEAK: EXISTING CONDITIONS AT THE DEVELOPMENT SITE.

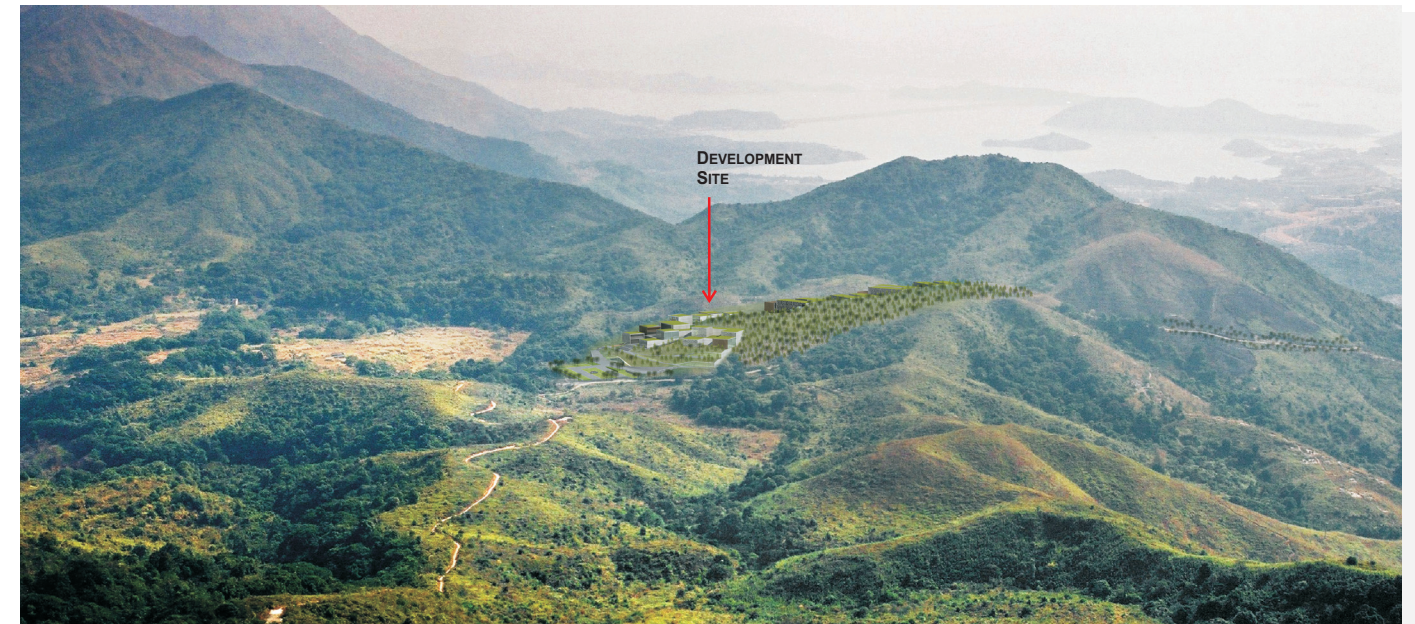
VIEW DISPLAYING THE 3D MODEL OF THE DEVELOPMENT SITE WITH LANDSCAPE MITIGATION AT DAY 1.

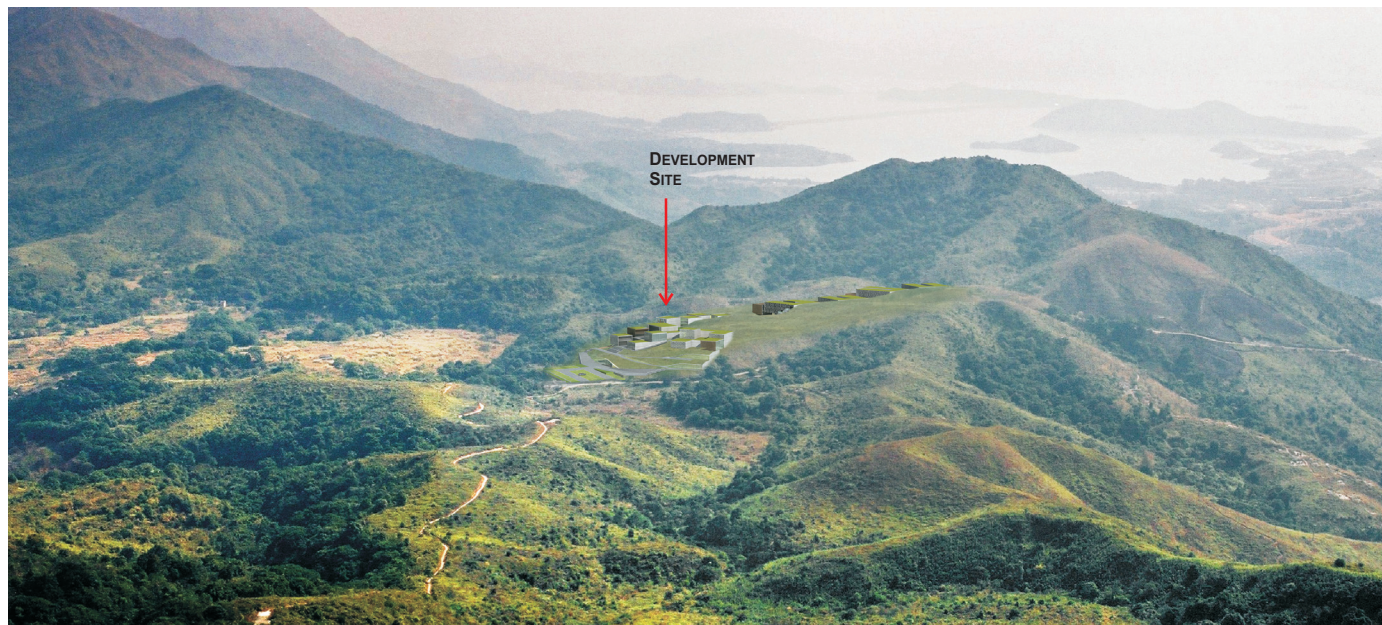
VIEW DISPLAYING THE 3D MODEL OF THE DEVELOPMENT SITE WITHOUT LANDSCAPE MITIGATION

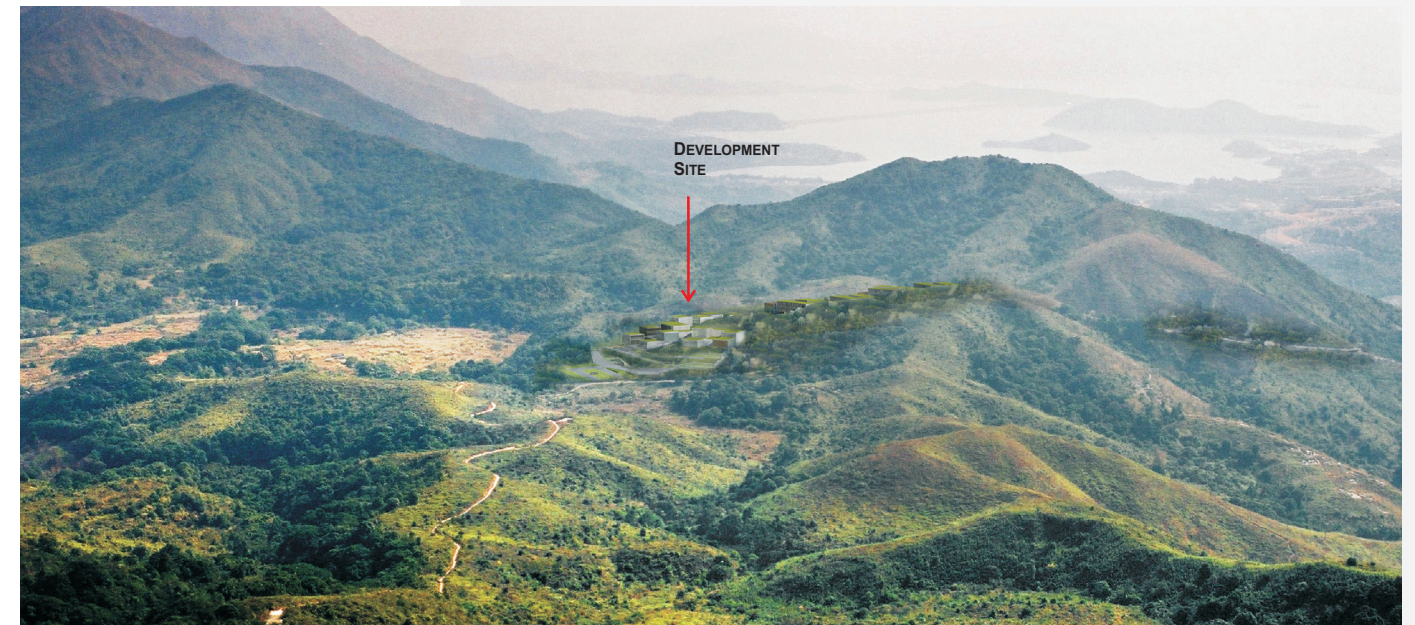
VIEW DISPLAYING THE 3D MODEL OF THE DEVELOPMENT SITE WITH LANDSCAPE MITIGATION AT YEAR 10.

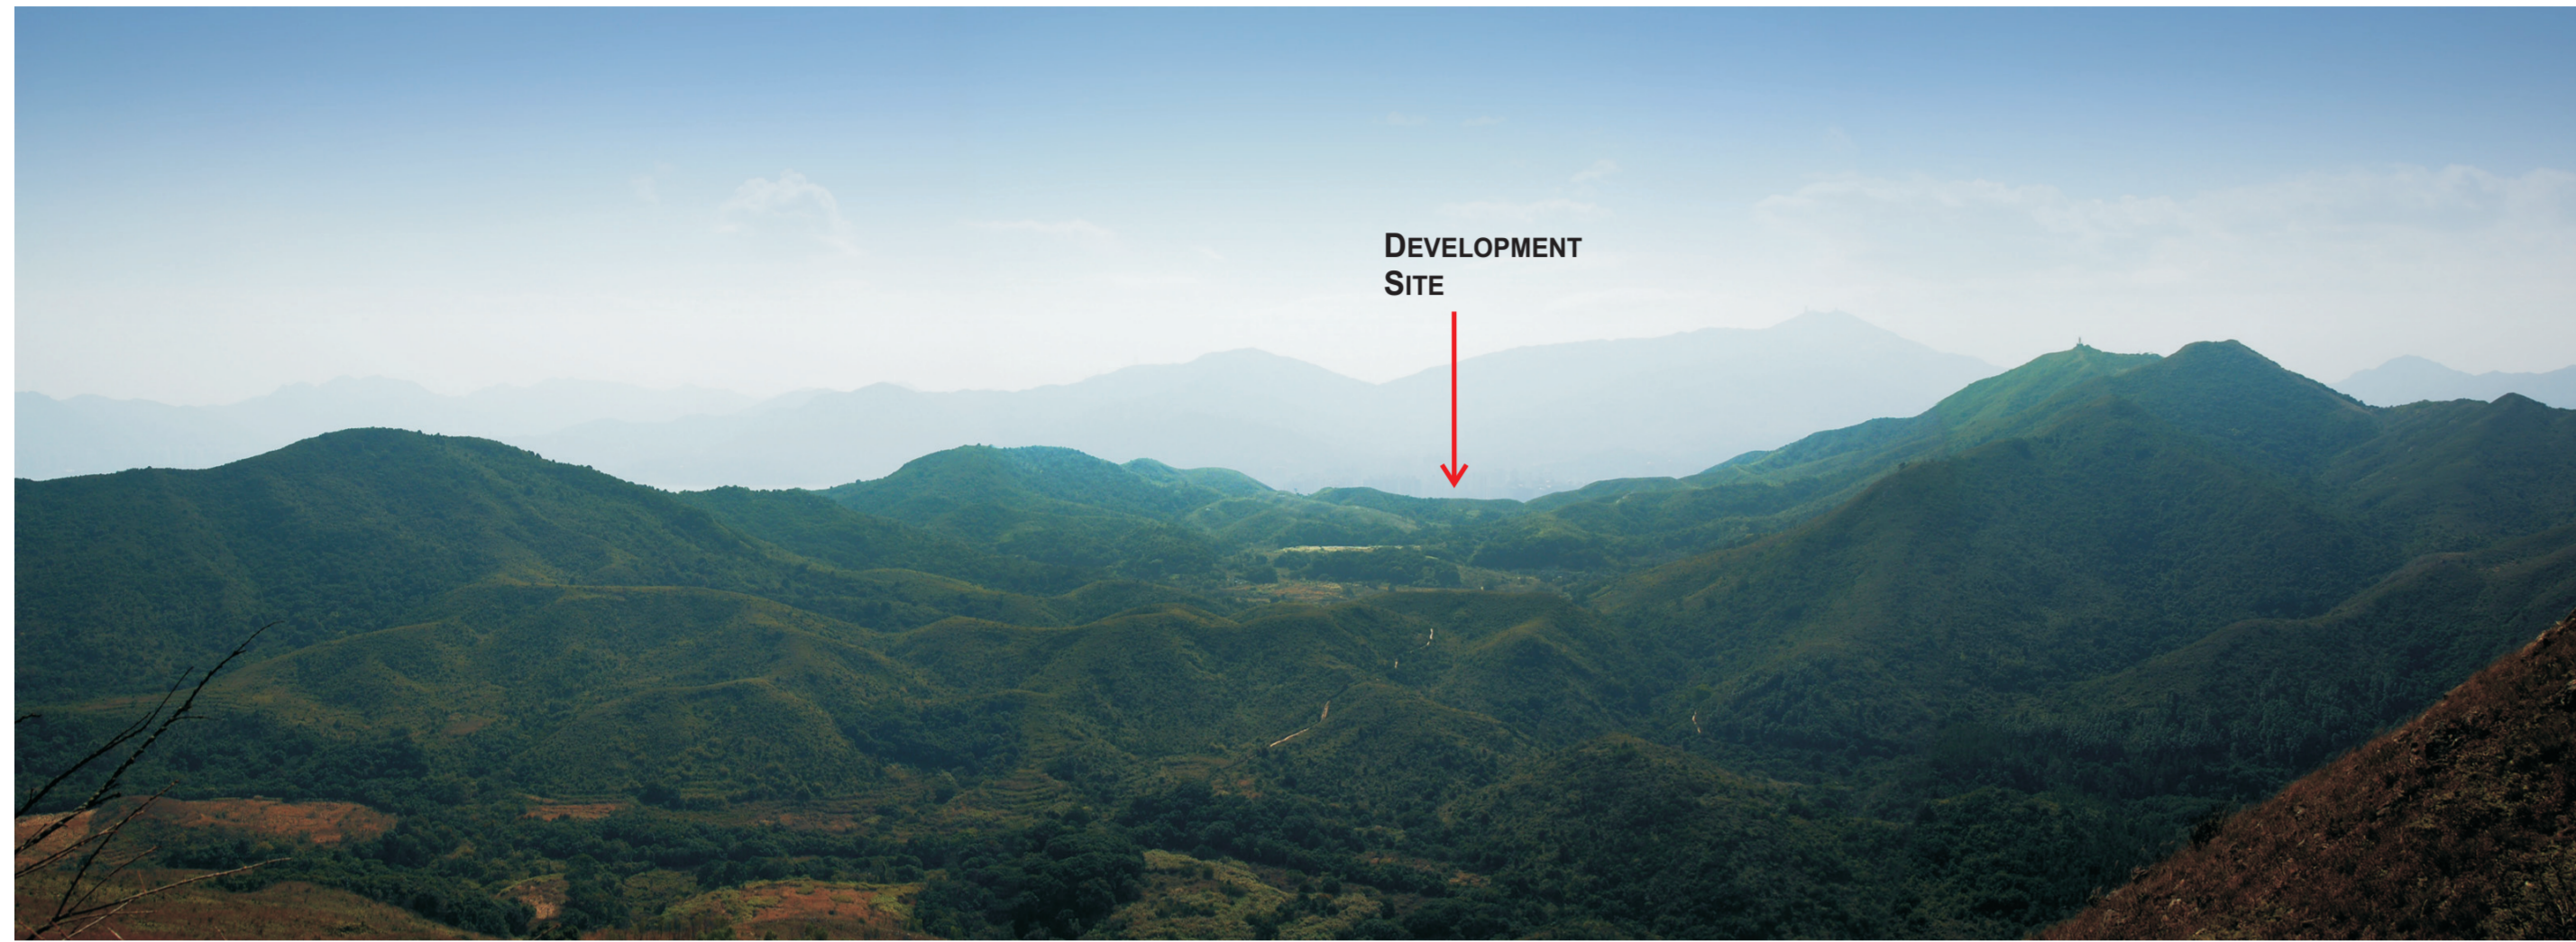
VIEWPOINT 2- LOOKING SOUTH WEST FROM WILSON TRAIL: EXISTING CONDITIONS AT THE DEVELOPMENT SITE.

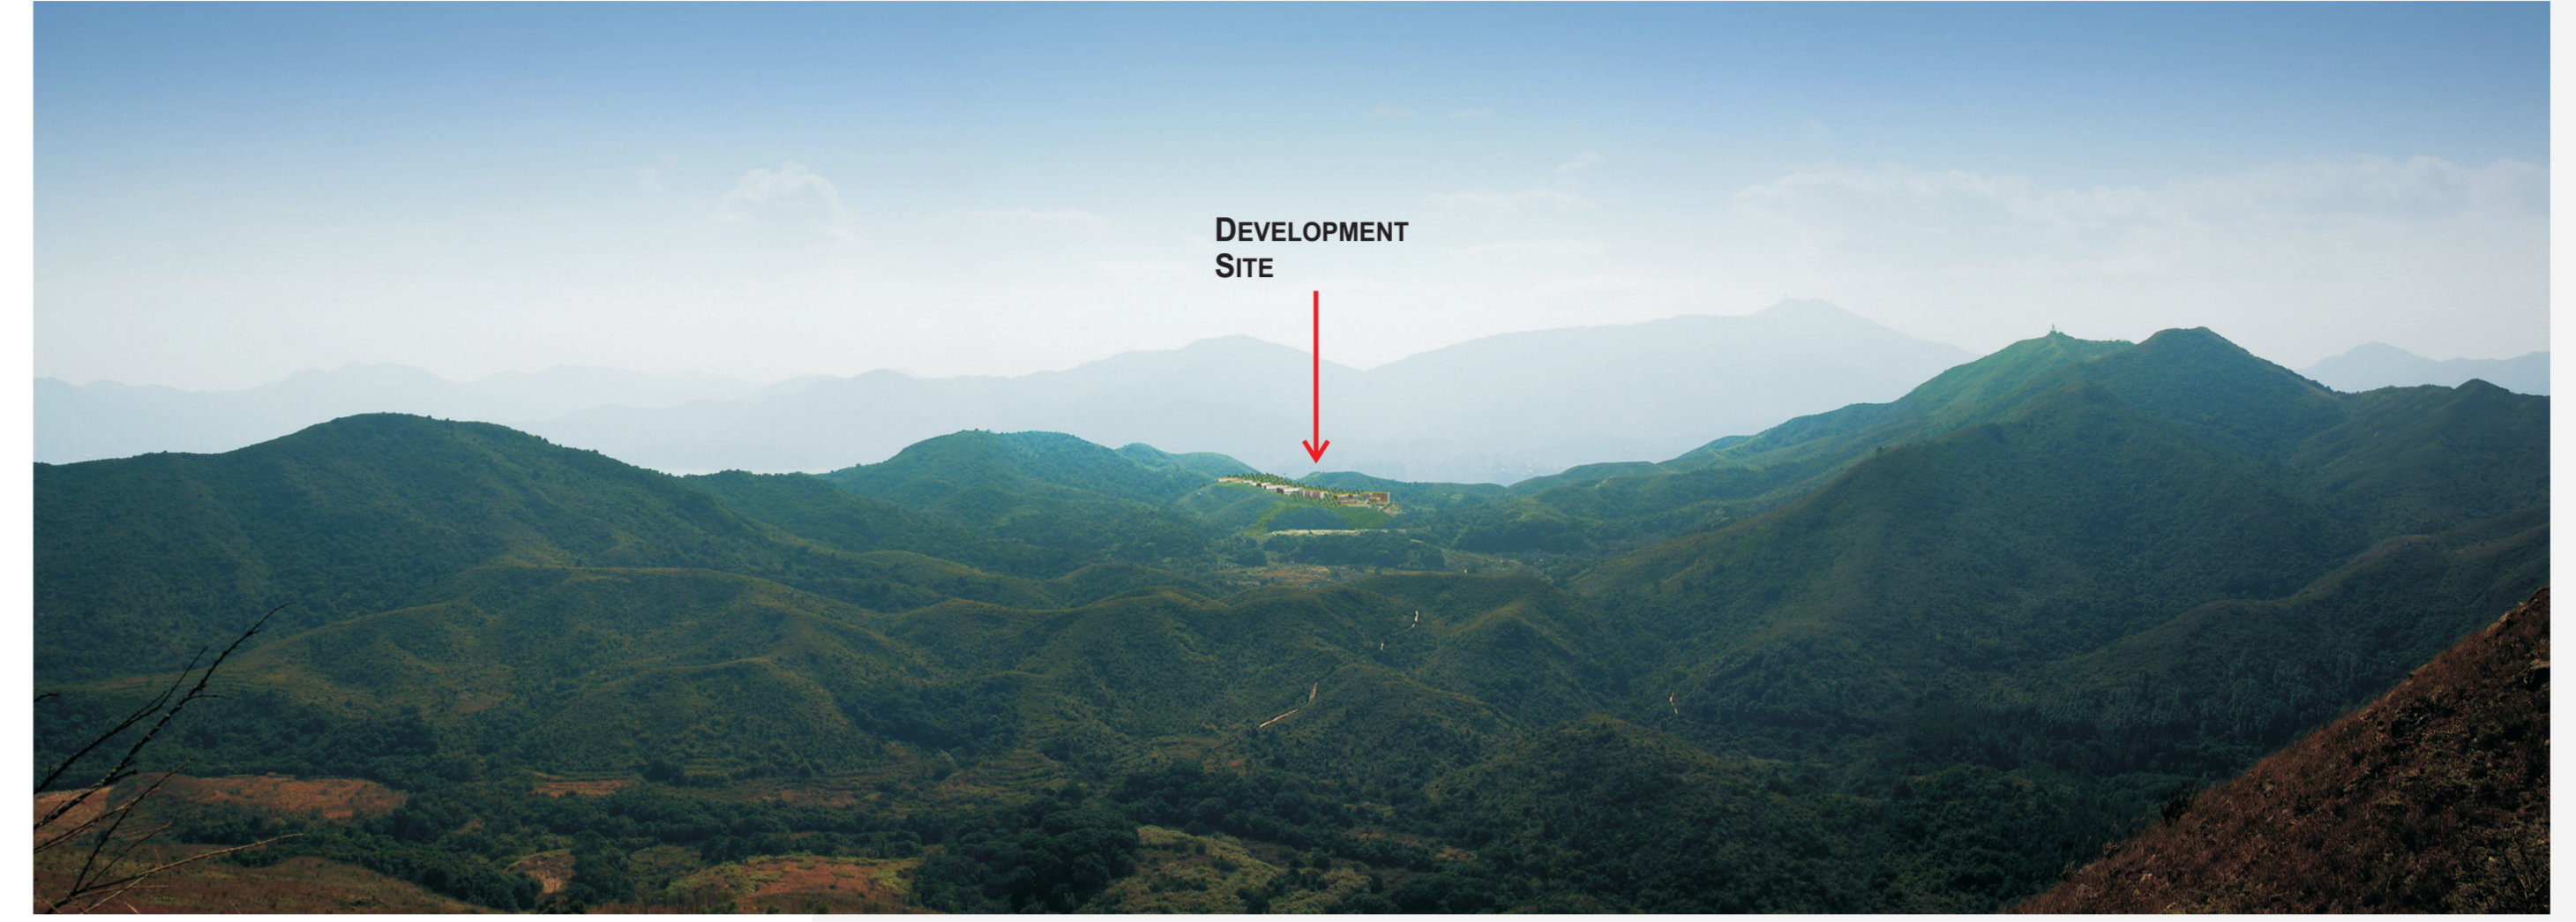
VIEW DISPLAYING THE 3D MODEL OF THE DEVELOPMENT SITE WITH LANDSCAPE MITIGATION AT DAY 1.

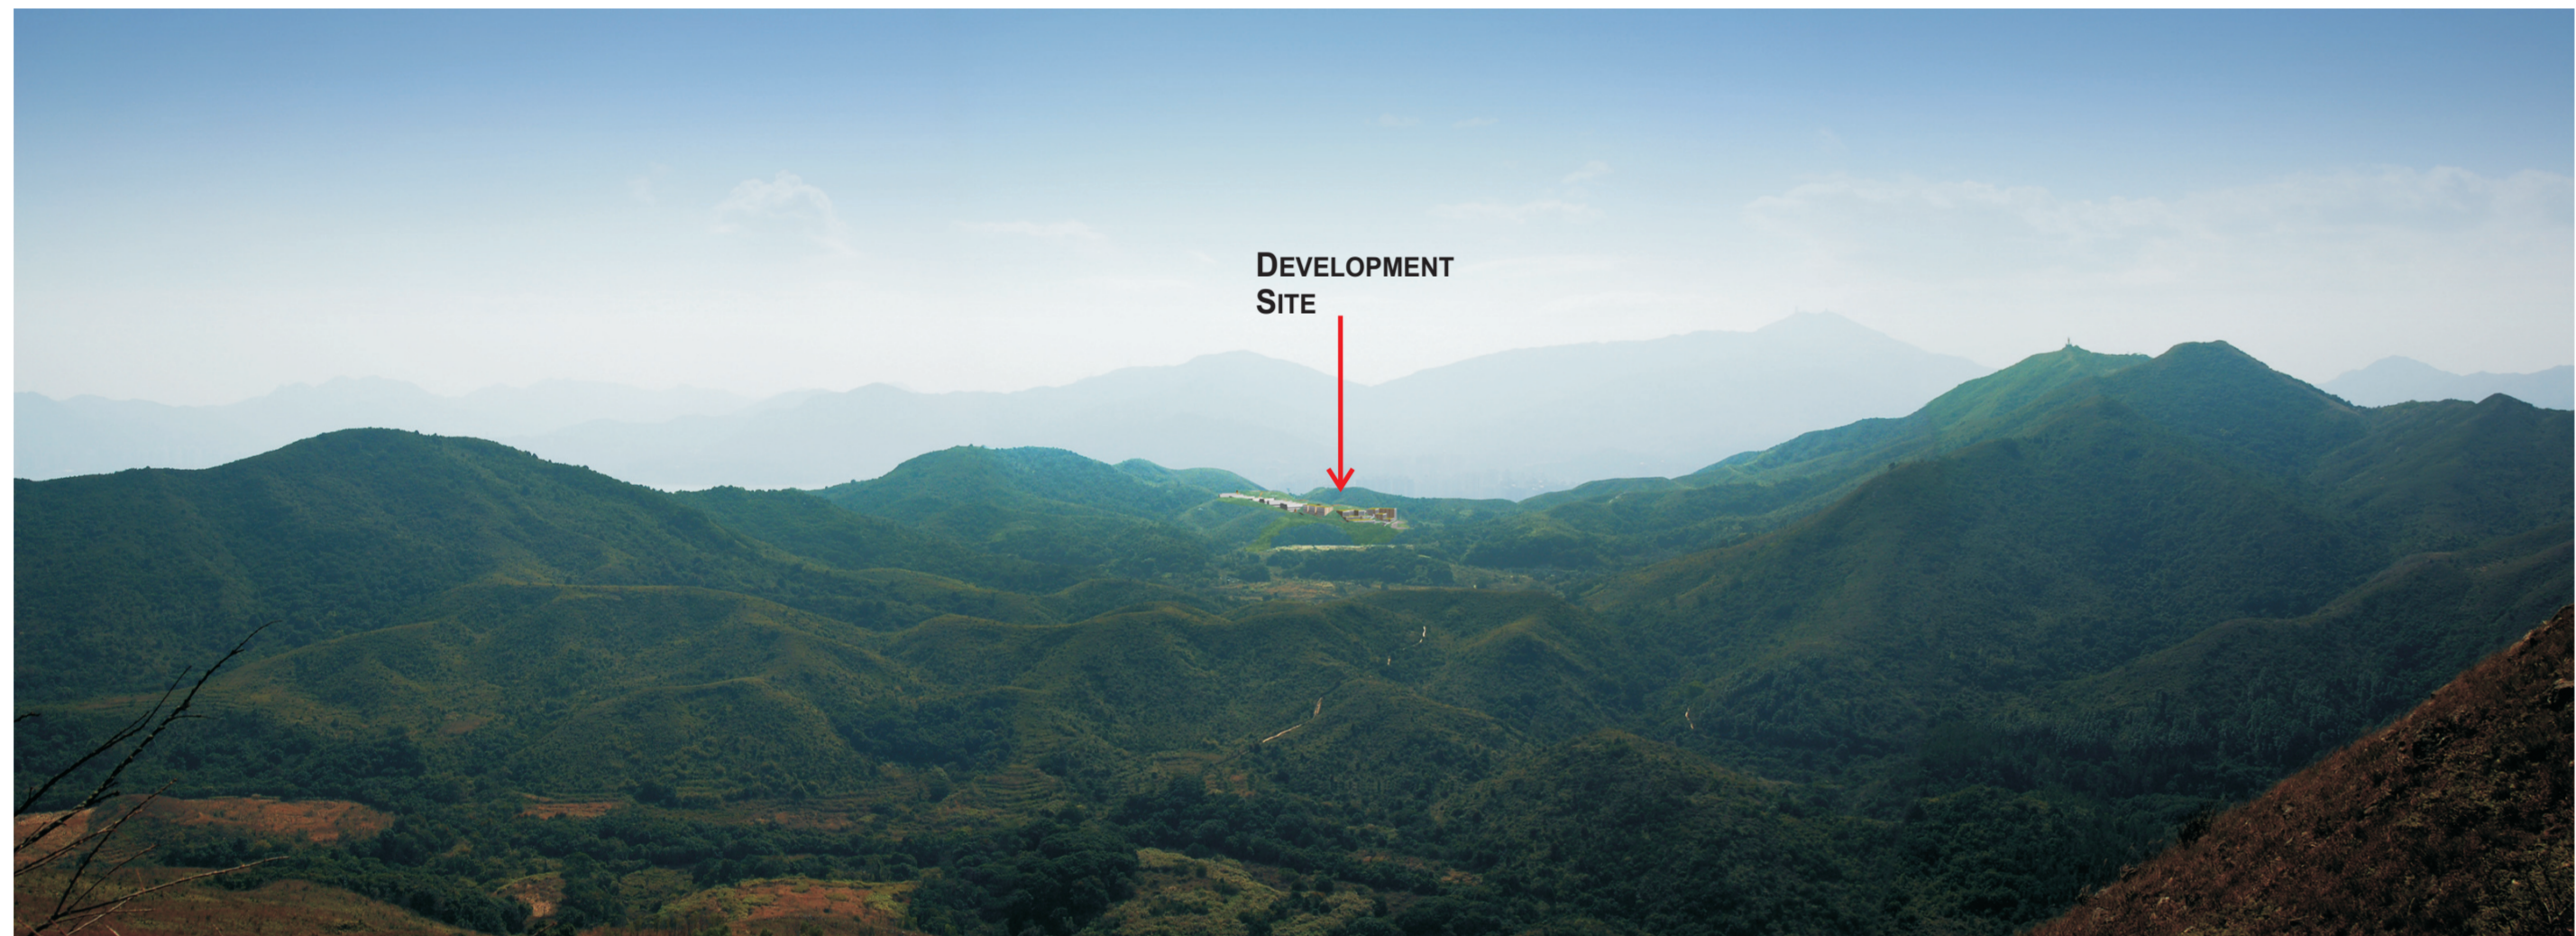
VIEW DISPLAYING THE 3D MODEL OF THE DEVELOPMENT SITE WITHOUT LANDSCAPE MITIGATION.

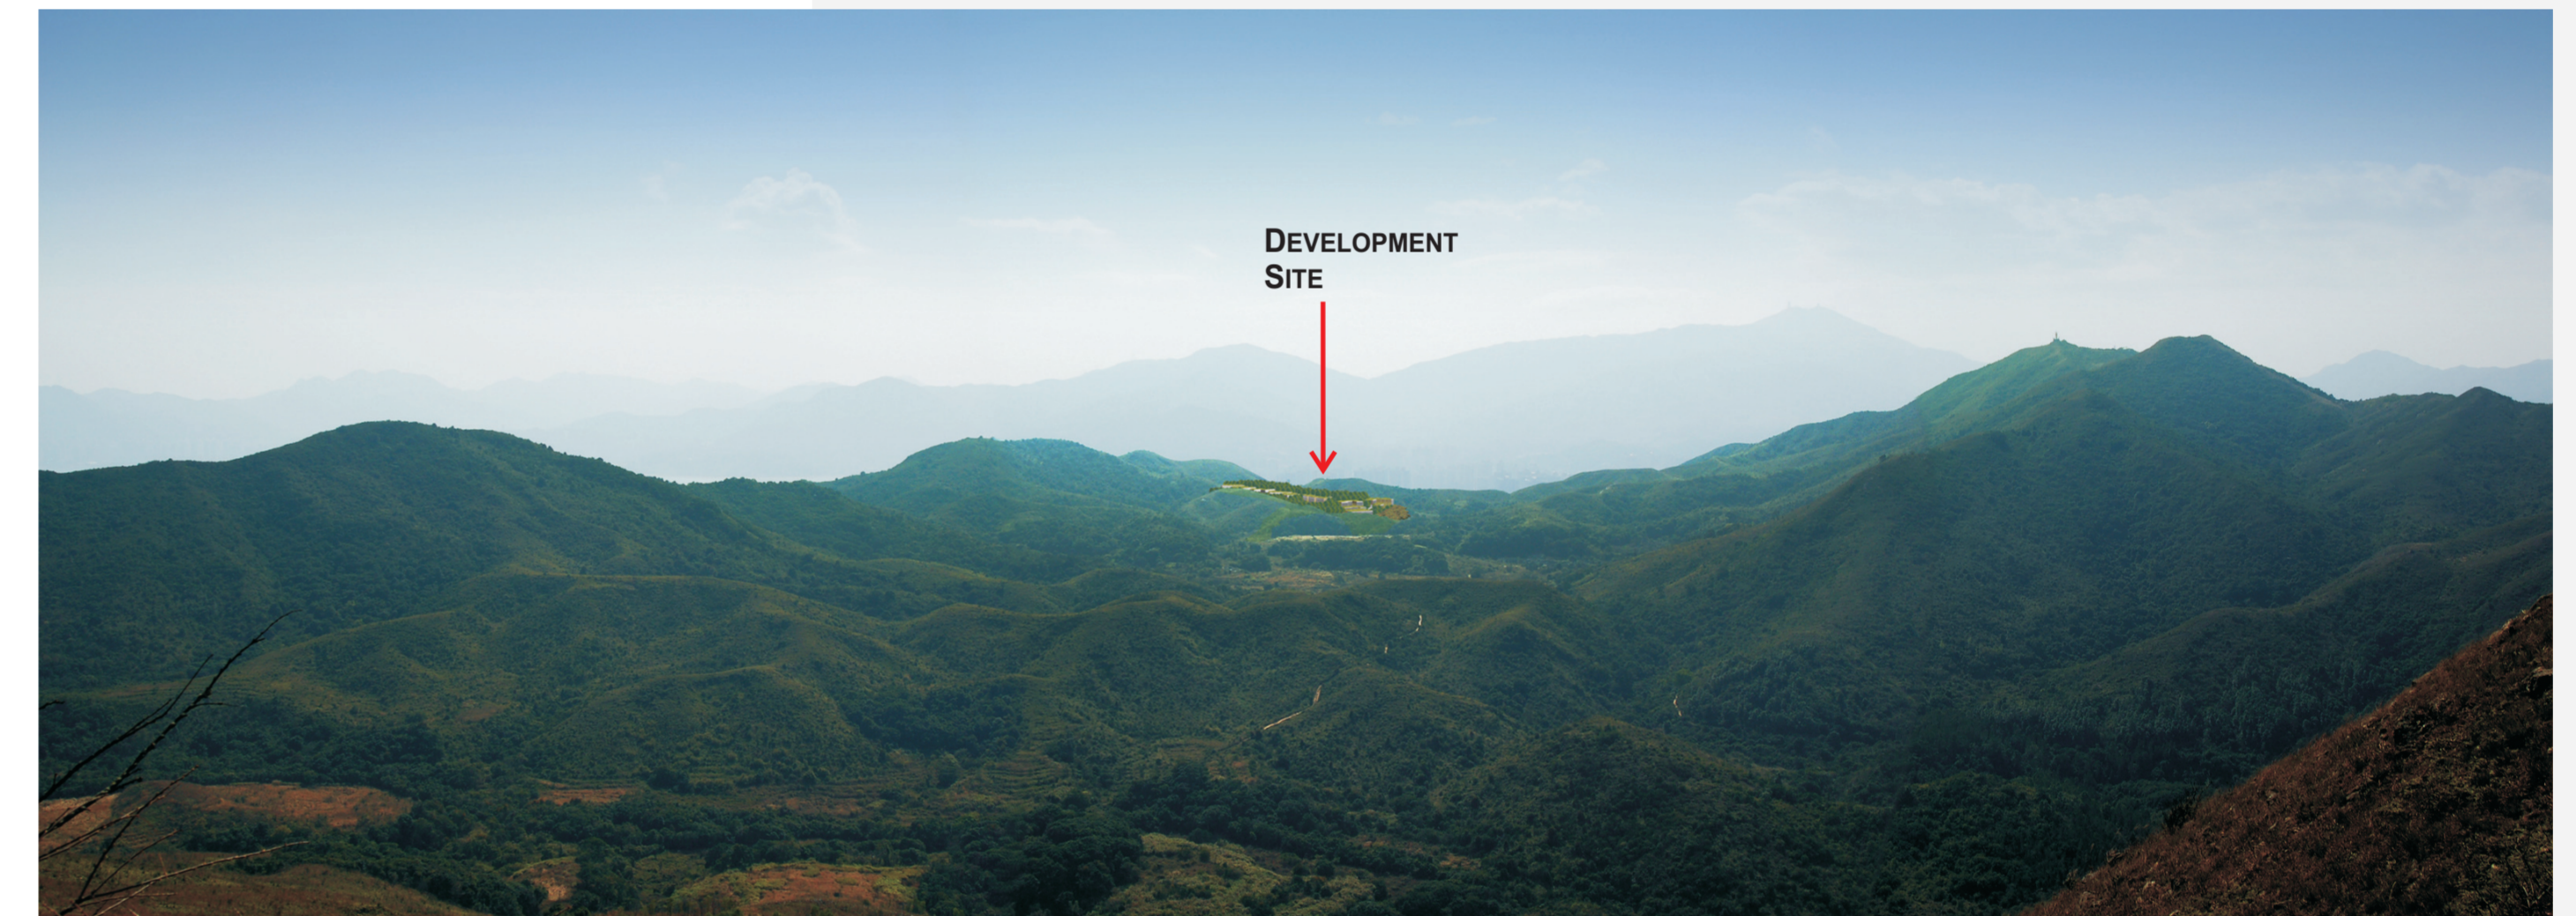
VIEW DISPLAYING THE 3D MODEL OF THE DEVELOPMENT SITE WITH LANDSCAPE MITIGATION AT YEAR 10.

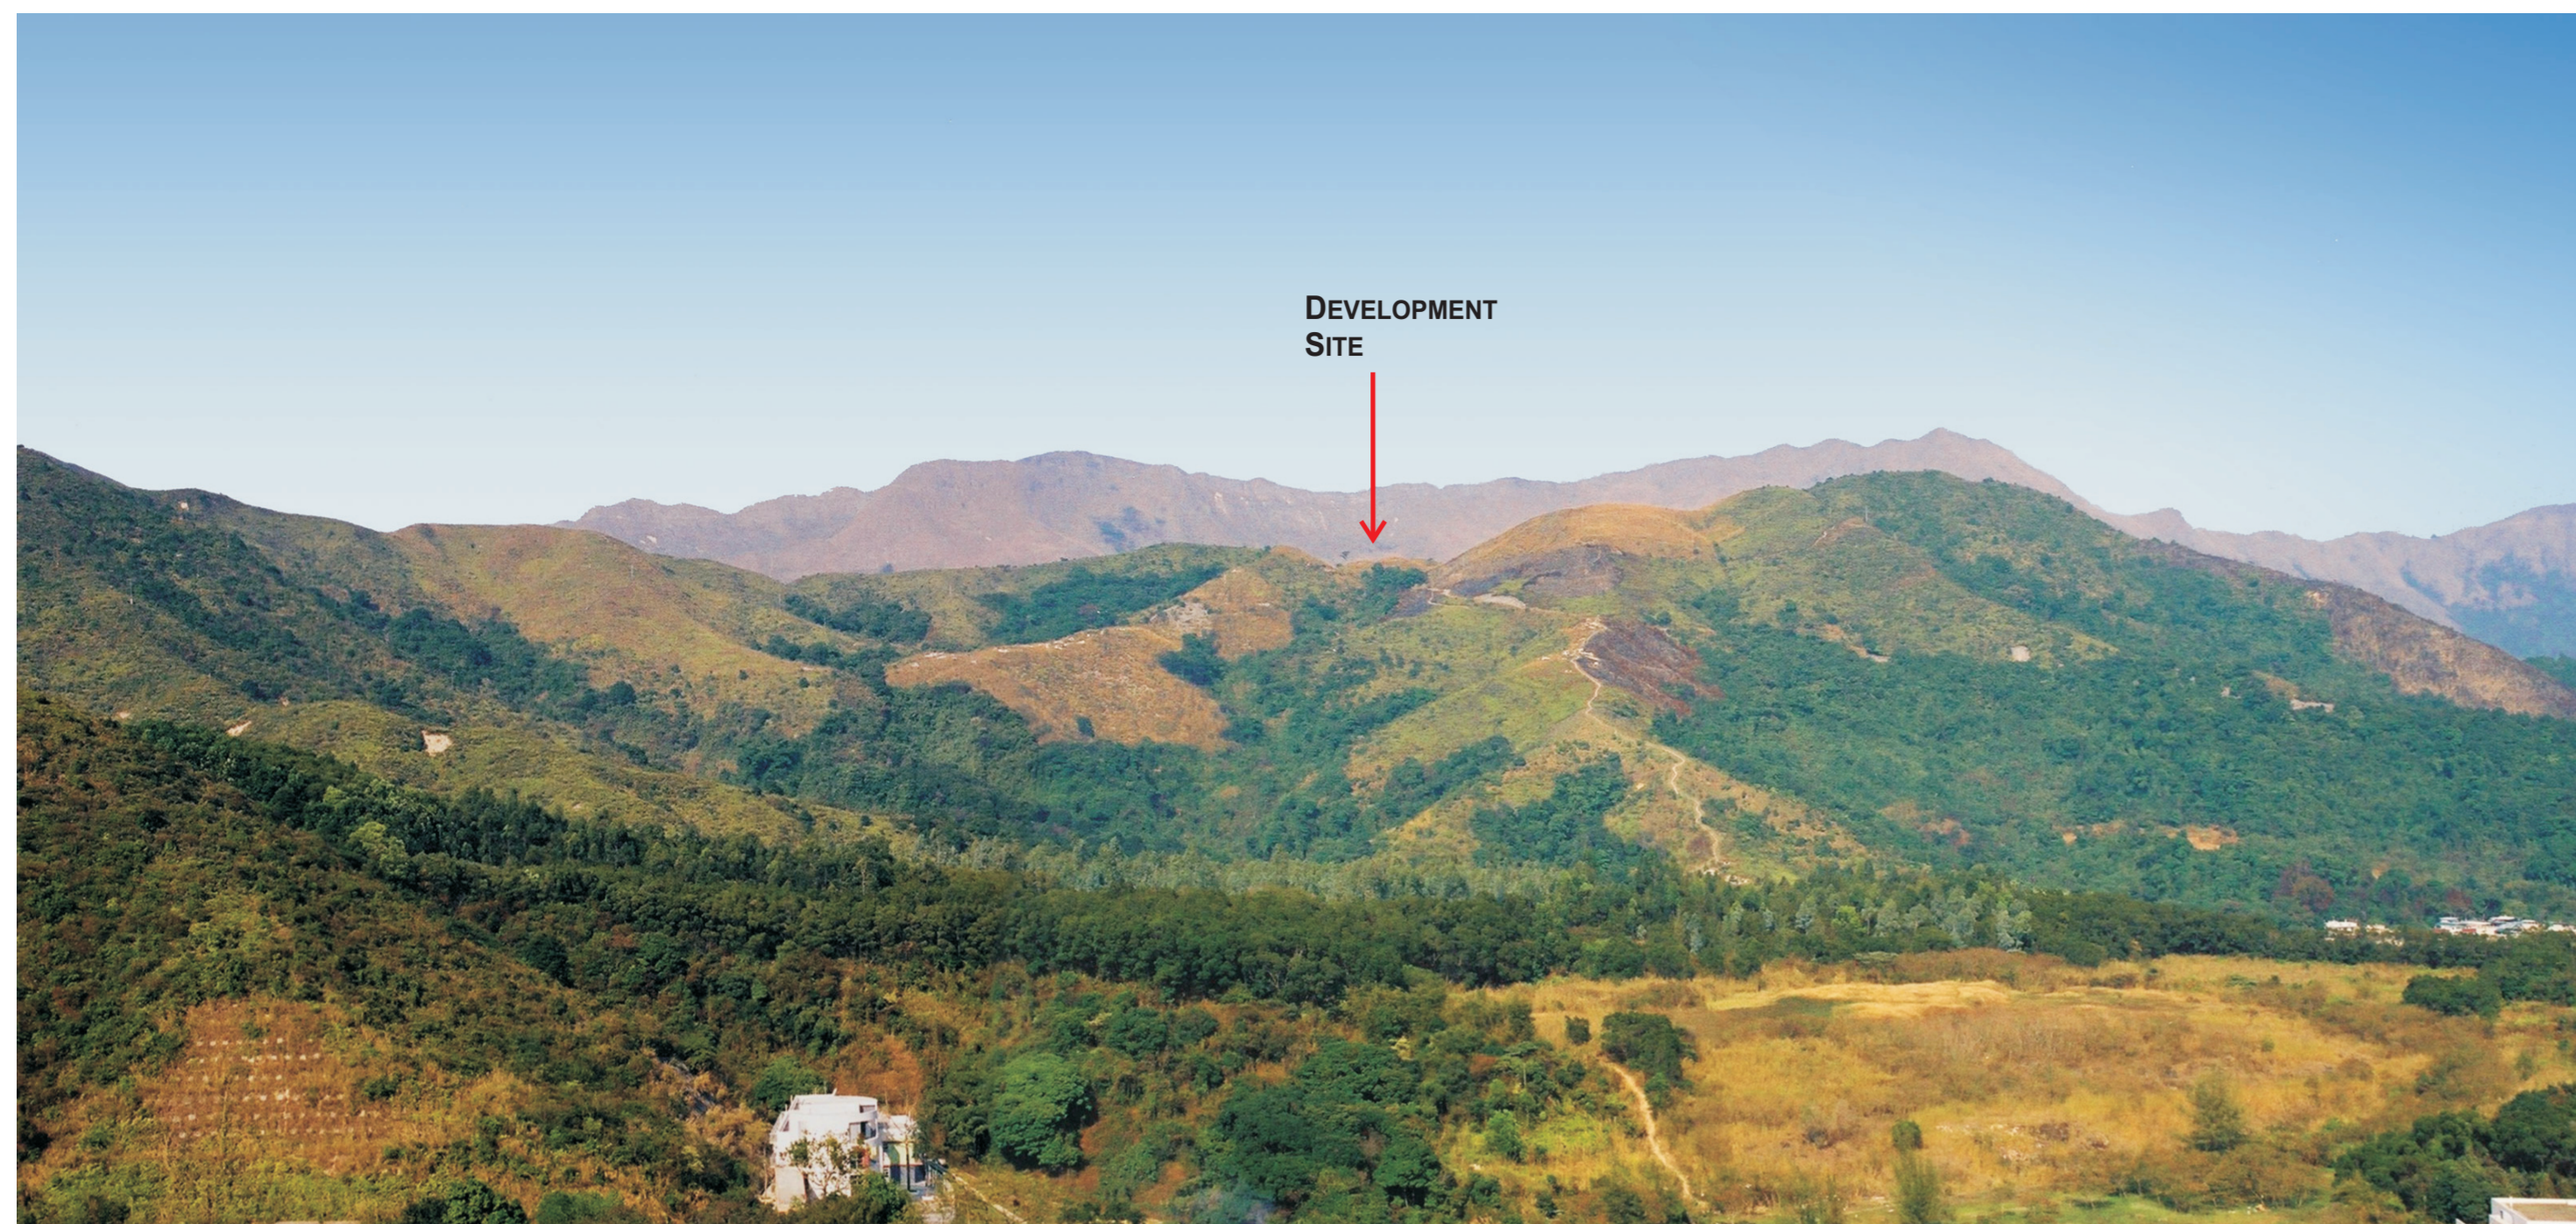
VIEWPOINT 3- LOOKING NORTH FROM HENG WING HOUSE: EXISTING CONDITIONS AT THE DEVELOPMENT SITE.

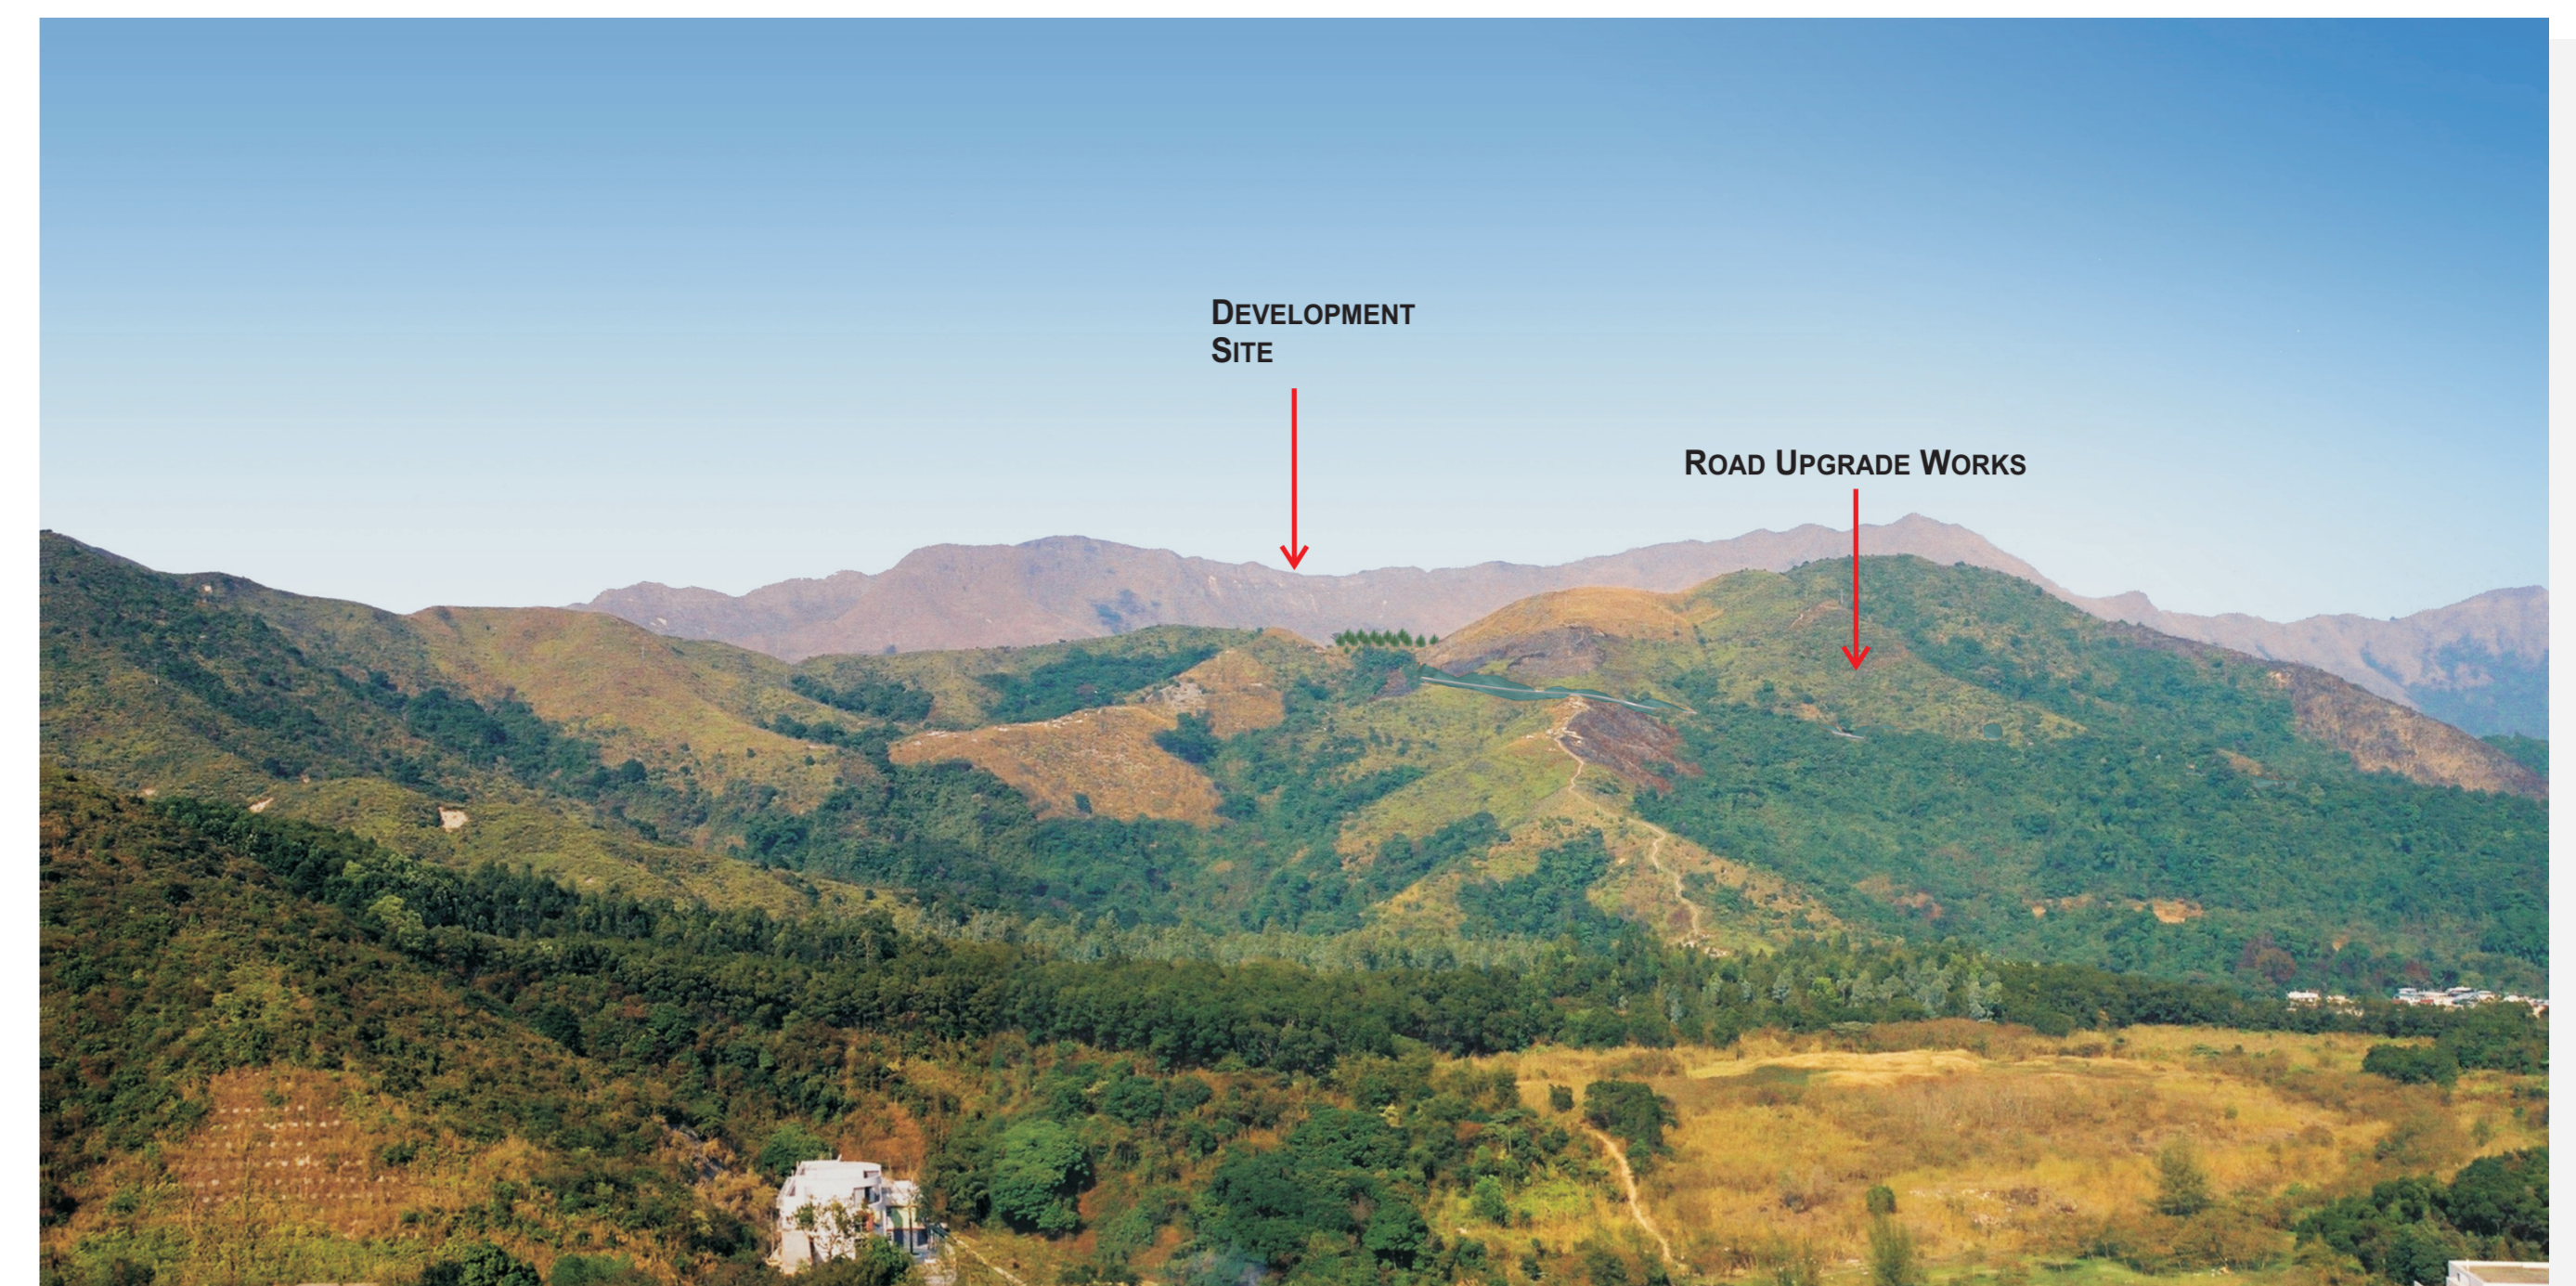
VIEW DISPLAYING THE 3D MODEL OF THE DEVELOPMENT SITE WITH LANDSCAPE MITIGATION AT DAY 1.

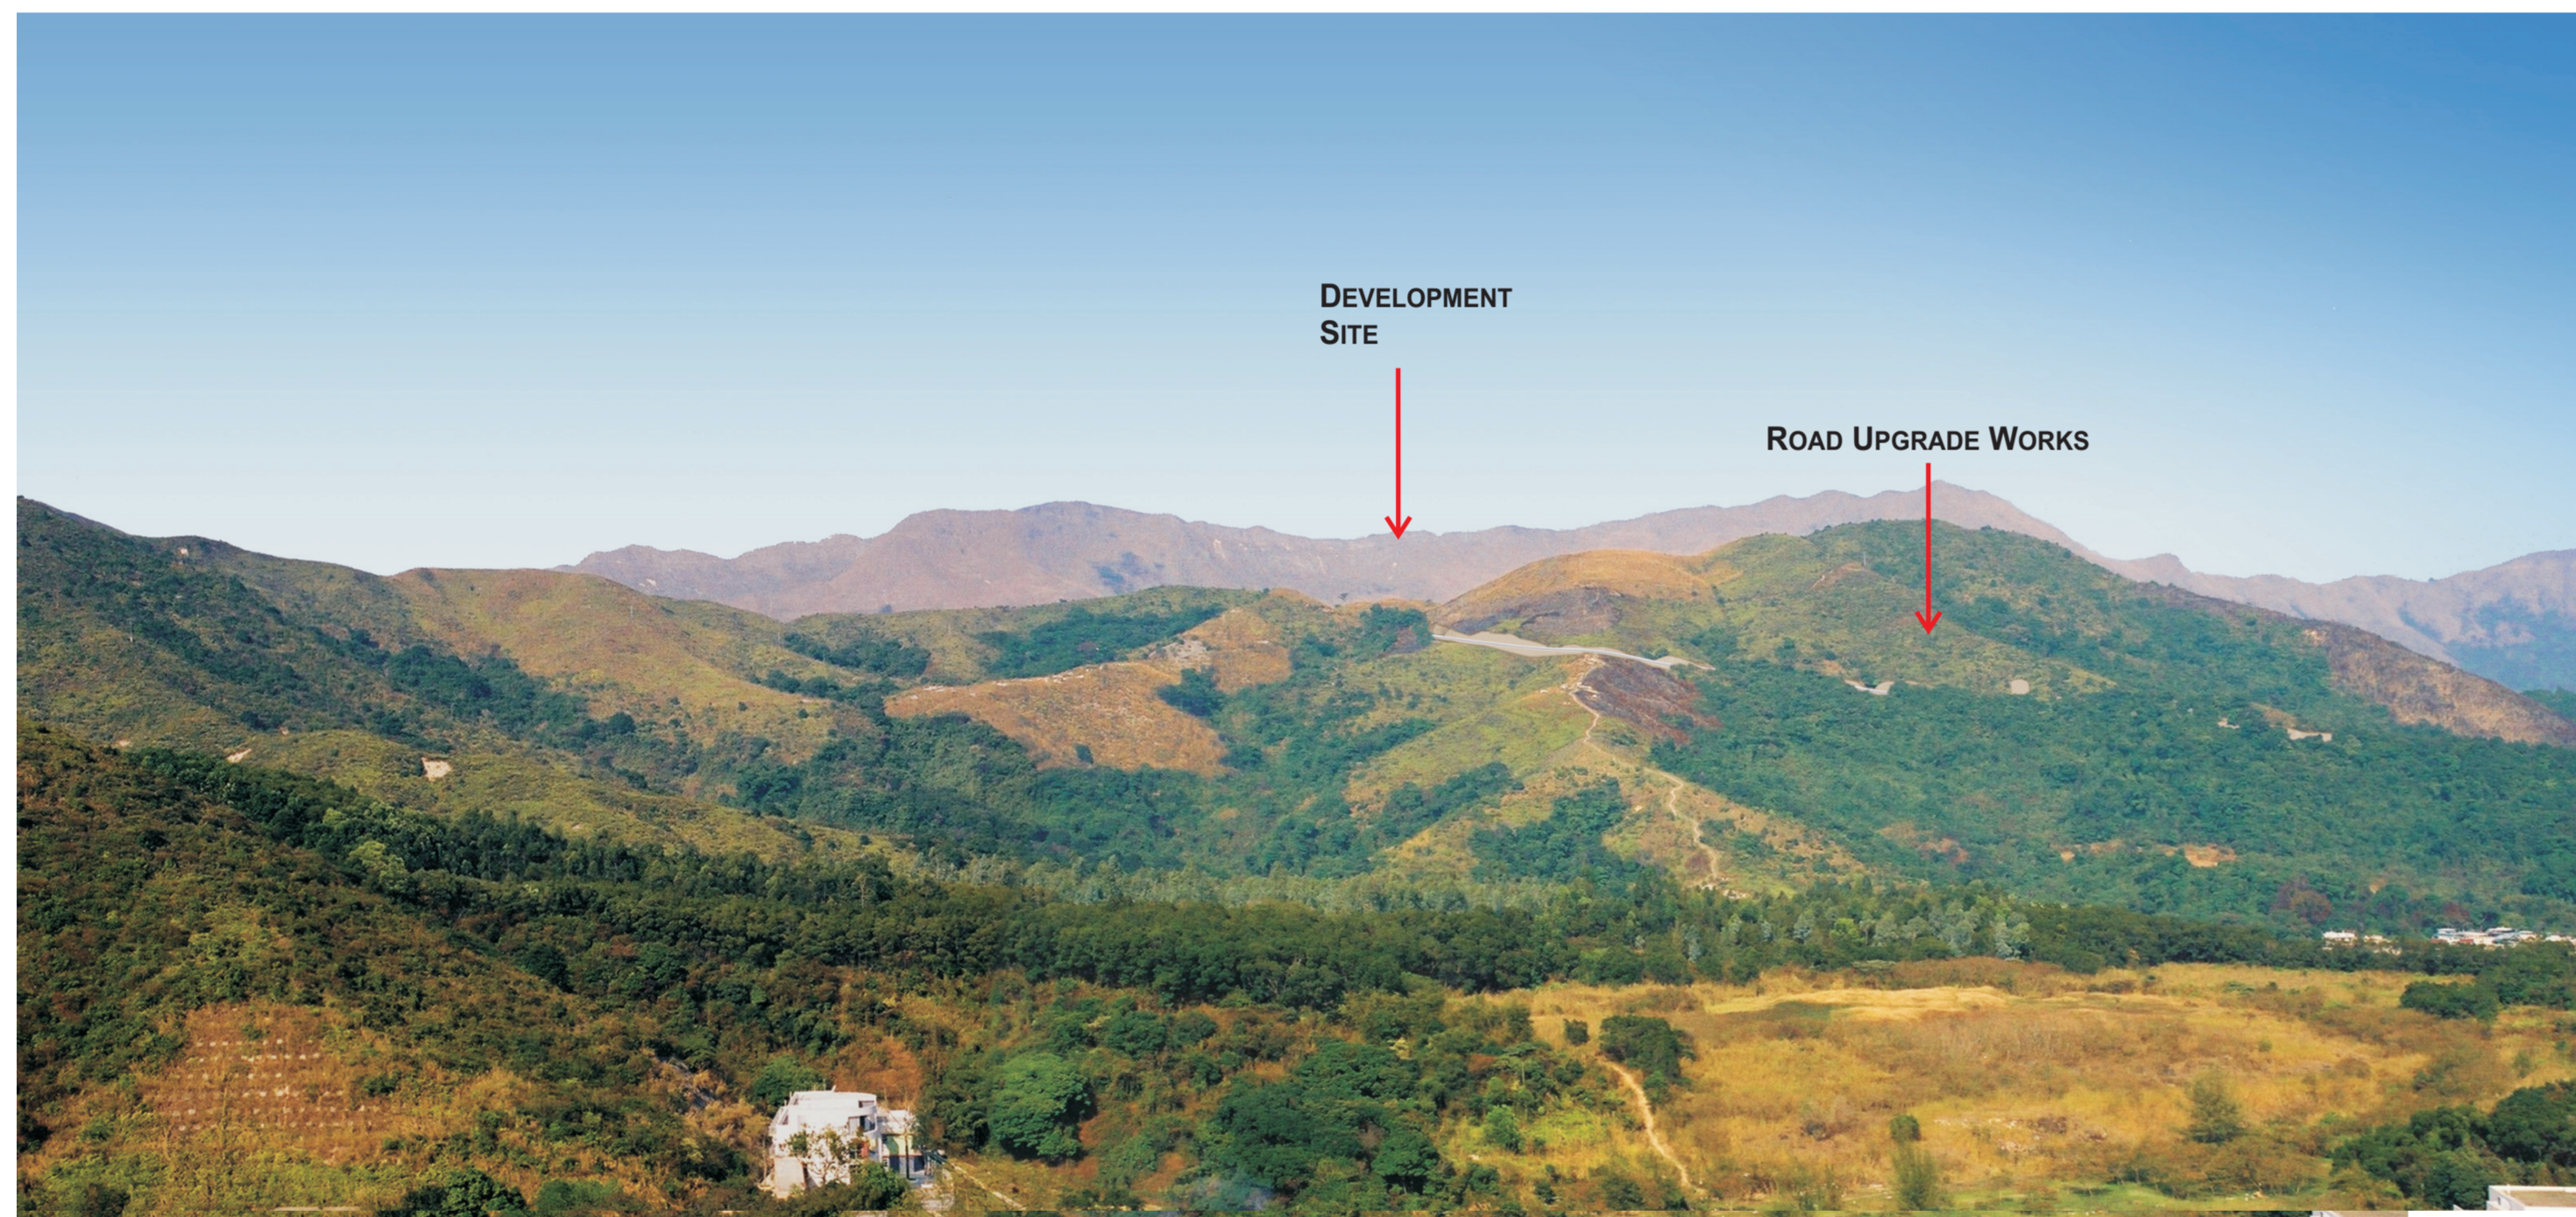
VIEW DISPLAYING THE 3D MODEL OF THE DEVELOPMENT SITE WITHOUT LANDSCAPE MITIGATION (THE DEVELOPMENT IS NOT VISIBLE FROM THIS VIEWPOINT).
