**FIGURE 10.18
PHOTOMONTAGE
VIEW POINT 1
CLOUDY PEAK**

**FIGURE 10.19
PHOTOMONTAGE
VIEWPOINT 2
WILSON TRAIL**

FIGURE 10.26
SECTIONS
THROUGH THE DEVELOPMENT SITE
TO THE EAST

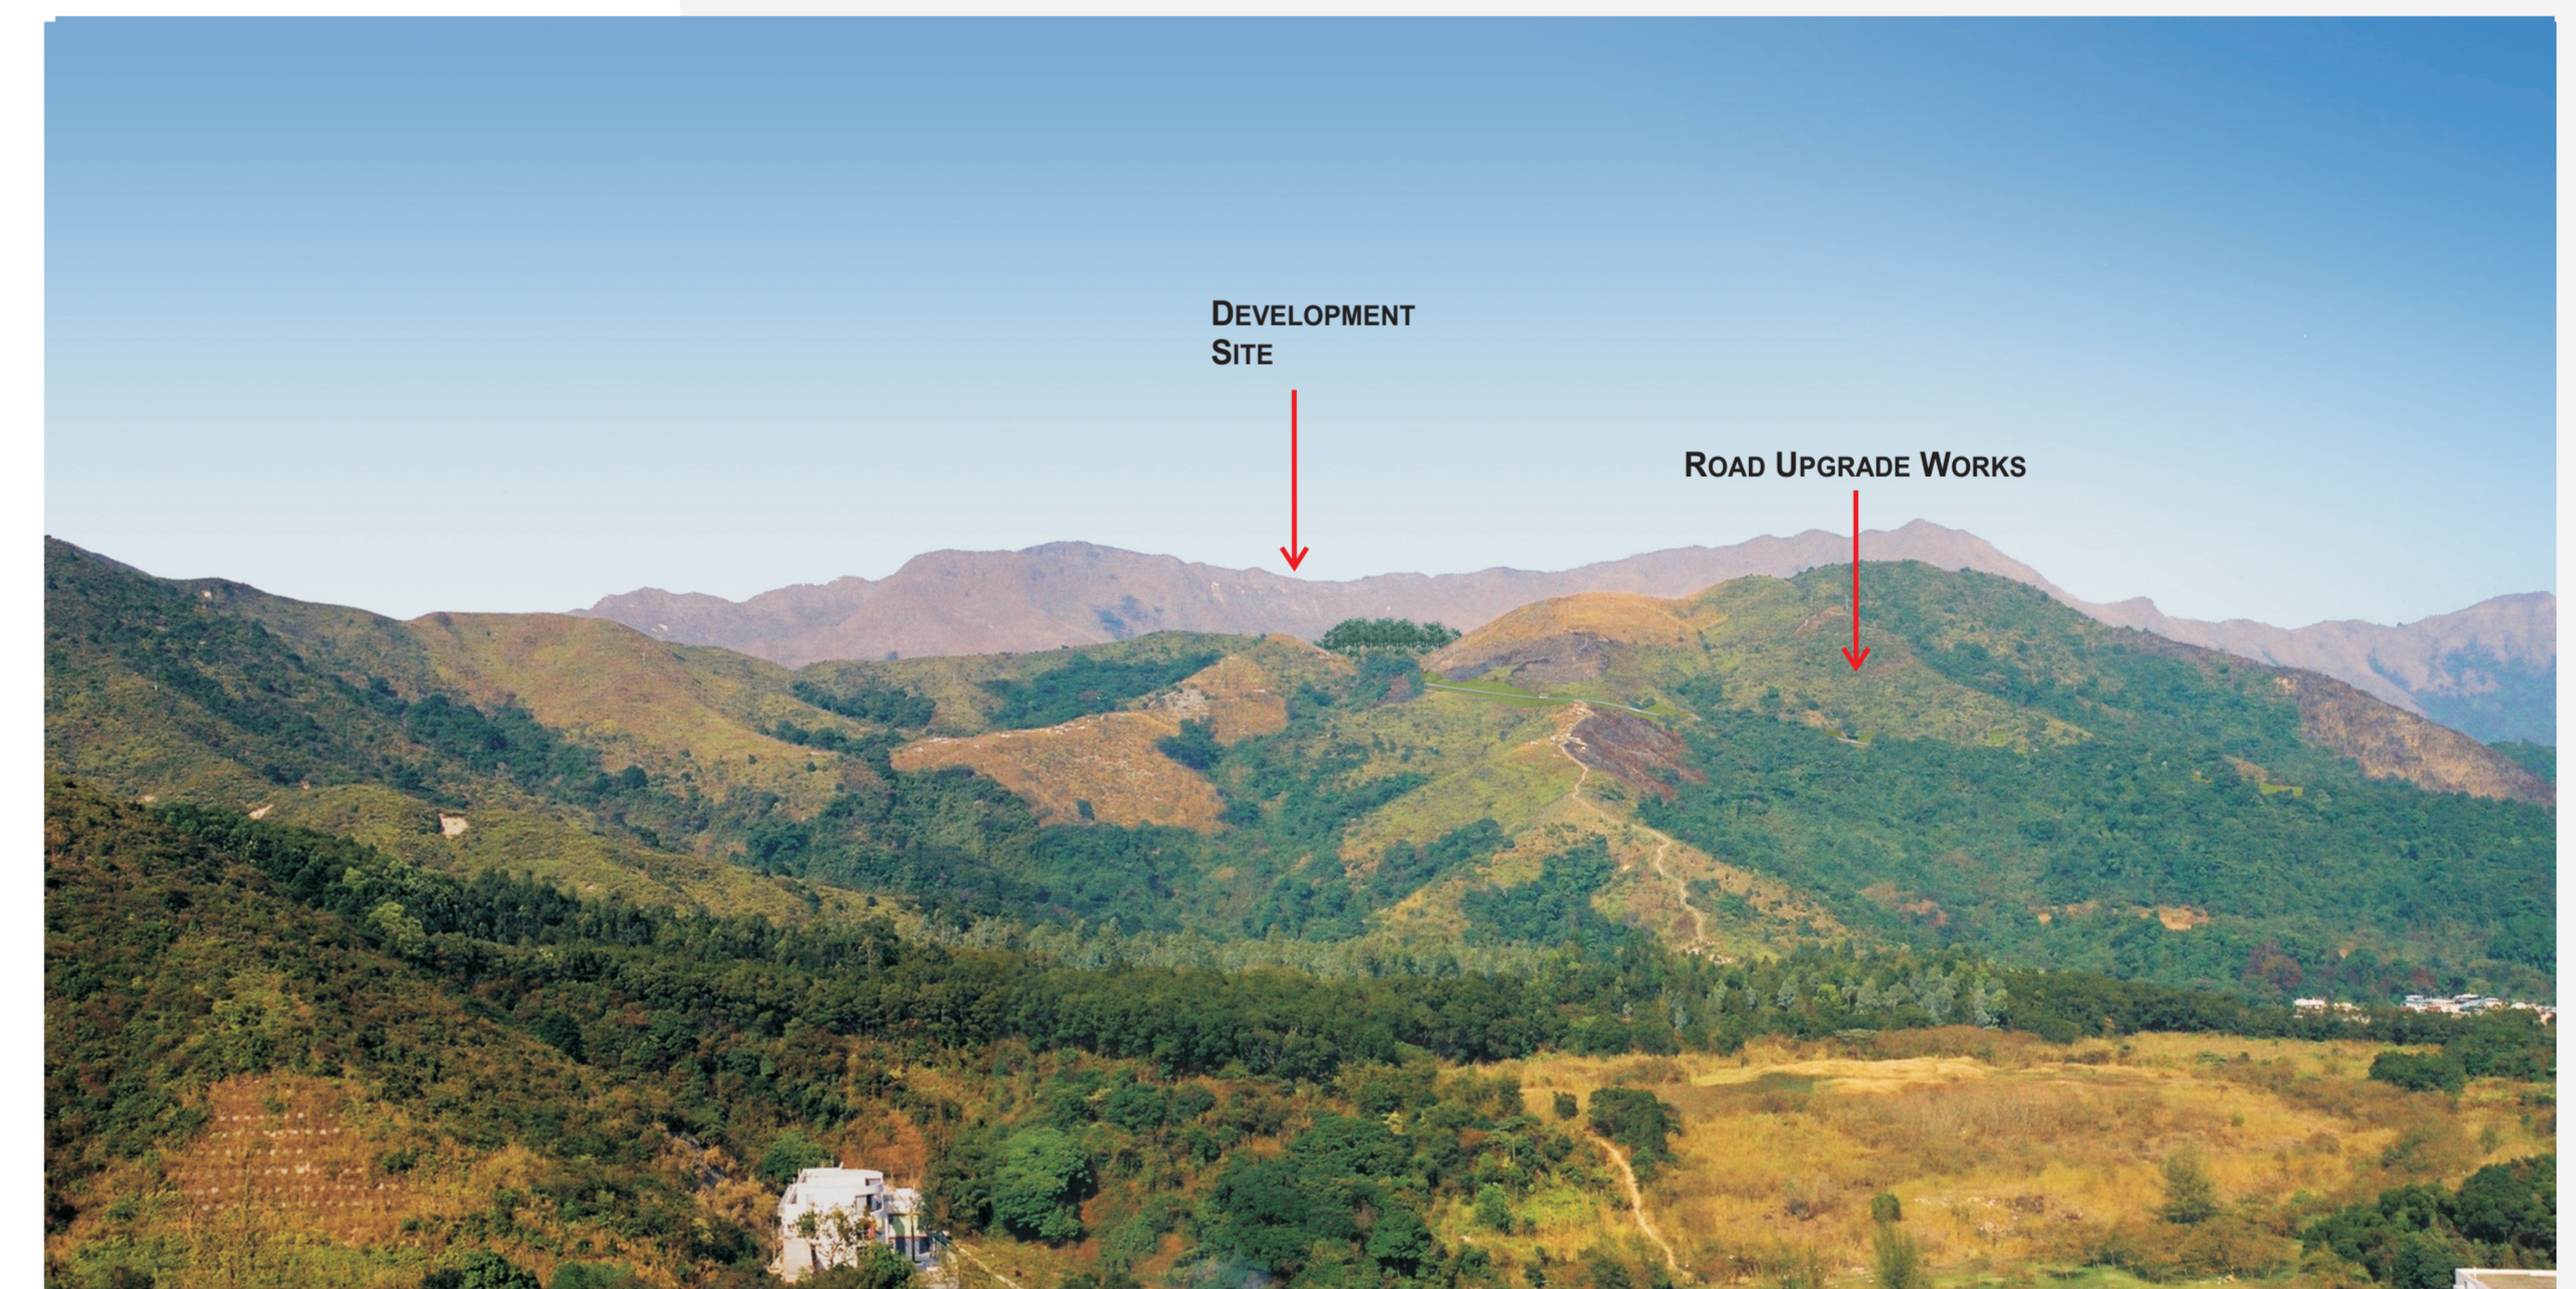
VIEW DISPLAYING THE 3D MODEL OF THE DEVELOPMENT SITE WITH LANDSCAPE MITIGATION AT YEAR 10.

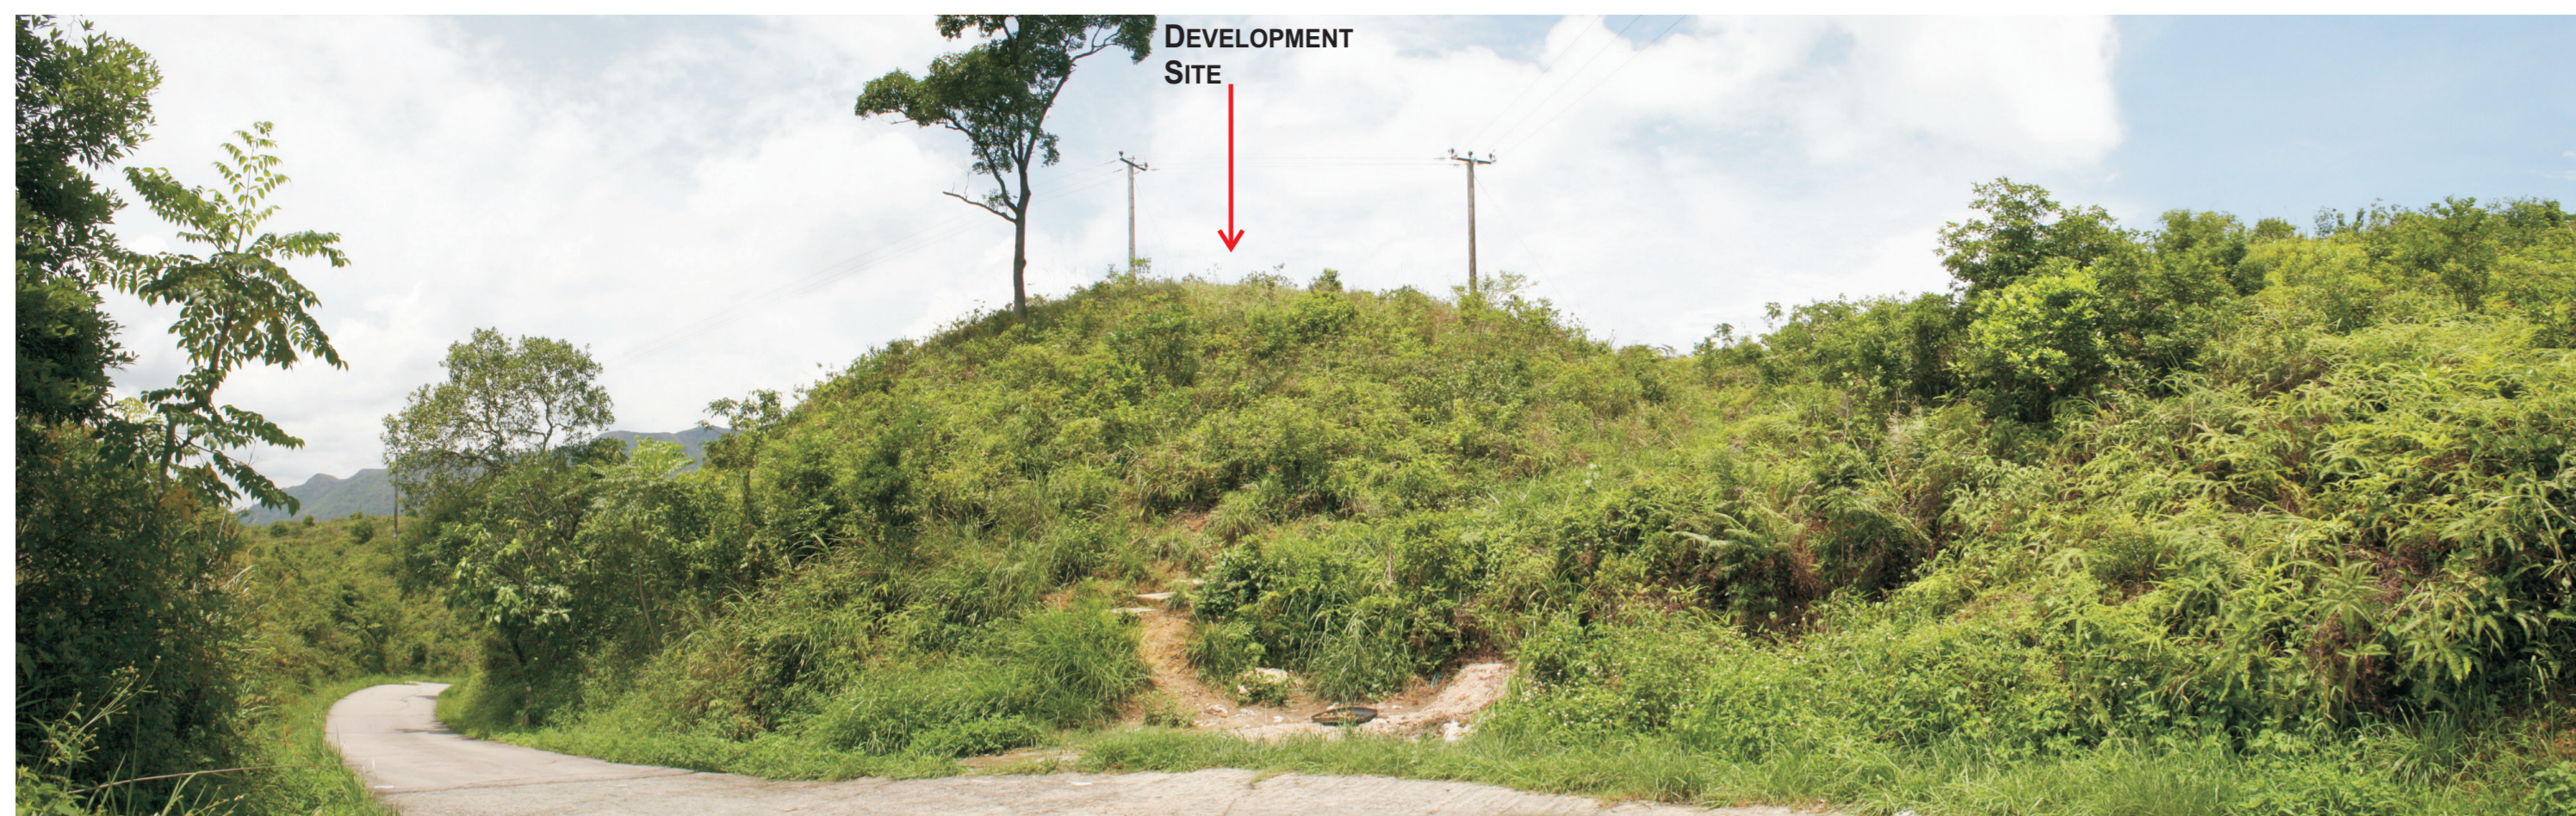
VIEWPOINT 4- LOOKING NORTH FROM SHA LO TUNG ROAD: EXISTING CONDITIONS AT THE DEVELOPMENT SITE.

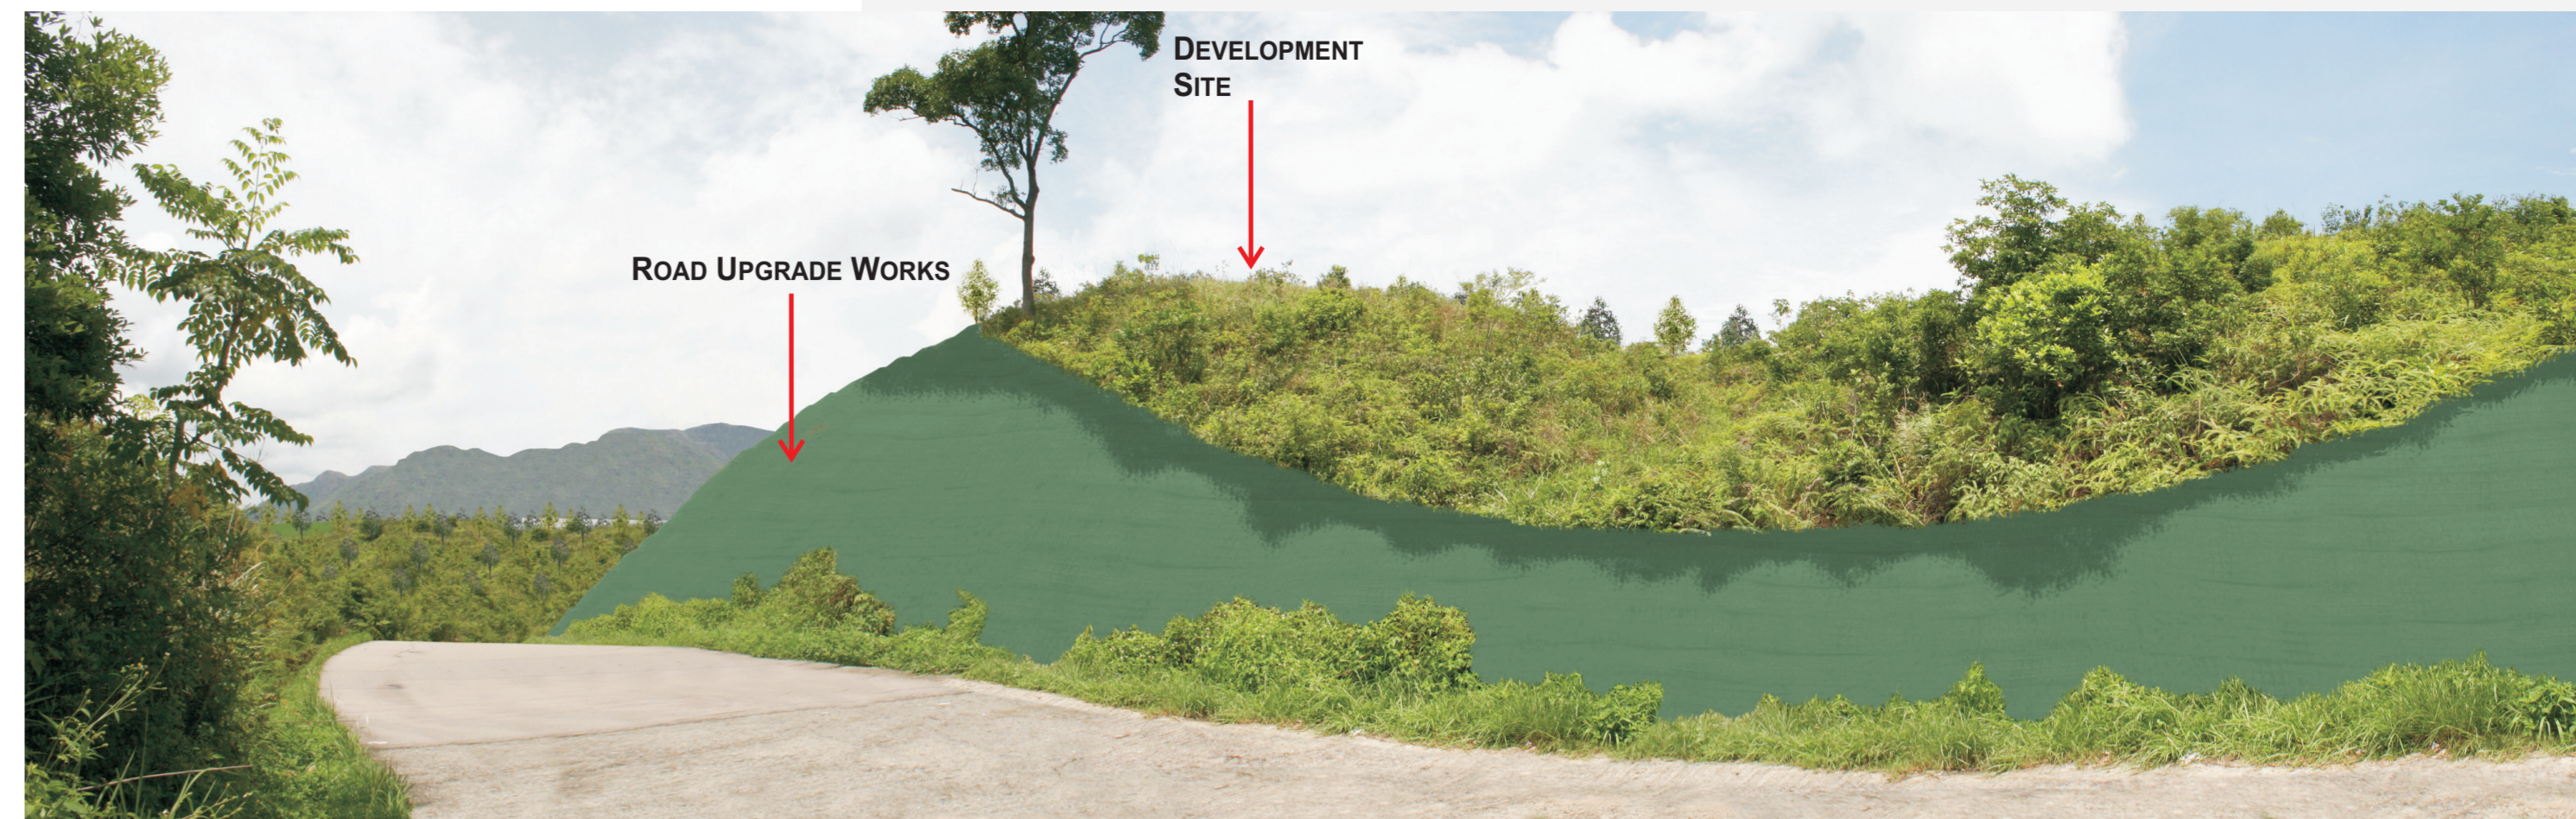
VIEW DISPLAYING THE 3D MODEL OF THE DEVELOPMENT SITE WITH LANDSCAPE MITIGATION AT DAY 1.

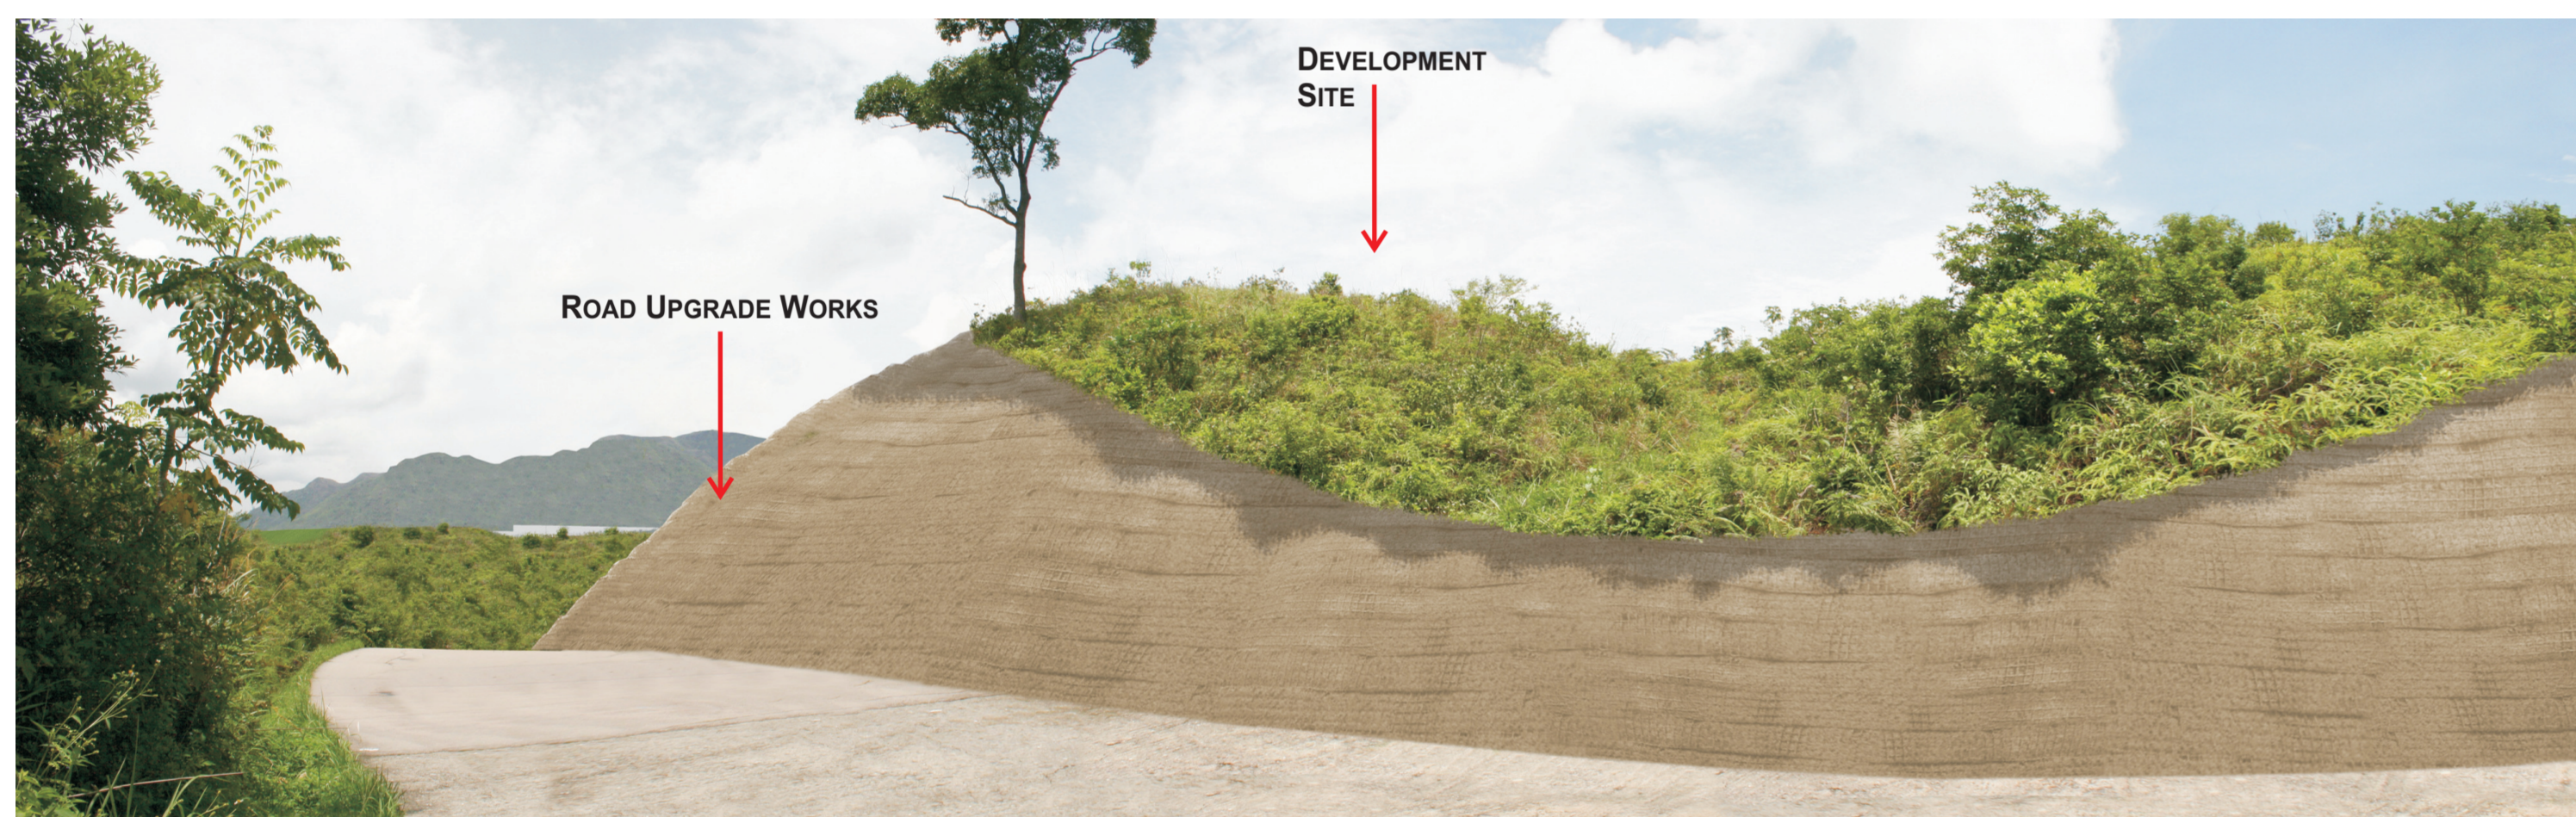
VIEW DISPLAYING THE 3D MODEL OF THE DEVELOPMENT SITE WITHOUT LANDSCAPE MITIGATION (THE DEVELOPMENT IS NOT VISIBLE FROM THIS VIEWPOINT).

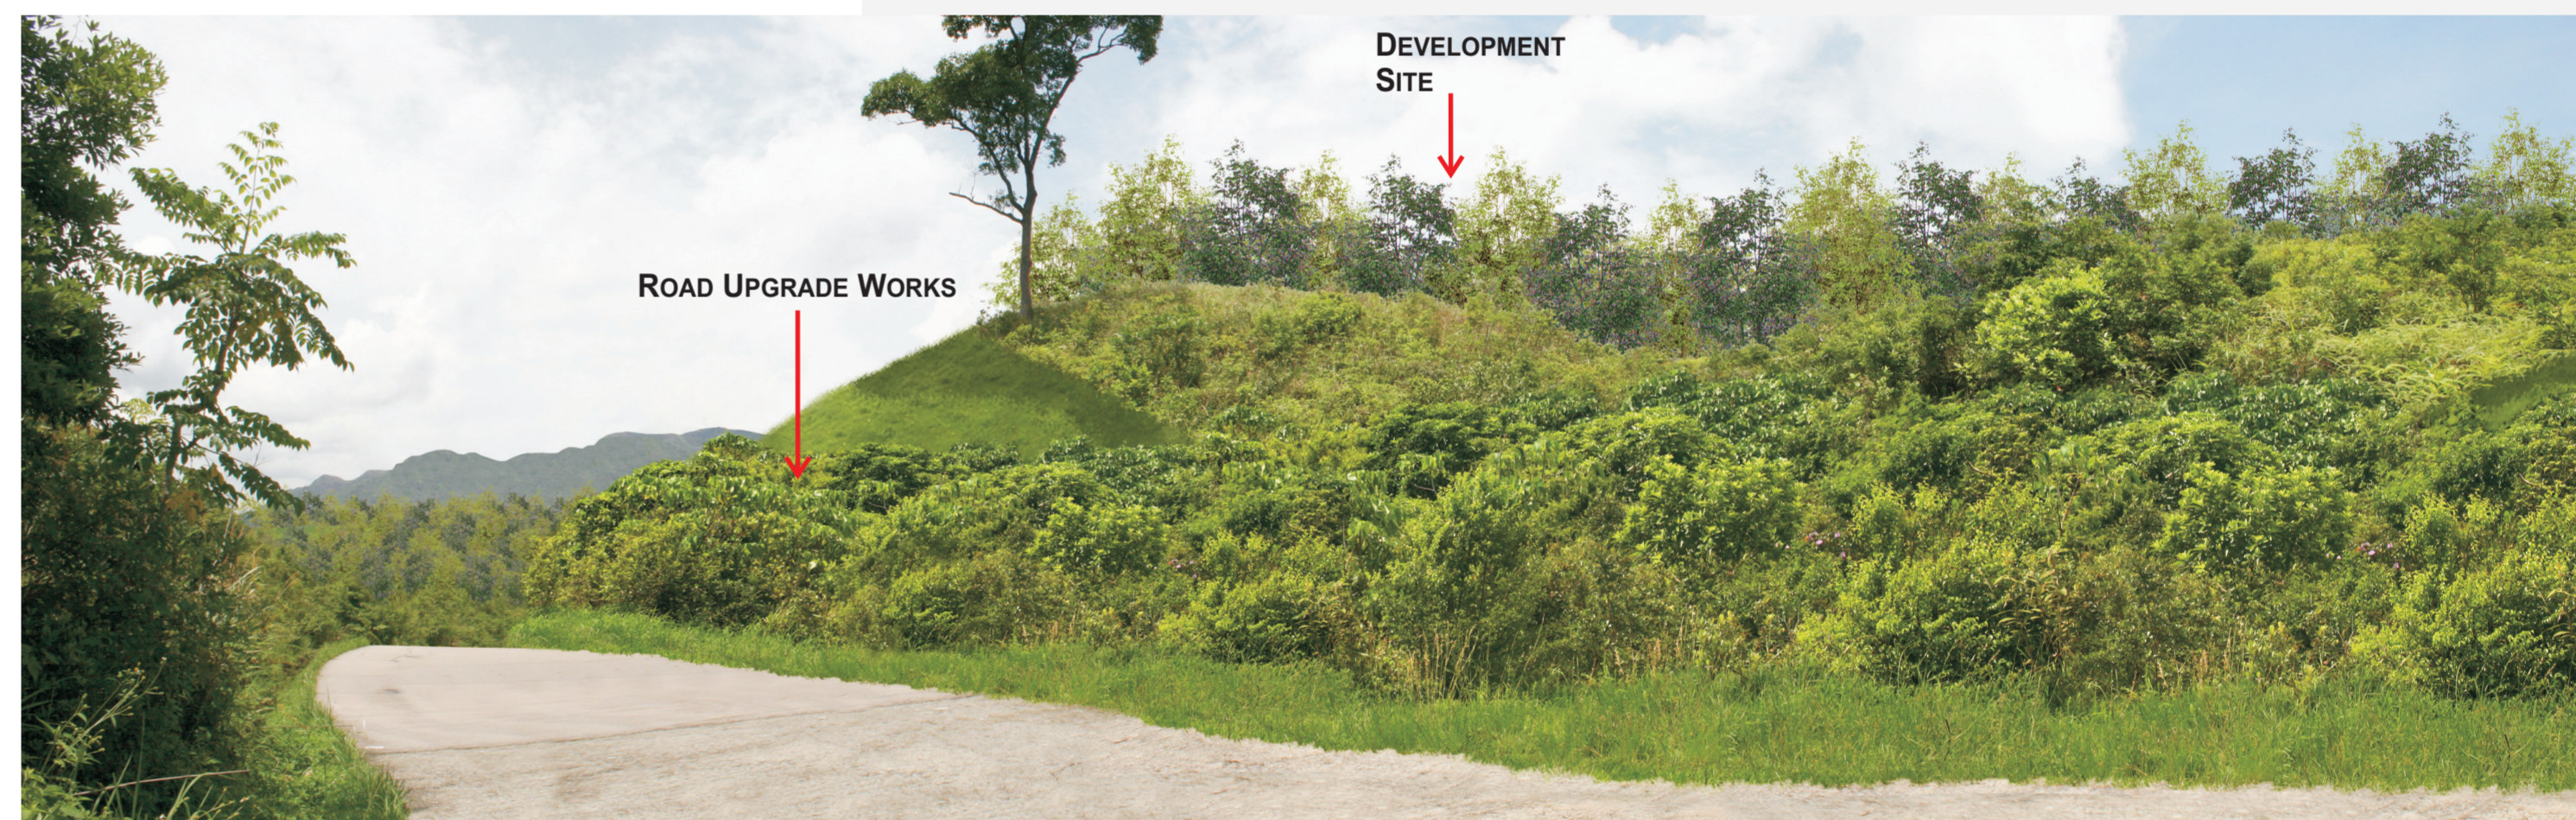
VIEW DISPLAYING THE 3D MODEL OF THE DEVELOPMENT SITE WITH LANDSCAPE MITIGATION AT YEAR 10.

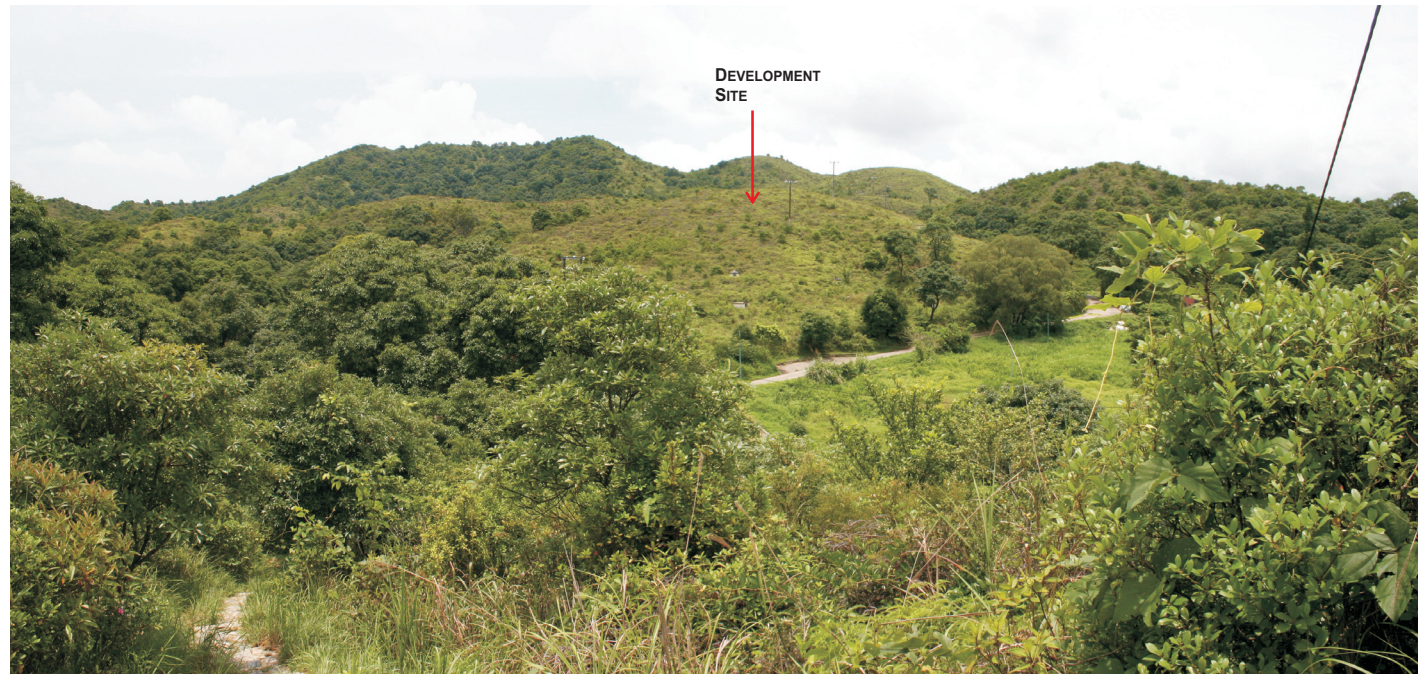
VIEWPOINT 5- LOOKING SOUTH FROM TRAIL WALK: EXISTING CONDITIONS AT THE DEVELOPMENT SITE.

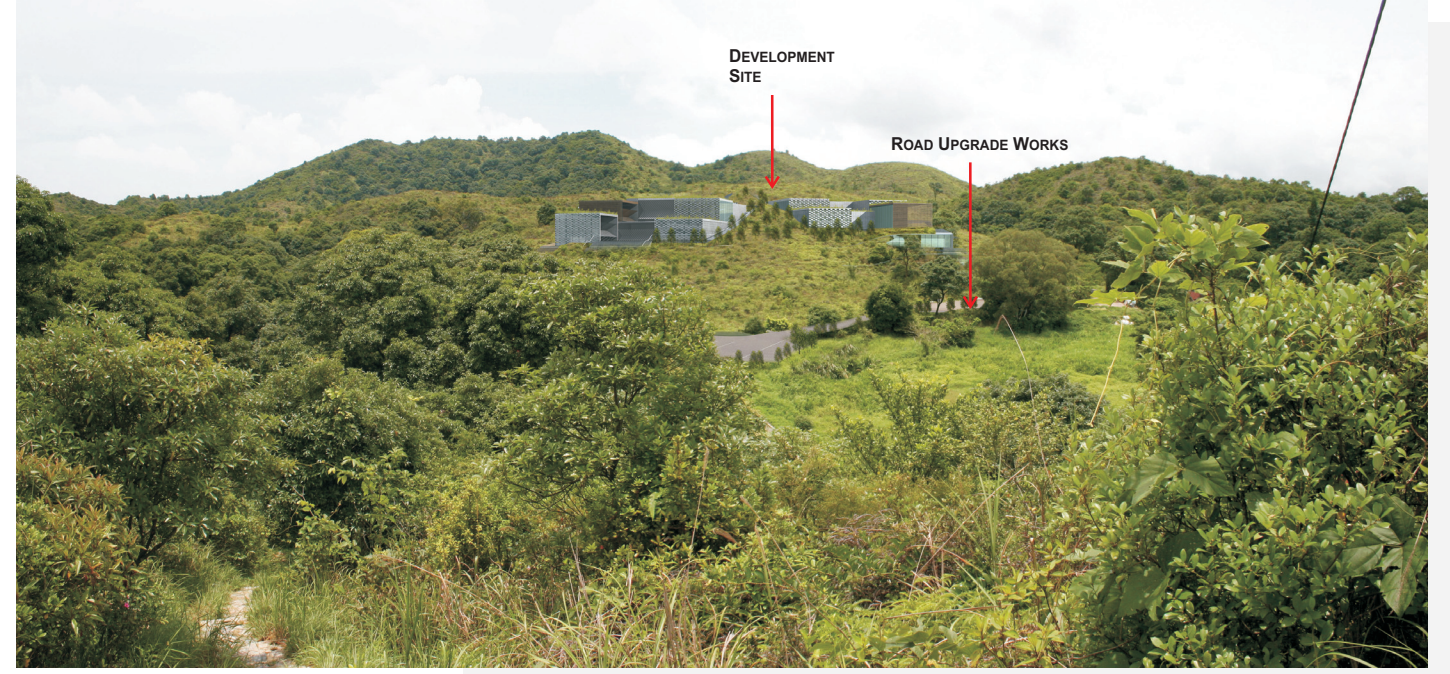
VIEW DISPLAYING THE 3D MODEL OF THE DEVELOPMENT SITE WITH LANDSCAPE MITIGATION AT DAY 1.

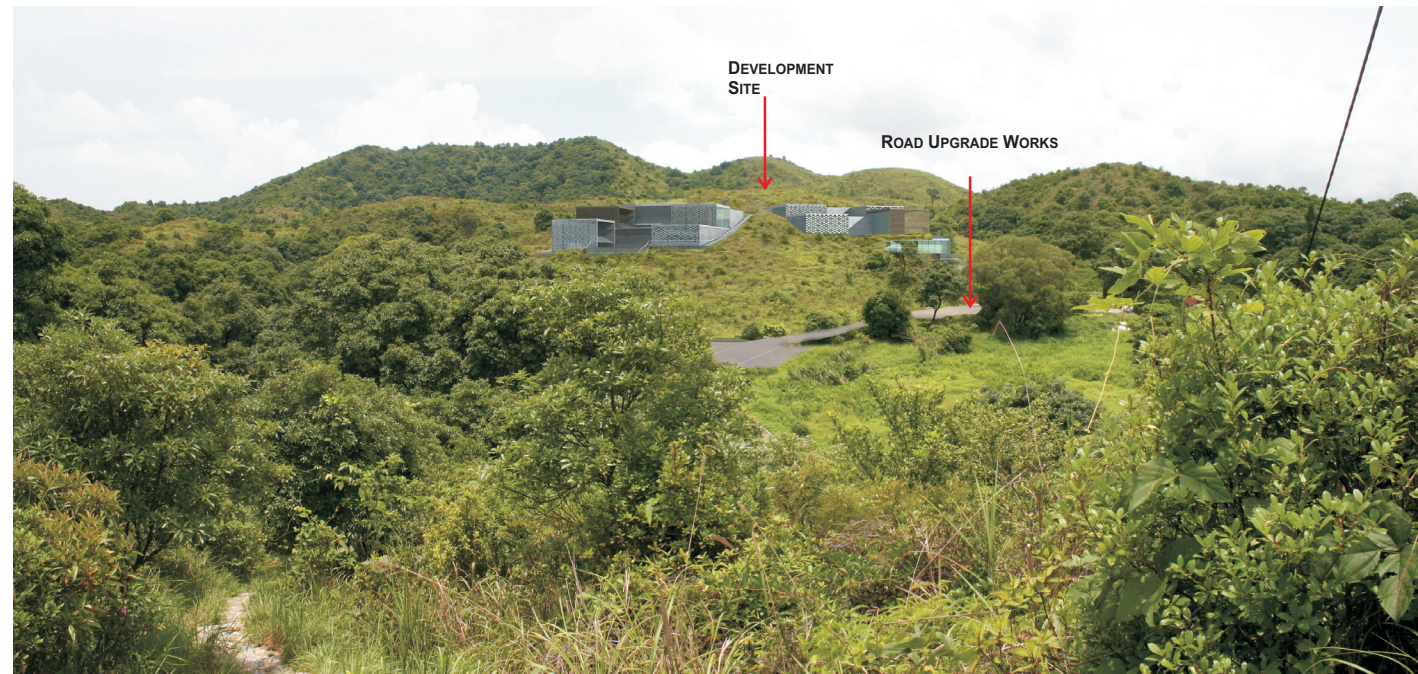
VIEW DISPLAYING THE 3D MODEL OF THE DEVELOPMENT SITE WITHOUT LANDSCAPE MITIGATION

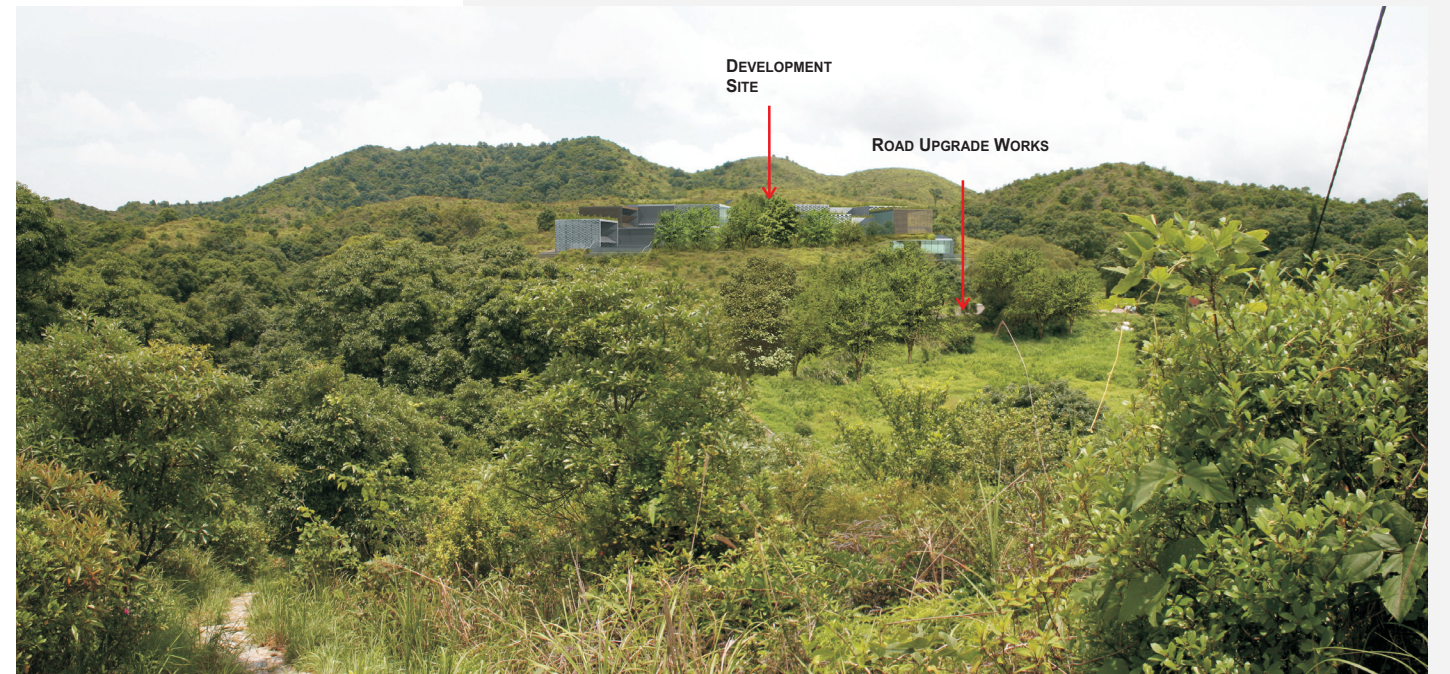
VIEW DISPLAYING THE 3D MODEL OF THE DEVELOPMENT SITE WITH LANDSCAPE MITIGATION AT YEAR 10.

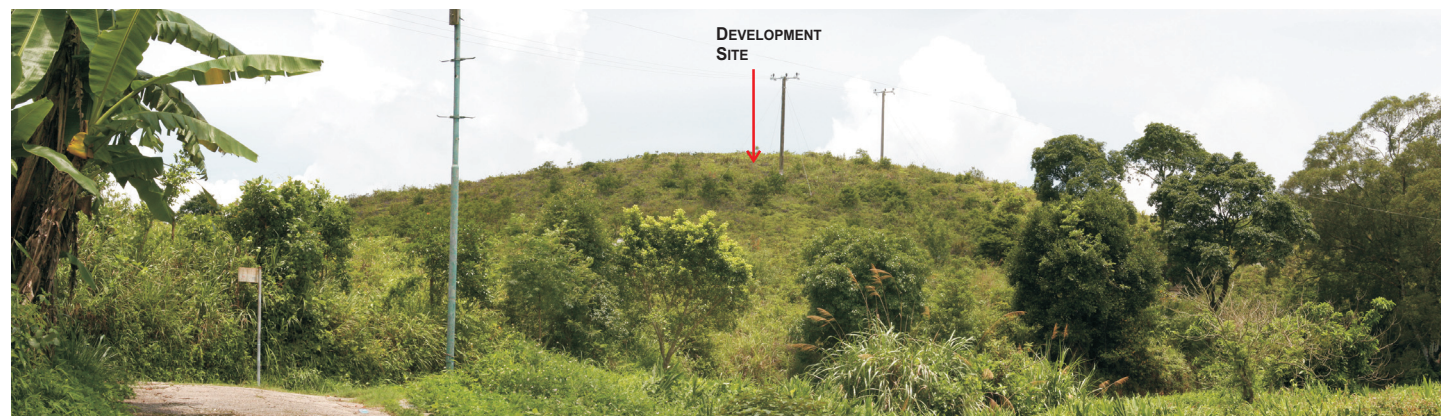
VIEWPOINT 6- LOOKING SOUTH FROM FOOT PATH BETWEEN TAI PO COUNTRY TRAIL ENTRANCE AND CAR PARK NEAR SHA LO TUNG ROAD: EXISTING CONDITIONS AT THE DEVELOPMENT SITE.

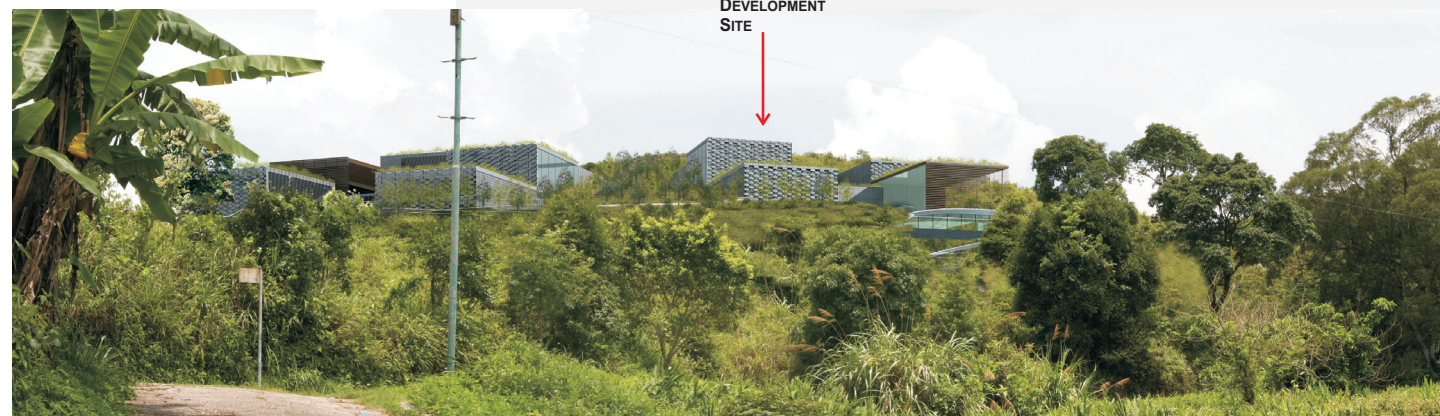
VIEW DISPLAYING THE 3D MODEL OF THE DEVELOPMENT SITE WITH LANDSCAPE MITIGATION AT DAY 1.

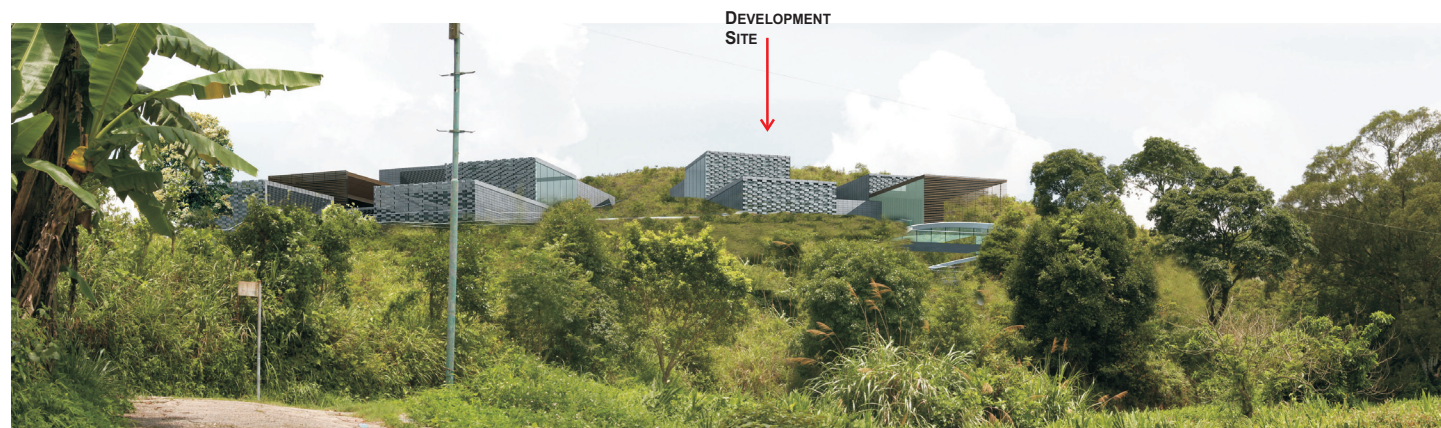
VIEW DISPLAYING THE 3D MODEL OF THE DEVELOPMENT SITE WITHOUT LANDSCAPE MITIGATION.

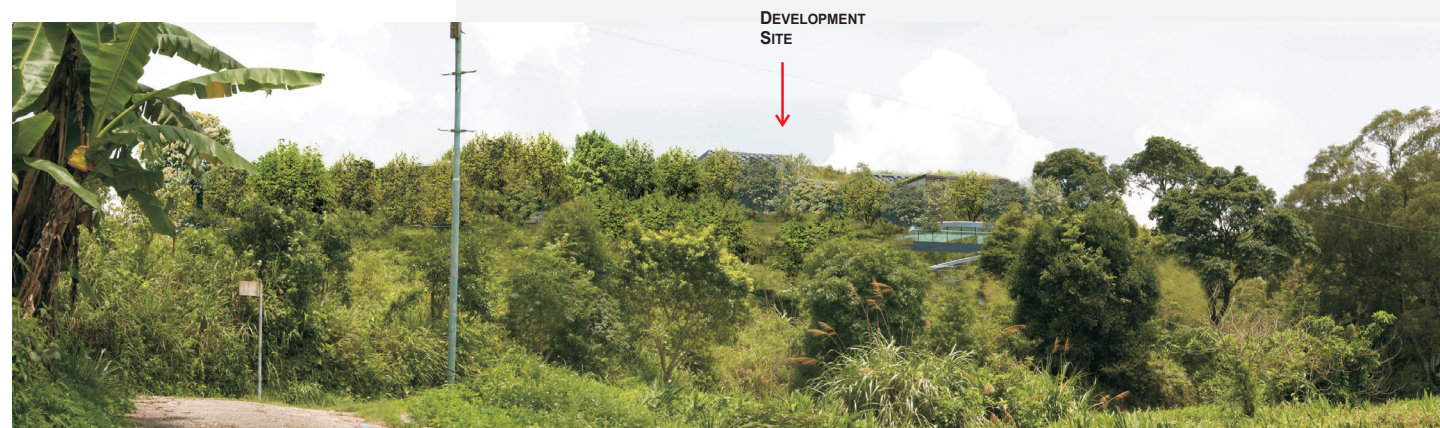
VIEW DISPLAYING THE 3D MODEL OF THE DEVELOPMENT SITE WITH LANDSCAPE MITIGATION AT YEAR 10.

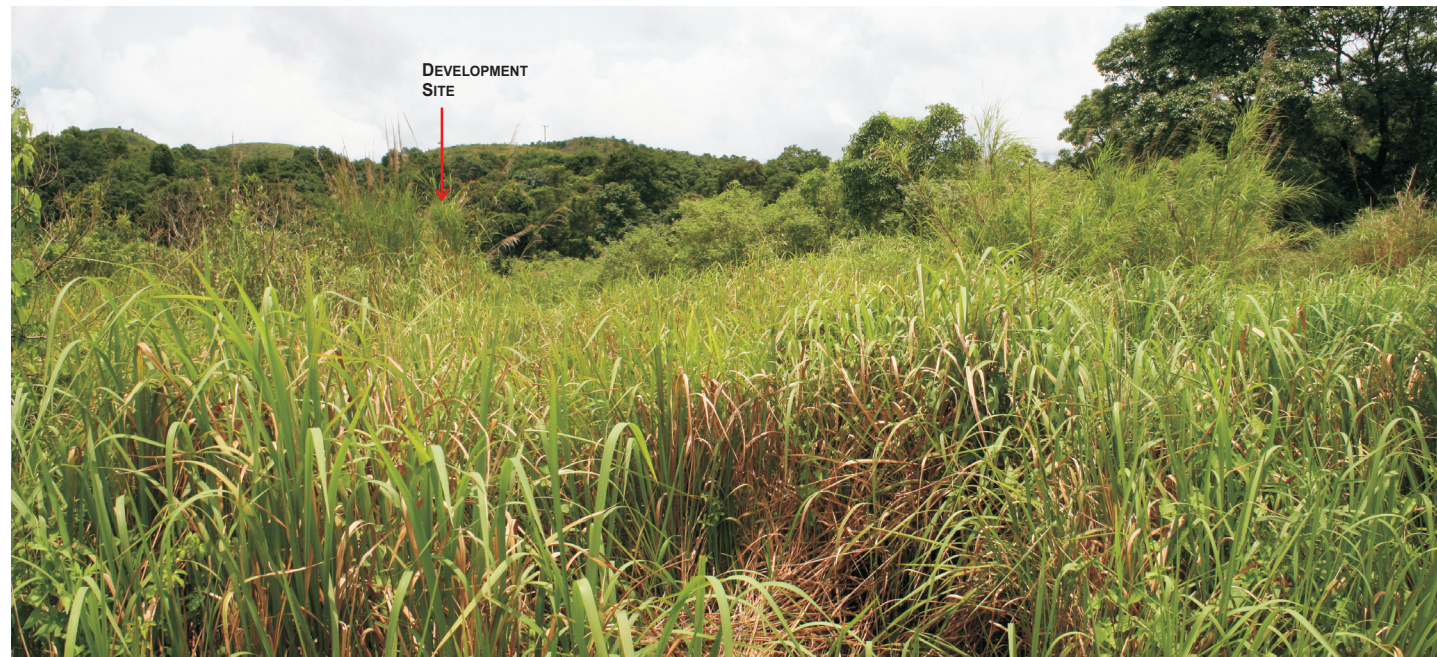
**VIEWPOINT 7- LOOKING TOWARDS THE SITE FROM LOCATION OF TEMPORARY FOOTBRIDGE:
EXISTING CONDITIONS AT THE DEVELOPMENT SITE.**

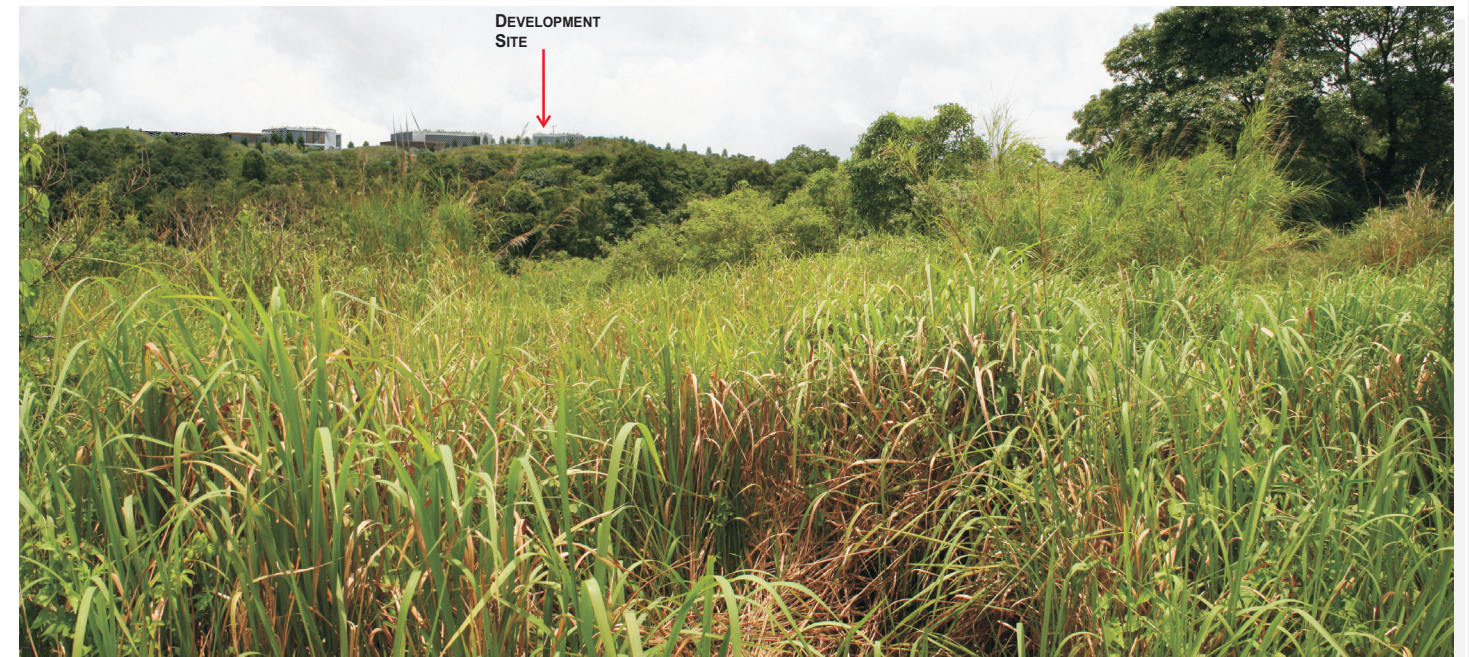
**VIEW DISPLAYING THE 3D MODEL OF THE DEVELOPMENT SITE WITH LANDSCAPE MITIGATION AT
DAY 1.**

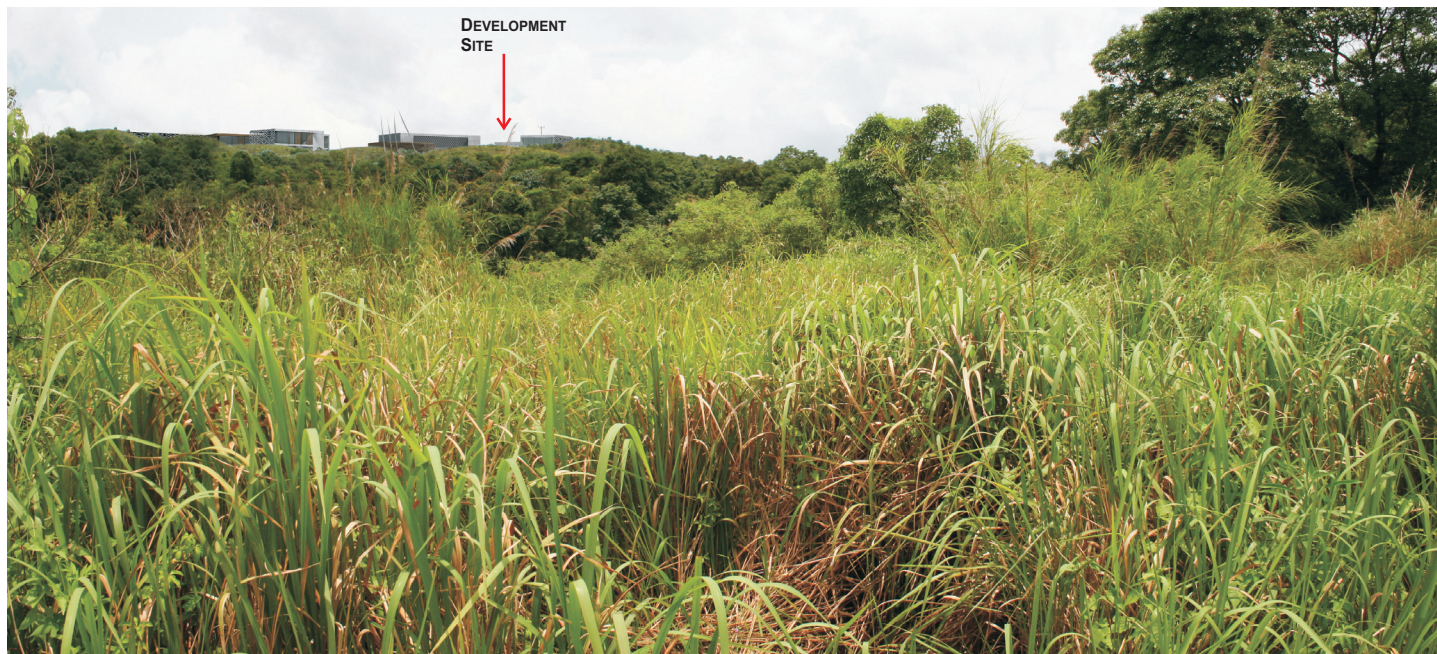
VIEW DISPLAYING THE 3D MODEL OF THE DEVELOPMENT SITE WITHOUT LANDSCAPE MITIGATION

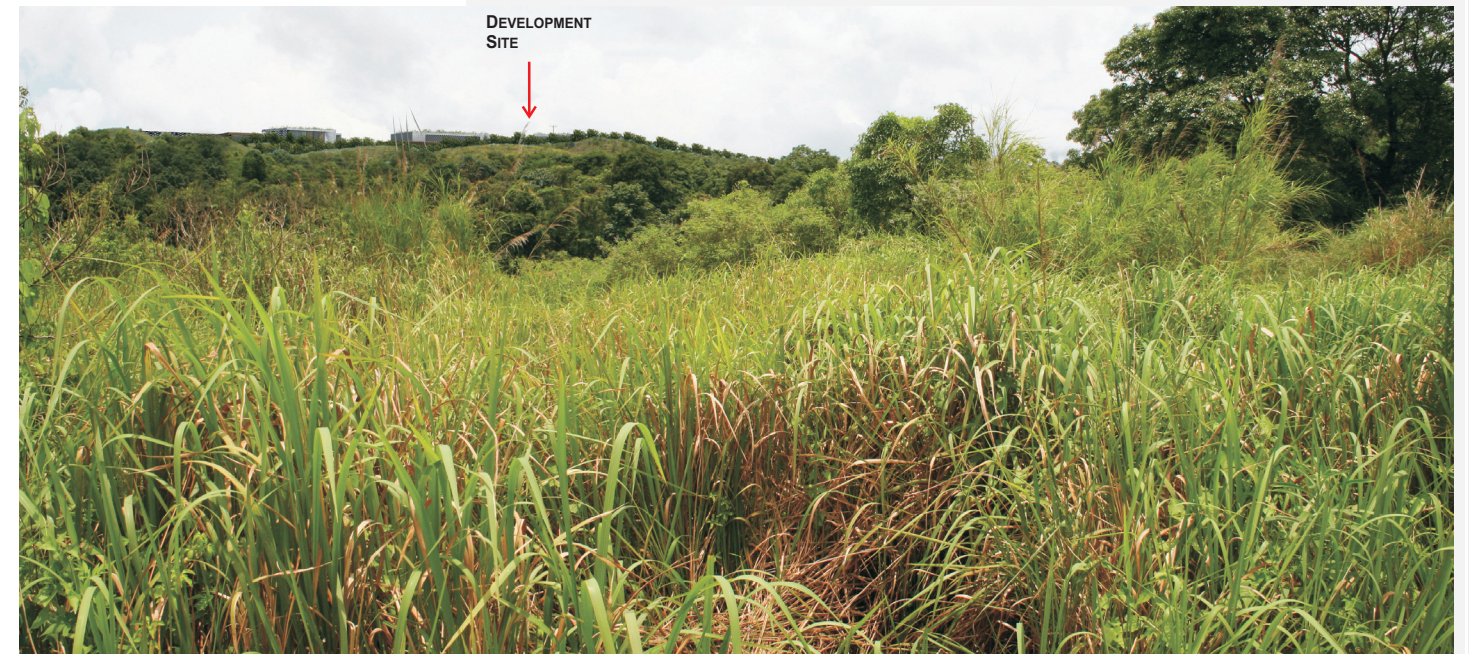
**VIEW DISPLAYING THE 3D MODEL OF THE DEVELOPMENT SITE WITH LANDSCAPE MITIGATION AT
YEAR 10.**
