**FIGURE 10.18
PHOTOMONTAGE
VIEW POINT 1
CLOUDY PEAK**

**FIGURE 10.19
PHOTOMONTAGE
VIEWPOINT 2
WILSON TRAIL**

FIGURE 10.26
SECTIONS
THROUGH THE DEVELOPMENT SITE
TO THE EAST

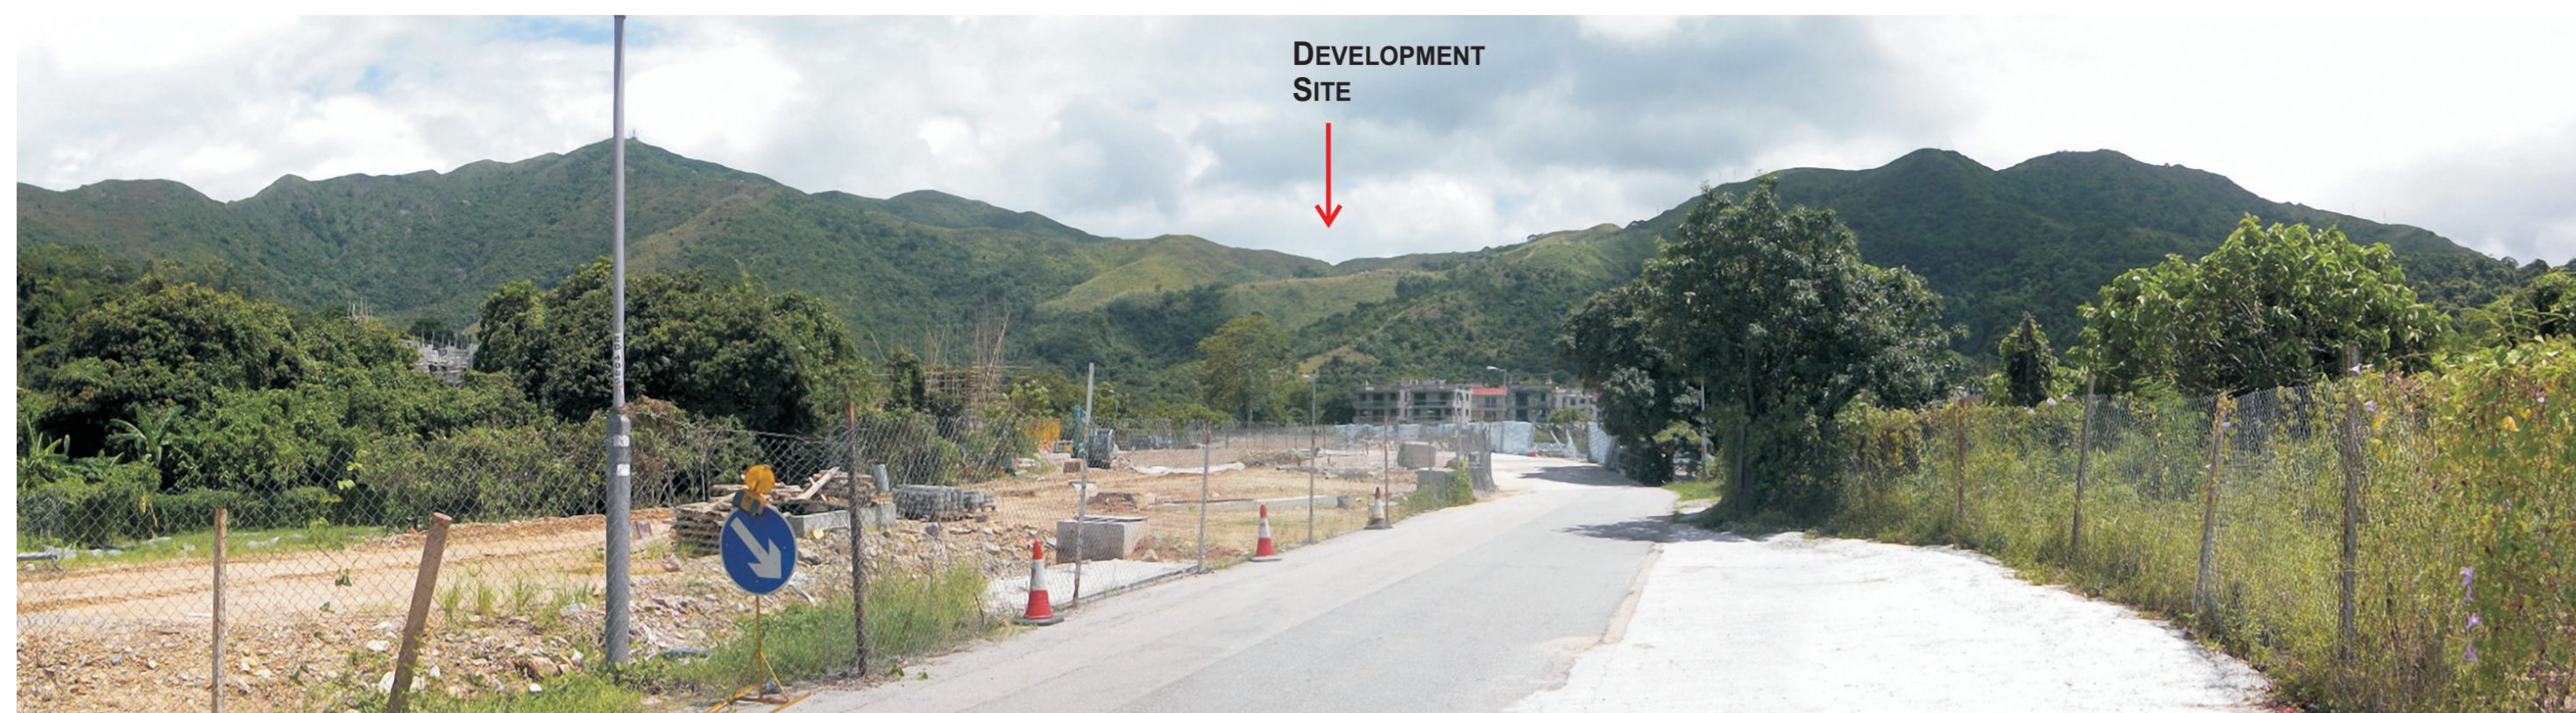
VIEWPOINT 8- VIEW FROM FUNG YUEN VALLEY: EXISTING CONDITIONS AT THE DEVELOPMENT SITE.

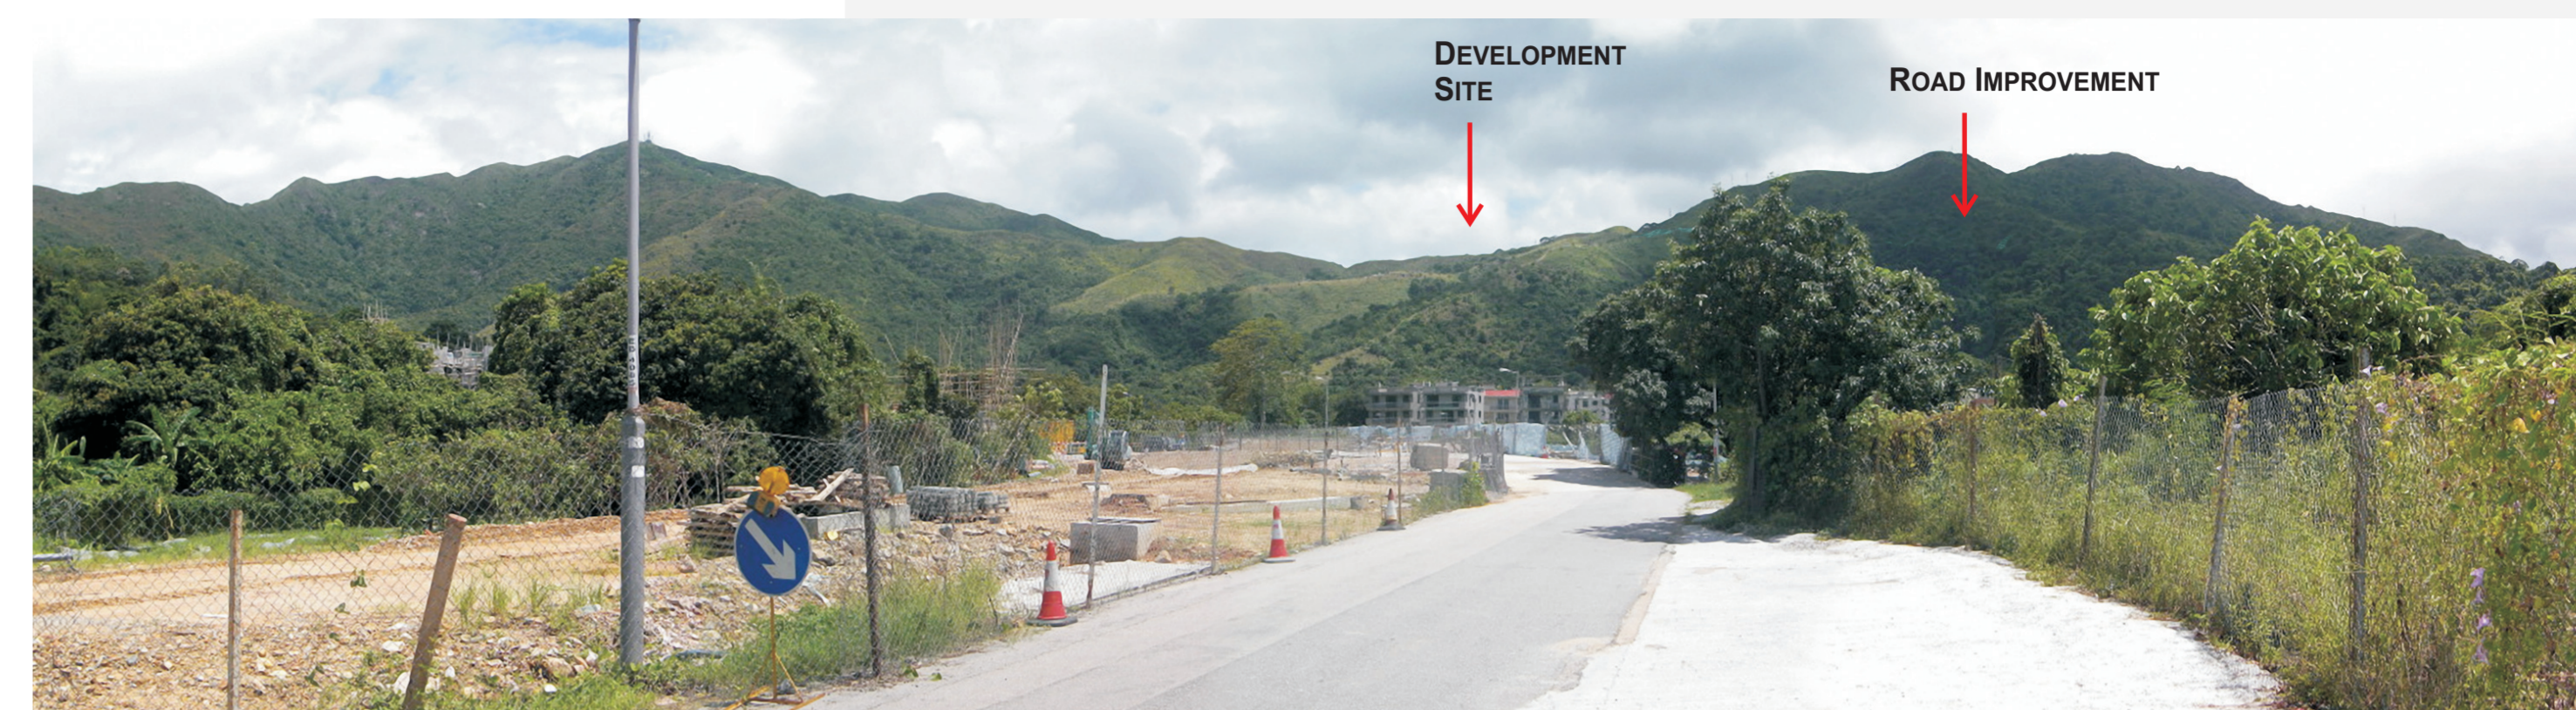
VIEW DISPLAYING THE 3D MODEL OF THE DEVELOPMENT SITE WITH LANDSCAPE MITIGATION AT DAY 1.

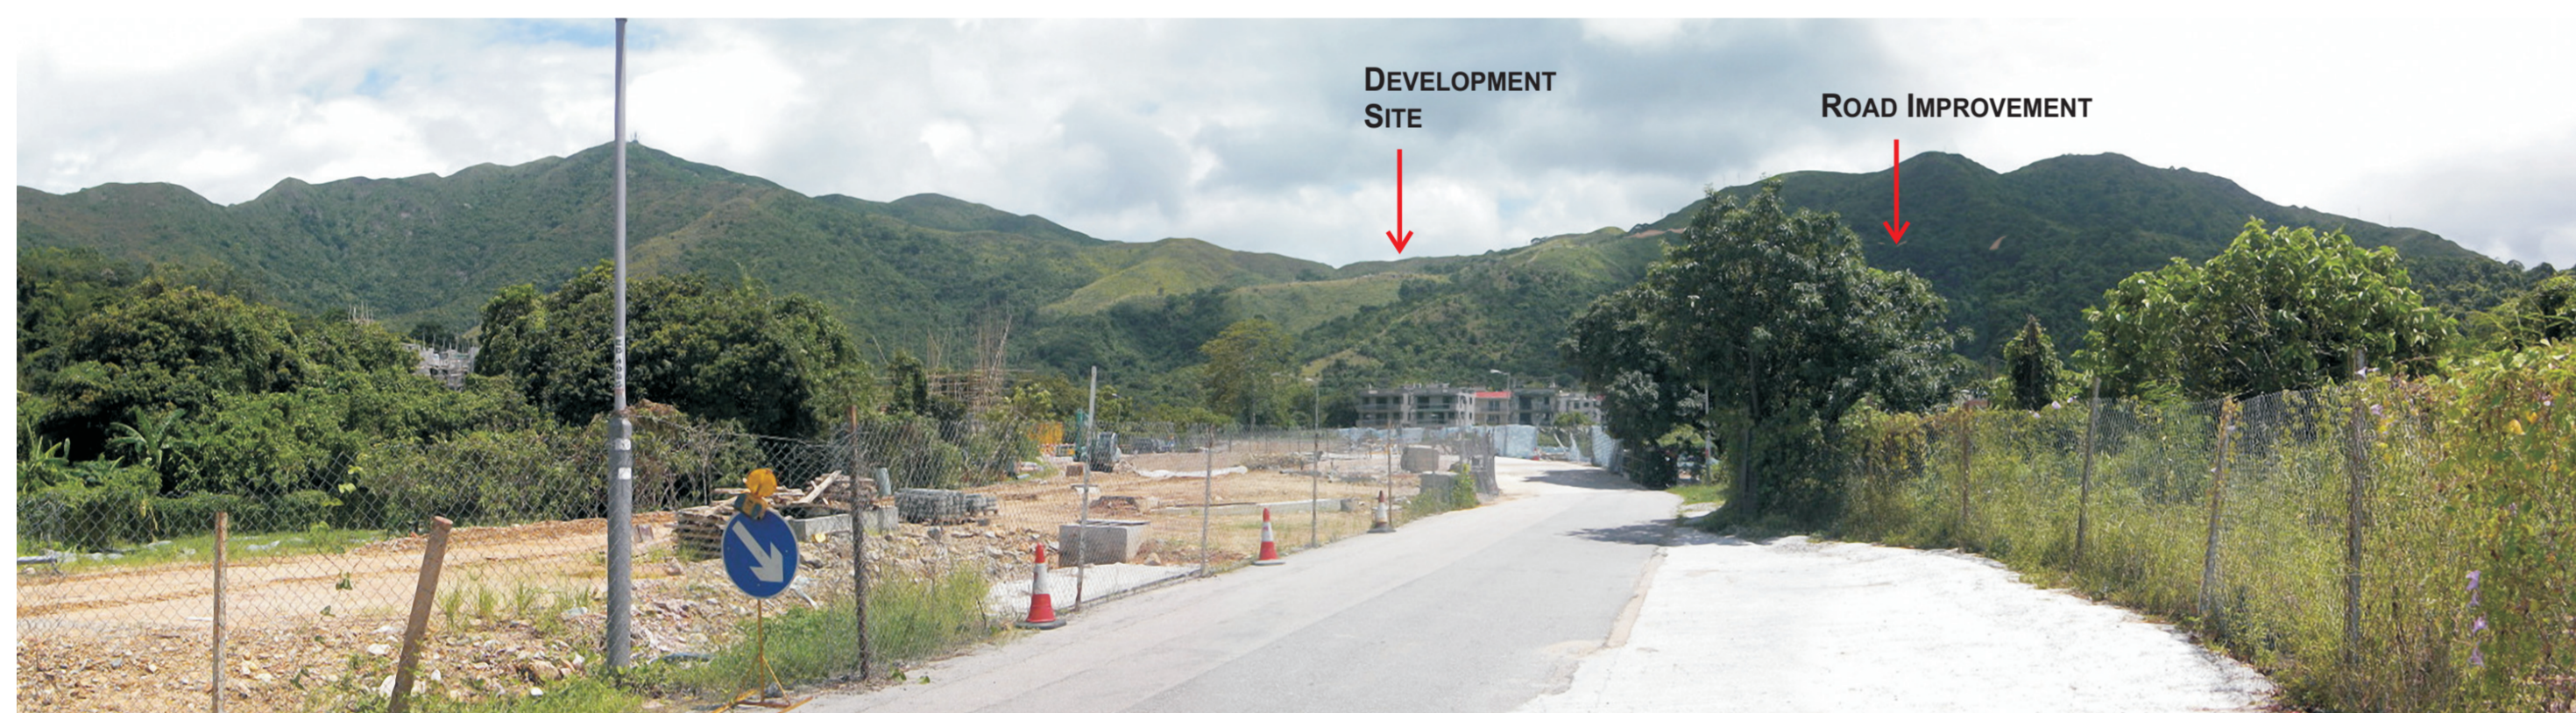
VIEW DISPLAYING THE 3D MODEL OF THE DEVELOPMENT SITE WITHOUT LANDSCAPE MITIGATION (THE DEVELOPMENT SITE IS NOT VISIBLE FROM THIS VIEWPOINT).

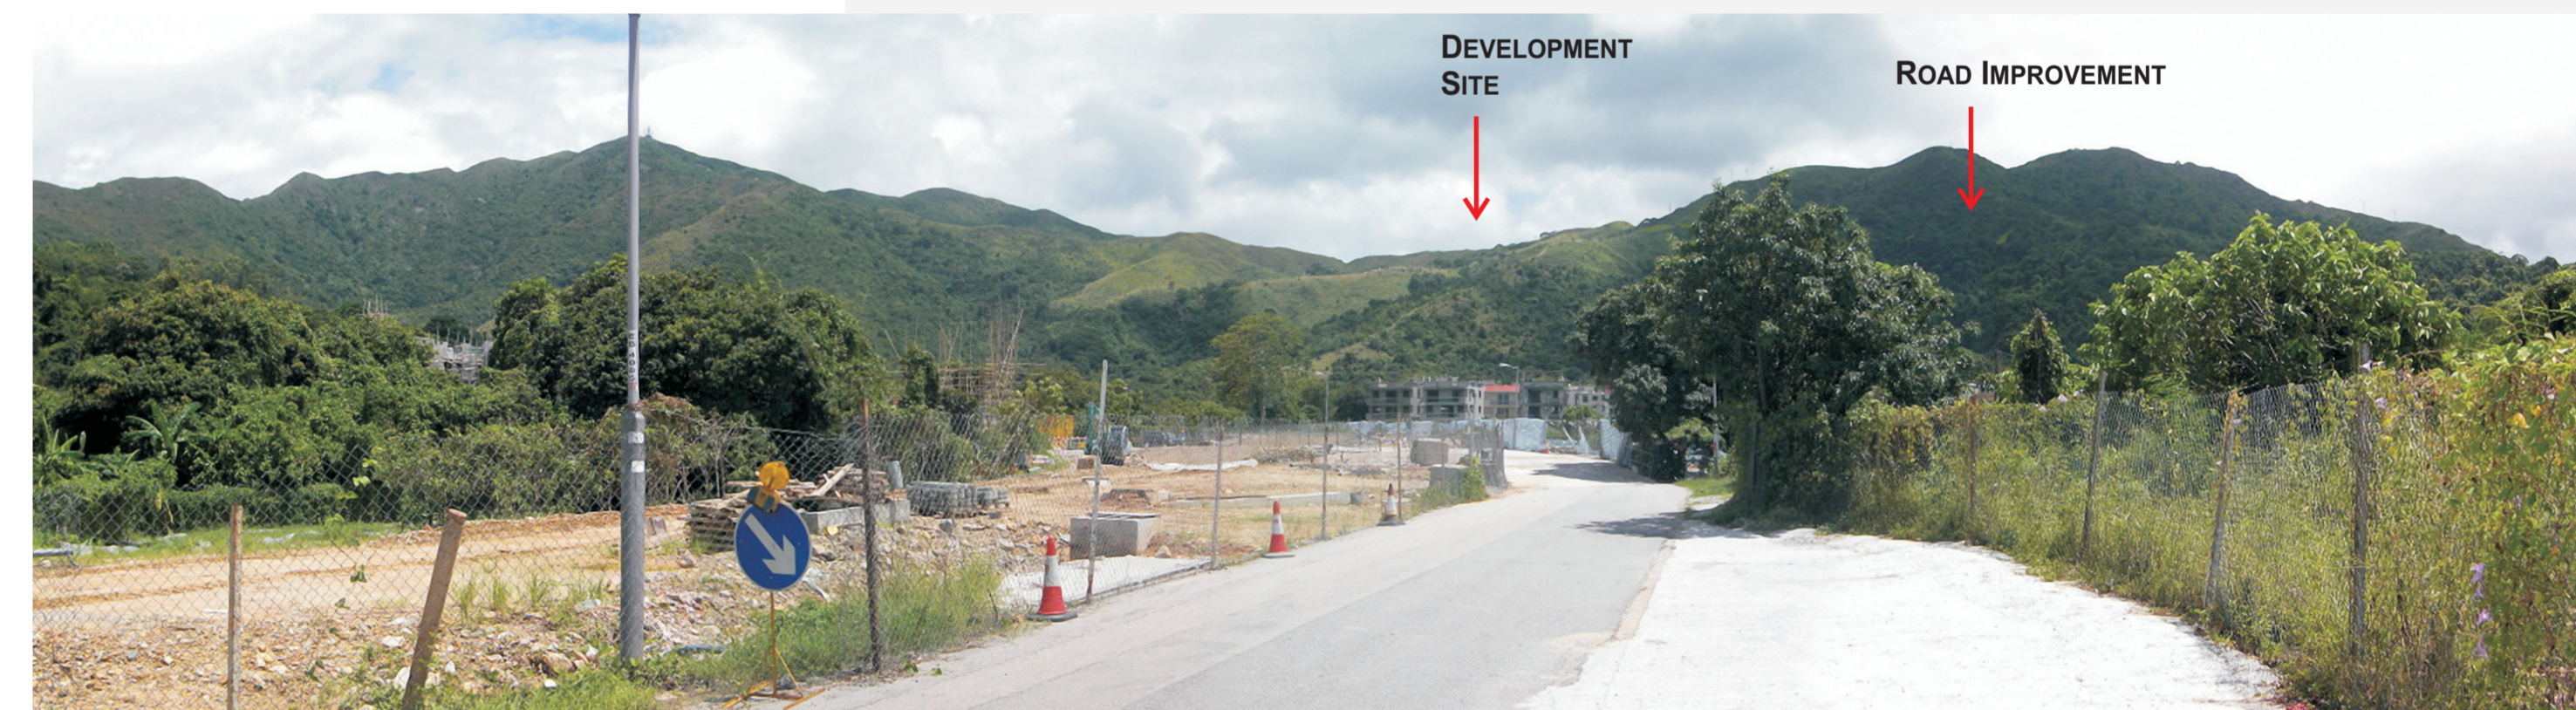
VIEW DISPLAYING THE 3D MODEL OF THE DEVELOPMENT SITE WITH LANDSCAPE MITIGATION AT YEAR 10.

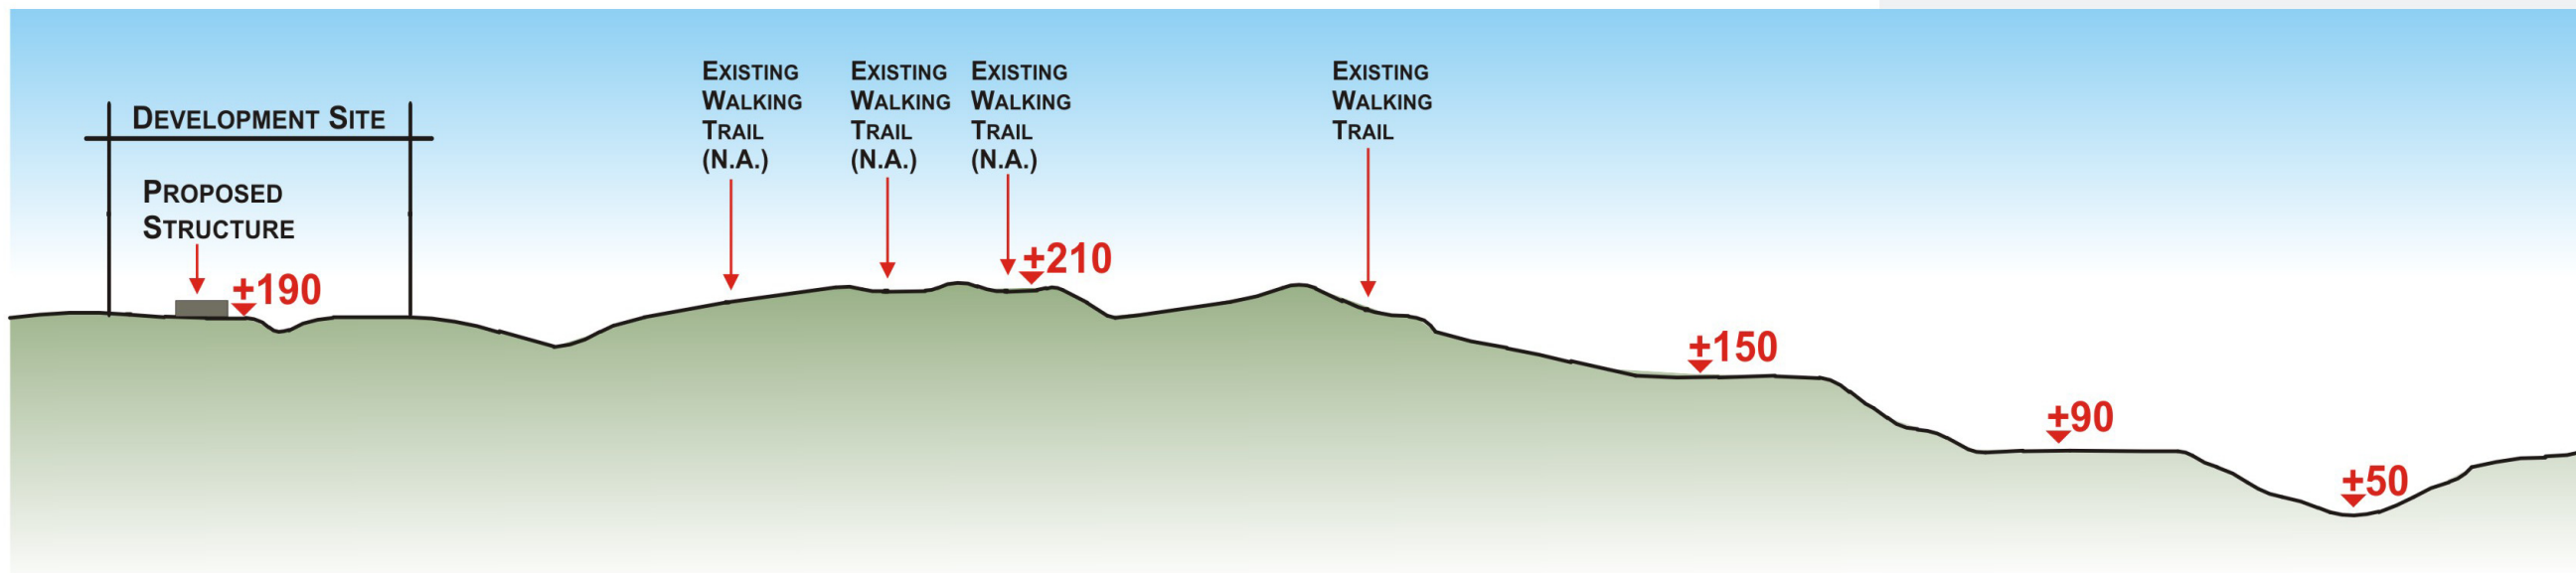
SECTION THRU B-B

N.A. DENOTES TRAIL NOT ACCESSIBLE DURING SITE INSPECTIONS.

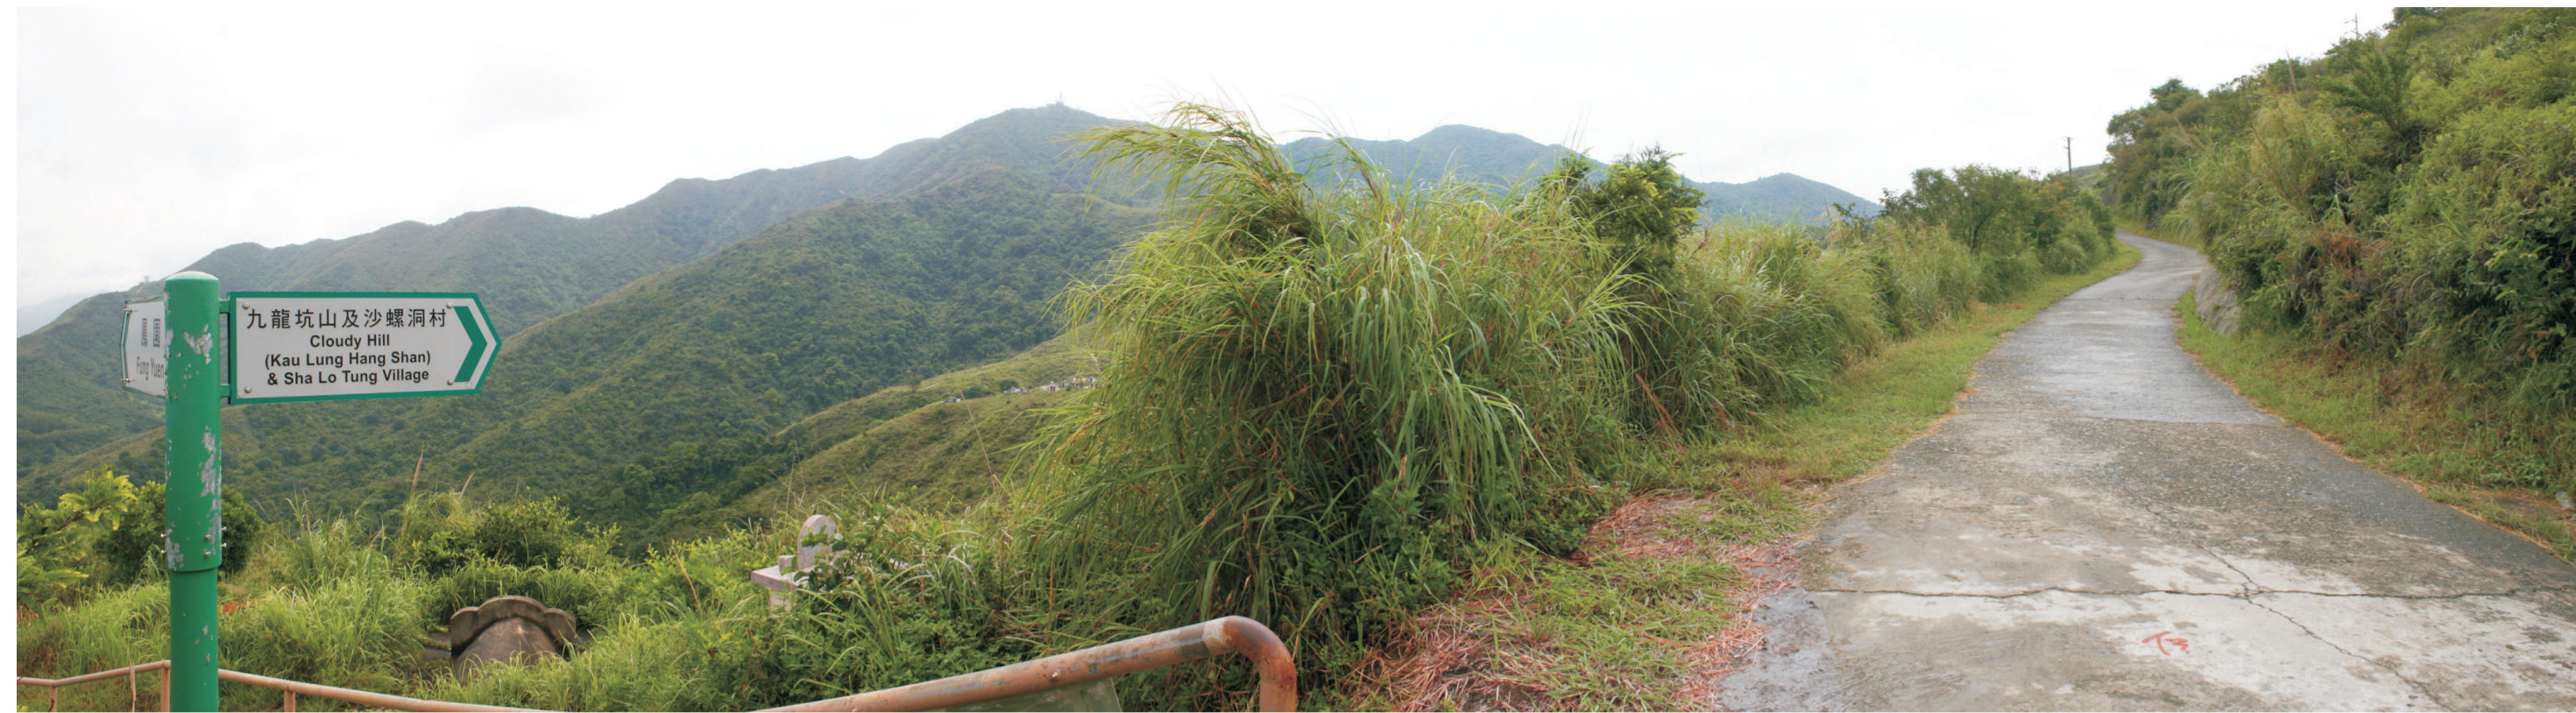
VIEWPOINT 9- SHA LO TUNG ROAD AT INTERSECTION WITH FOOTPATH TO FUNG YUEN: EXISTING CONDITIONS AT THE DEVELOPMENT SITE.

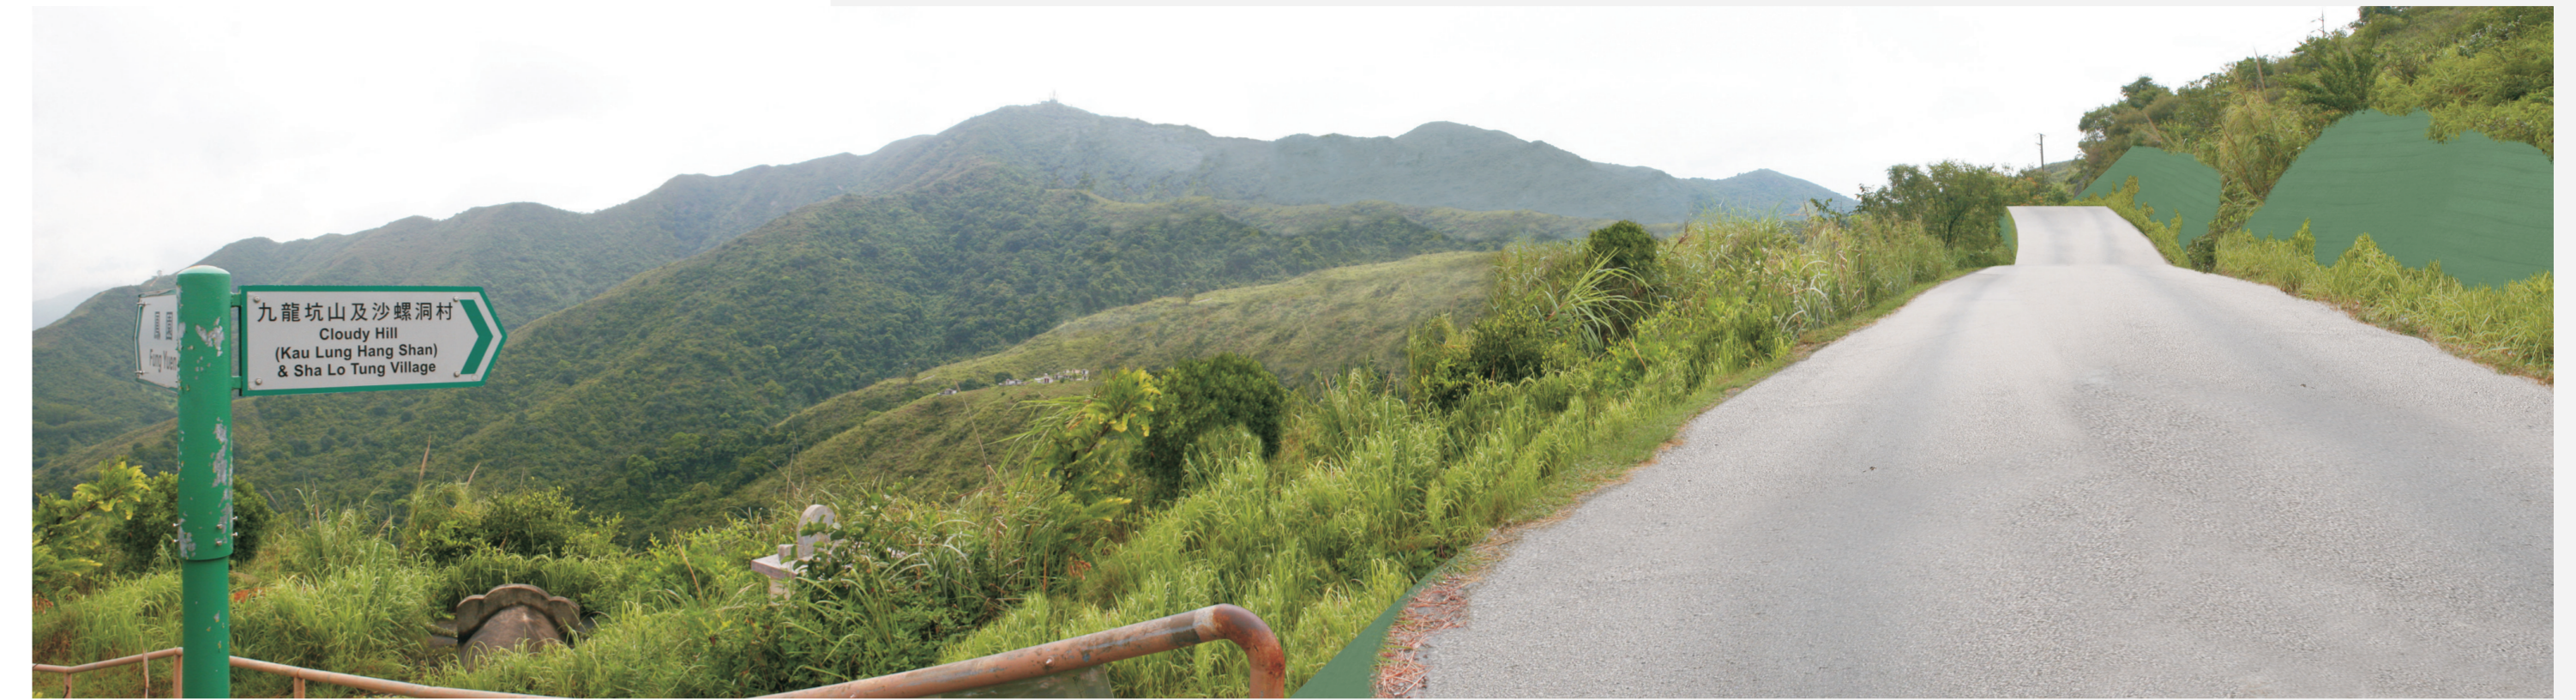
VIEW DISPLAYING THE 3D MODEL OF THE DEVELOPMENT SITE WITH LANDSCAPE MITIGATION AT DAY 1.

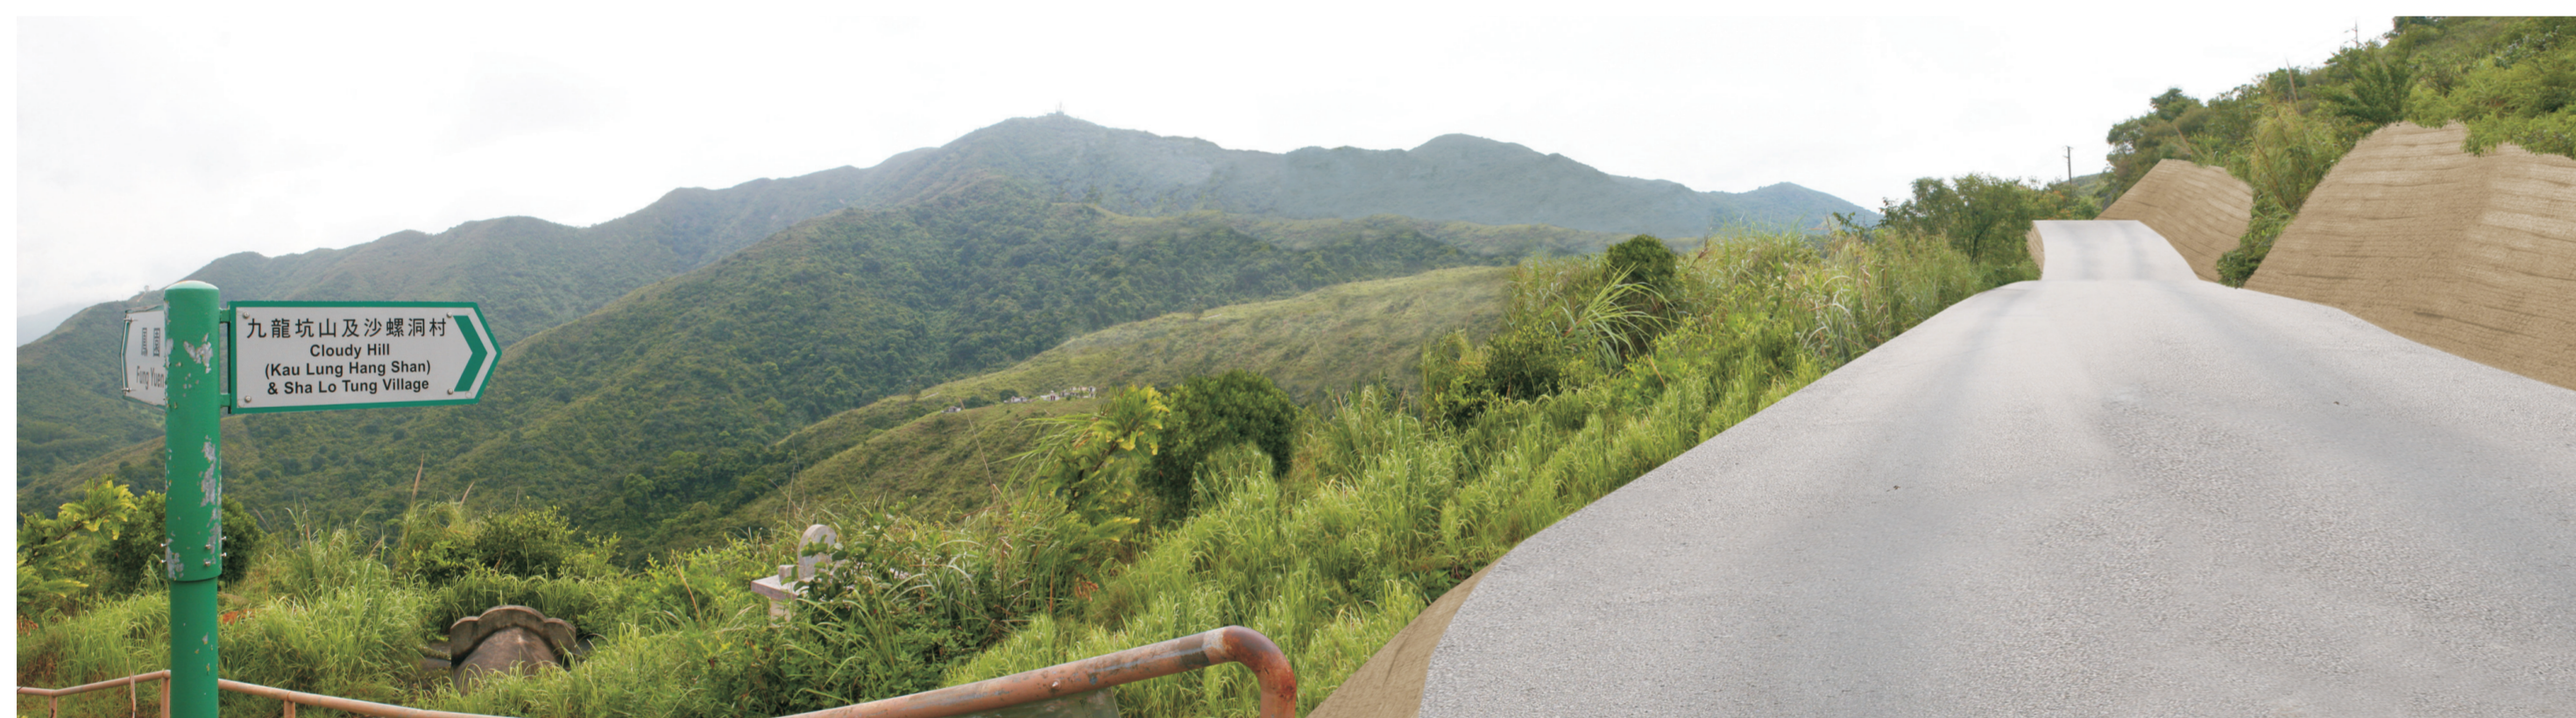
VIEW DISPLAYING THE 3D MODEL OF THE DEVELOPMENT SITE WITHOUT LANDSCAPE MITIGATION (THE DEVELOPMENT IS NOT VISIBLE FROM THIS VIEWPOINT).

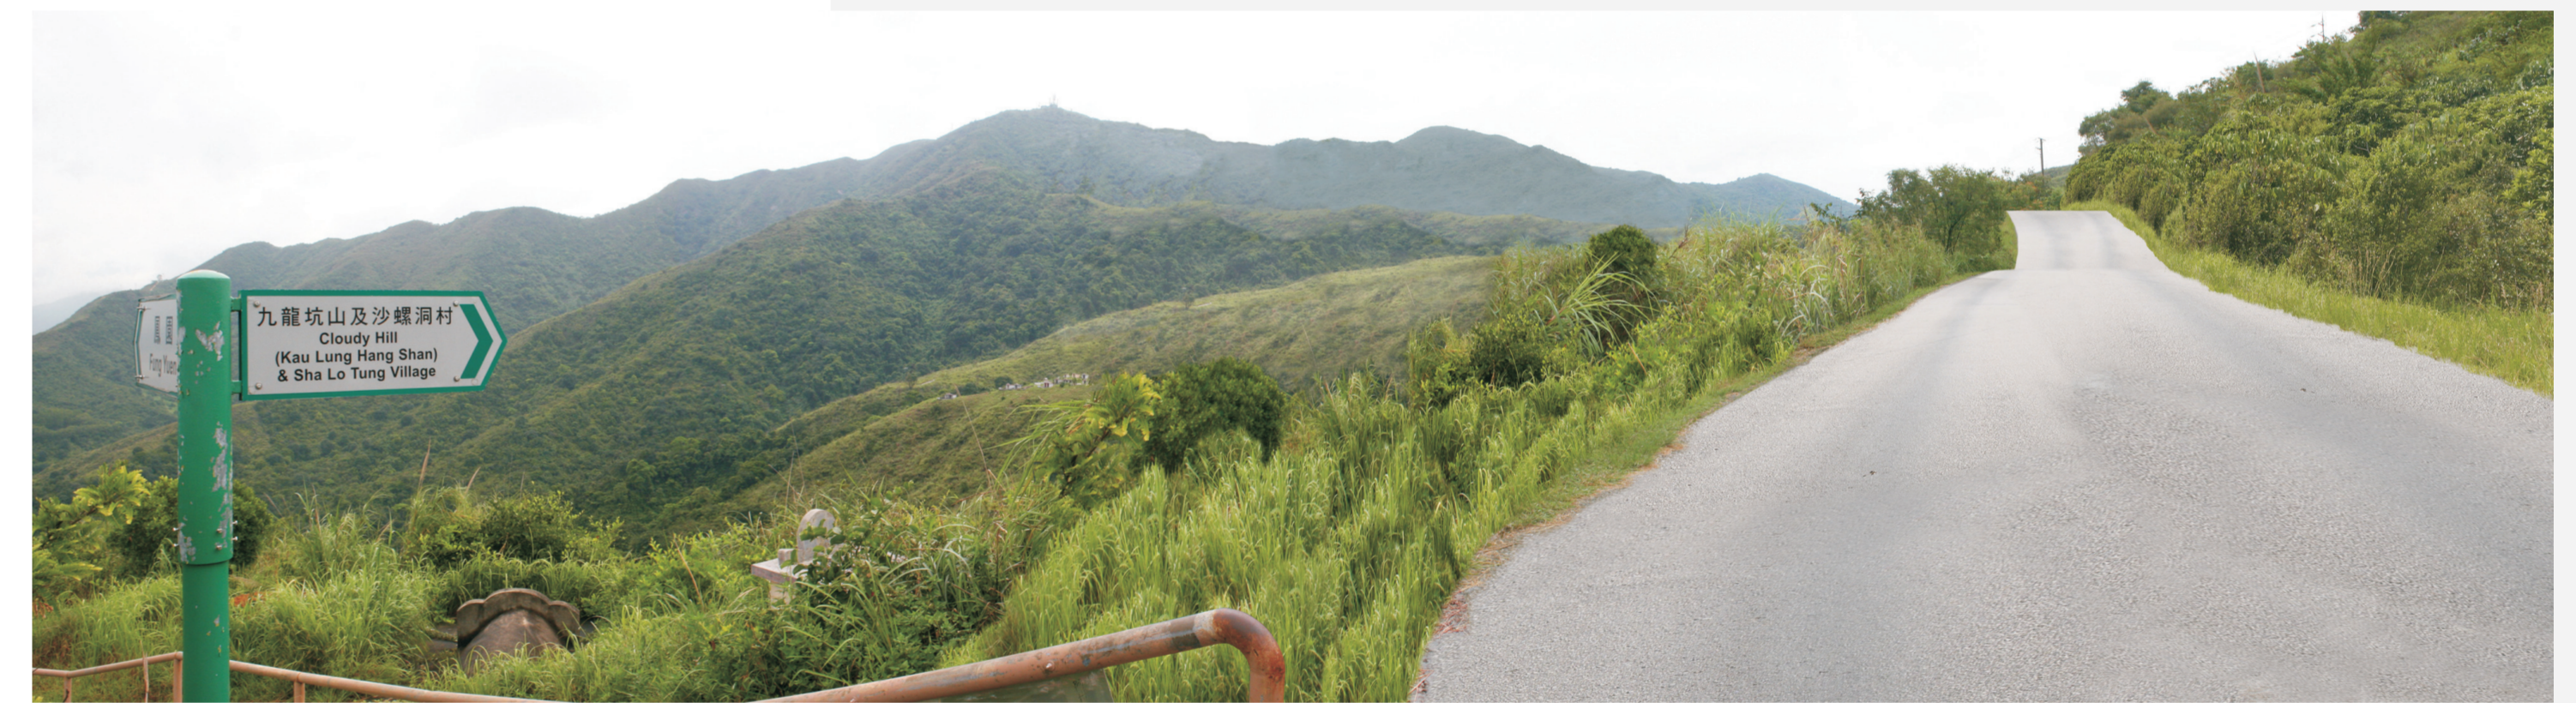
VIEW DISPLAYING THE 3D MODEL OF THE DEVELOPMENT SITE WITH LANDSCAPE MITIGATION AT YEAR 10.
