Figure 1: Study Area for the Marine Archaeological Investigation.

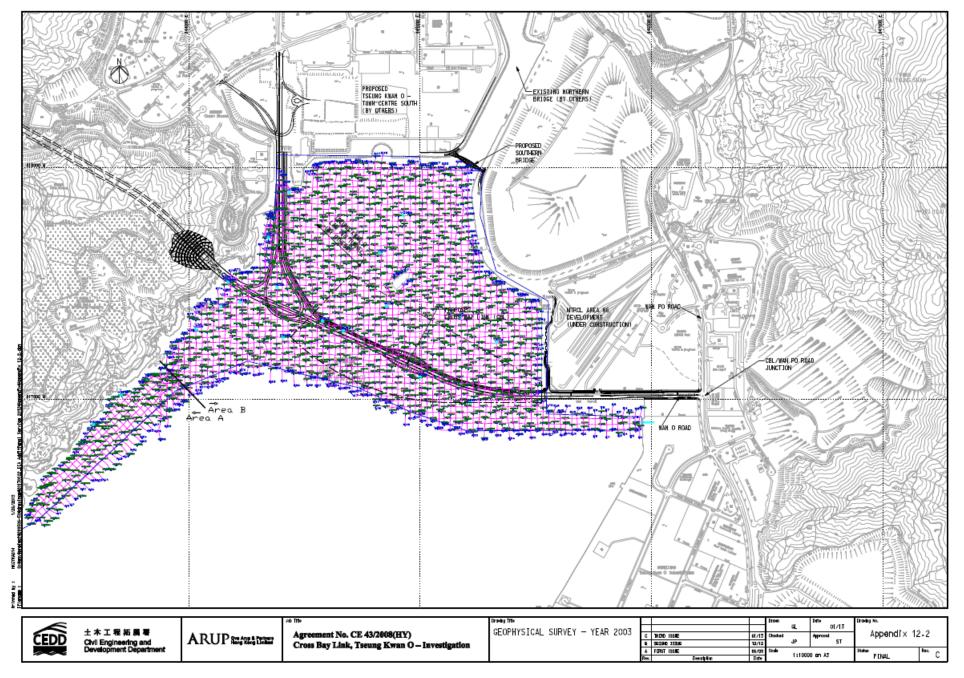
Figure 2: 2003 Geophysical Survey area with current study area overlain to show there is 100% coverage.

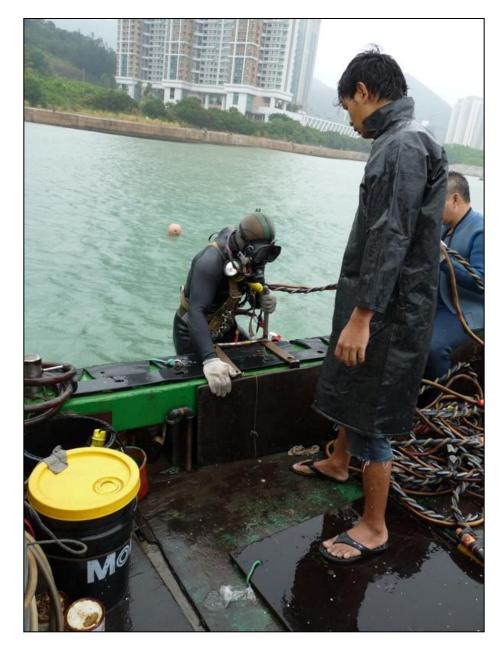
Figure 4: Divers at Tseung Kwan O, using a buoy as the centre point for circular search.

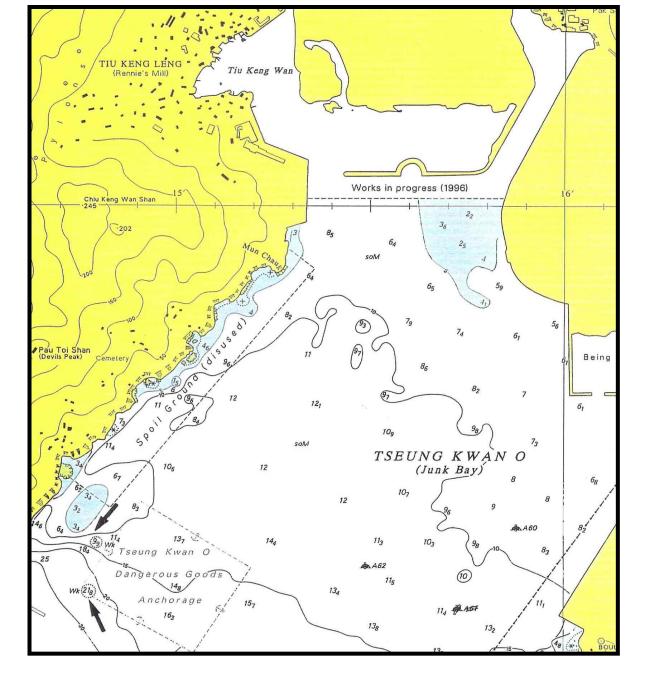
Figure 10: Hydrographic Chart No. 3279 showing two shipwrecks in Tseung Kwan O.

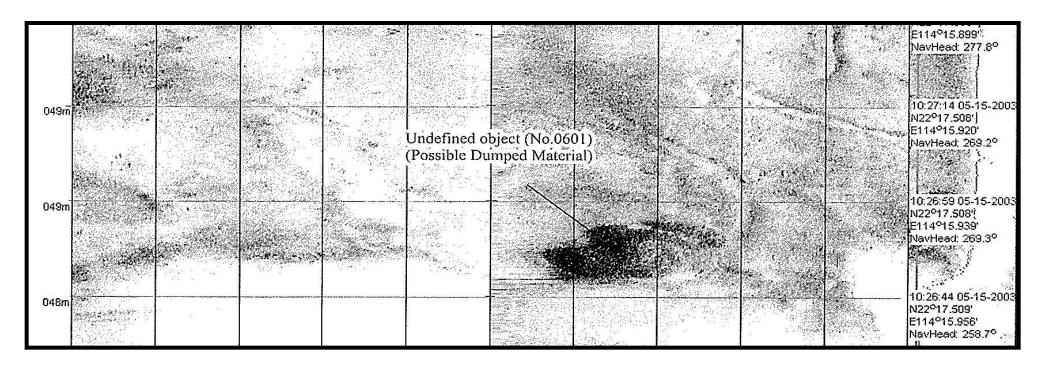
Figure 12: Side Scan Sonar data showing Unidentified Object No. 0601.

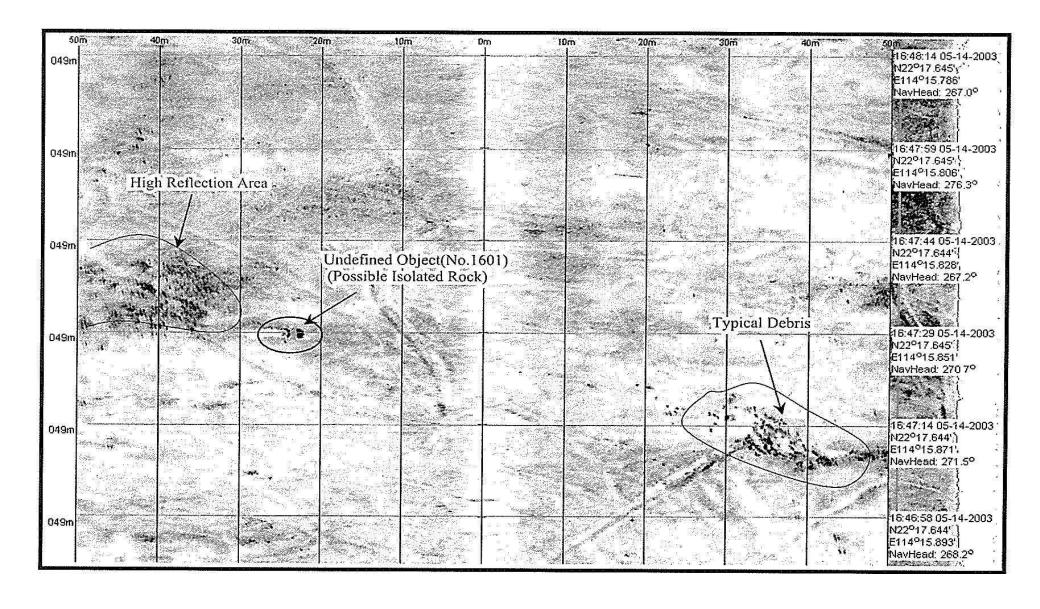
Figure 13: Side Scan Sonar data showing Unidentified Object No. 1601.

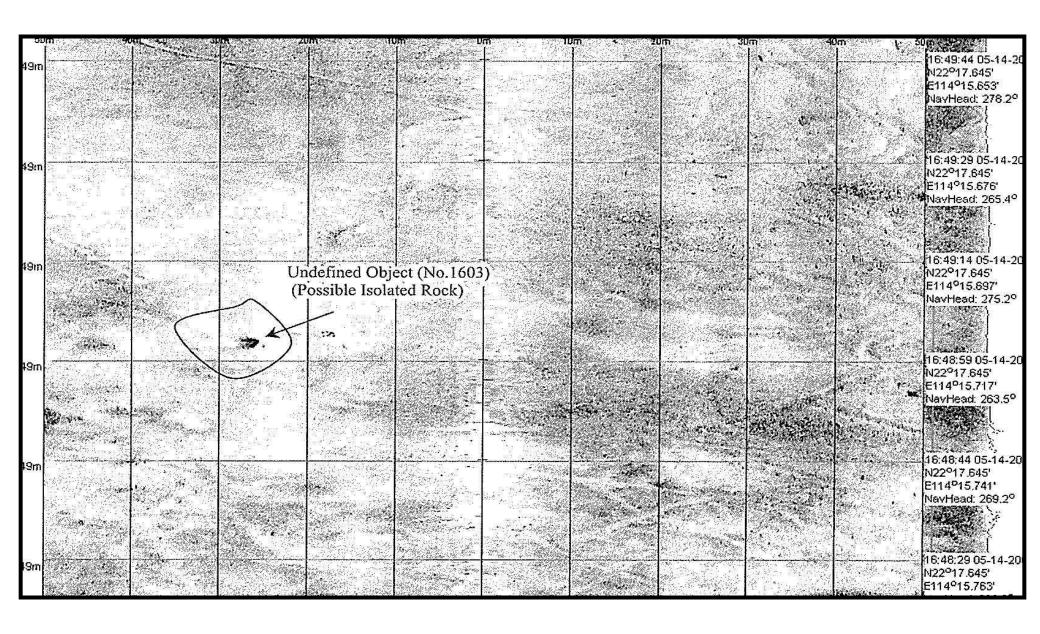
Figure 14: Side Scan Sonar data showing Unidentified Object No. 1603.

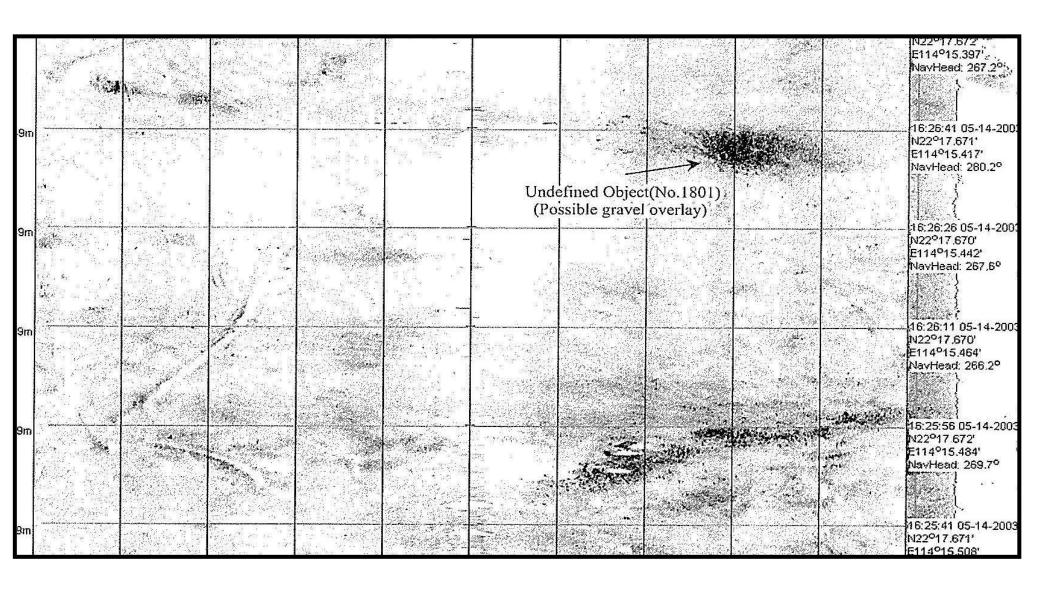
Figure 15: Side Scan Sonar data showing Unidentified Object No. 1801.

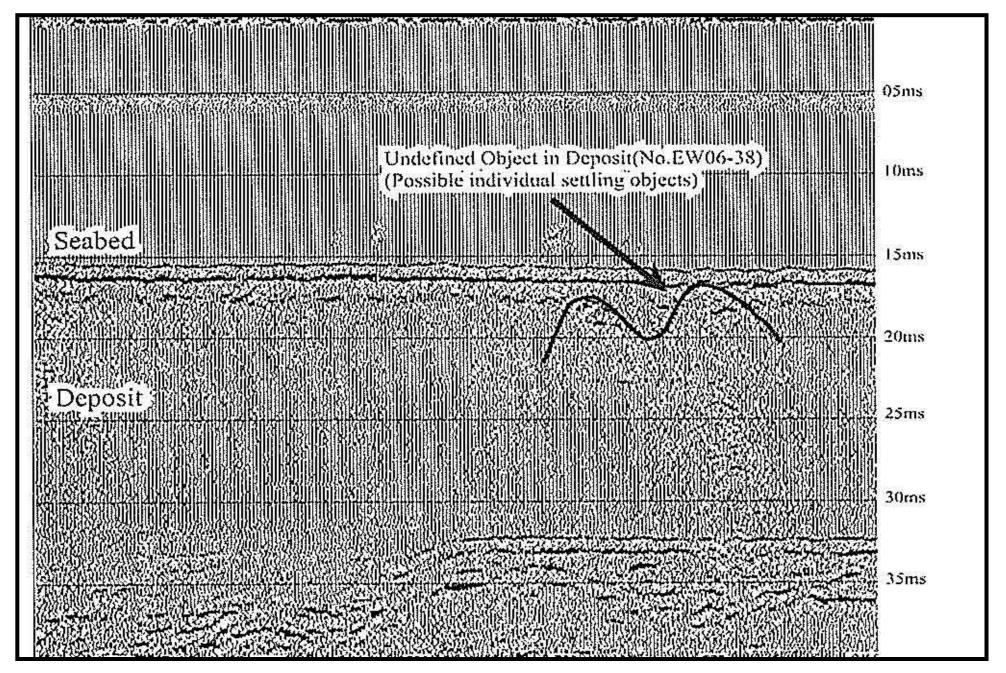
Figure 16: Seismic Profiler data showing Unidentified Object No. EW06-38.

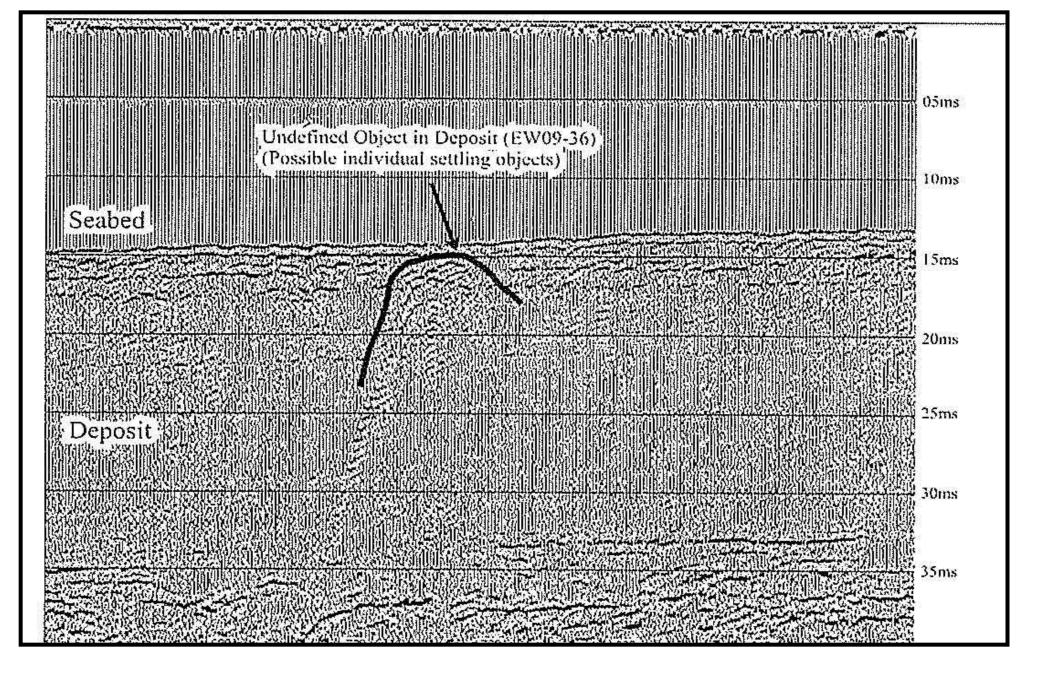
Figure 17: Seismic Profiler data showing Unidentified Object No. EW09-36.

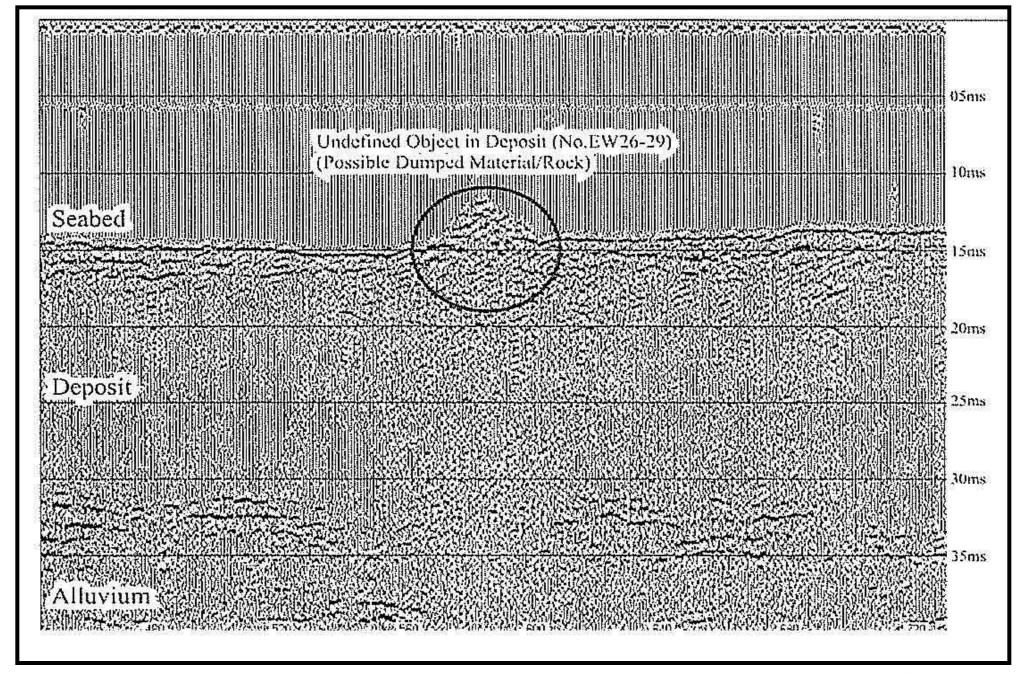
Figure 18: Seismic Profiler data showing Unidentified Object No. EW26-29.

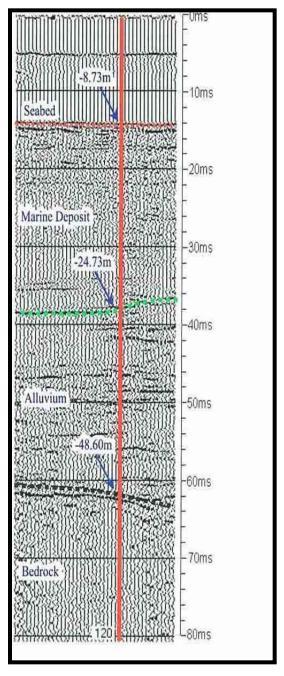
Figure 19: Seabed Stratigraphy in the Study Area.

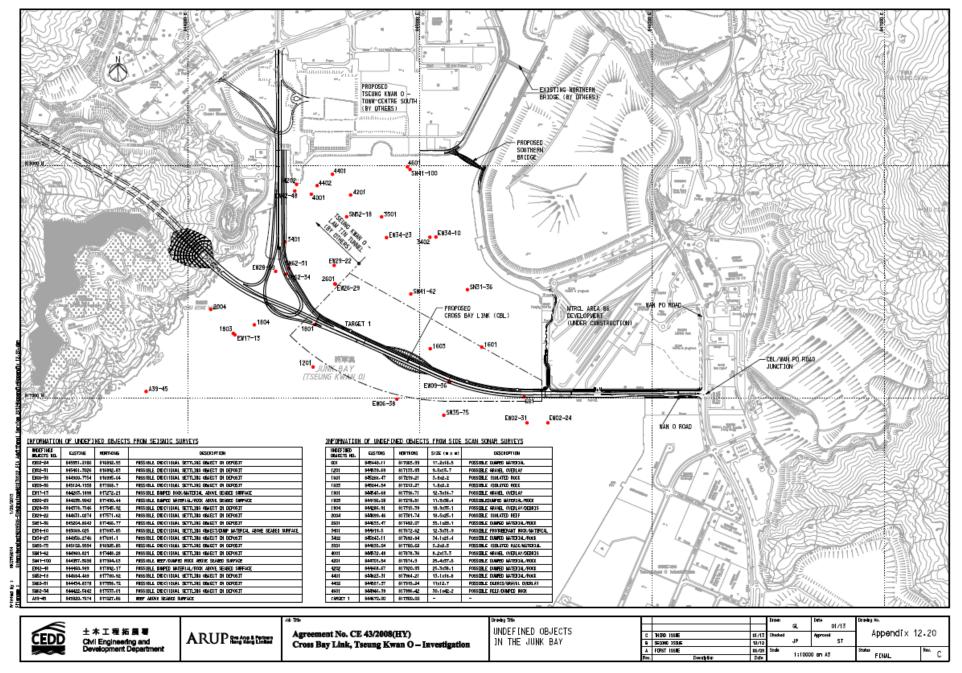
Figure 20: Distribution of Unidentified Objects across the Study Area.
