潛在受污染區域 A
 Location of Potentially Contaminated Site A

Project: CAP Programme

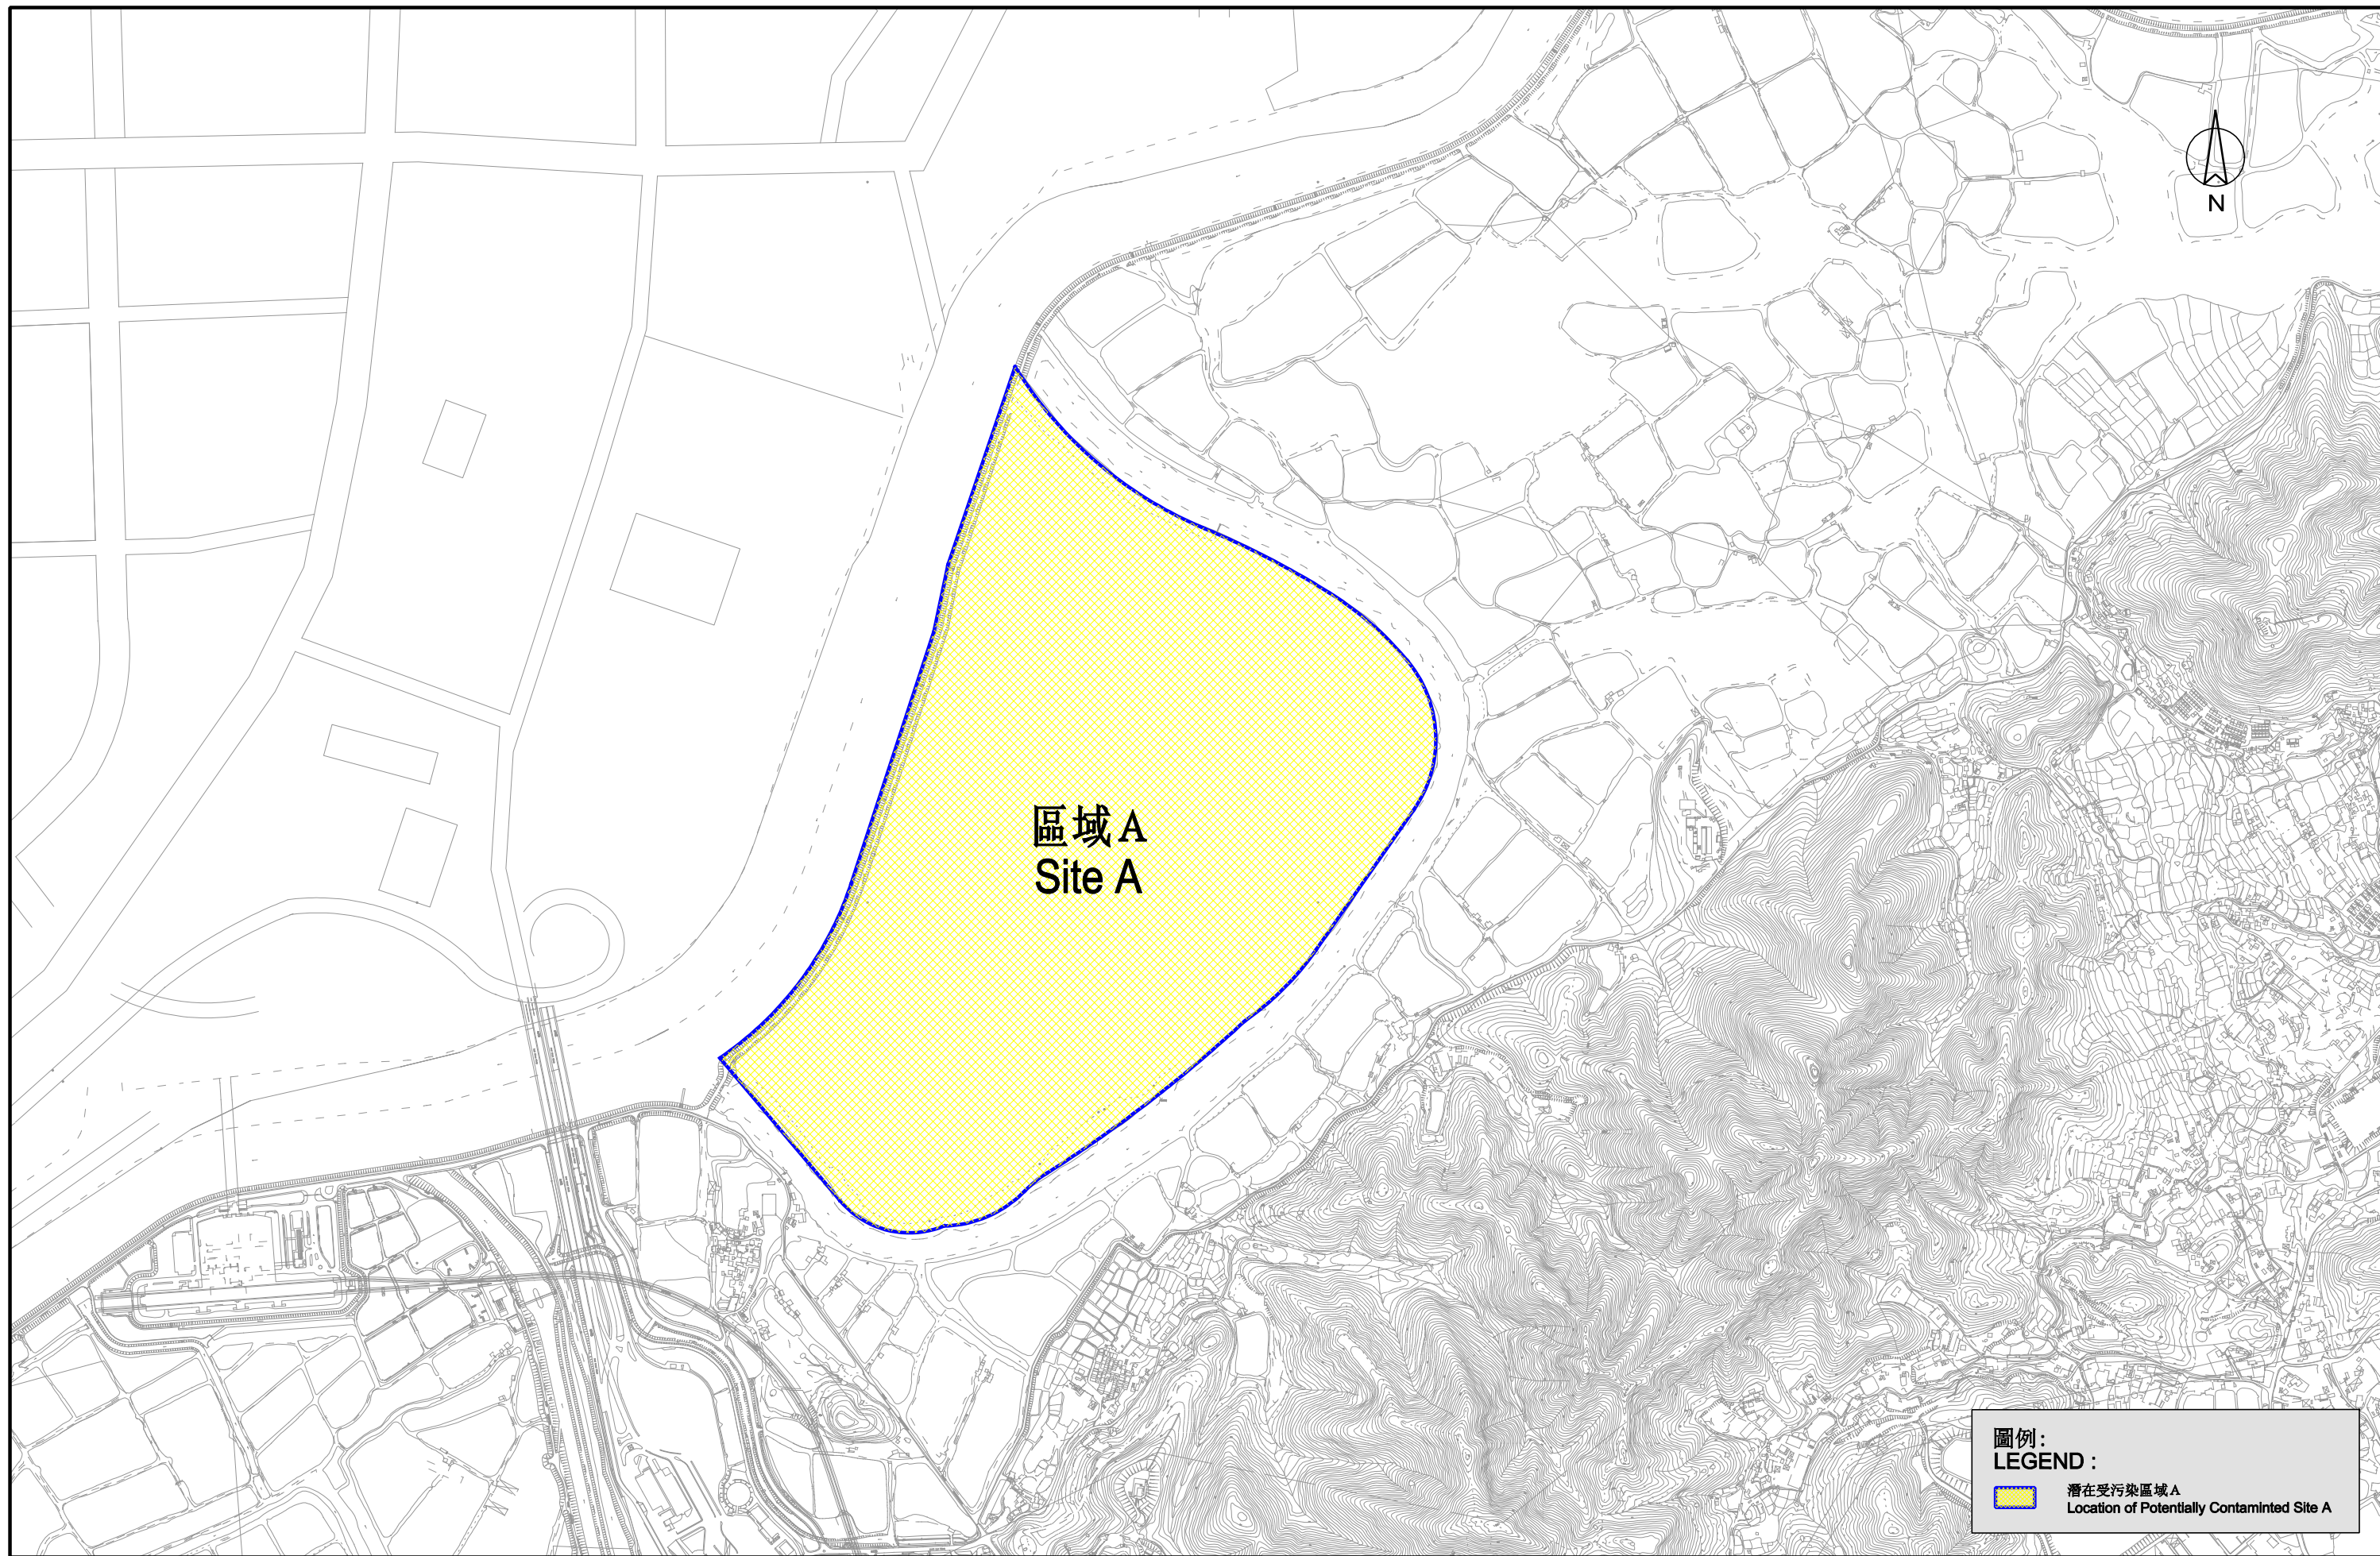
探井類型 Type of Borehole	探井編號 Boreholes ID	坐標 Coordinates	
		東距 Easting	北距 Northing
土壤樣本 Soil Sampling Only	A-S01	826297	842935
	A-S02	826457	842866
	A-S03	826627	842800
	A-S04	826089	842857
	A-S05	826256	842804
	A-S06	826592	842698
	A-S07	826203	842637
	A-S08	826370	842583
	A-S09	826538	842530
	A-S10	826706	842476
	A-S11	825981	842522
	A-S12	826149	842469
	A-S13	826485	842361
	A-S14	846094	842301
	A-S15	826263	842248
	A-S16	826431	842194
	A-S17	826551	842192
	A-S18	825875	842187
	A-S19	826042	842133
	A-S20	826341	842035
	A-S21	825696	842043
	A-S22	825989	841966
	A-S23	826156	841912
	A-S24	825822	841887
	A-S25	825944	841825
土壤及地下水樣本 Soil and Groundwater Sampling	A-SG01	826142	843025
	A-SG02	826423	842751
	A-SG03	826738	842631
	A-SG04	826035	842690
	A-SG05	826317	842415
	A-SG06	826622	842323
	A-SG07	825928	842354
	A-SG08	826210	842080
	A-SG09	825821	842019
	A-SG10	826067	841813

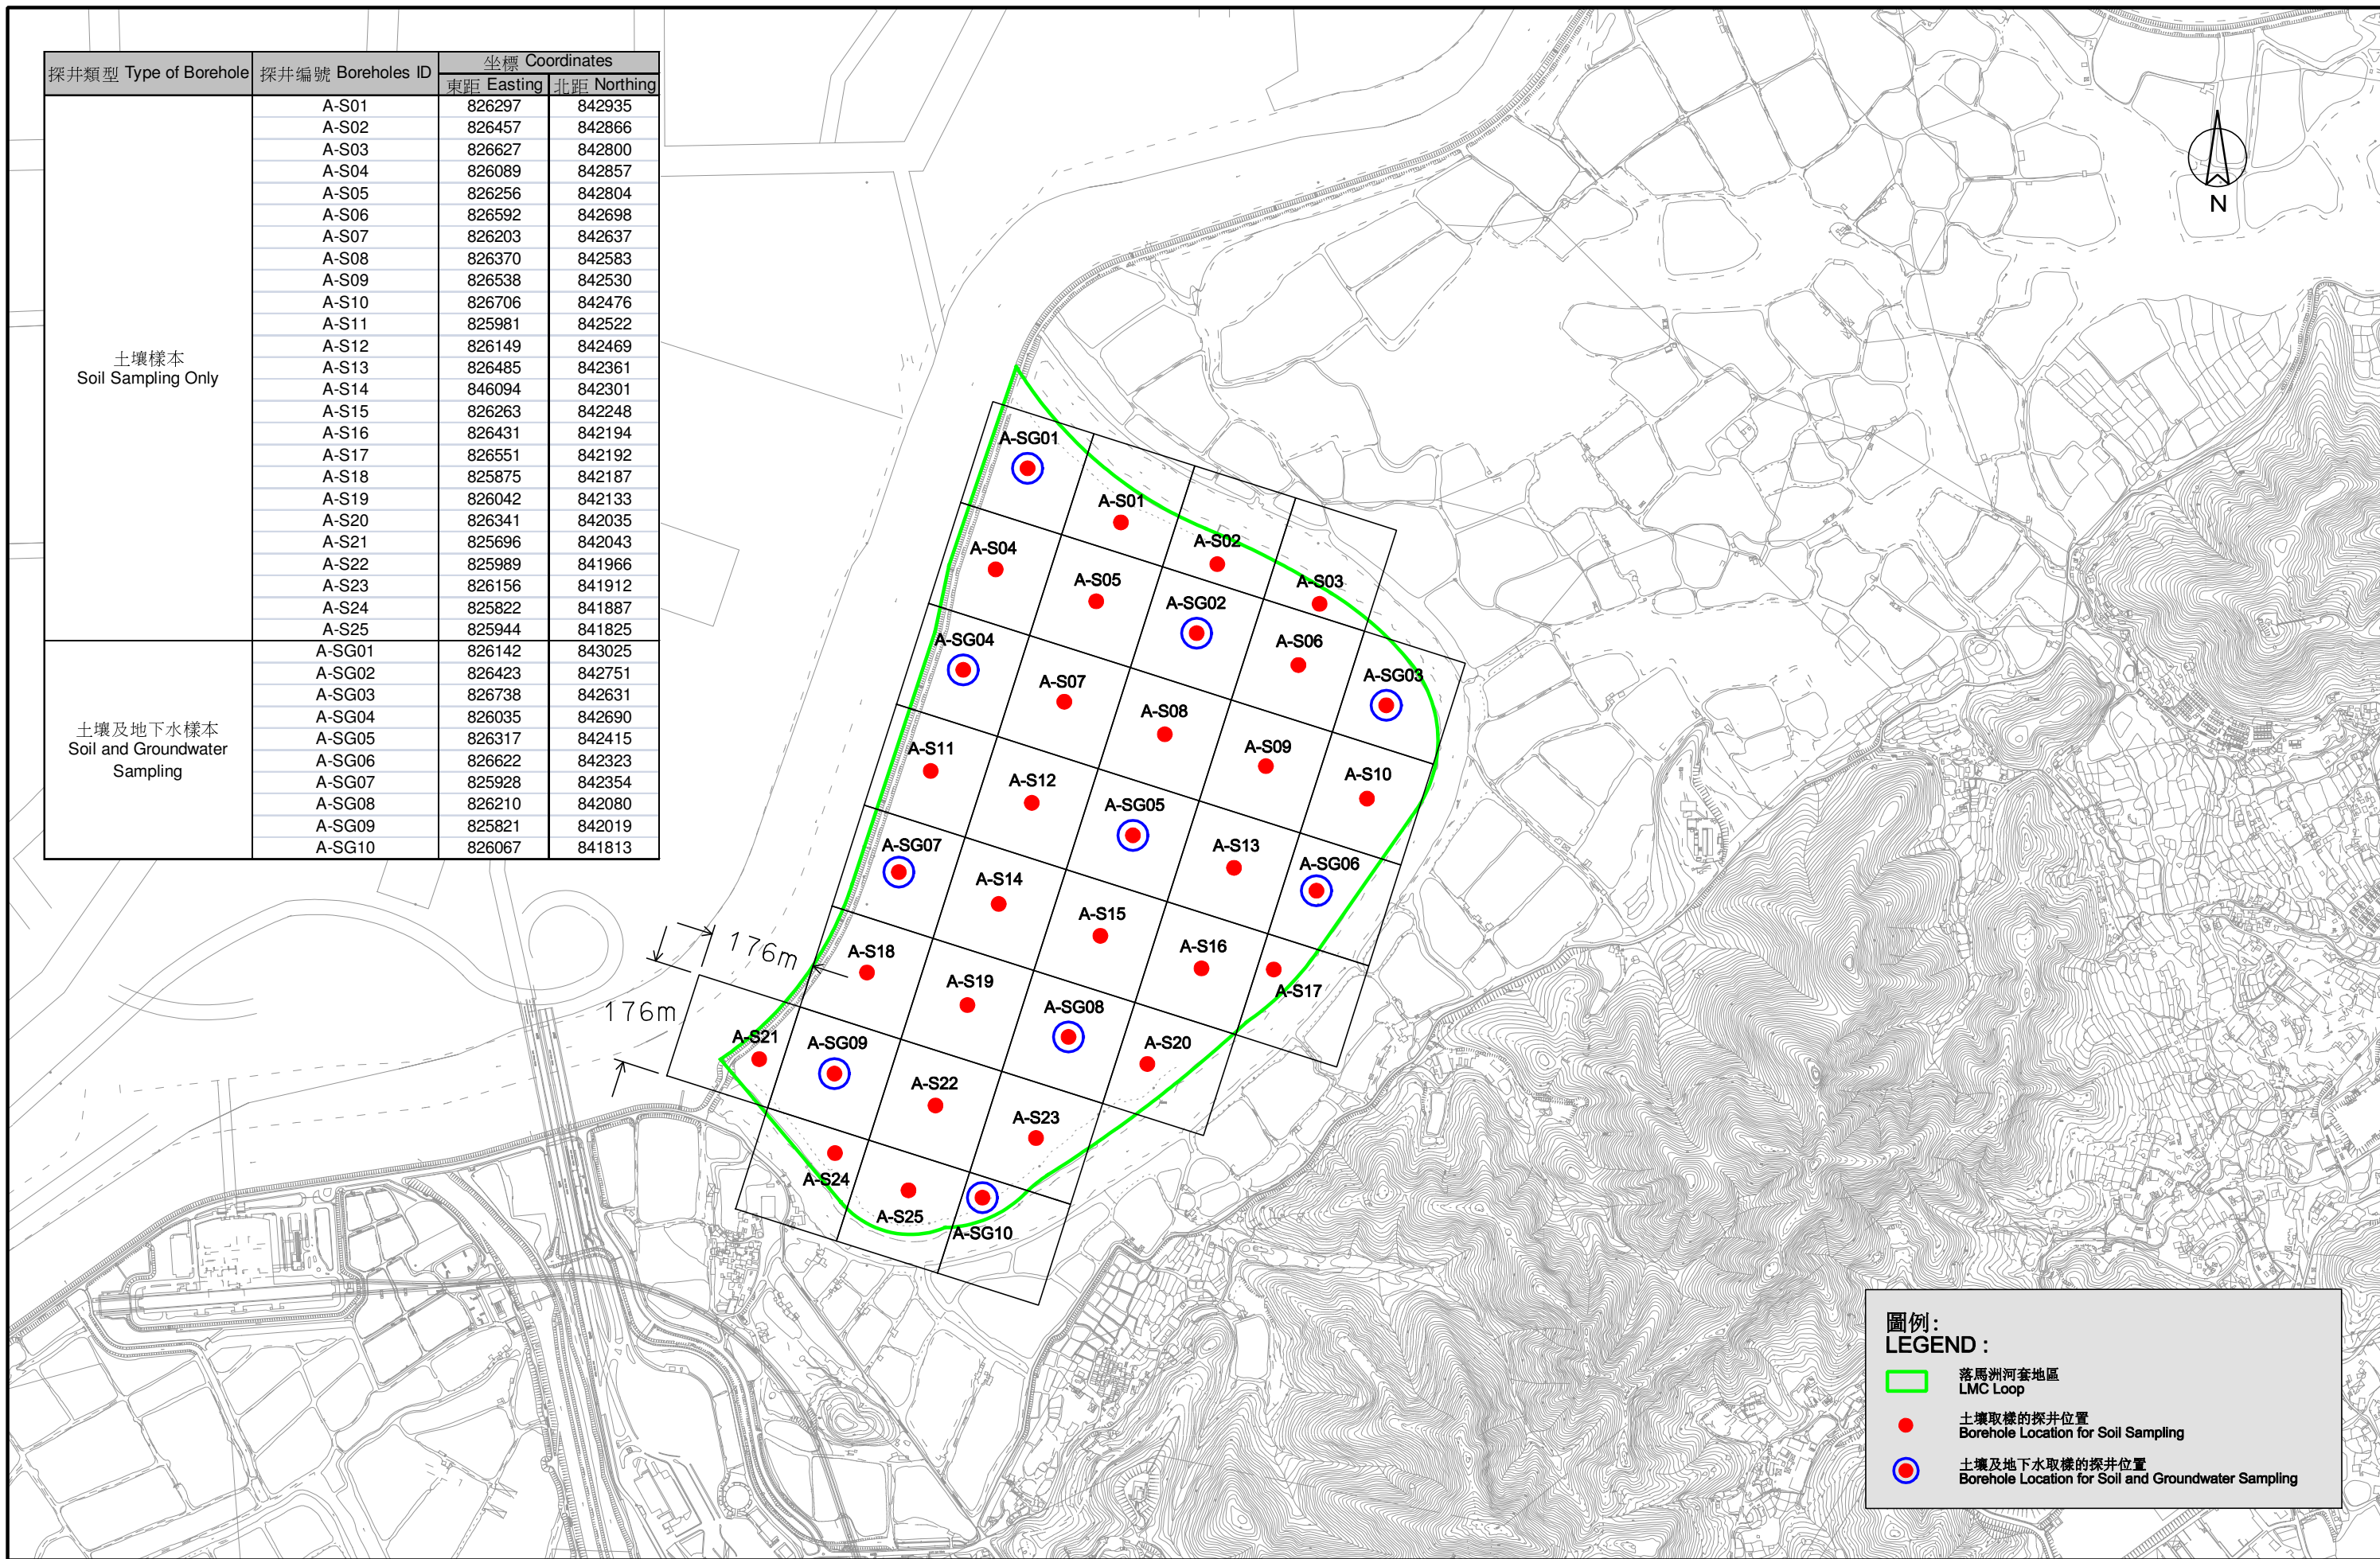
- 落馬洲河套地區
LMC Loop
- 土壤取樣的探井位置
Borehole Location for Soil Sampling
- 土壤及地下水取樣的探井位置
Borehole Location for Soil and Groundwater Sampling

探井位置 Borehole No.	土壤取樣深度(地面以下米數) Depth of Soil Sampling (mbgl)	污染物 Contaminant
A-S01	3.0 – 3.45	砷 Arsenic
	4.5 – 4.95	
A-S03	3.0 – 3.45	砷 Arsenic
A-S20	3.0 – 3.45	砷 Arsenic
A-S24	3.0 – 3.45	砷 Arsenic
A-SG10	4.5 – 4.95	砷 Arsenic

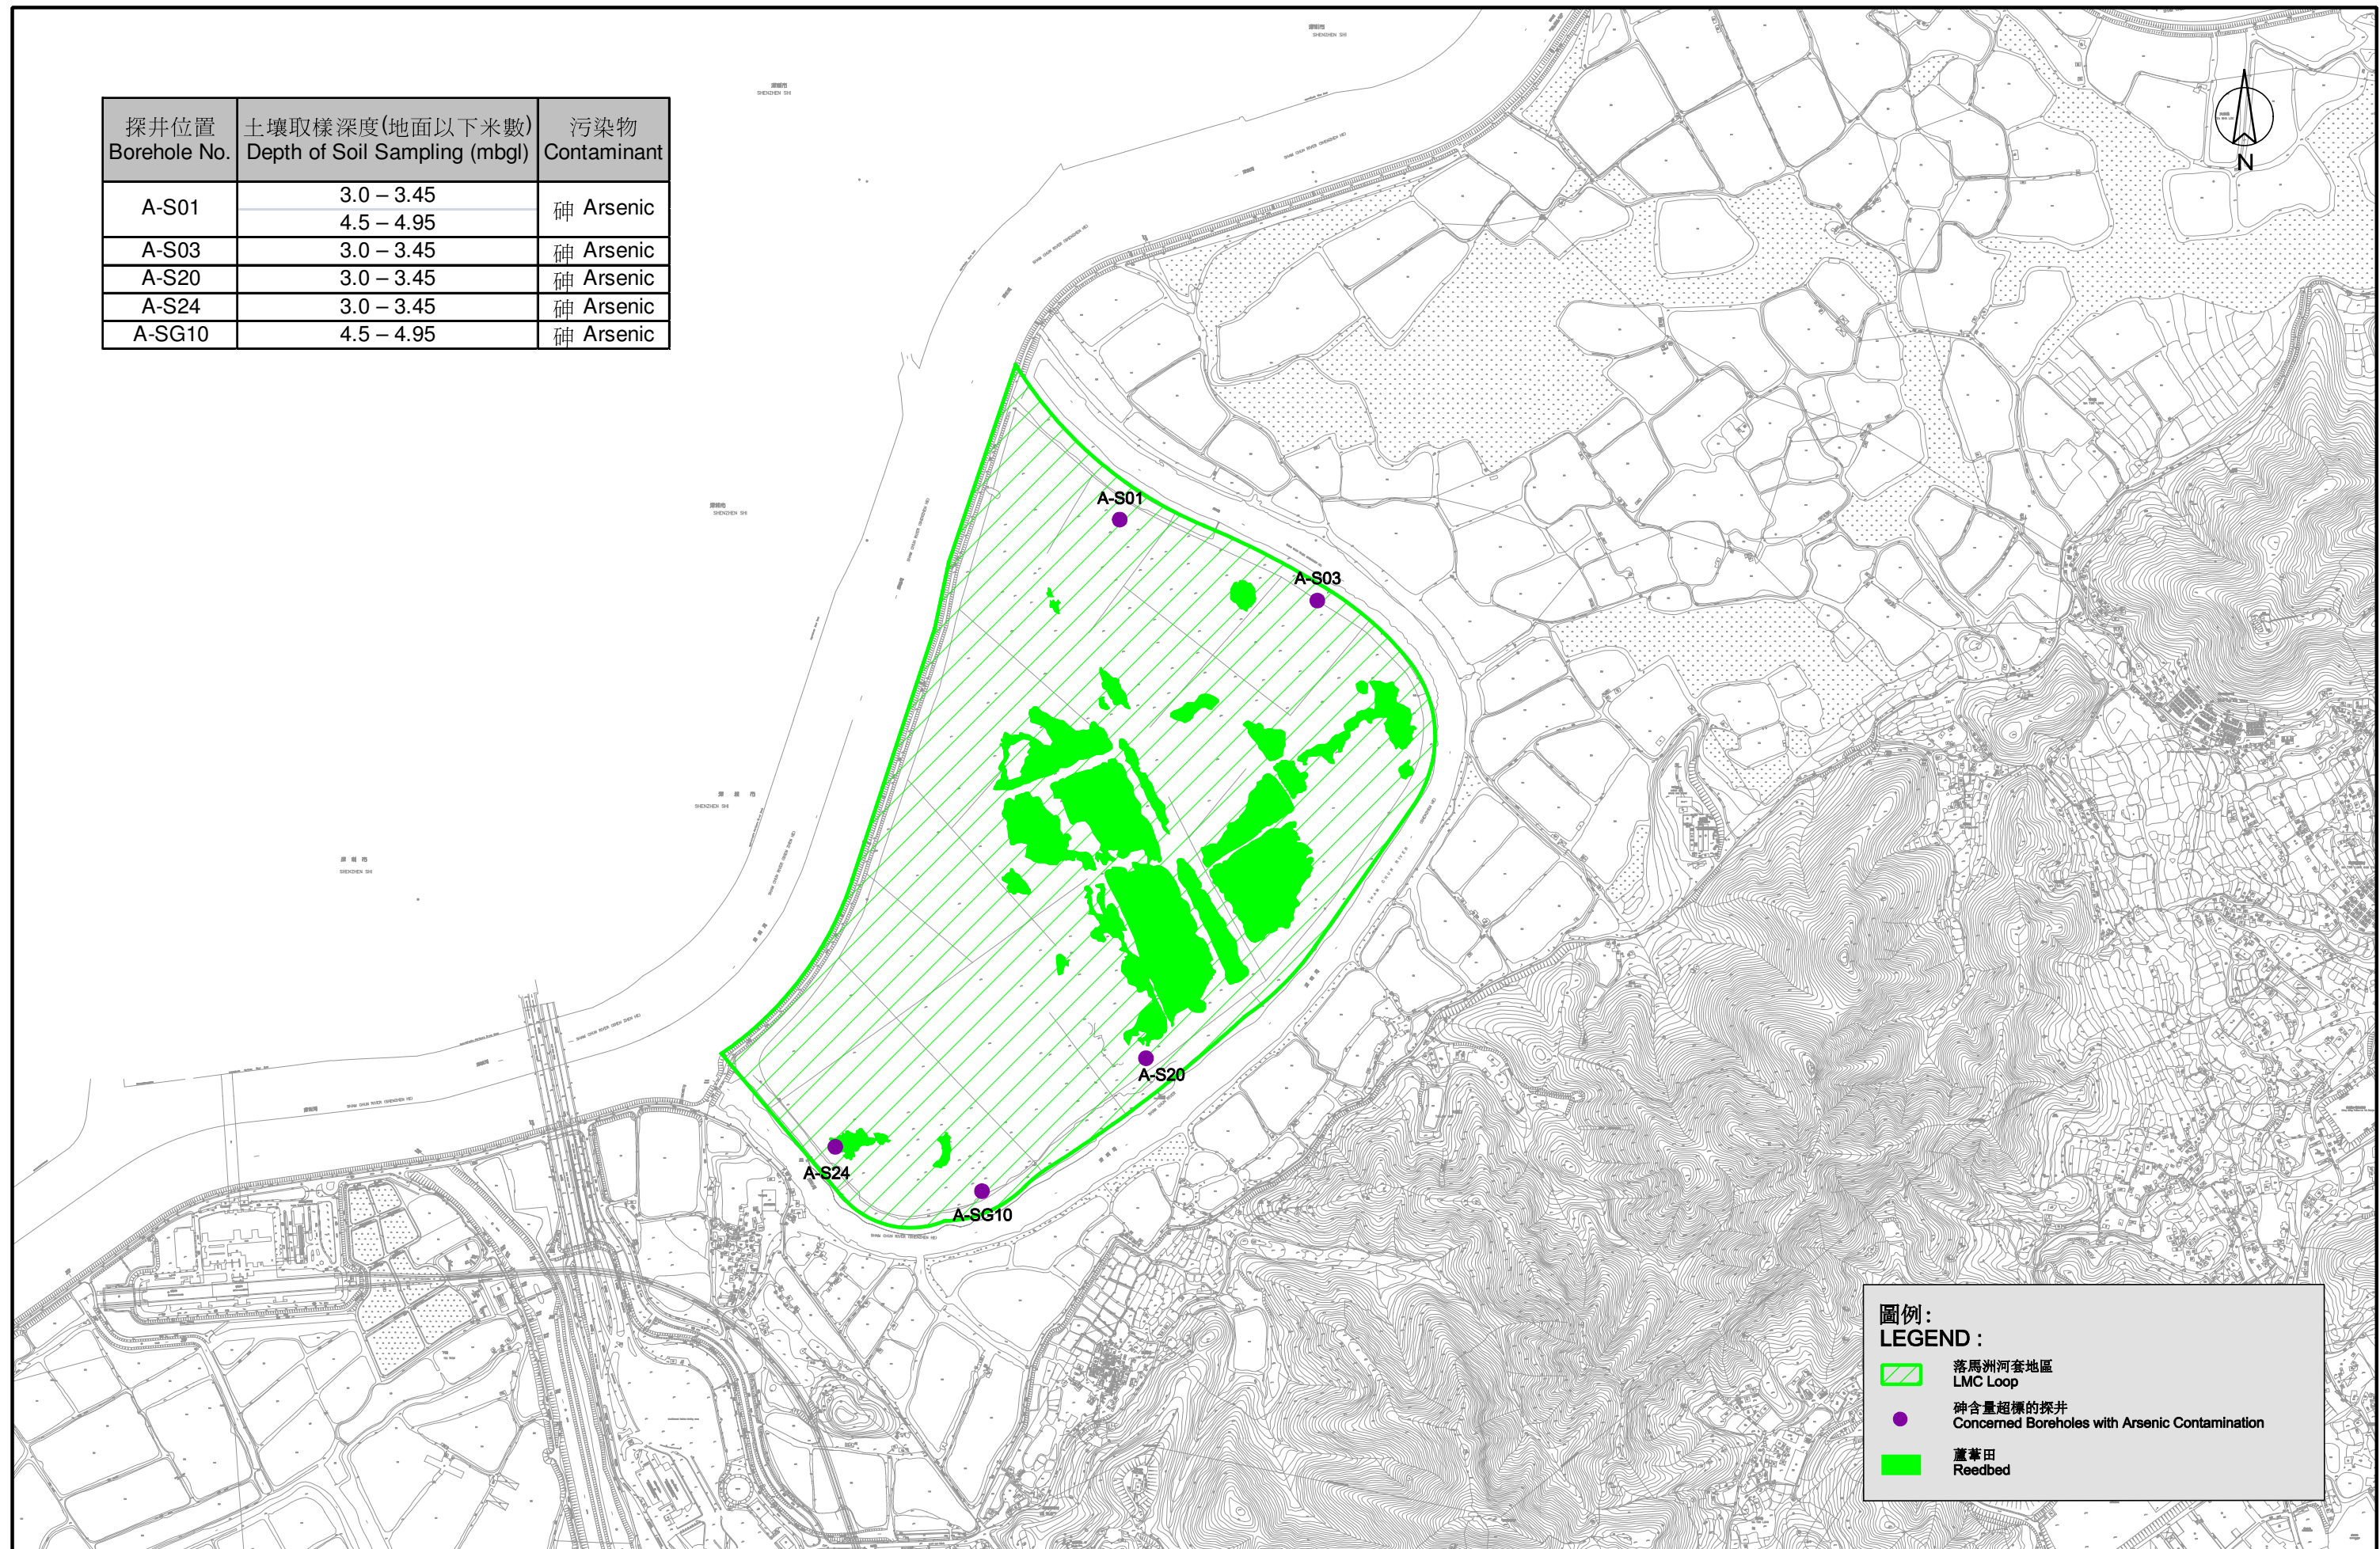
受污染探井 Contaminated Borehole	新增探井編號 Additional Borehole ID	坐標 Coordinates		與受污染探井 之距離(米) Distance from Contaminated Borehole (m)
		東距 Easting	北距 Northing	
A-S01	A-S01a	826220	842980	90
	A-S01b	826276	842869	69
	A-S01c	826377	842900	87
A-S03	A-S03a	826526	842839	91
	A-S03b	826609	842749	54
	A-S03c	826683	842715	102
A-S20	A-S20a	826261	841982	96
	A-S20b	826293	842137	112
	A-S20c	826399	842092	82
A-S24	A-S24a	825825	841950	63
	A-S24b	825906	841927	92
	A-S24c	825883	841856	68
A-SG10	A-SG10a	826006	841819	62
	A-SG10b	826028	841890	86
	A-SG10c	826112	841863	67

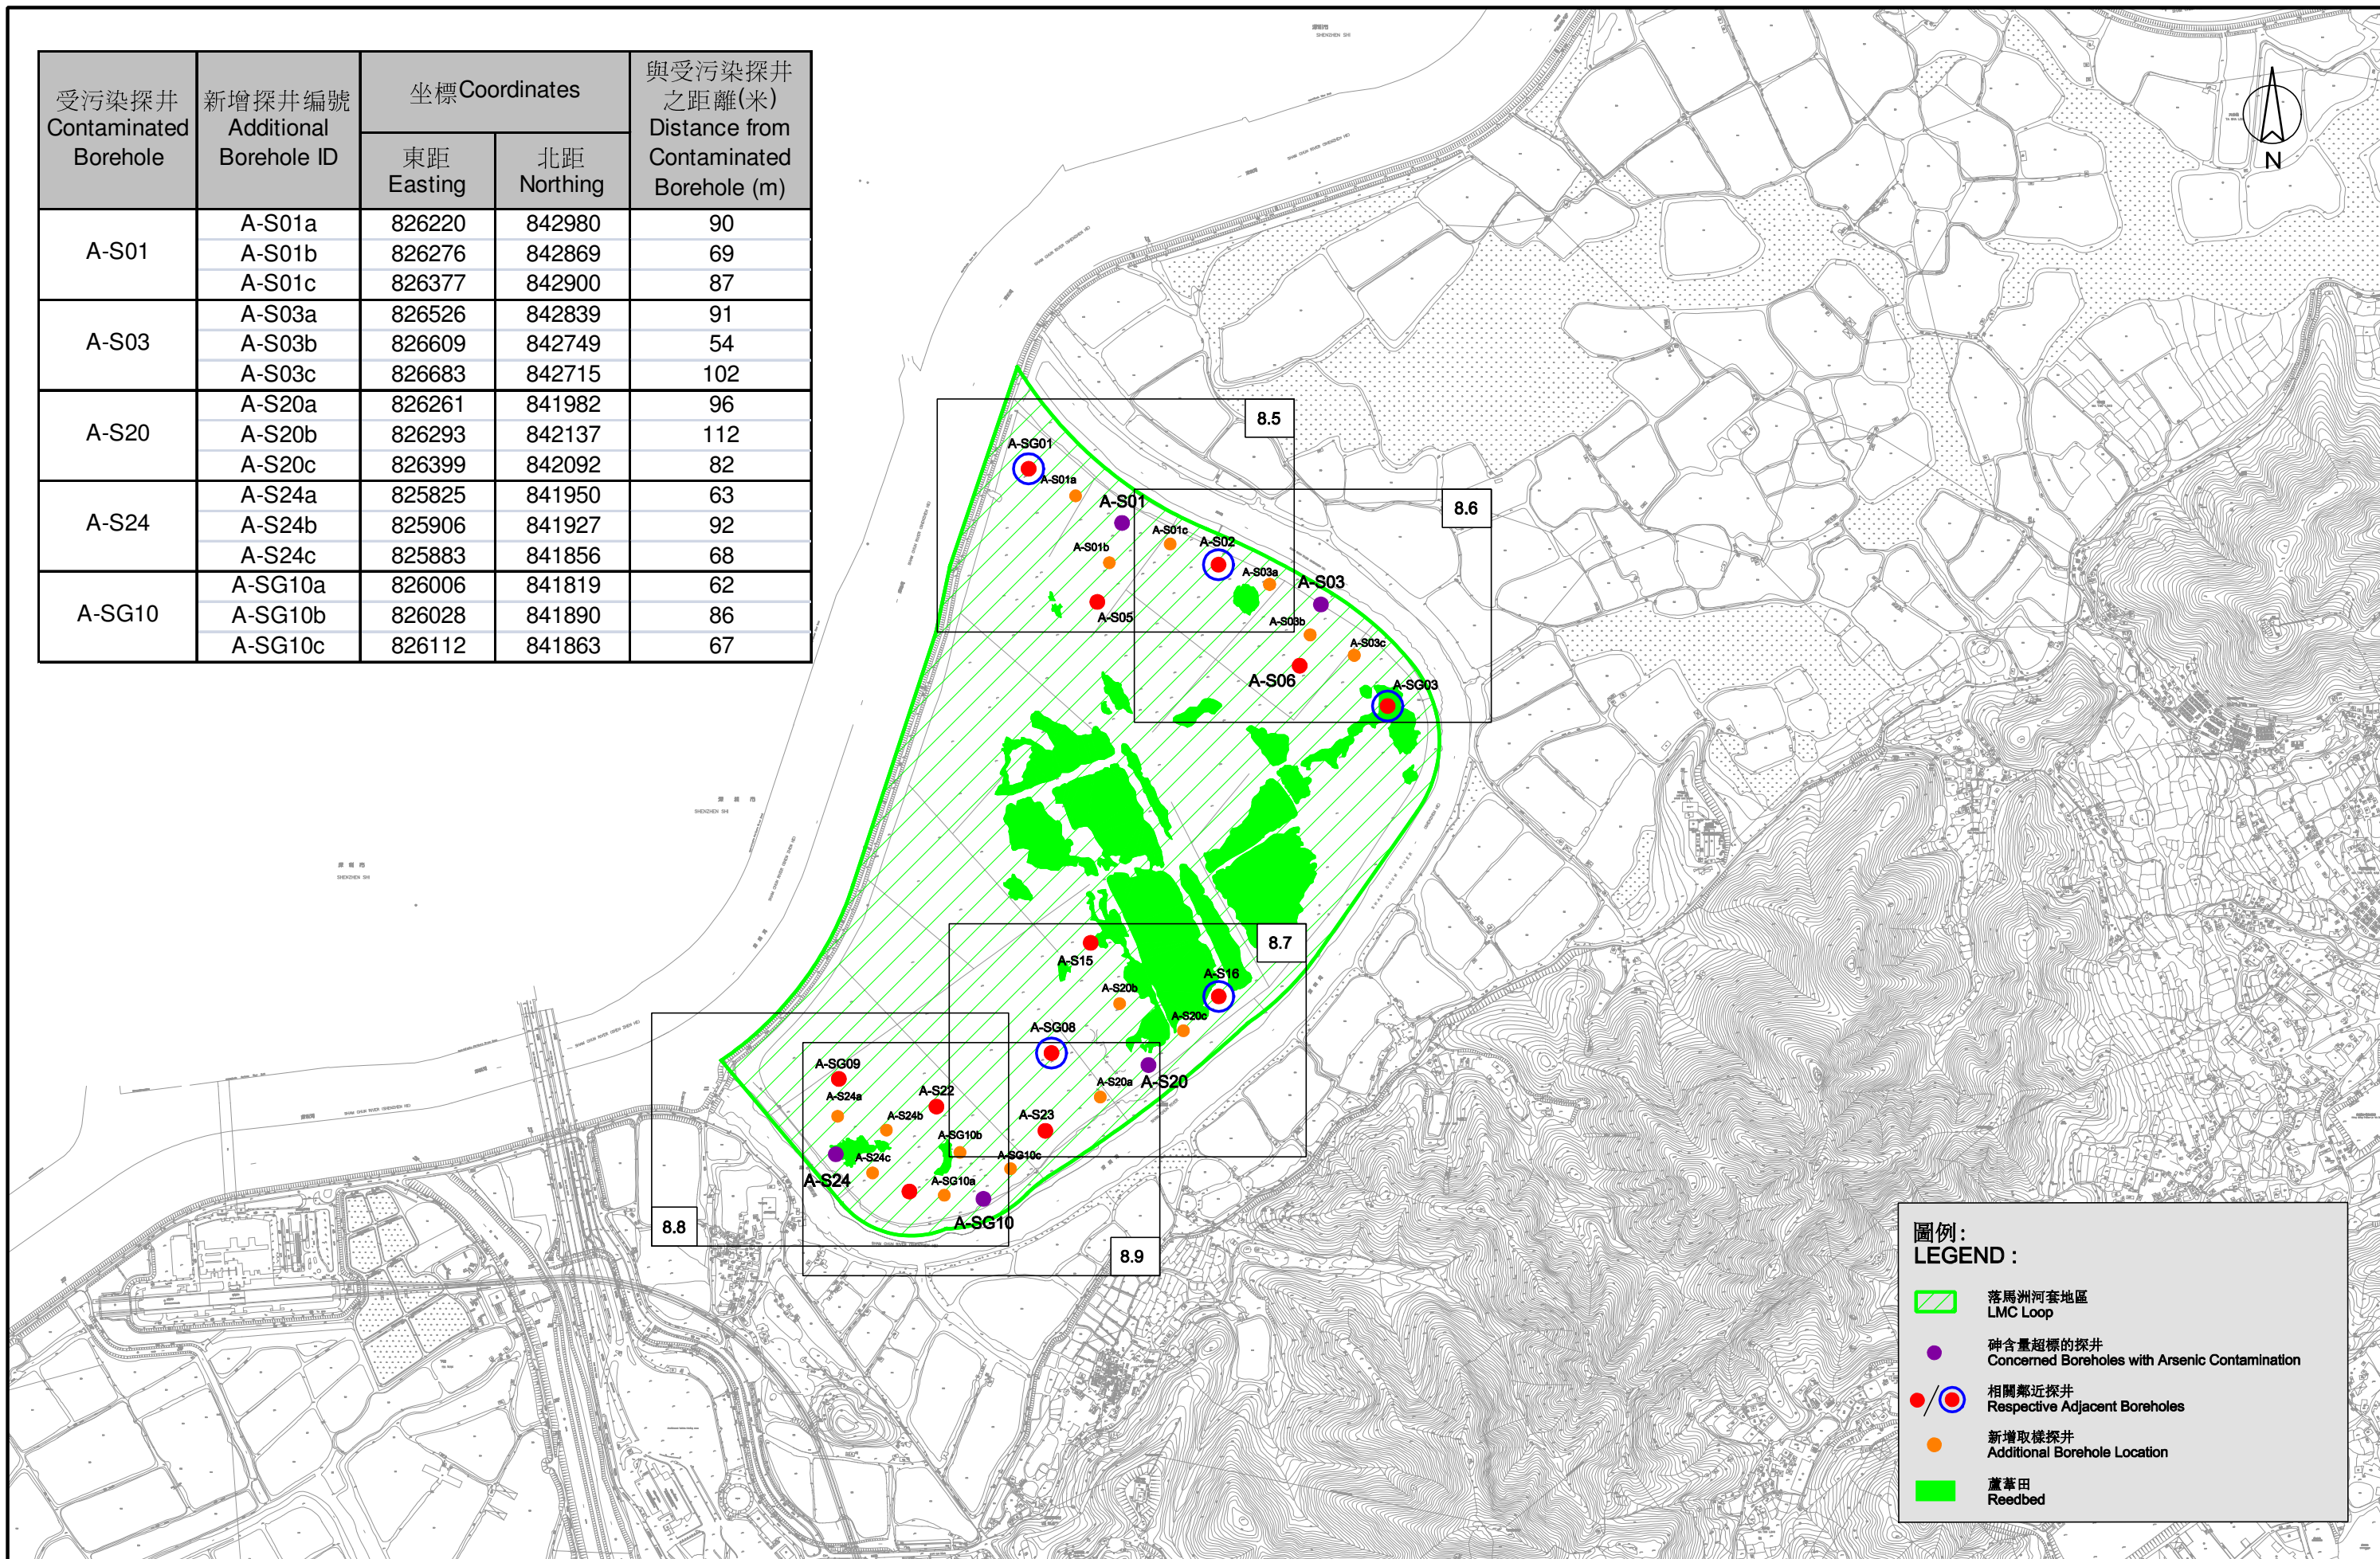
受污染探井 Contaminated Borehole	新增探井編號 Additional Borehole ID	坐標 Coordinates		與受污染探井 之距離(米) Distance from Contaminated Borehole (m)
		東距 Easting	北距 Northing	
A-S01	A-S01a	826220	842980	90
	A-S01b	826276	842869	69
	A-S01c	826377	842900	87

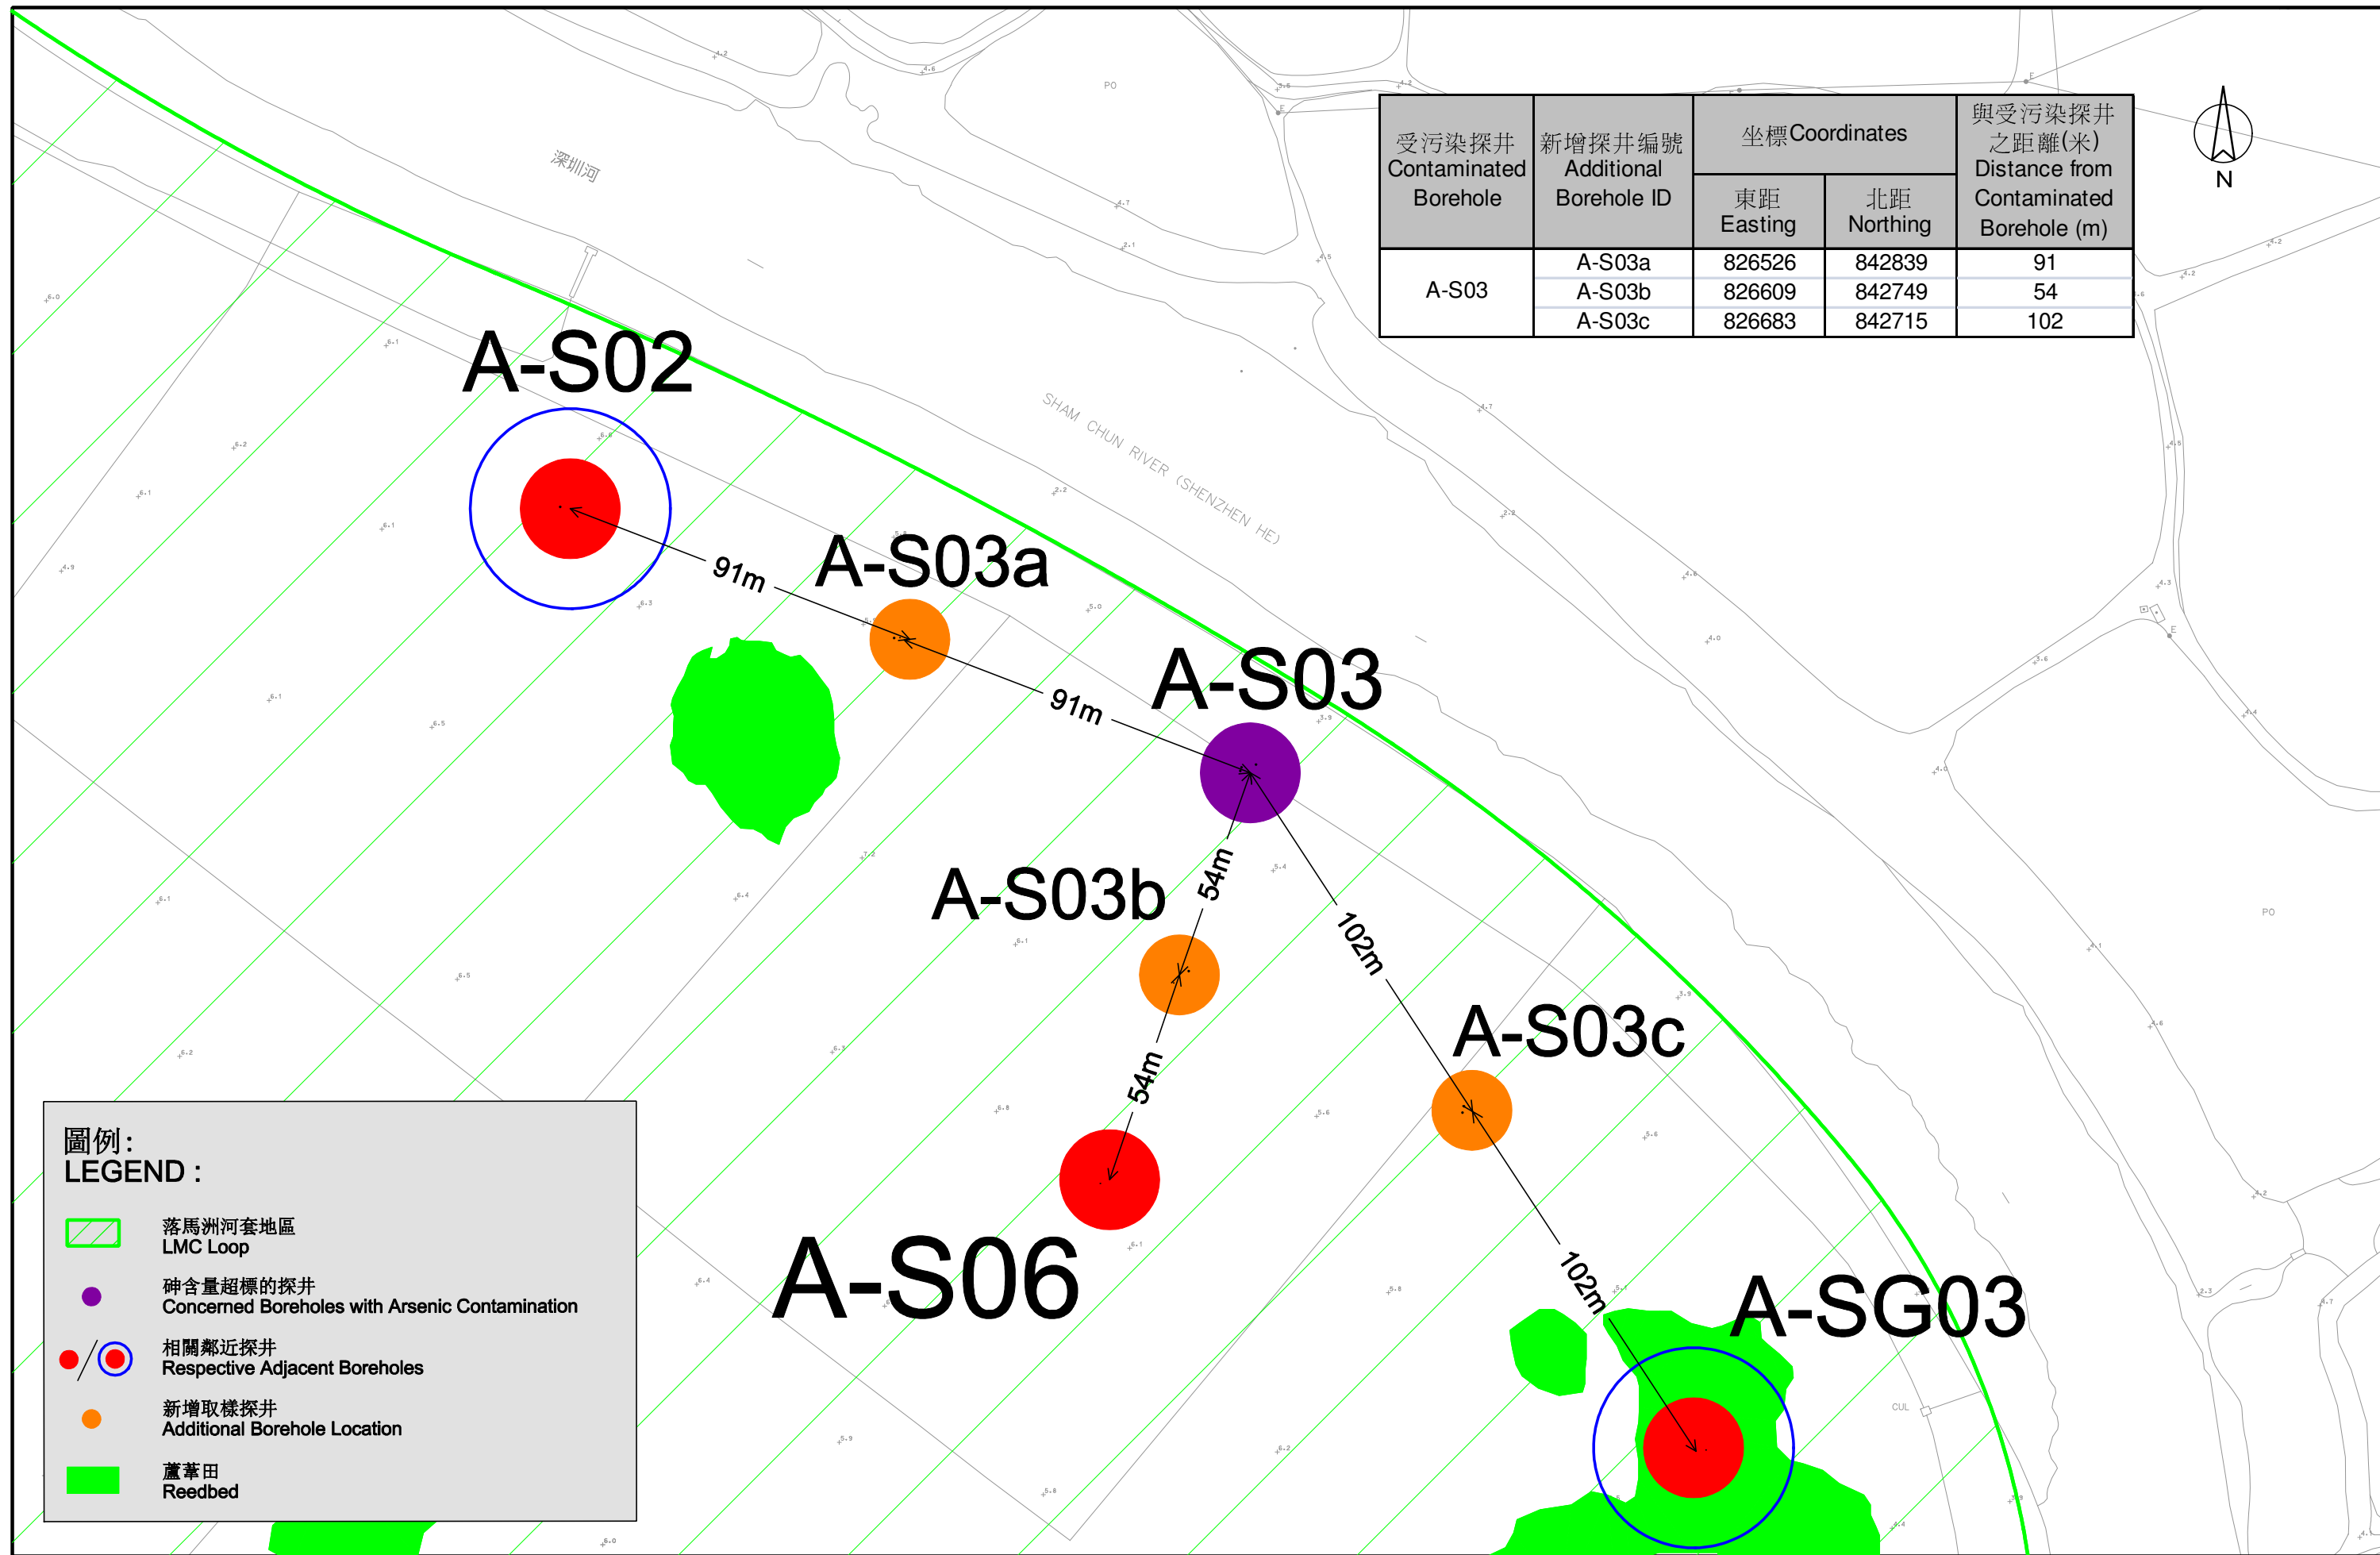
受污染探井 Contaminated Borehole	新增探井編號 Additional Borehole ID	坐標 Coordinates		與受污染探井 之距離(米) Distance from Contaminated Borehole (m)
		東距 Easting	北距 Northing	
A-S03	A-S03a	826526	842839	91
	A-S03b	826609	842749	54
	A-S03c	826683	842715	102

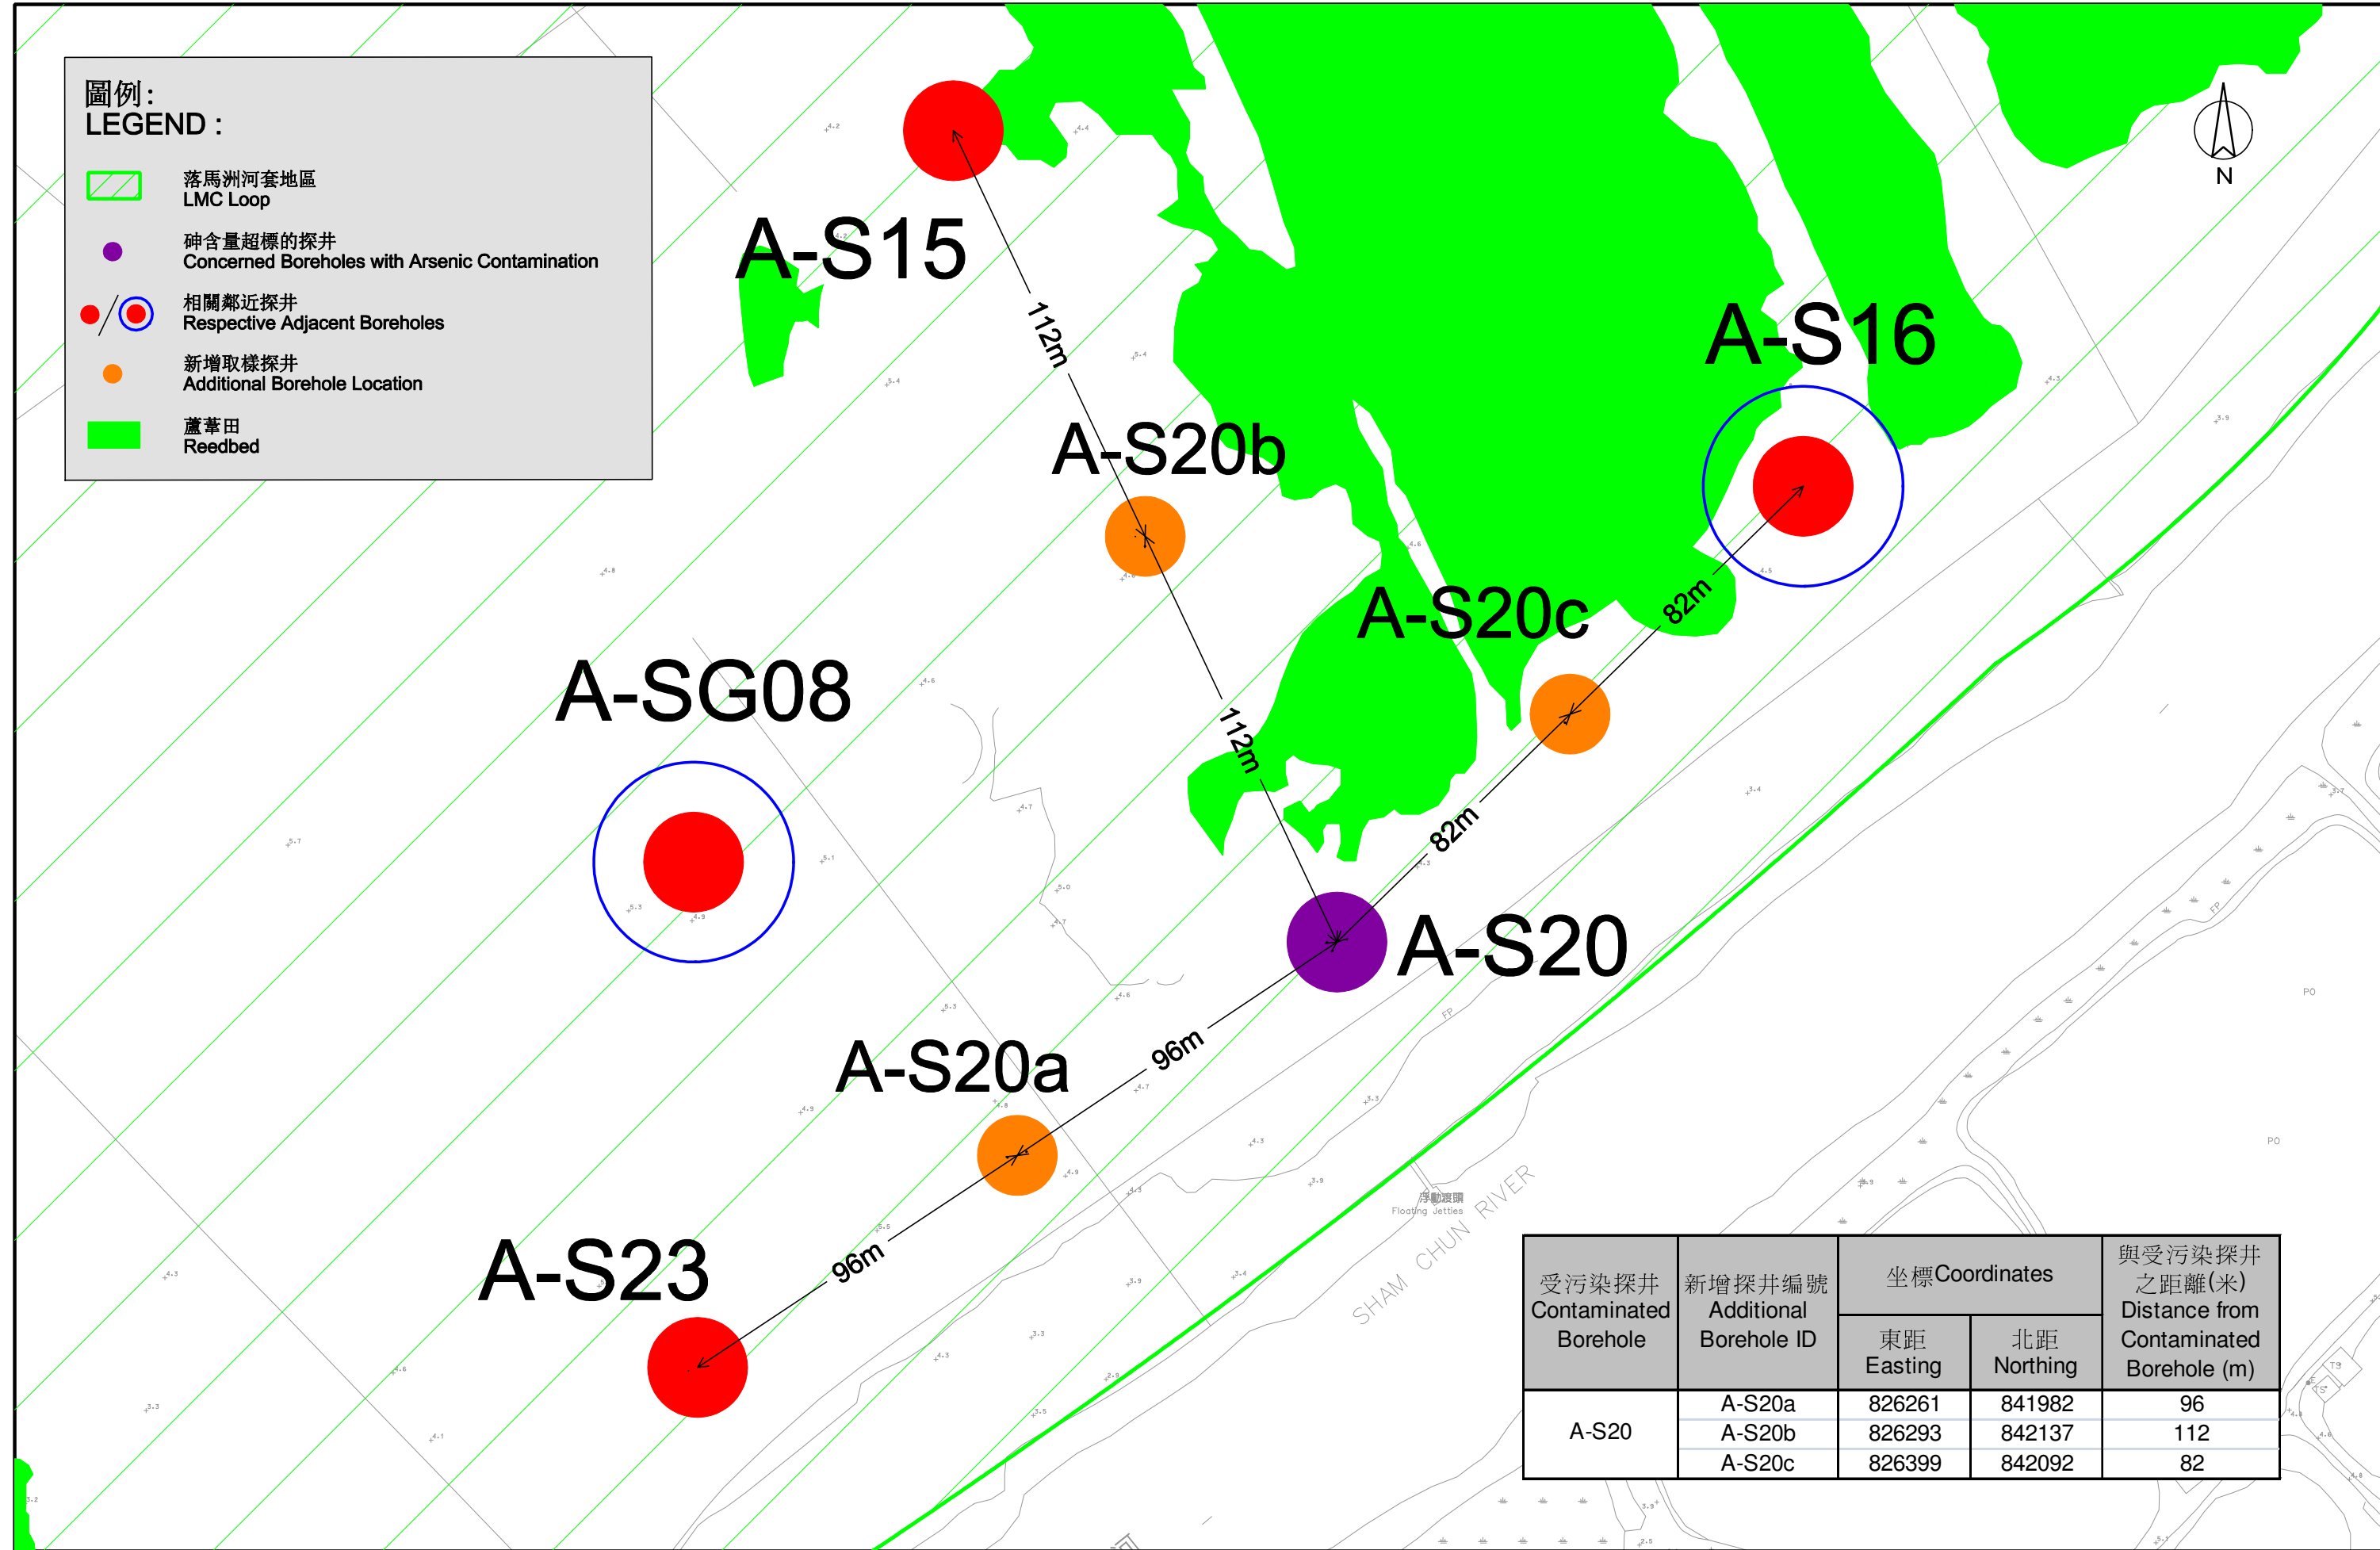
受污染探井 Contaminated Borehole	新增探井編號 Additional Borehole ID	坐標Coordinates		與受污染探井 之距離(米) Distance from Contaminated Borehole (m)
		東距 Easting	北距 Northing	
A-S20	A-S20a	826261	841982	96
	A-S20b	826293	842137	112
	A-S20c	826399	842092	82
