潛在受污染區域 A
 Location of Potentially Contaminated Site A

Project: CAP Programme

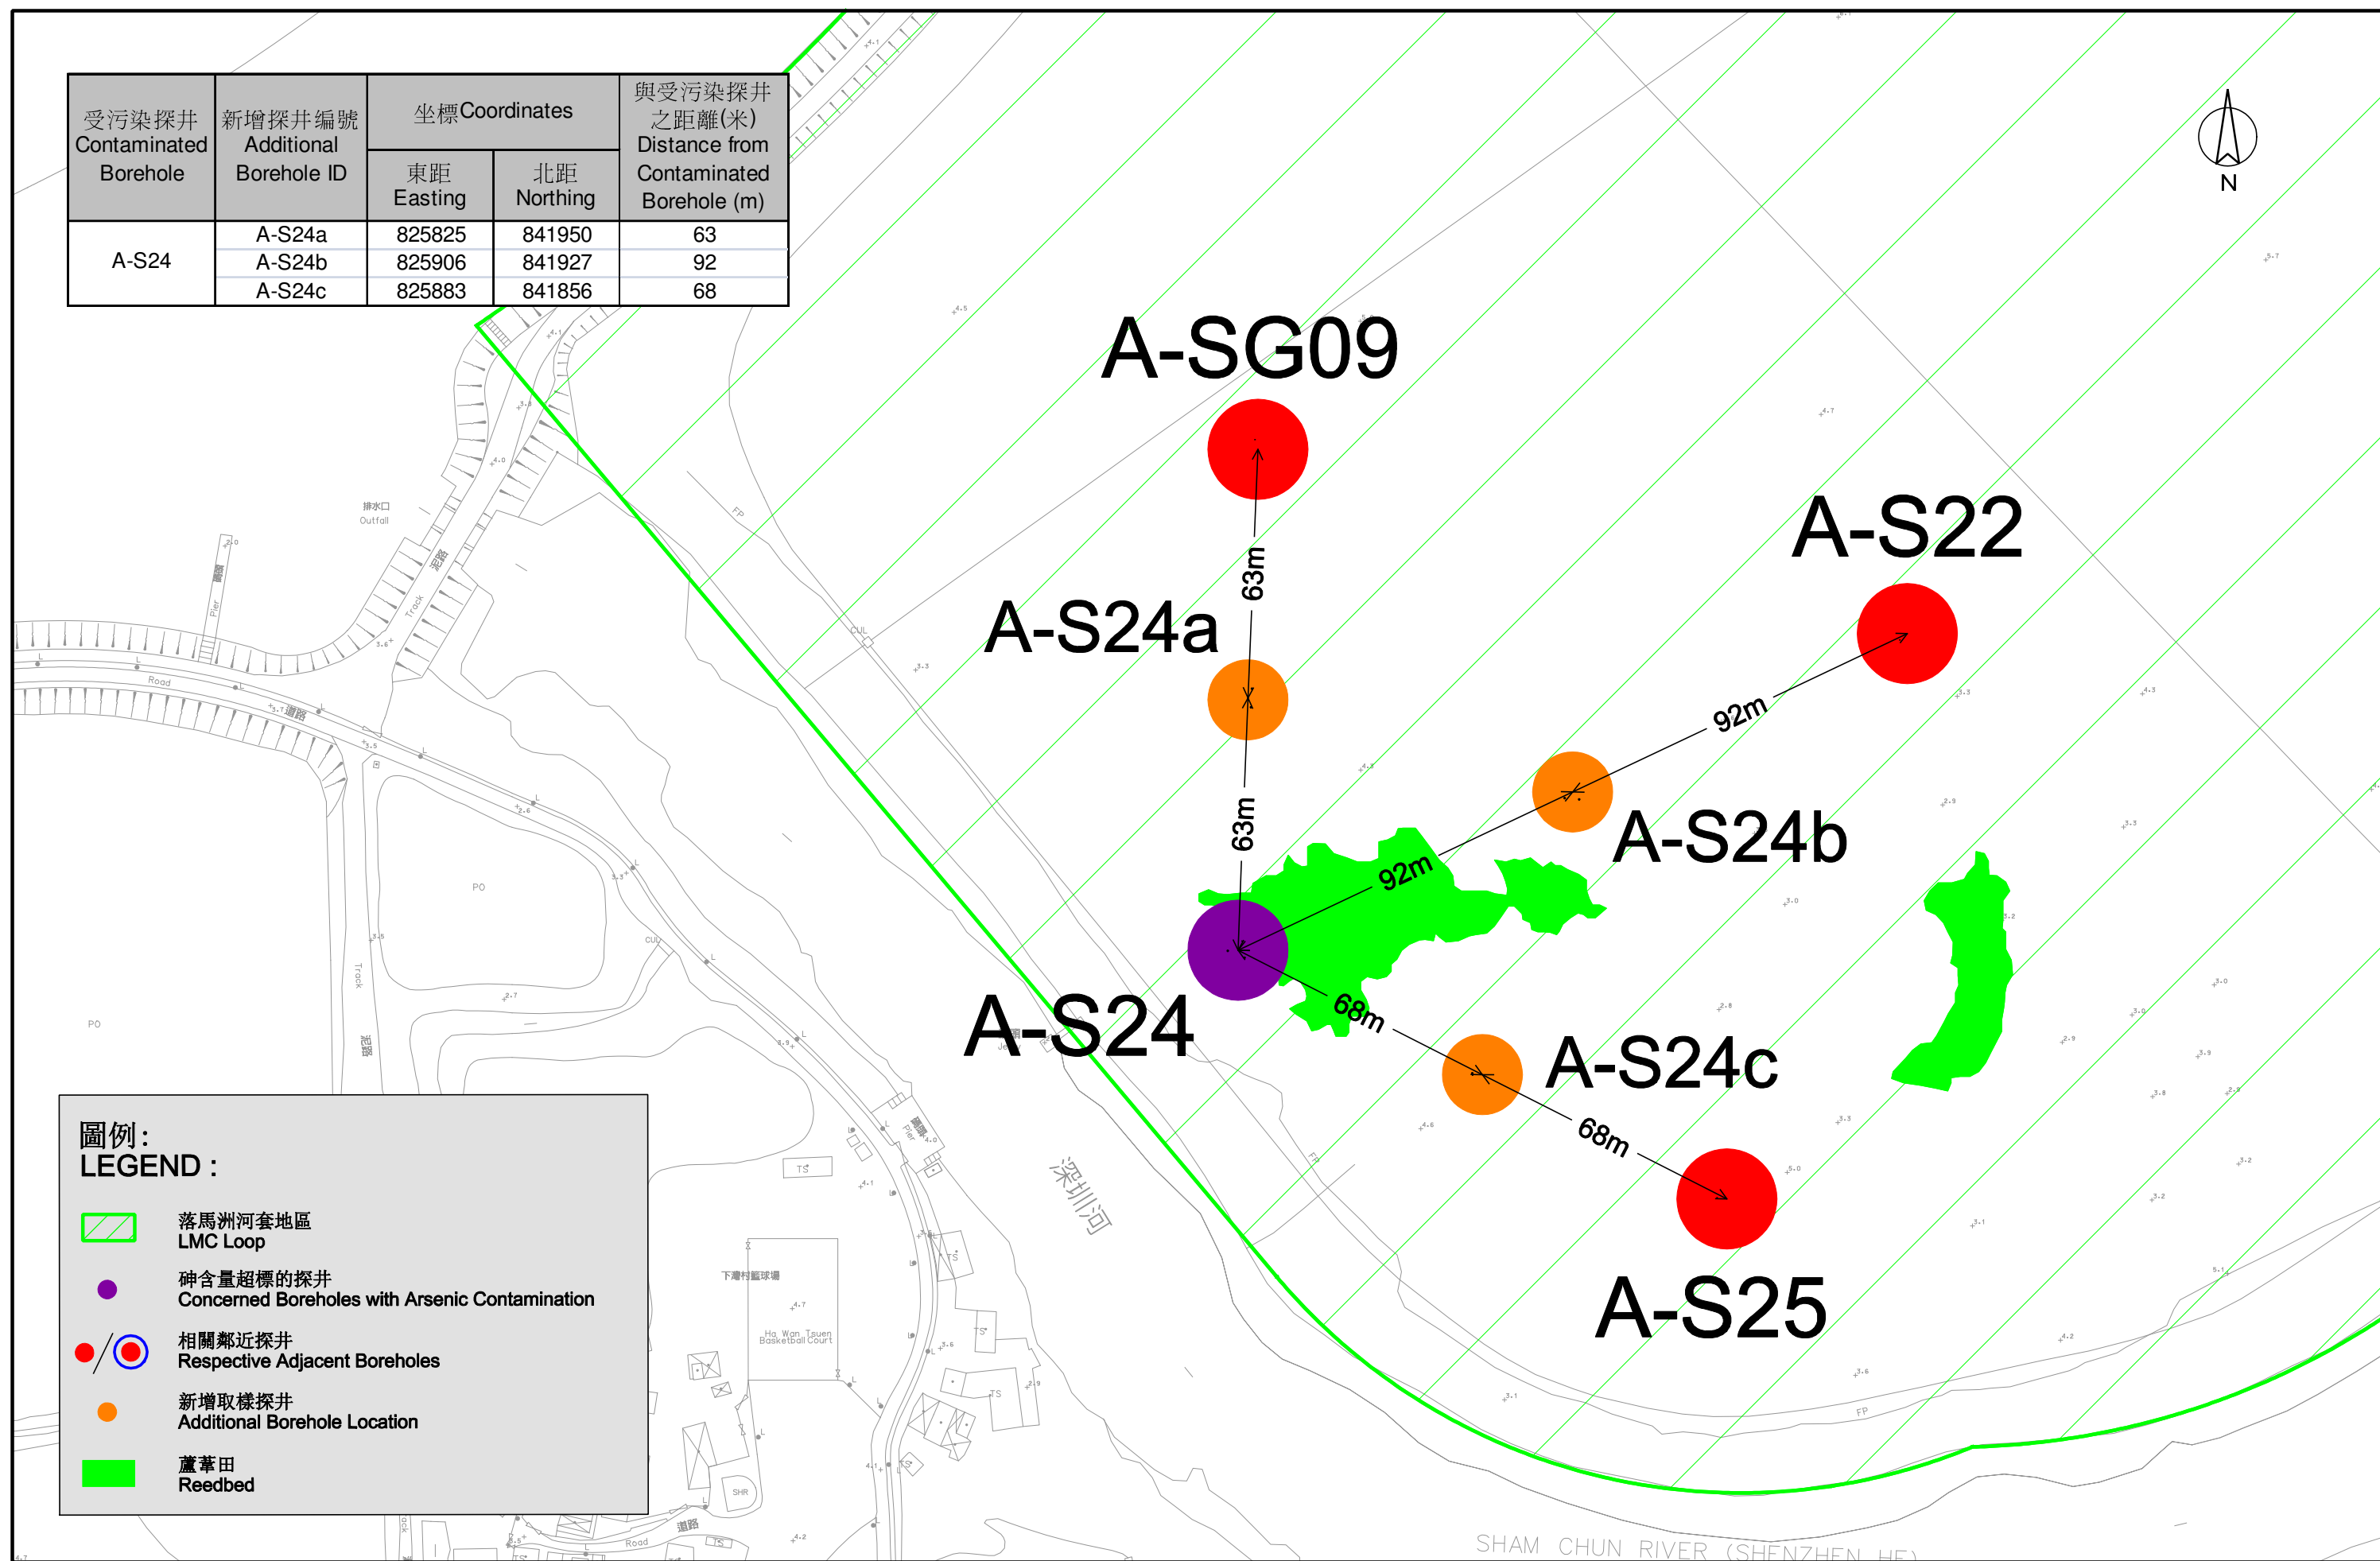
受污染探井 Contaminated Borehole	新增探井編號 Additional Borehole ID	坐標Coordinates		與受污染探井 之距離(米) Distance from Contaminated Borehole (m)
		東距 Easting	北距 Northing	
A-S24	A-S24a	825825	841950	63
	A-S24b	825906	841927	92
	A-S24c	825883	841856	68

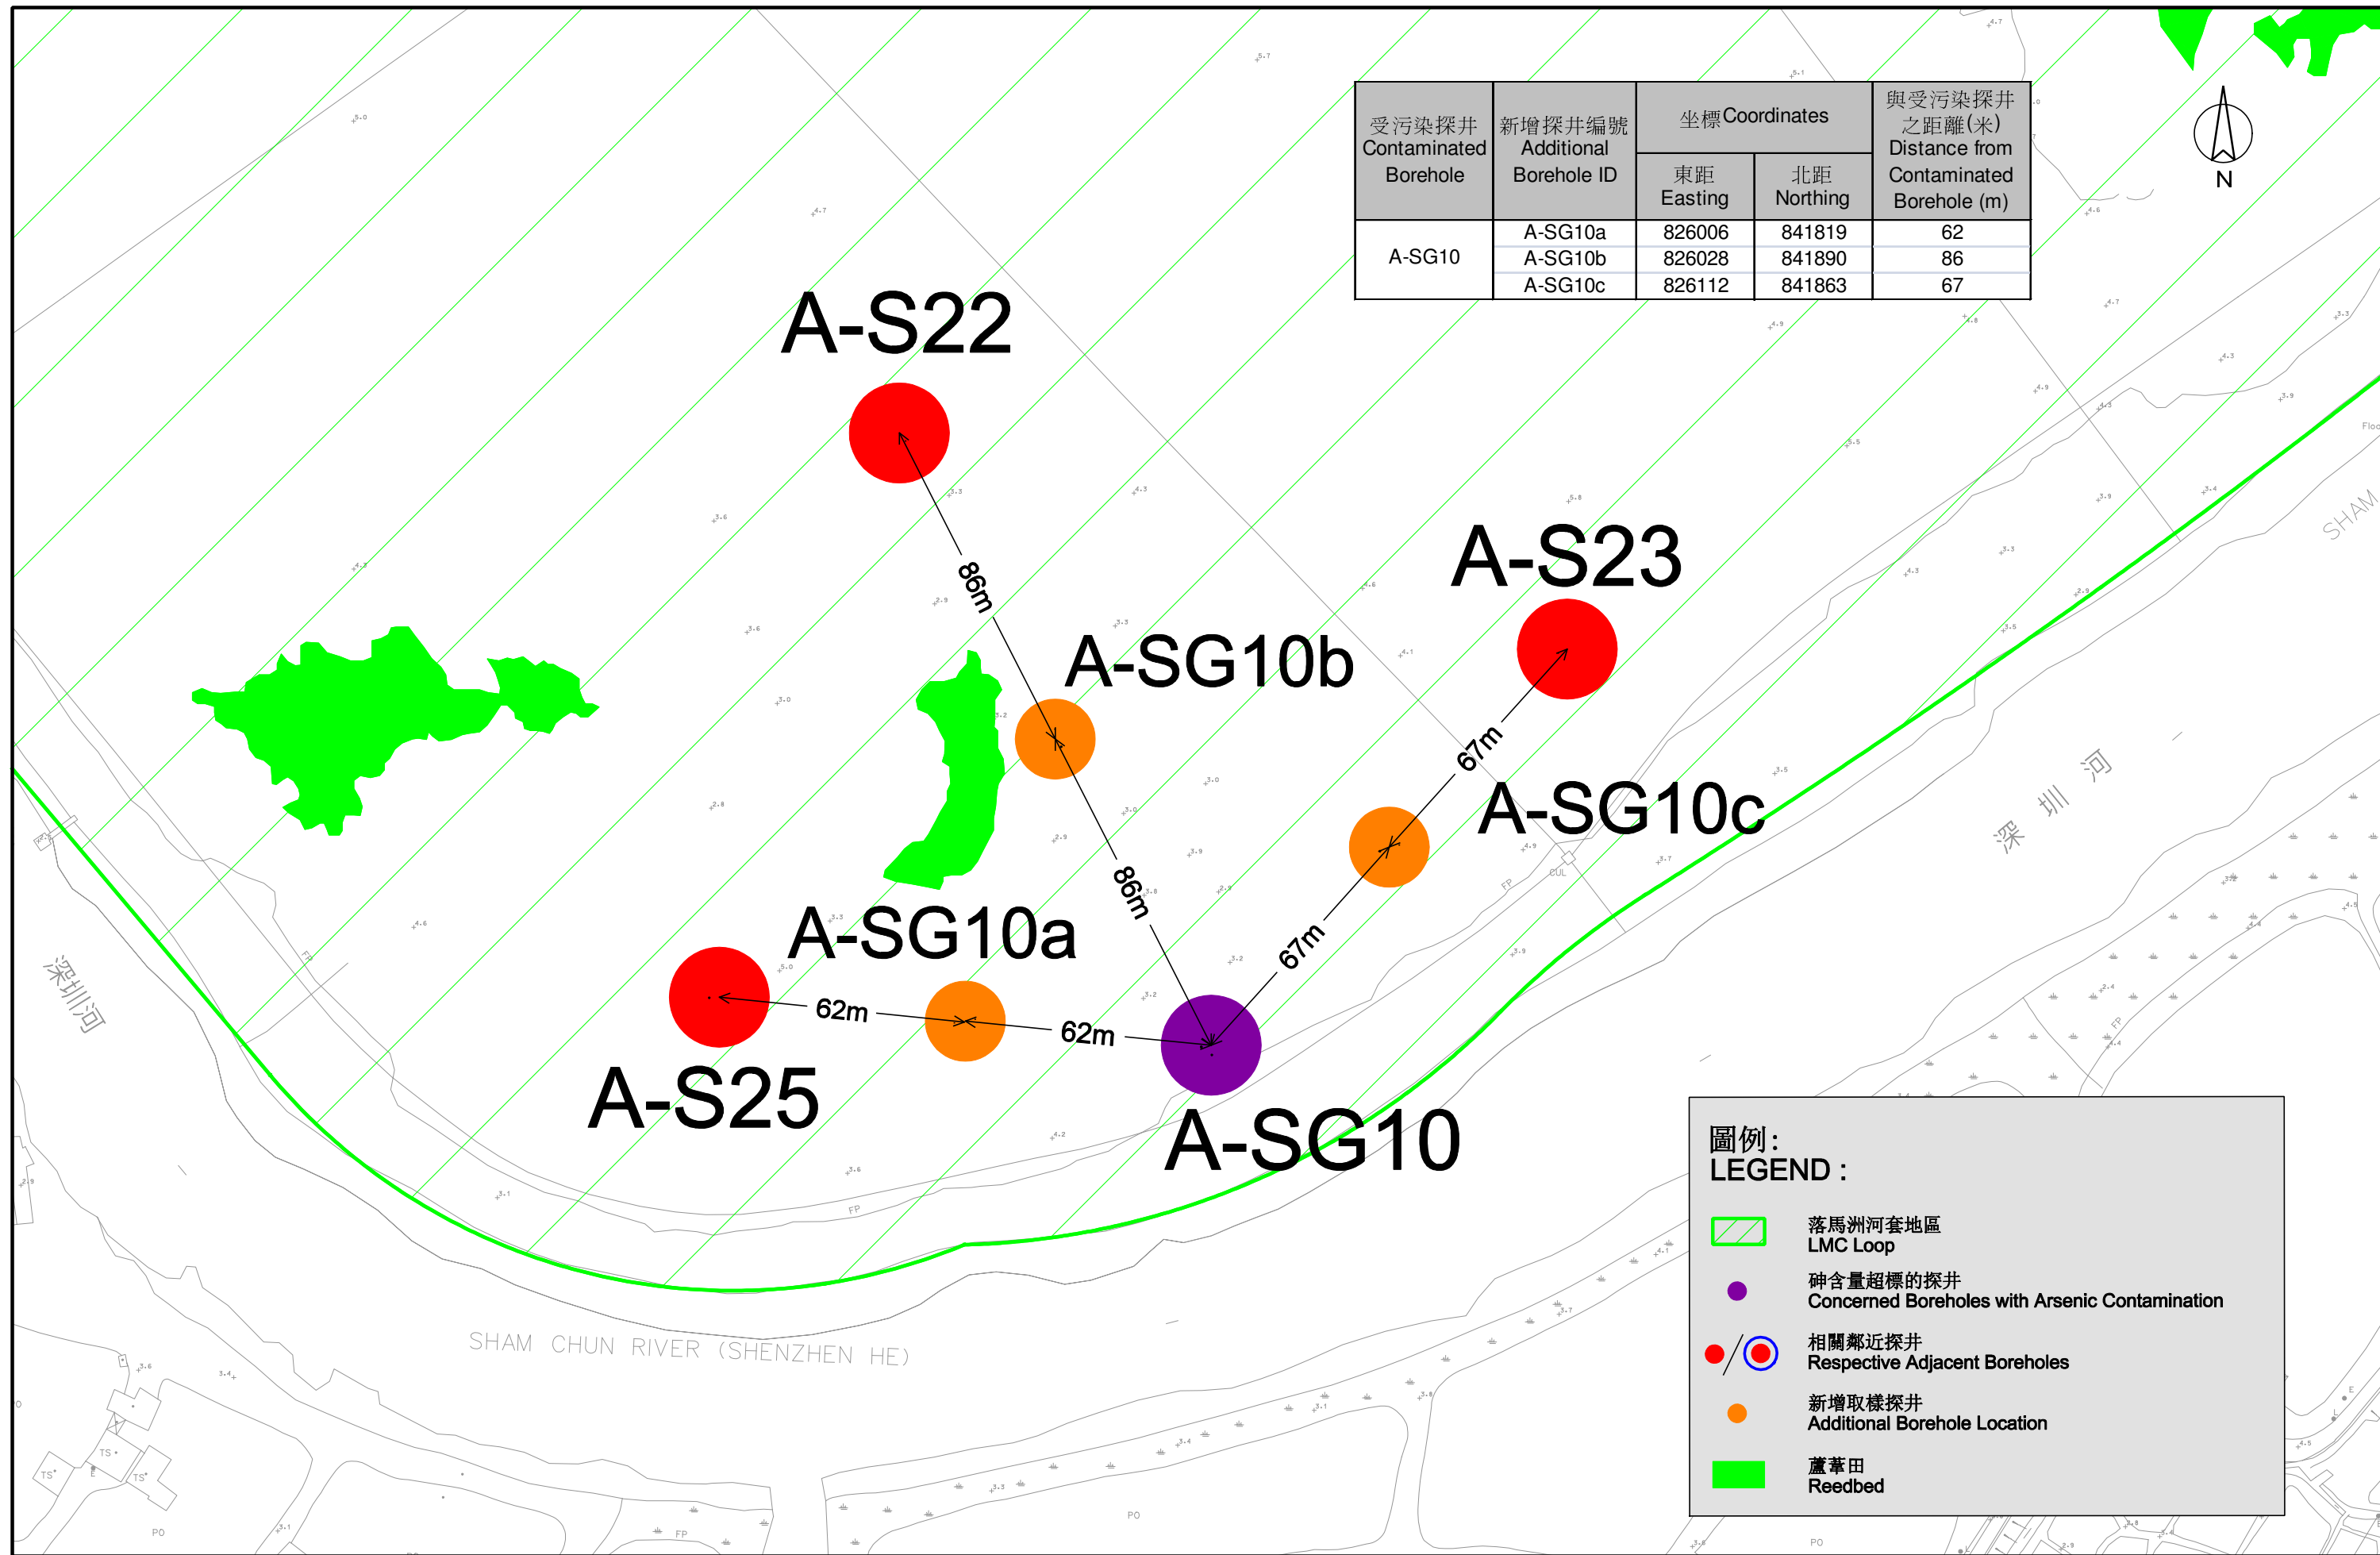
受污染探井 Contaminated Borehole	新增探井編號 Additional Borehole ID	坐標 Coordinates		與受污染探井 之距離(米) Distance from Contaminated Borehole (m)
		東距 Easting	北距 Northing	
A-SG10	A-SG10a	826006	841819	62
	A-SG10b	826028	841890	86
	A-SG10c	826112	841863	67

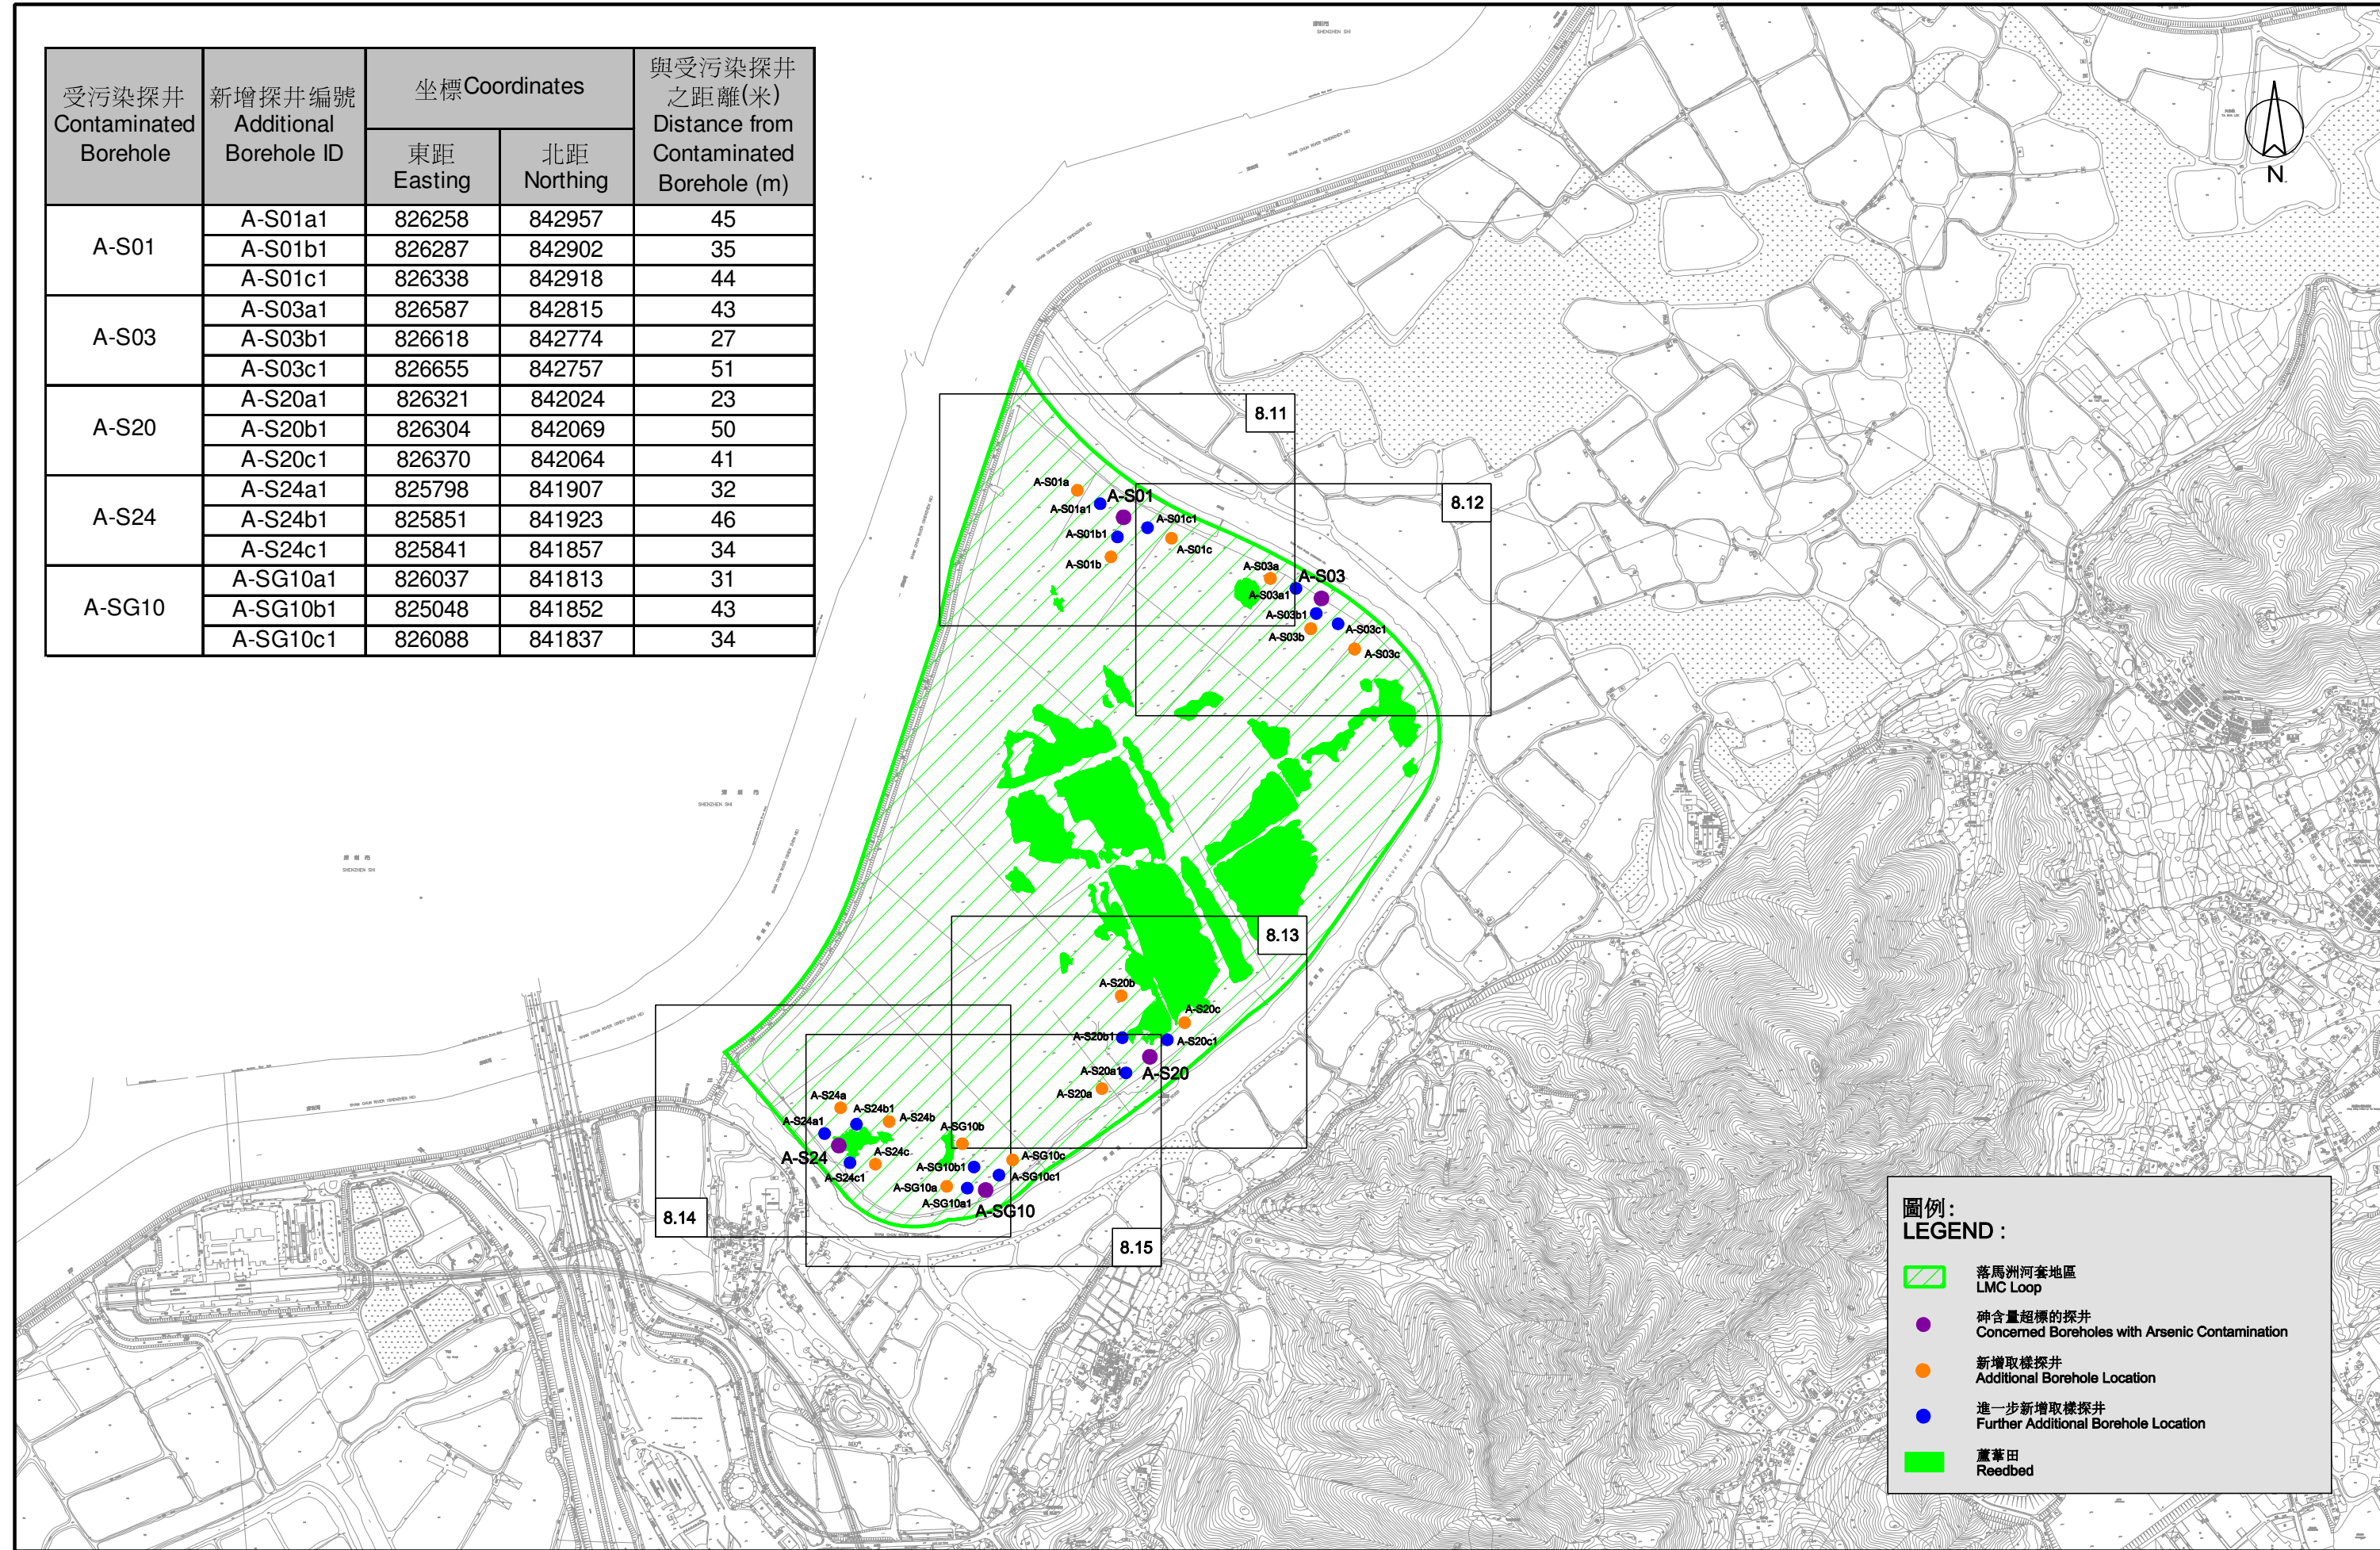
受污染探井 Contaminated Borehole	新增探井編號 Additional Borehole ID	坐標 Coordinates		與受污染探井 之距離(米) Distance from Contaminated Borehole (m)
		東距 Easting	北距 Northing	
A-S01	A-S01a1	826258	842957	45
	A-S01b1	826287	842902	35
	A-S01c1	826338	842918	44

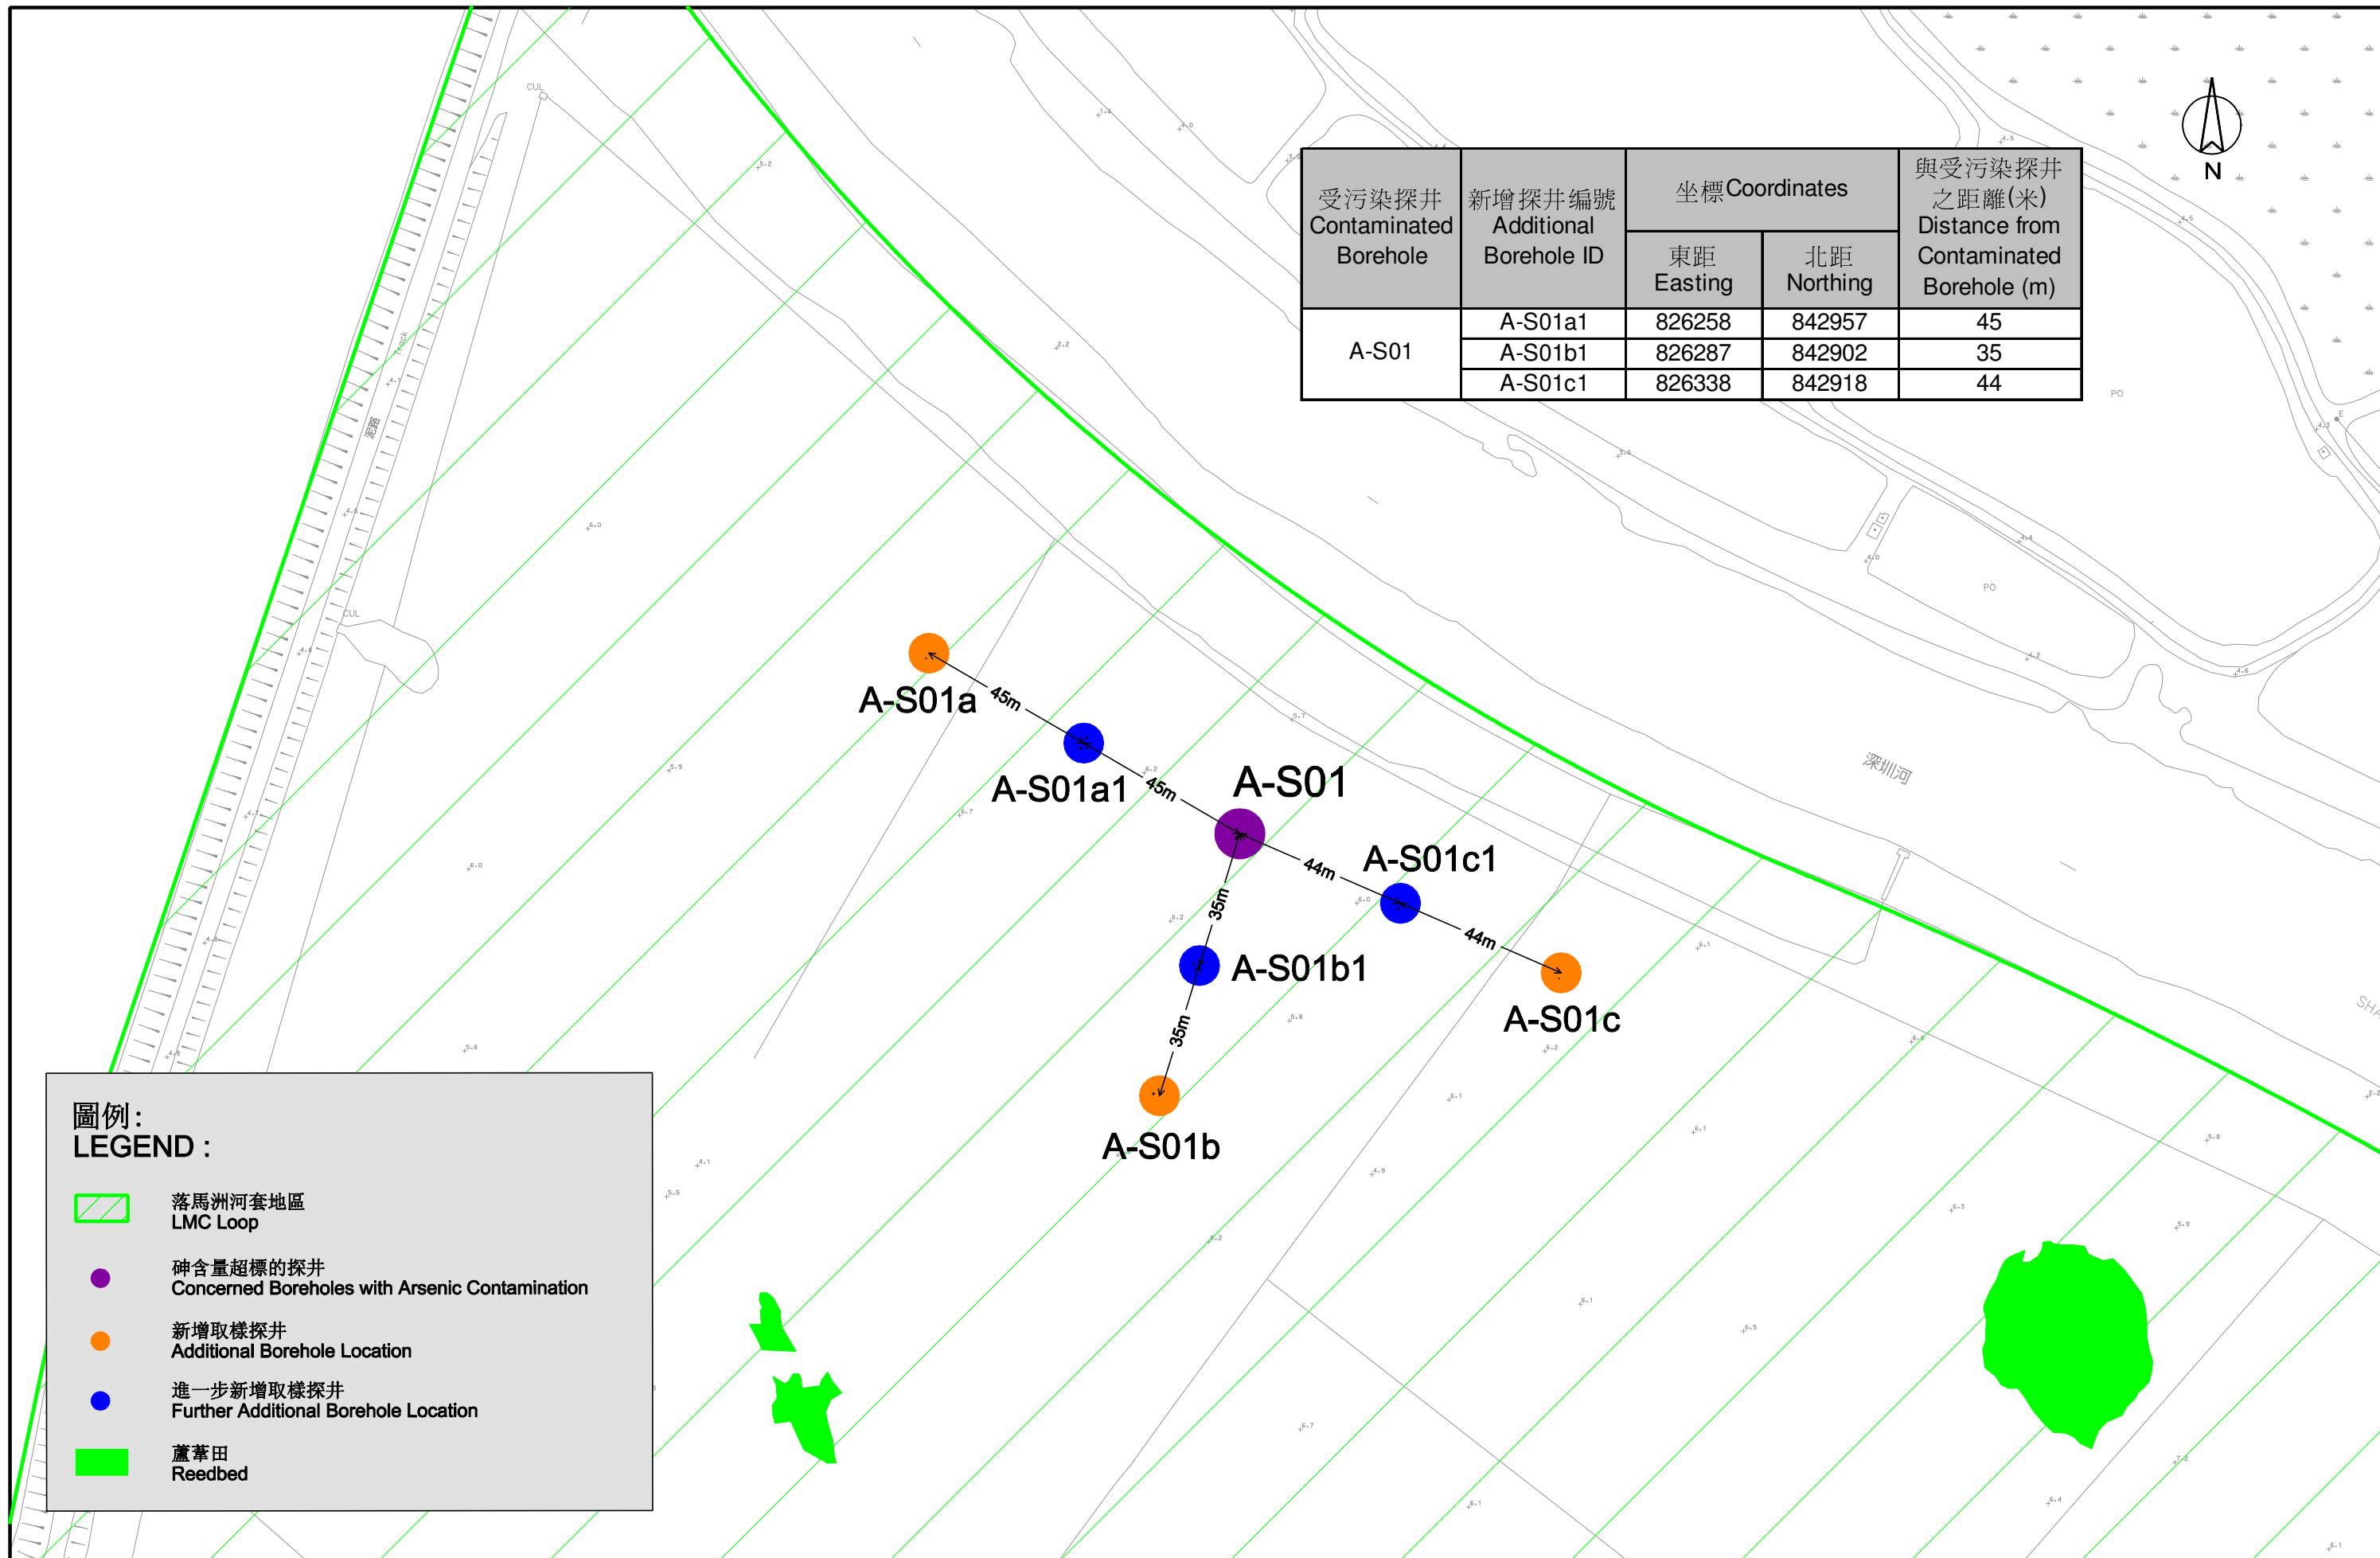
- 落馬洲河套地區
LMC Loop
- 砷含量超標的探井
Concerned Boreholes with Arsenic Contamination
- 新增取樣探井
Additional Borehole Location
- 進一步新增取樣探井
Further Additional Borehole Location
- 蘆葦田
Reedbed

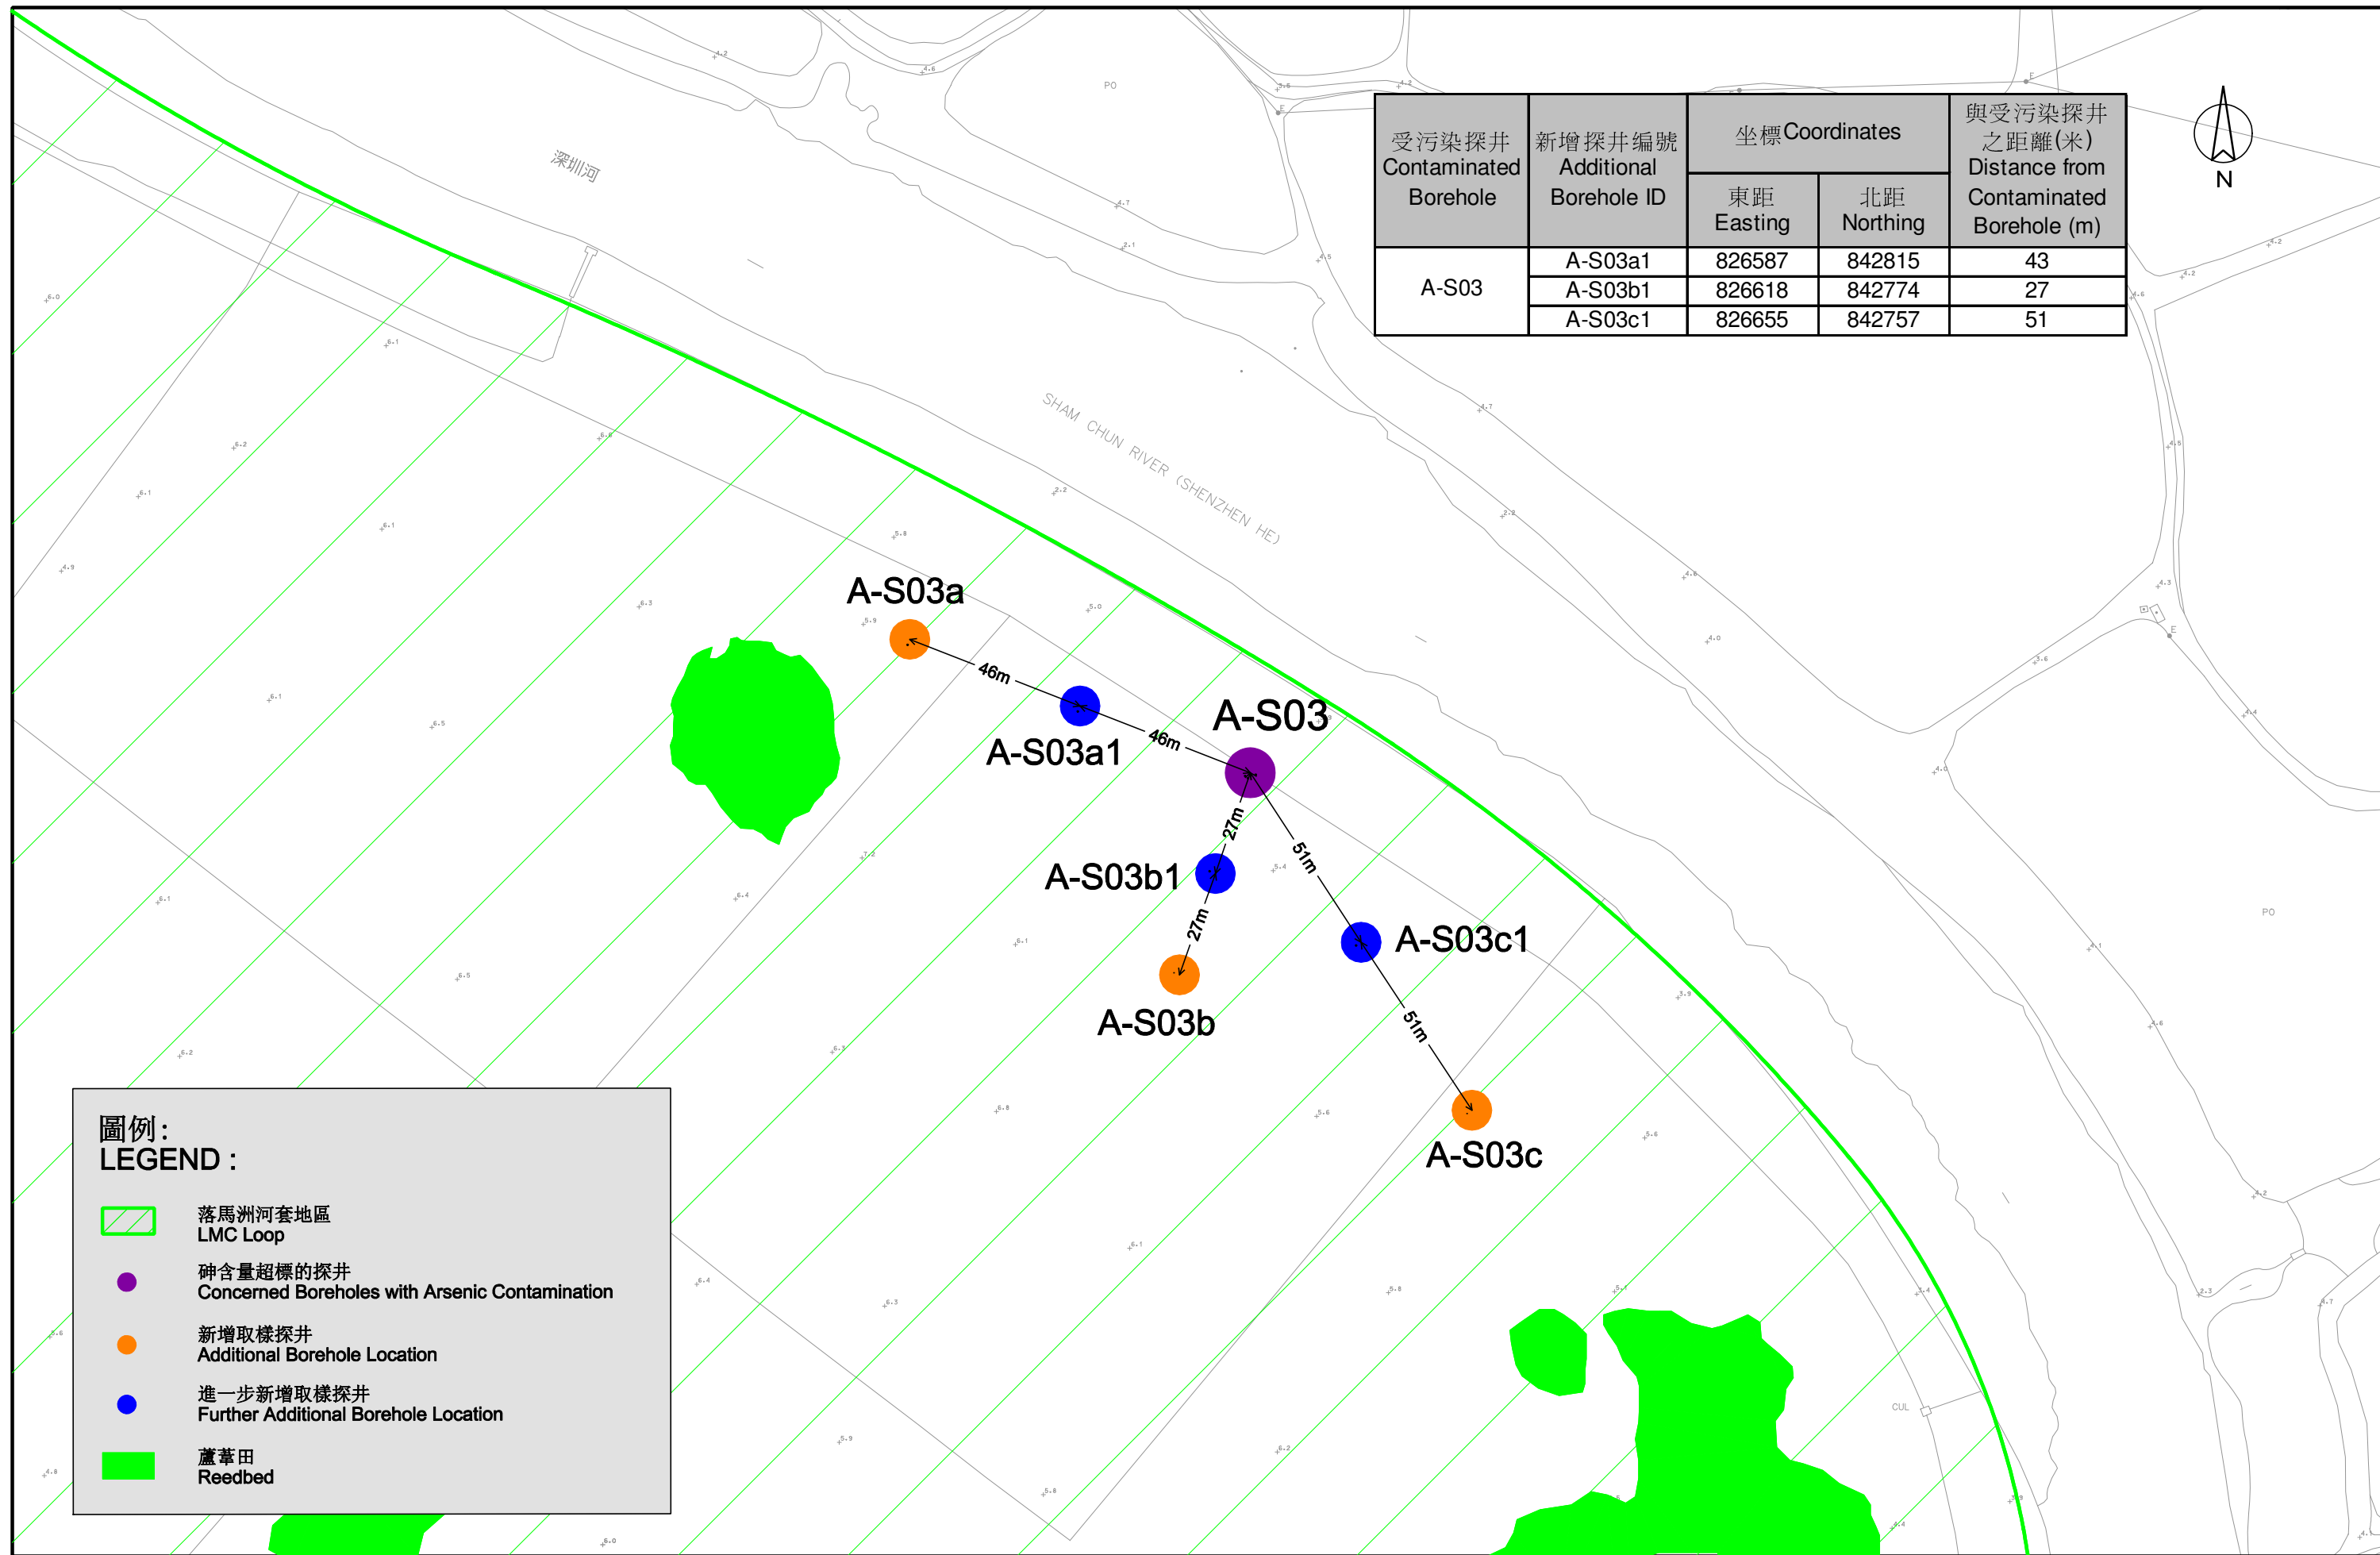
受污染探井 Contaminated Borehole	新增探井編號 Additional Borehole ID	坐標 Coordinates		與受污染探井 之距離(米) Distance from Contaminated Borehole (m)
		東距 Easting	北距 Northing	
A-S03	A-S03a1	826587	842815	43
	A-S03b1	826618	842774	27
	A-S03c1	826655	842757	51

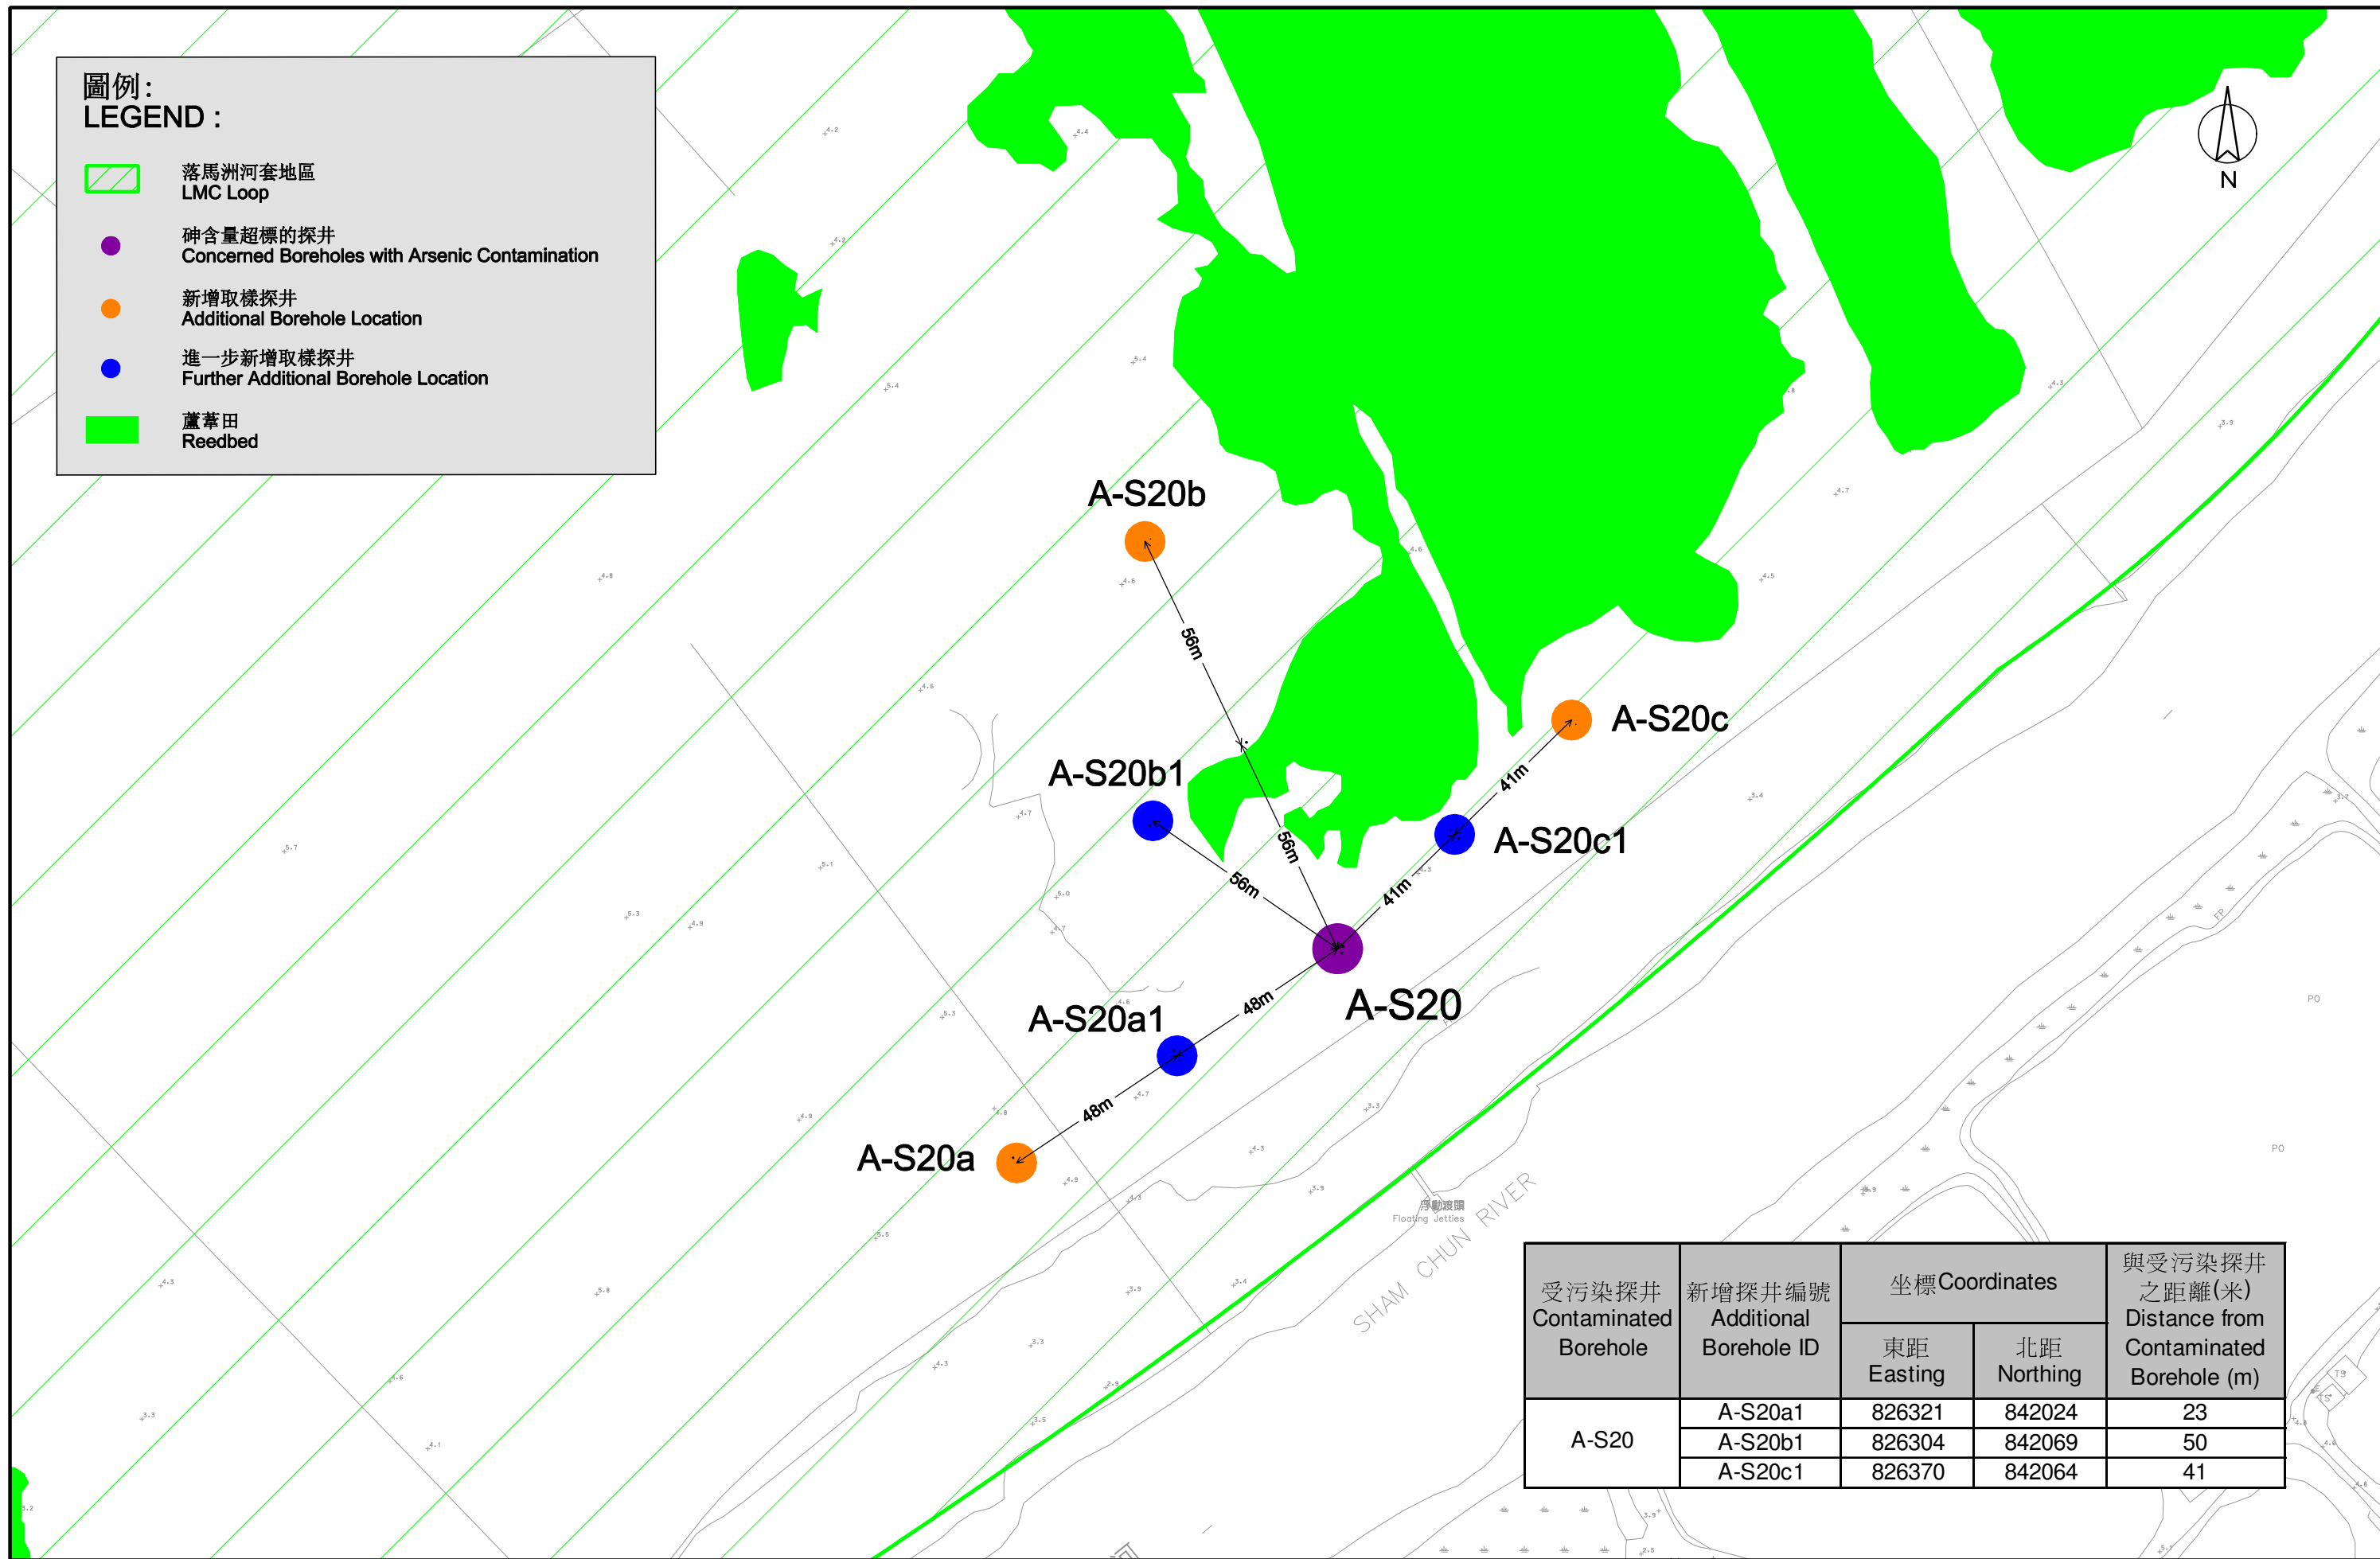
受污染探井 Contaminated Borehole	新增探井編號 Additional Borehole ID	坐標Coordinates		與受污染探井 之距離(米) Distance from Contaminated Borehole (m)
		東距 Easting	北距 Northing	
A-S20	A-S20a1	826321	842024	23
	A-S20b1	826304	842069	50
	A-S20c1	826370	842064	41
