潛在受污染區域 A
 Location of Potentially Contaminated Site A

Project: CAP Programme

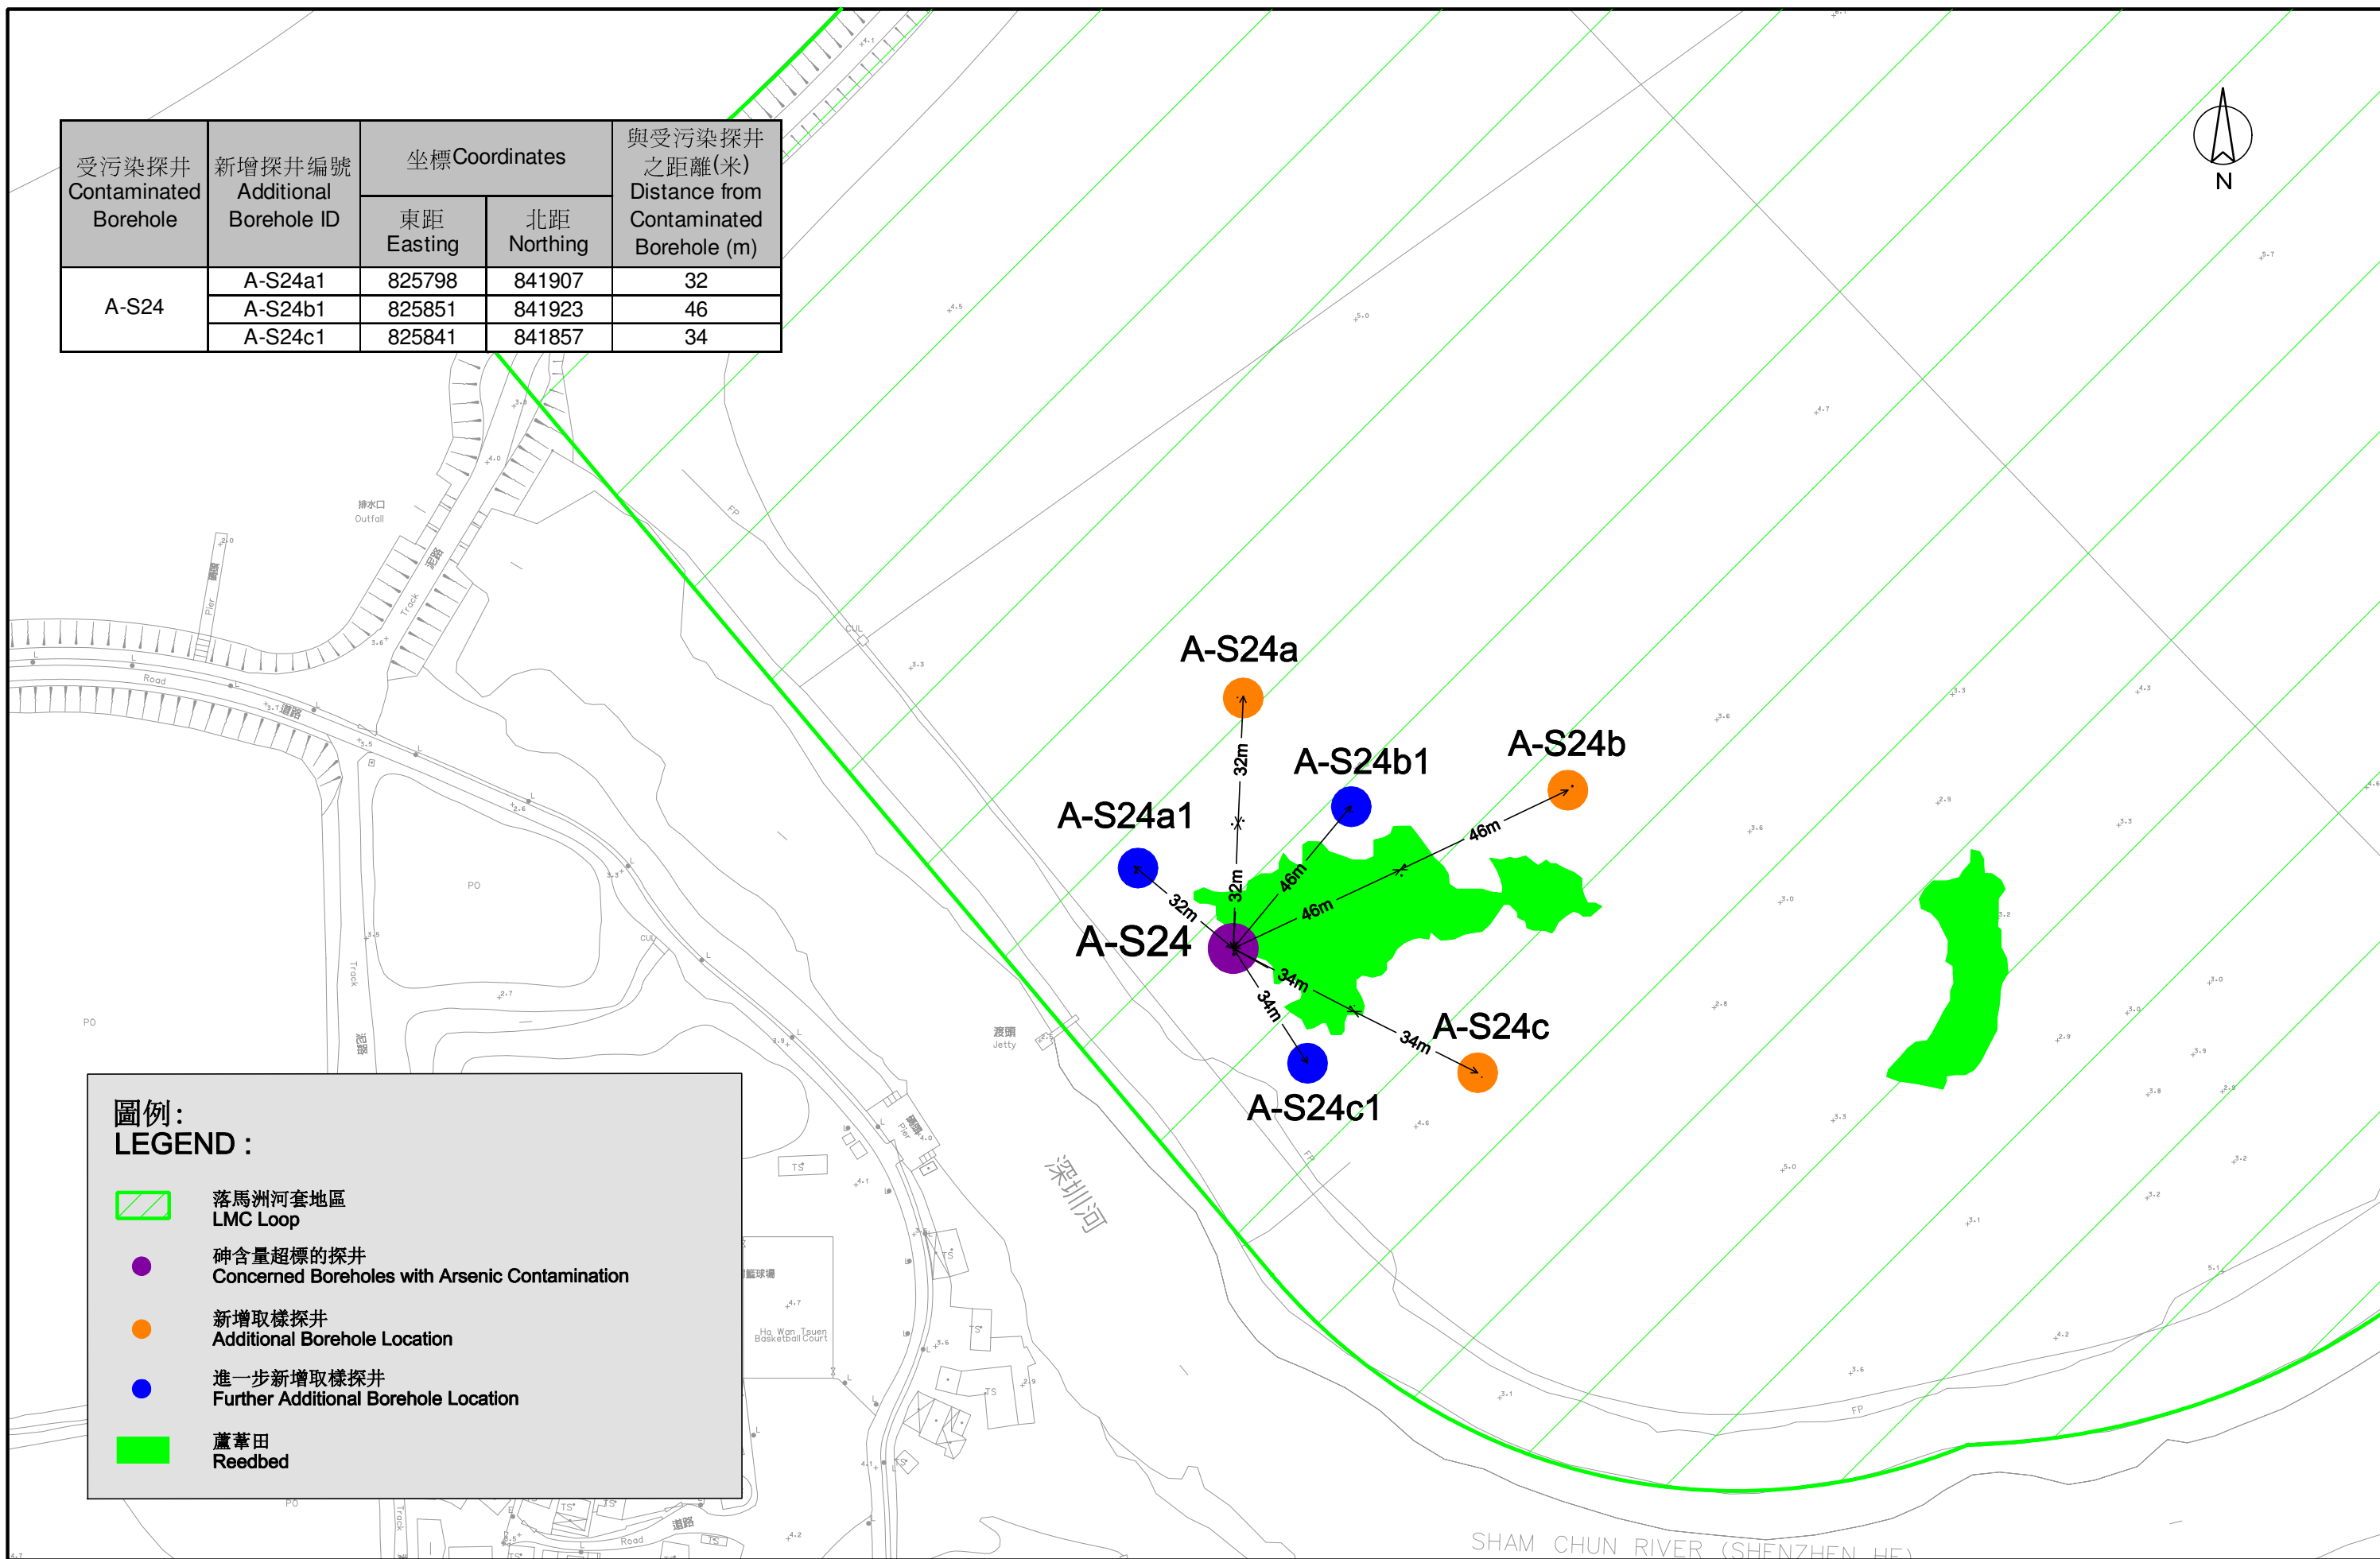
受污染探井 Contaminated Borehole	新增探井編號 Additional Borehole ID	坐標Coordinates		與受污染探井 之距離(米) Distance from Contaminated Borehole (m)
		東距 Easting	北距 Northing	
A-S24	A-S24a1	825798	841907	32
	A-S24b1	825851	841923	46
	A-S24c1	825841	841857	34

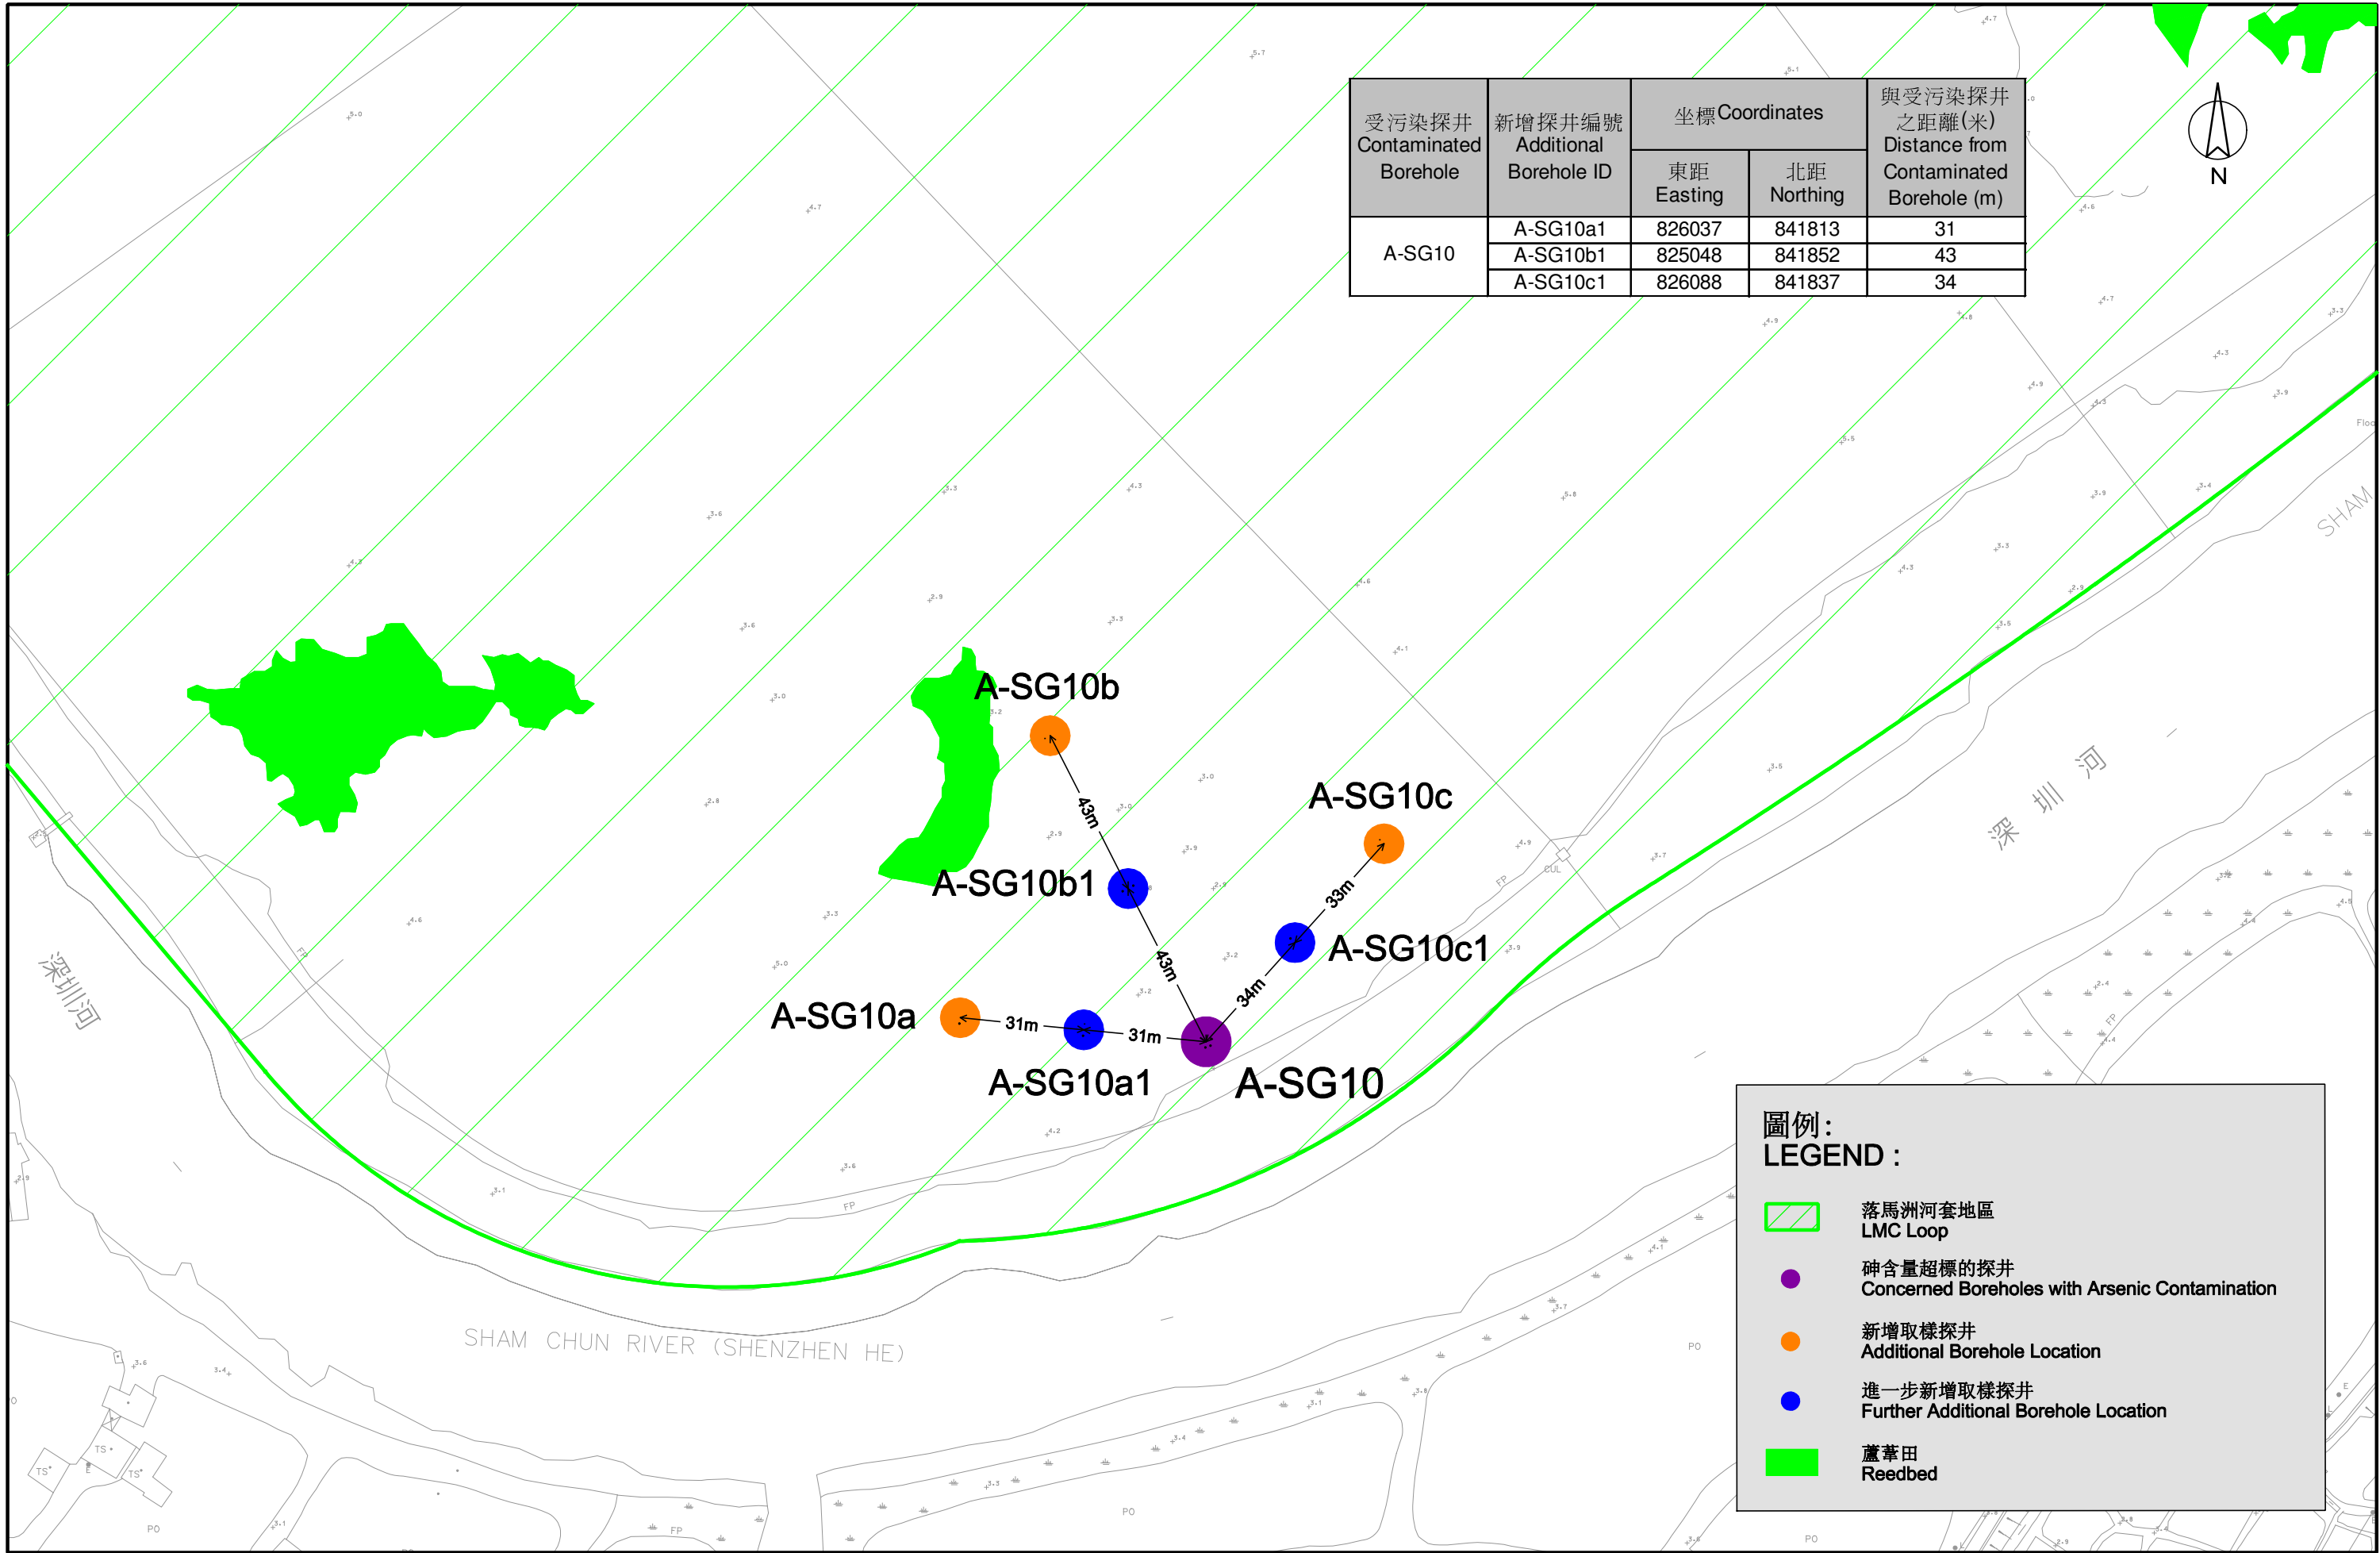
受污染探井 Contaminated Borehole	新增探井編號 Additional Borehole ID	坐標 Coordinates		與受污染探井 之距離(米) Distance from Contaminated Borehole (m)
		東距 Easting	北距 Northing	
A-SG10	A-SG10a1	826037	841813	31
	A-SG10b1	825048	841852	43
	A-SG10c1	826088	841837	34

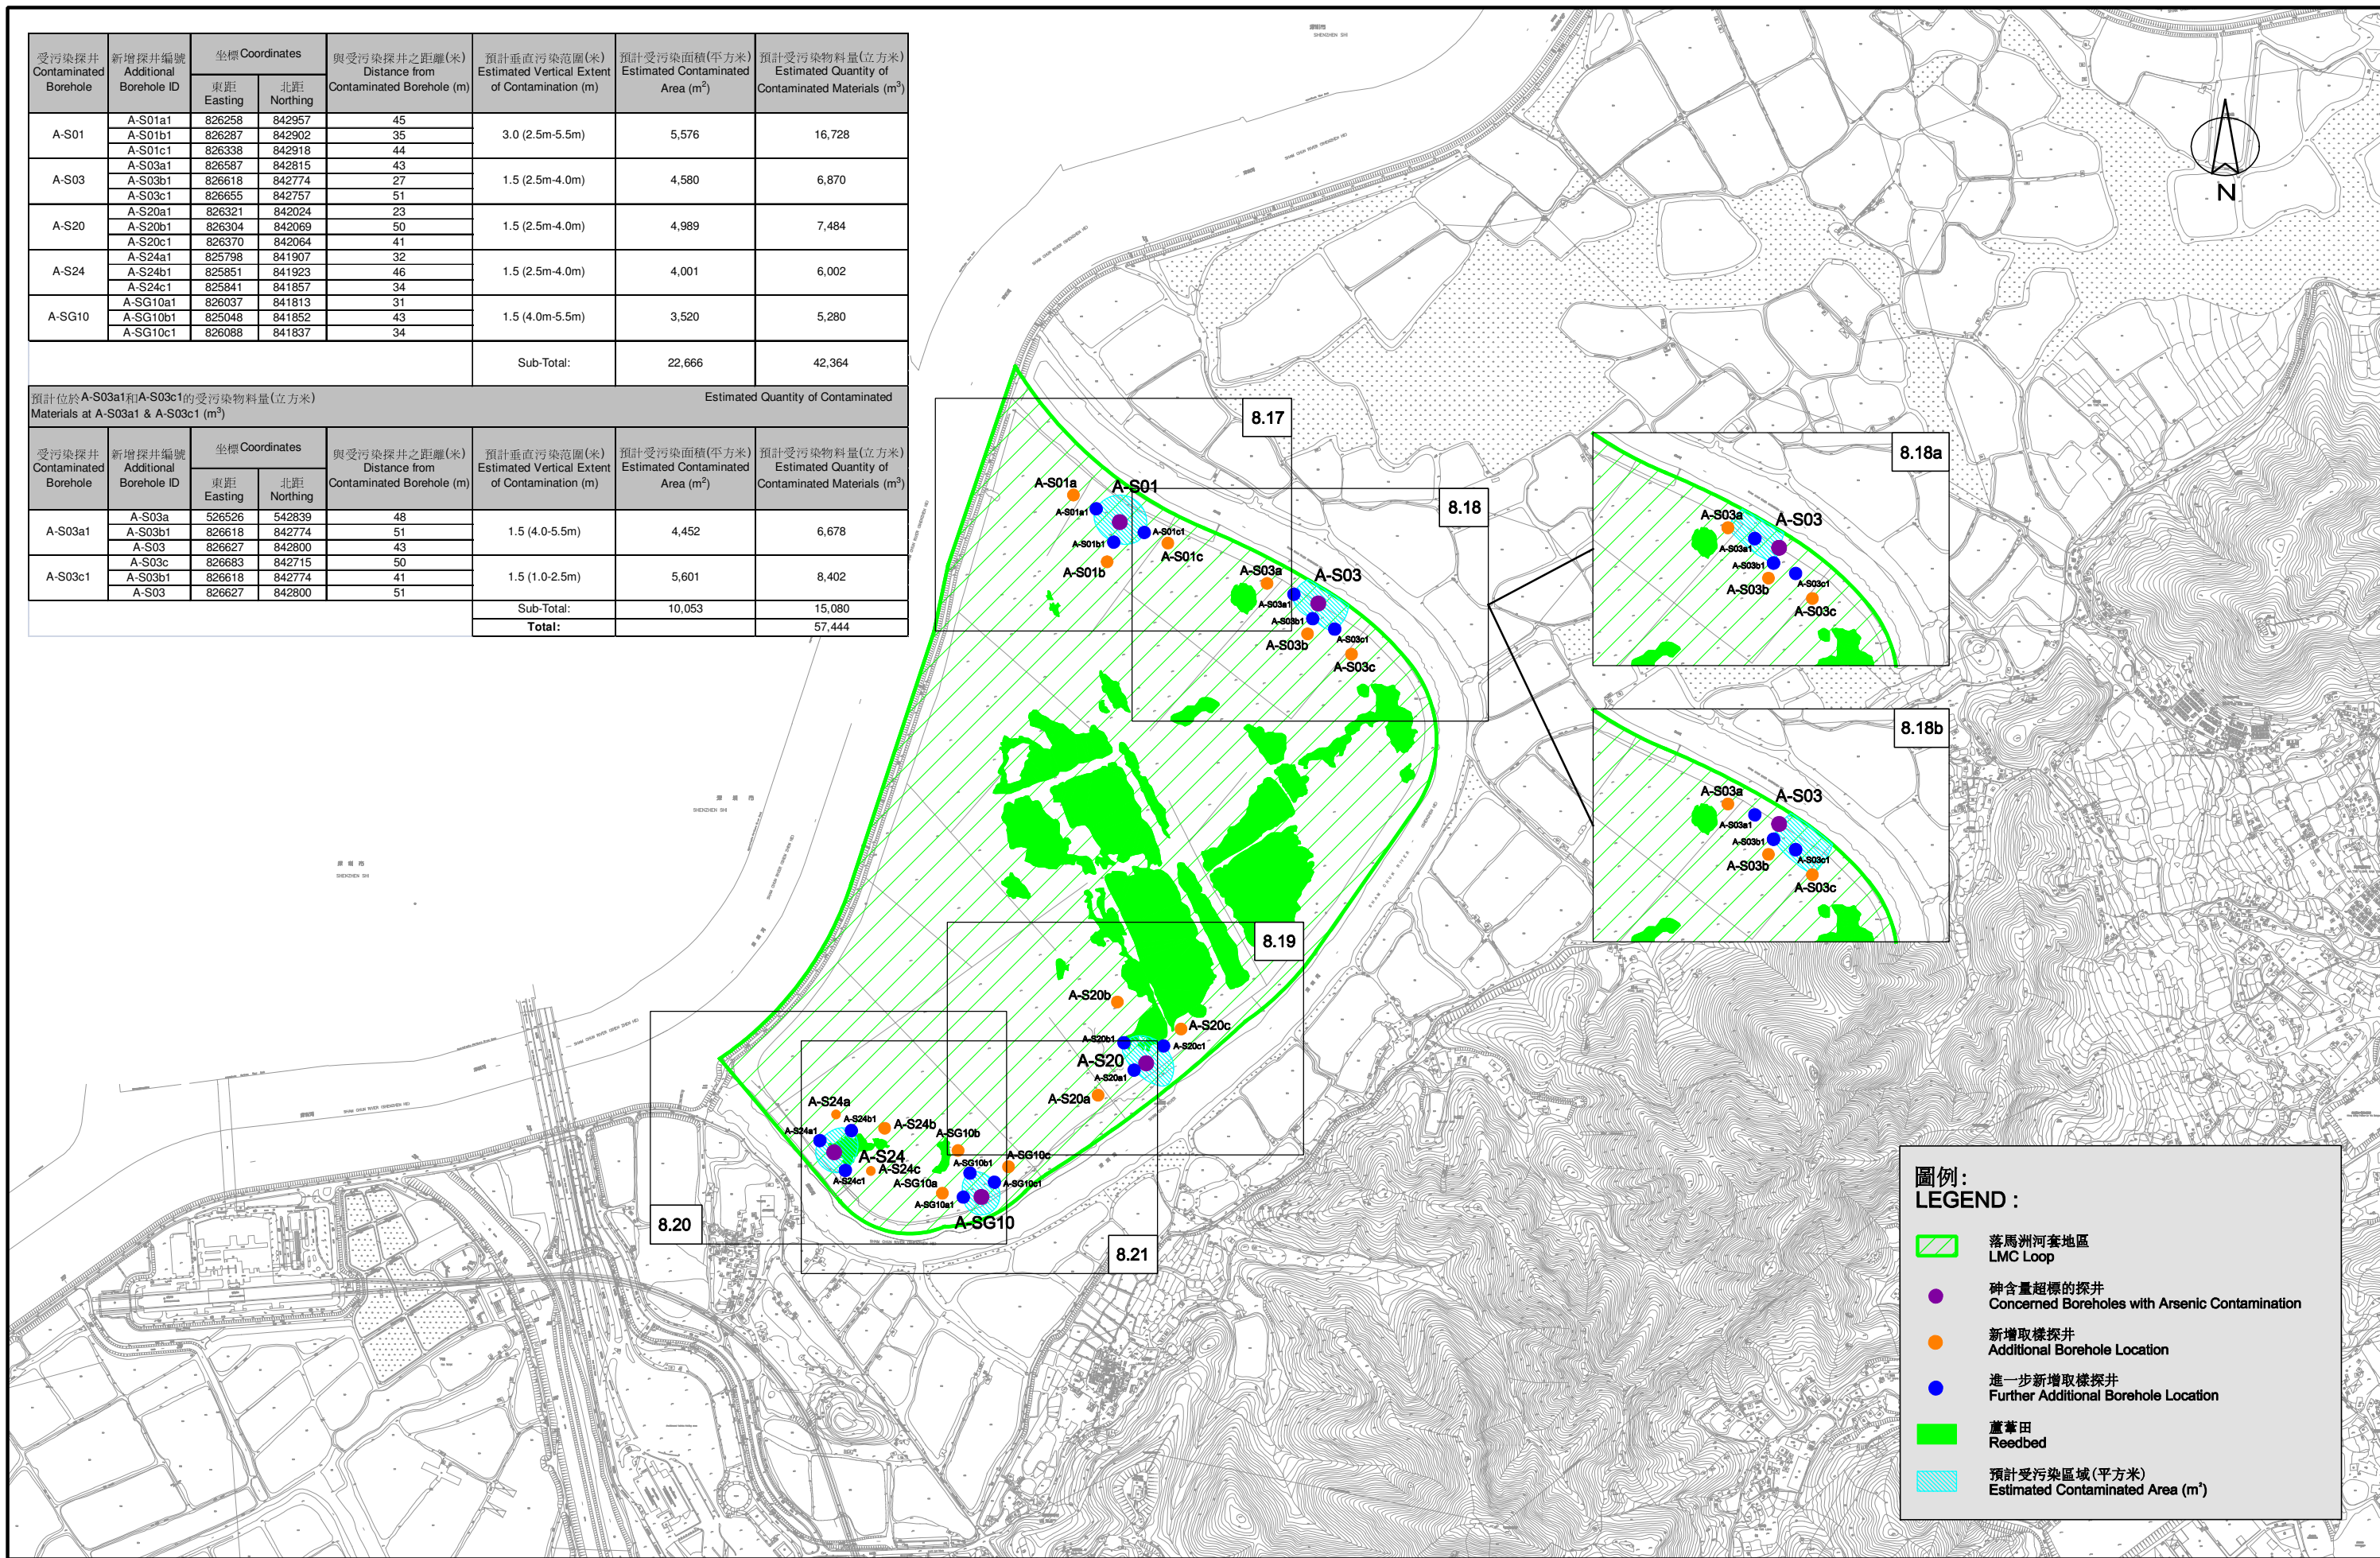
受污染探井 Contaminated Borehole	新增探井編號 Additional Borehole ID	坐標 Coordinates		與受污染探井之距離(米) Distance from Contaminated Borehole (m)	預計垂直污染範圍(米) Estimated Vertical Extent of Contamination (m)	預計受污染面積(平方米) Estimated Contaminated Area (m ²)	預計受污染物料量(立方米) Estimated Quantity of Contaminated Materials (m ³)
		東距 Easting	北距 Northing				
A-S01	A-S01a1	826258	842957	45	3.0 (2.5m-5.5m)	5,576	16,728
	A-S01b1	826287	842902	35			
	A-S01c1	826338	842918	44			
A-S03	A-S03a1	826587	842815	43	1.5 (2.5m-4.0m)	4,580	6,870
	A-S03b1	826618	842774	27			
	A-S03c1	826655	842757	51			
A-S20	A-S20a1	826321	842024	23	1.5 (2.5m-4.0m)	4,989	7,484
	A-S20b1	826304	842069	50			
	A-S20c1	826370	842064	41			
A-S24	A-S24a1	825798	841907	32	1.5 (2.5m-4.0m)	4,001	6,002
	A-S24b1	825851	841923	46			
	A-S24c1	825841	841857	34			
A-SG10	A-SG10a1	826037	841813	31	1.5 (4.0m-5.5m)	3,520	5,280
	A-SG10b1	825048	841852	43			
	A-SG10c1	826088	841837	34			
Sub-Total:						22,666	42,364

預計位於A-S03a1和A-S03c1的受污染物料量(立方米) Materials at A-S03a1 & A-S03c1 (m ³)							Estimated Quantity of Contaminated		
受污染探井 Contaminated Borehole	新增探井編號 Additional Borehole ID	坐標 Coordinates		與受污染探井之距離(米) Distance from Contaminated Borehole (m)	預計垂直污染範圍(米) Estimated Vertical Extent of Contamination (m)	預計受污染面積(平方米) Estimated Contaminated Area (m ²)	預計受污染物料量(立方米) Estimated Quantity of Contaminated Materials (m ³)		
		東距 Easting	北距 Northing						
A-S03a1	A-S03a	526526	542839	48	1.5 (4.0-5.5m)	4,452	6,678		
	A-S03b1	826618	842774	51					
	A-S03	826627	842800	43					
A-S03c1	A-S03c	826683	842715	50	1.5 (1.0-2.5m)	5,601	8,402		
	A-S03b1	826618	842774	41					
	A-S03	826627	842800	51					
Sub-Total:						10,053	15,080		
Total:							57,444

- 落馬洲河套地區 LMC Loop
- 砷含量超標的探井 Concerned Boreholes with Arsenic Contamination
- 新增取樣探井 Additional Borehole Location
- 進一步新增取樣探井 Further Additional Borehole Location
- 蘆葦田 Reedbed
- 預計受污染區域(平方米) Estimated Contaminated Area (m²)

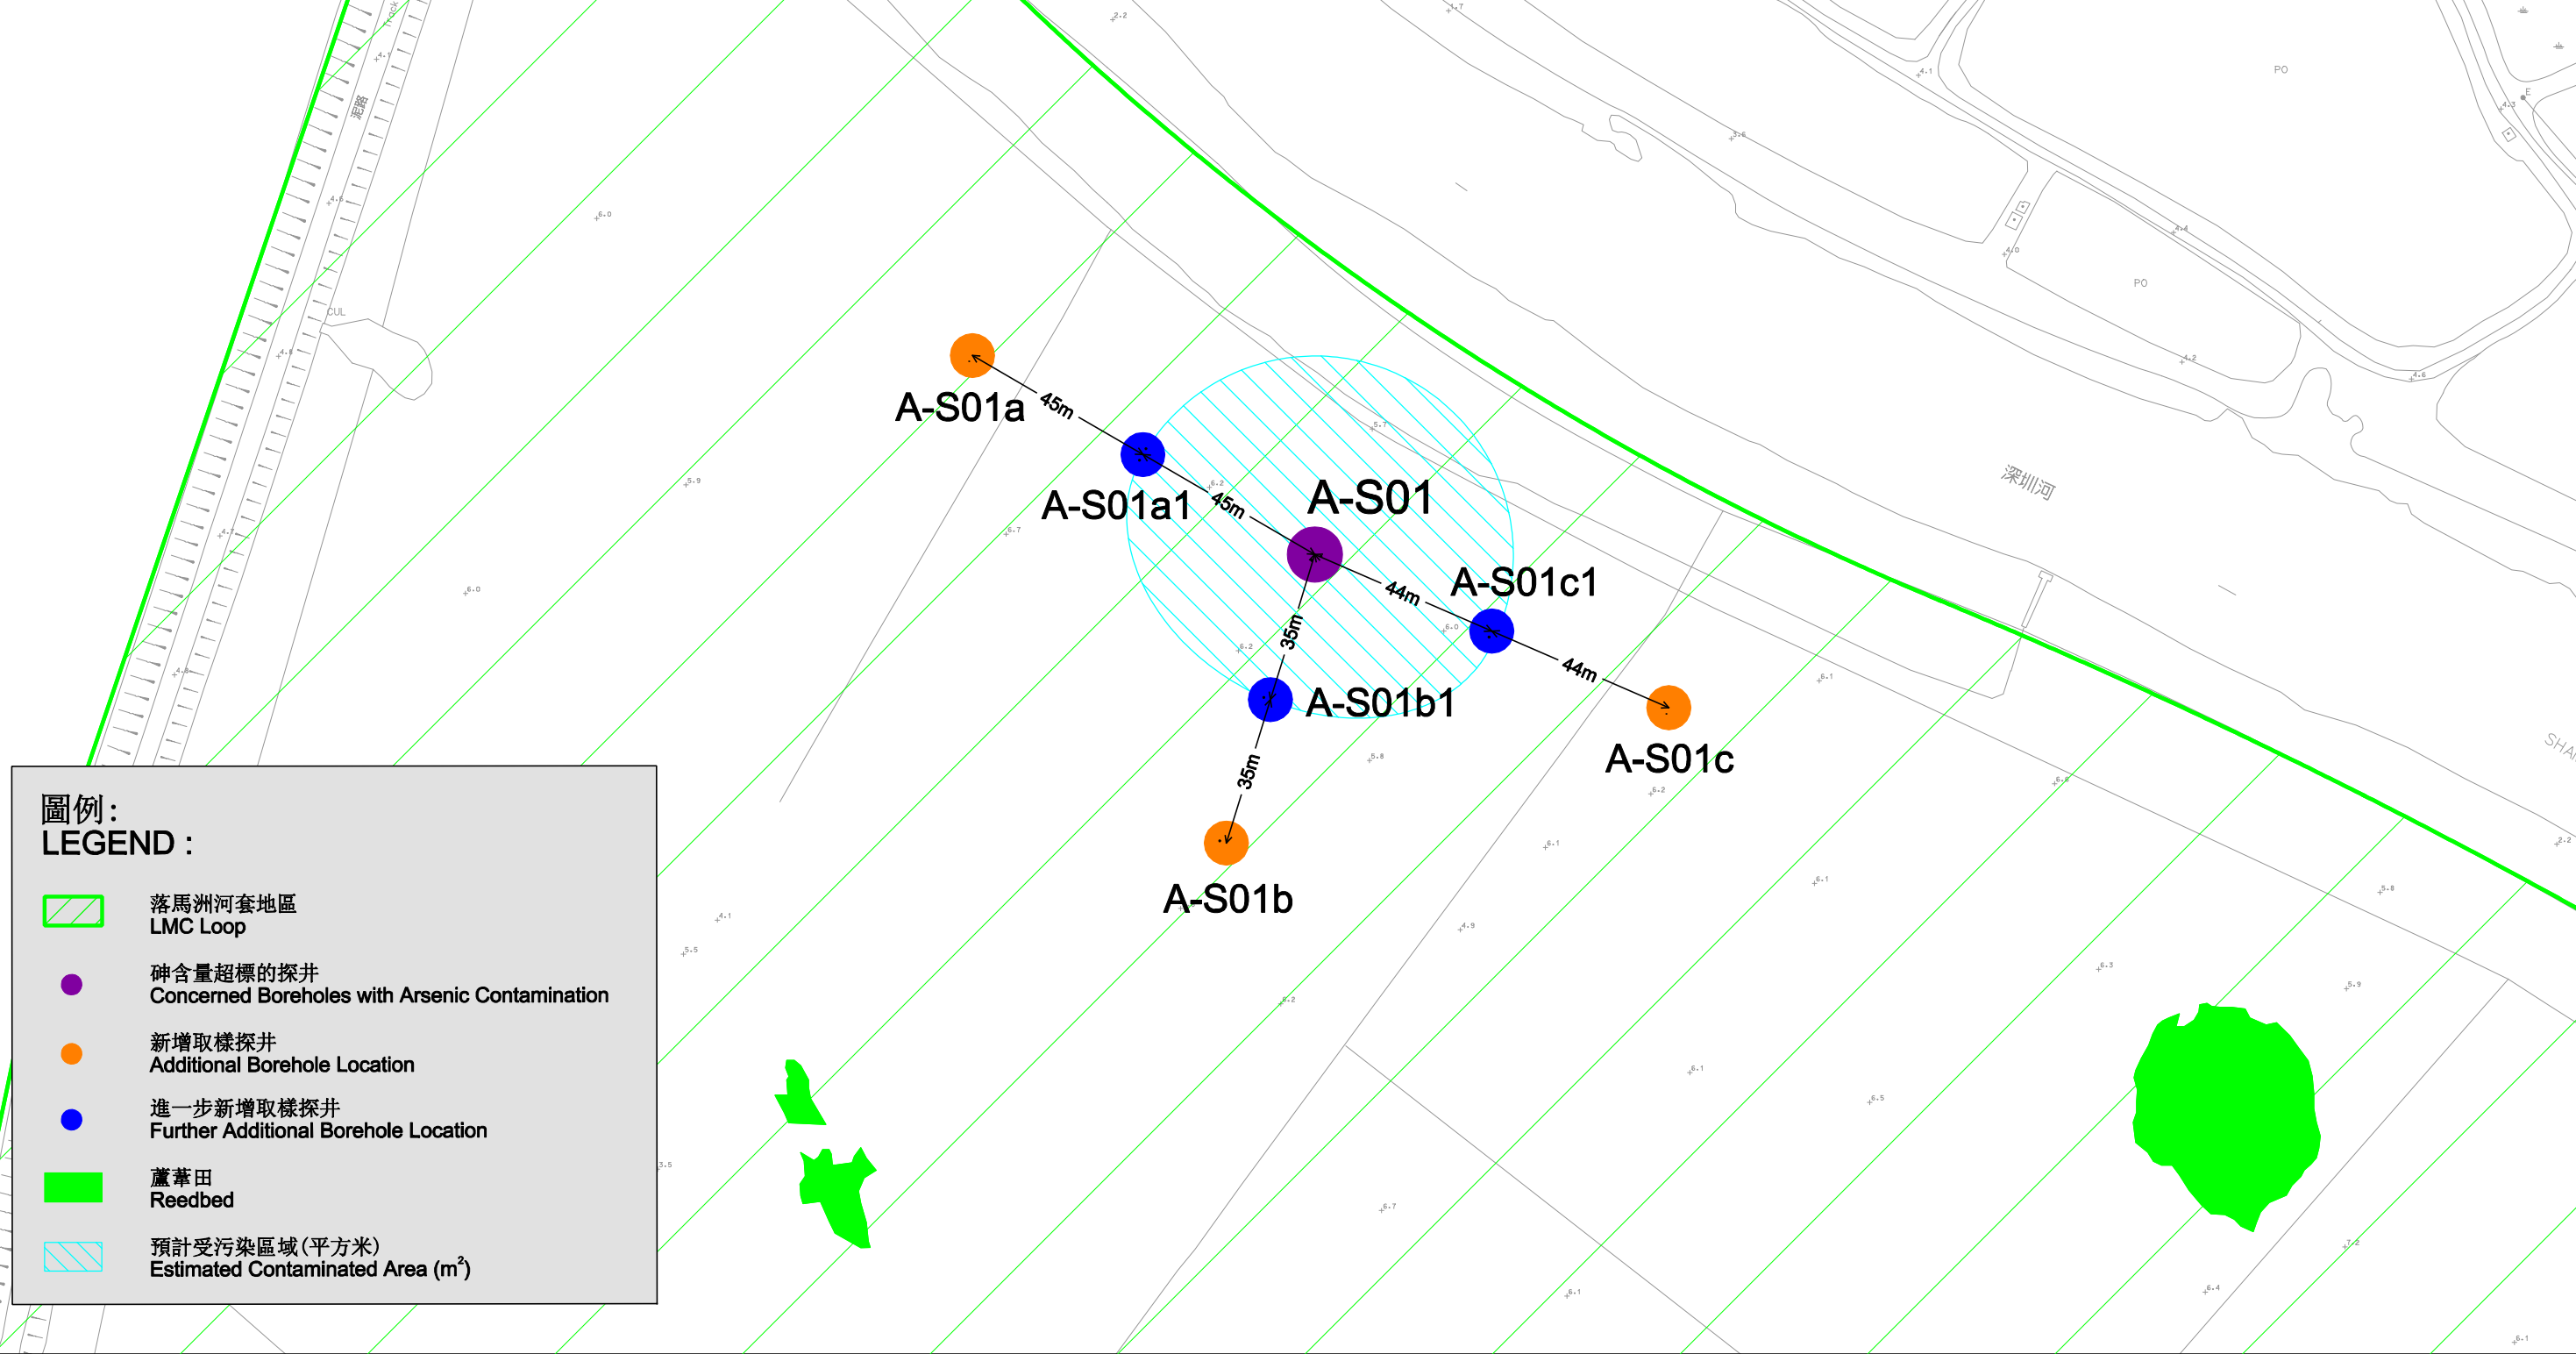
受污染探井 Contaminated Borehole	新增探井編號 Additional Borehole ID	坐標 Coordinates		與受污染探井之距離(米) Distance from Contaminated Borehole (m)	預計垂直污染範圍(米) Estimated Vertical Extent of Contamination (m)	預計受污染面積(平方米) Estimated Contaminated Area (m ²)	預計受污染物料量(立方米) Estimated Quantity of Contaminated Materials (m ³)
		東距 Easting	北距 Northing				
A-S01	A-S01a1	826258	842957	45	3.0 (2.5m-5.5m)	5,576	16,728
	A-S01b1	826287	842902	35			
	A-S01c1	826338	842918	44

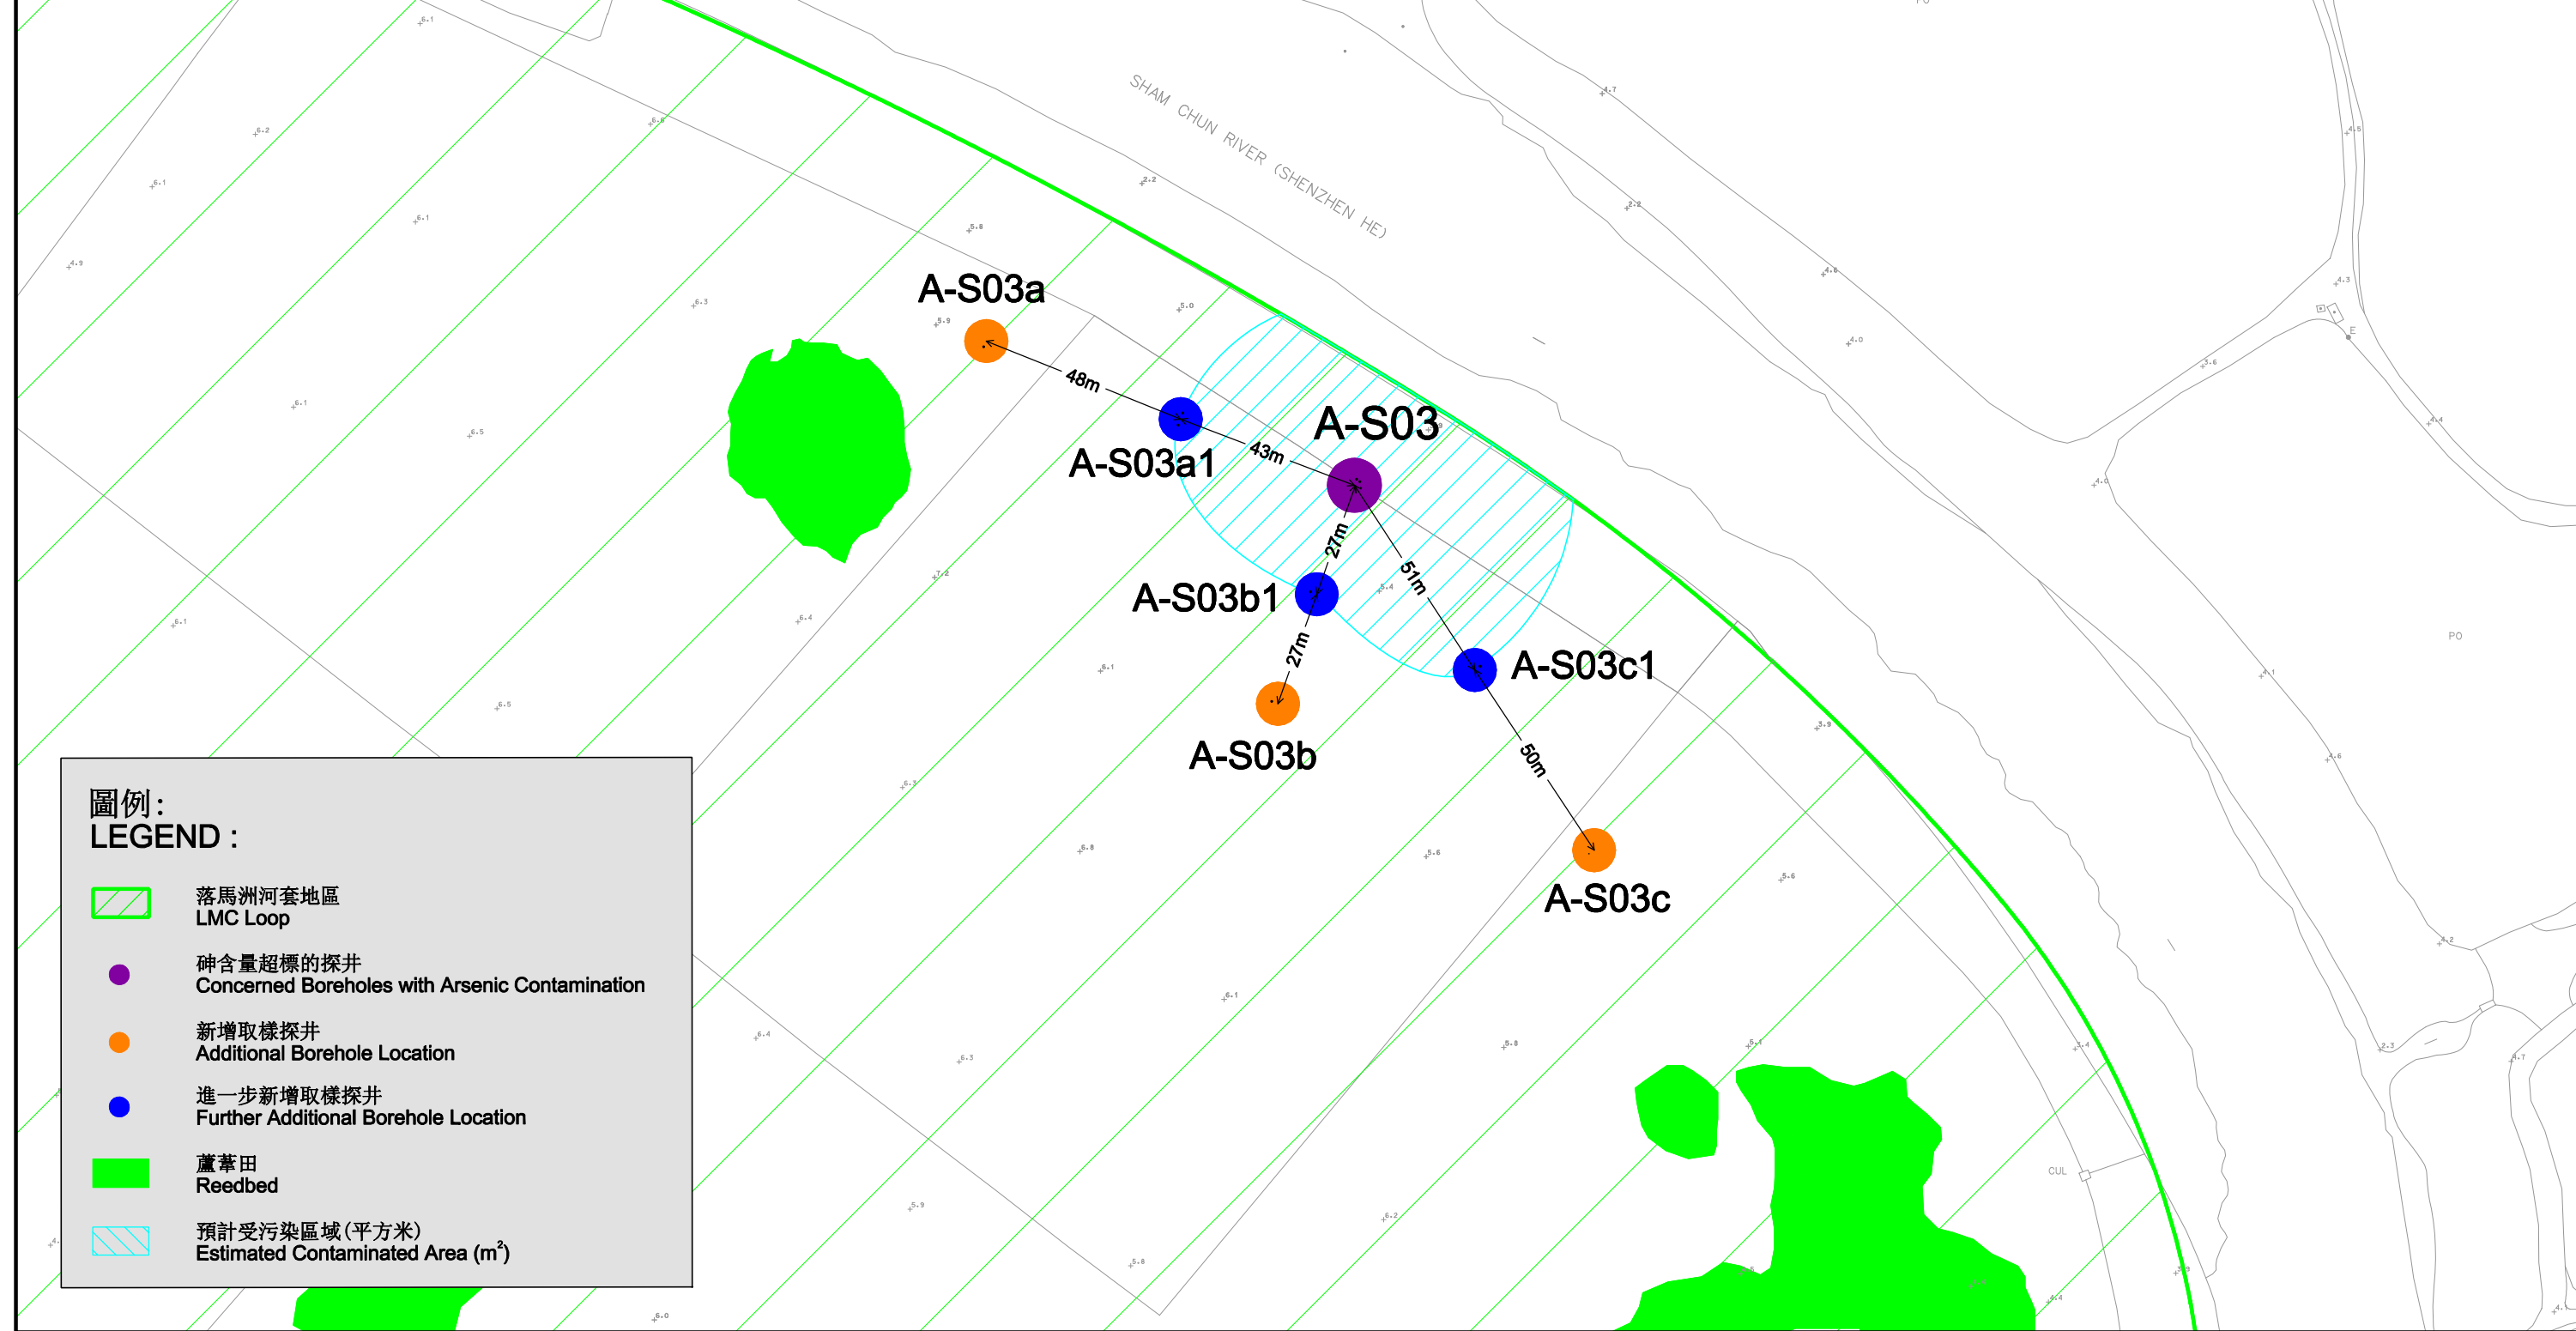
受污染探井 Contaminated Borehole	新增探井編號 Additional Borehole ID	坐標Coordinates		與受污染探井之距離(米) Distance from Contaminated Borehole (m)	預計垂直污染範圍(米) Estimated Vertical Extent of Contamination (m)	預計受污染面積(平方米) Estimated Contaminated Area (m ²)	預計受污染物料量(立方米) Estimated Quantity of Contaminated Materials (m ³)
		東距 Easting	北距 Northing				
A-S03	A-S03a1	826587	842815	43	1.5 (2.5m-4.0m)	4,580	6,870
	A-S03b1	826618	842774	27			
	A-S03c1	826655	842757	51

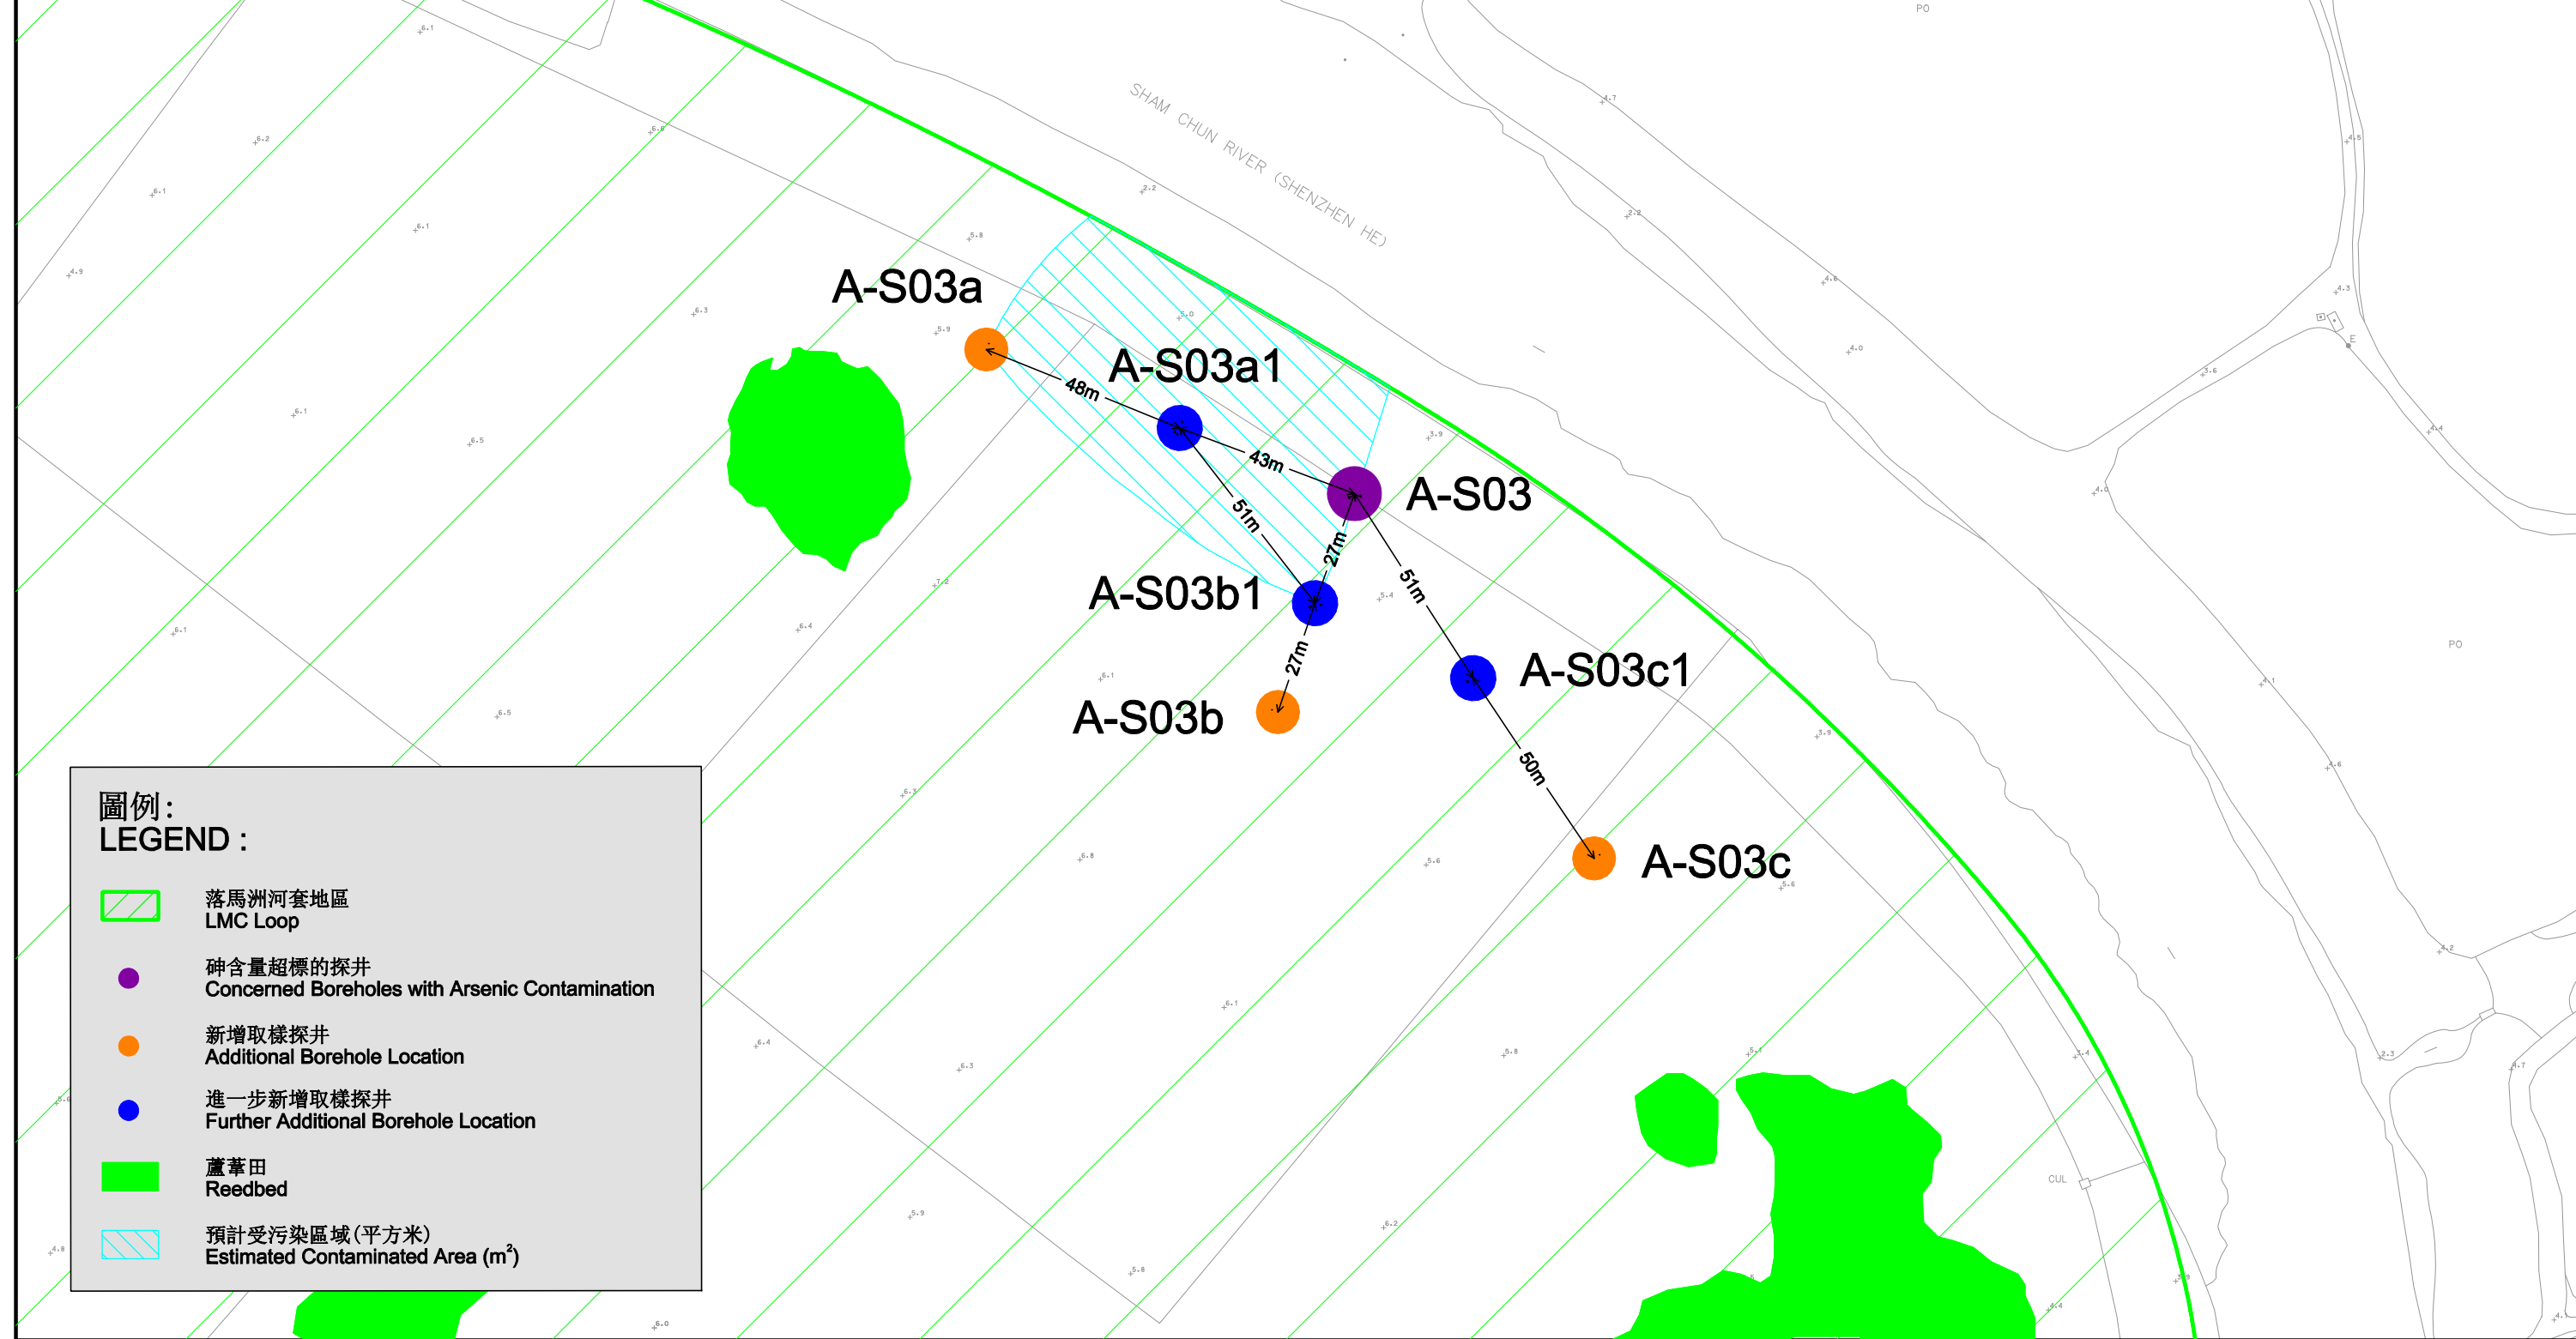
受污染探井 Contaminated Borehole	新增探井編號 Additional Borehole ID	坐標 Coordinates		與受污染探井之距離(米) Distance from Contaminated Borehole (m)	預計垂直污染範圍(米) Estimated Vertical Extent of Contamination (m)	預計受污染面積(平方米) Estimated Contaminated Area (m ²)	預計受污染物料量(立方米) Estimated Quantity of Contaminated Materials (m ³)
		東距 Easting	北距 Northing				
A-S03a1	A-S03a	526526	542839	48	1.5 (4.0-5.5m)	4,452	6,678
	A-S03b1	826618	842774	51			
	A-S03	826627	842800	43
