潛在受污染區域 A
 Location of Potentially Contaminated Site A

Project: CAP Programme

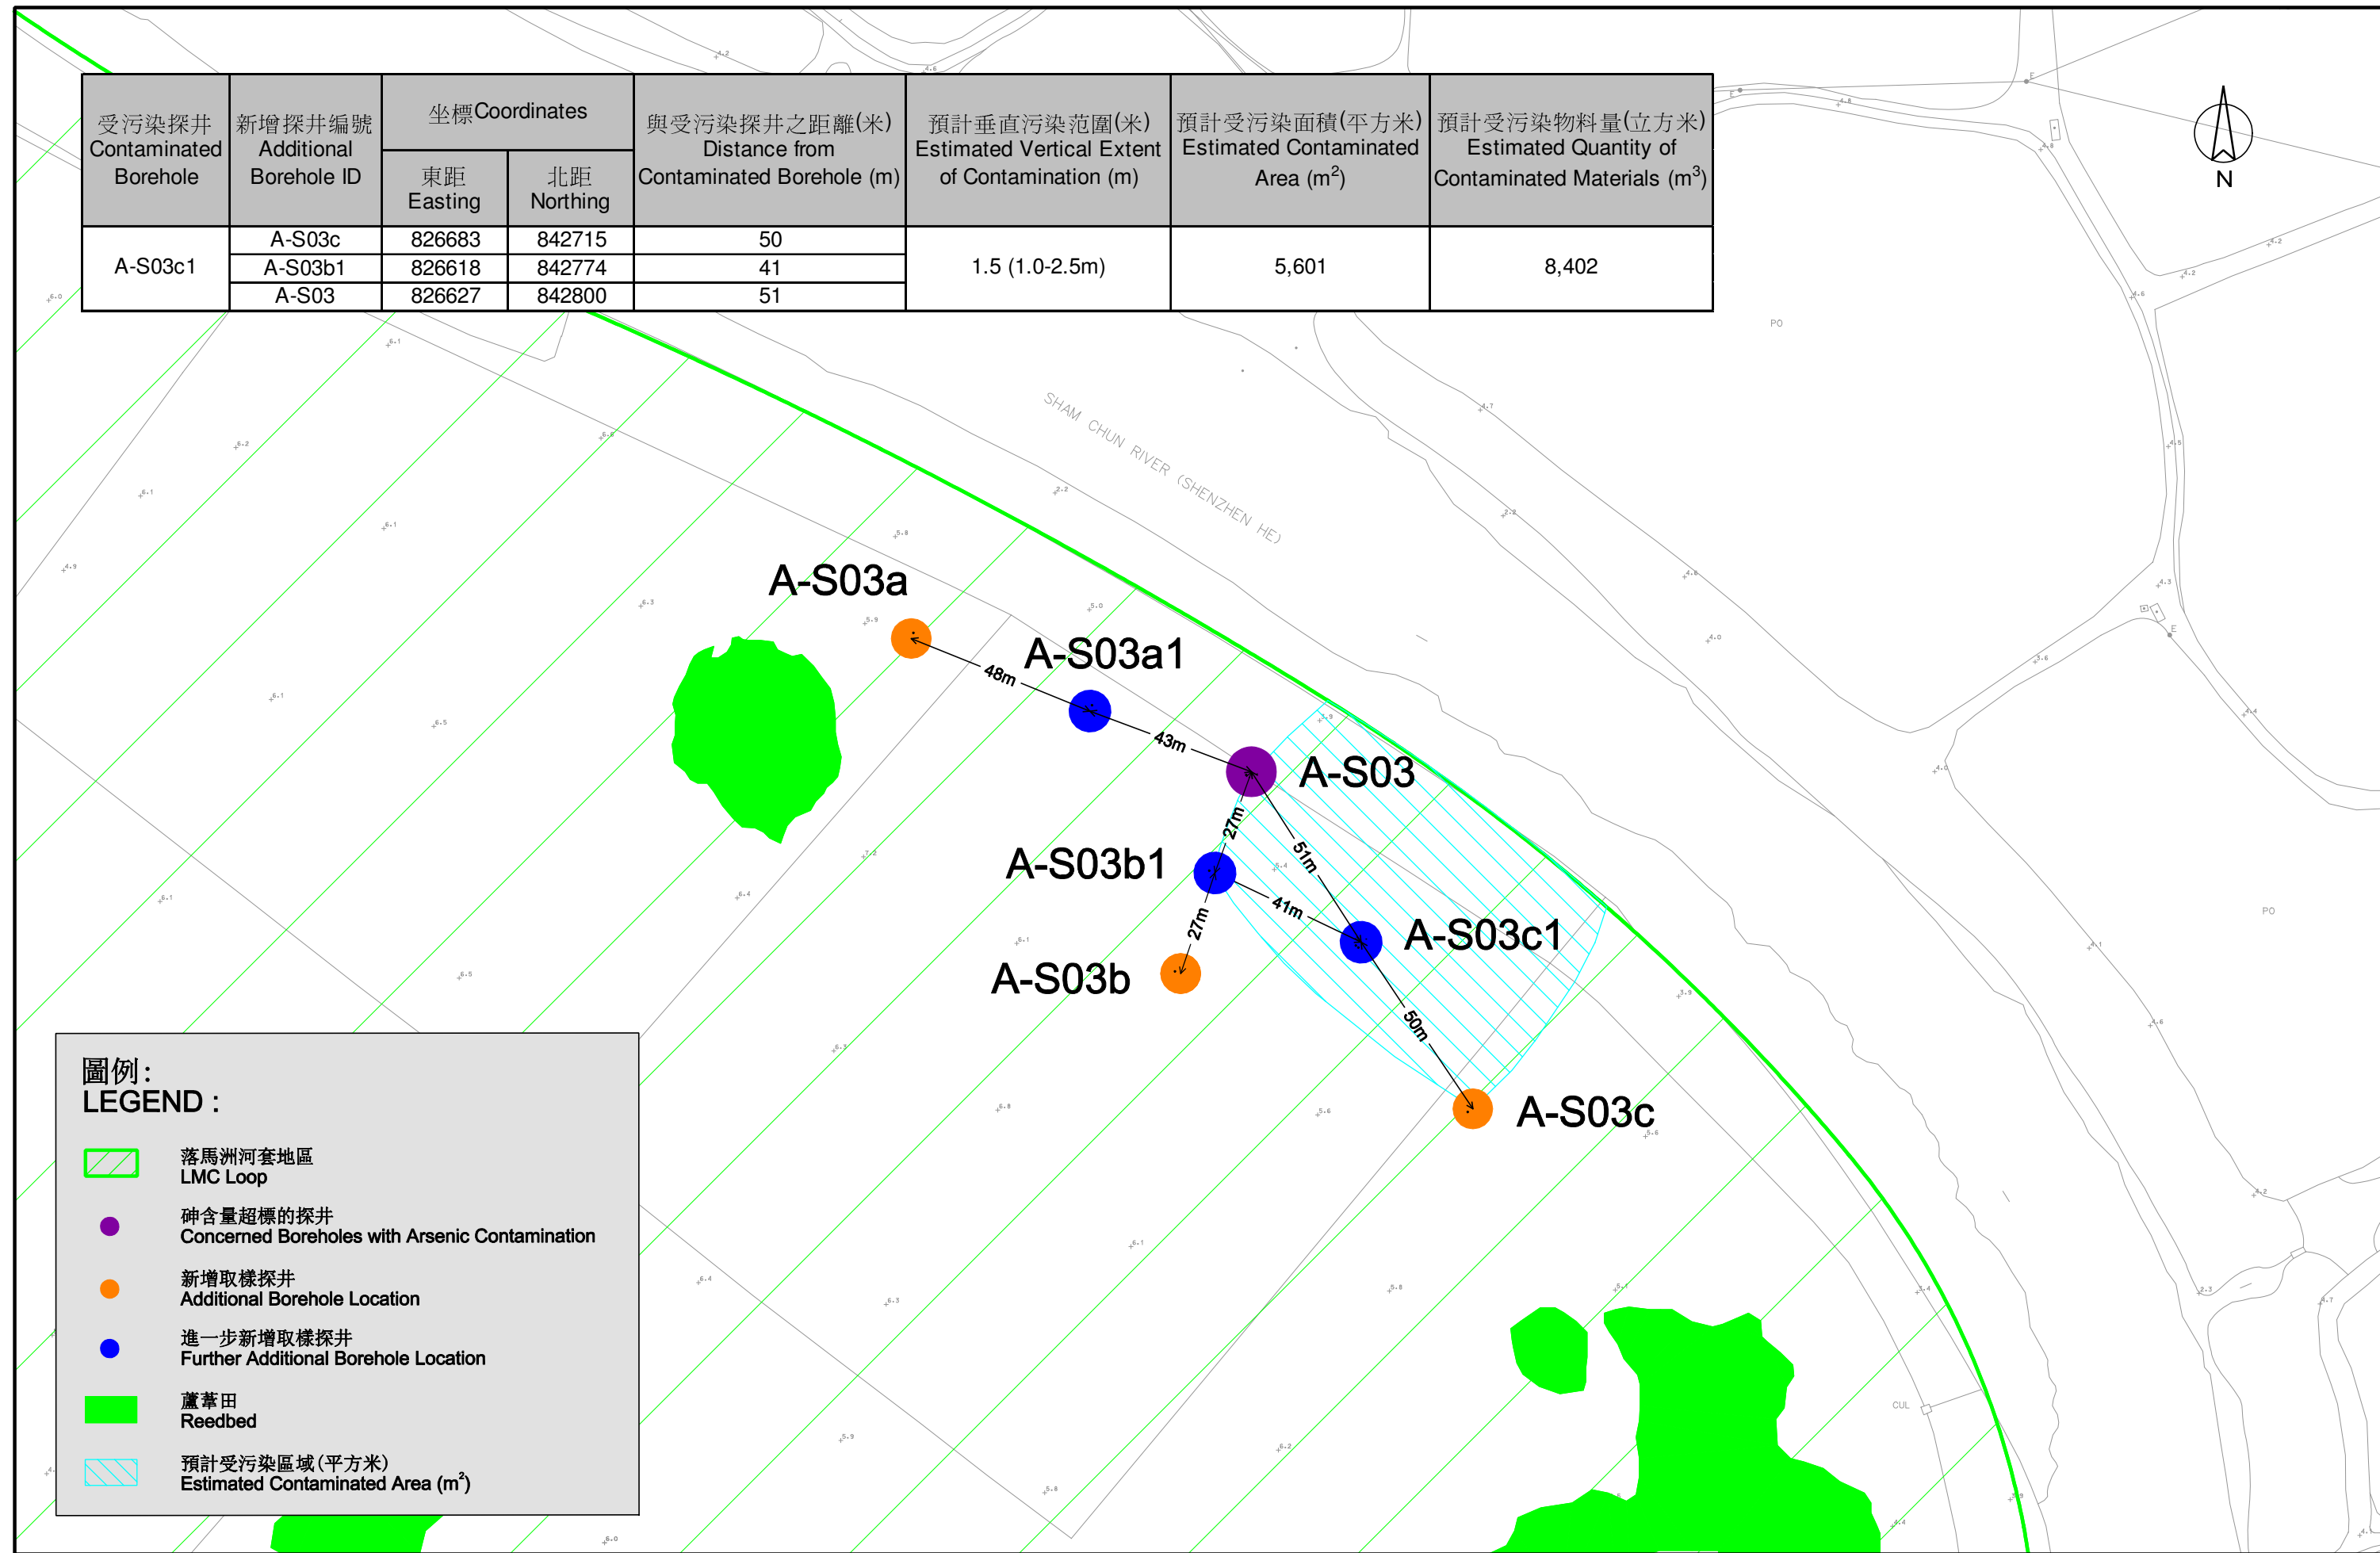
受污染探井 Contaminated Borehole	新增探井編號 Additional Borehole ID	坐標 Coordinates		與受污染探井之距離(米) Distance from Contaminated Borehole (m)	預計垂直污染範圍(米) Estimated Vertical Extent of Contamination (m)	預計受污染面積(平方米) Estimated Contaminated Area (m ²)	預計受污染物料量(立方米) Estimated Quantity of Contaminated Materials (m ³)
		東距 Easting	北距 Northing				
A-S03c1	A-S03c	826683	842715	50	1.5 (1.0-2.5m)	5,601	8,402
	A-S03b1	826618	842774	41			
	A-S03	826627	842800	51

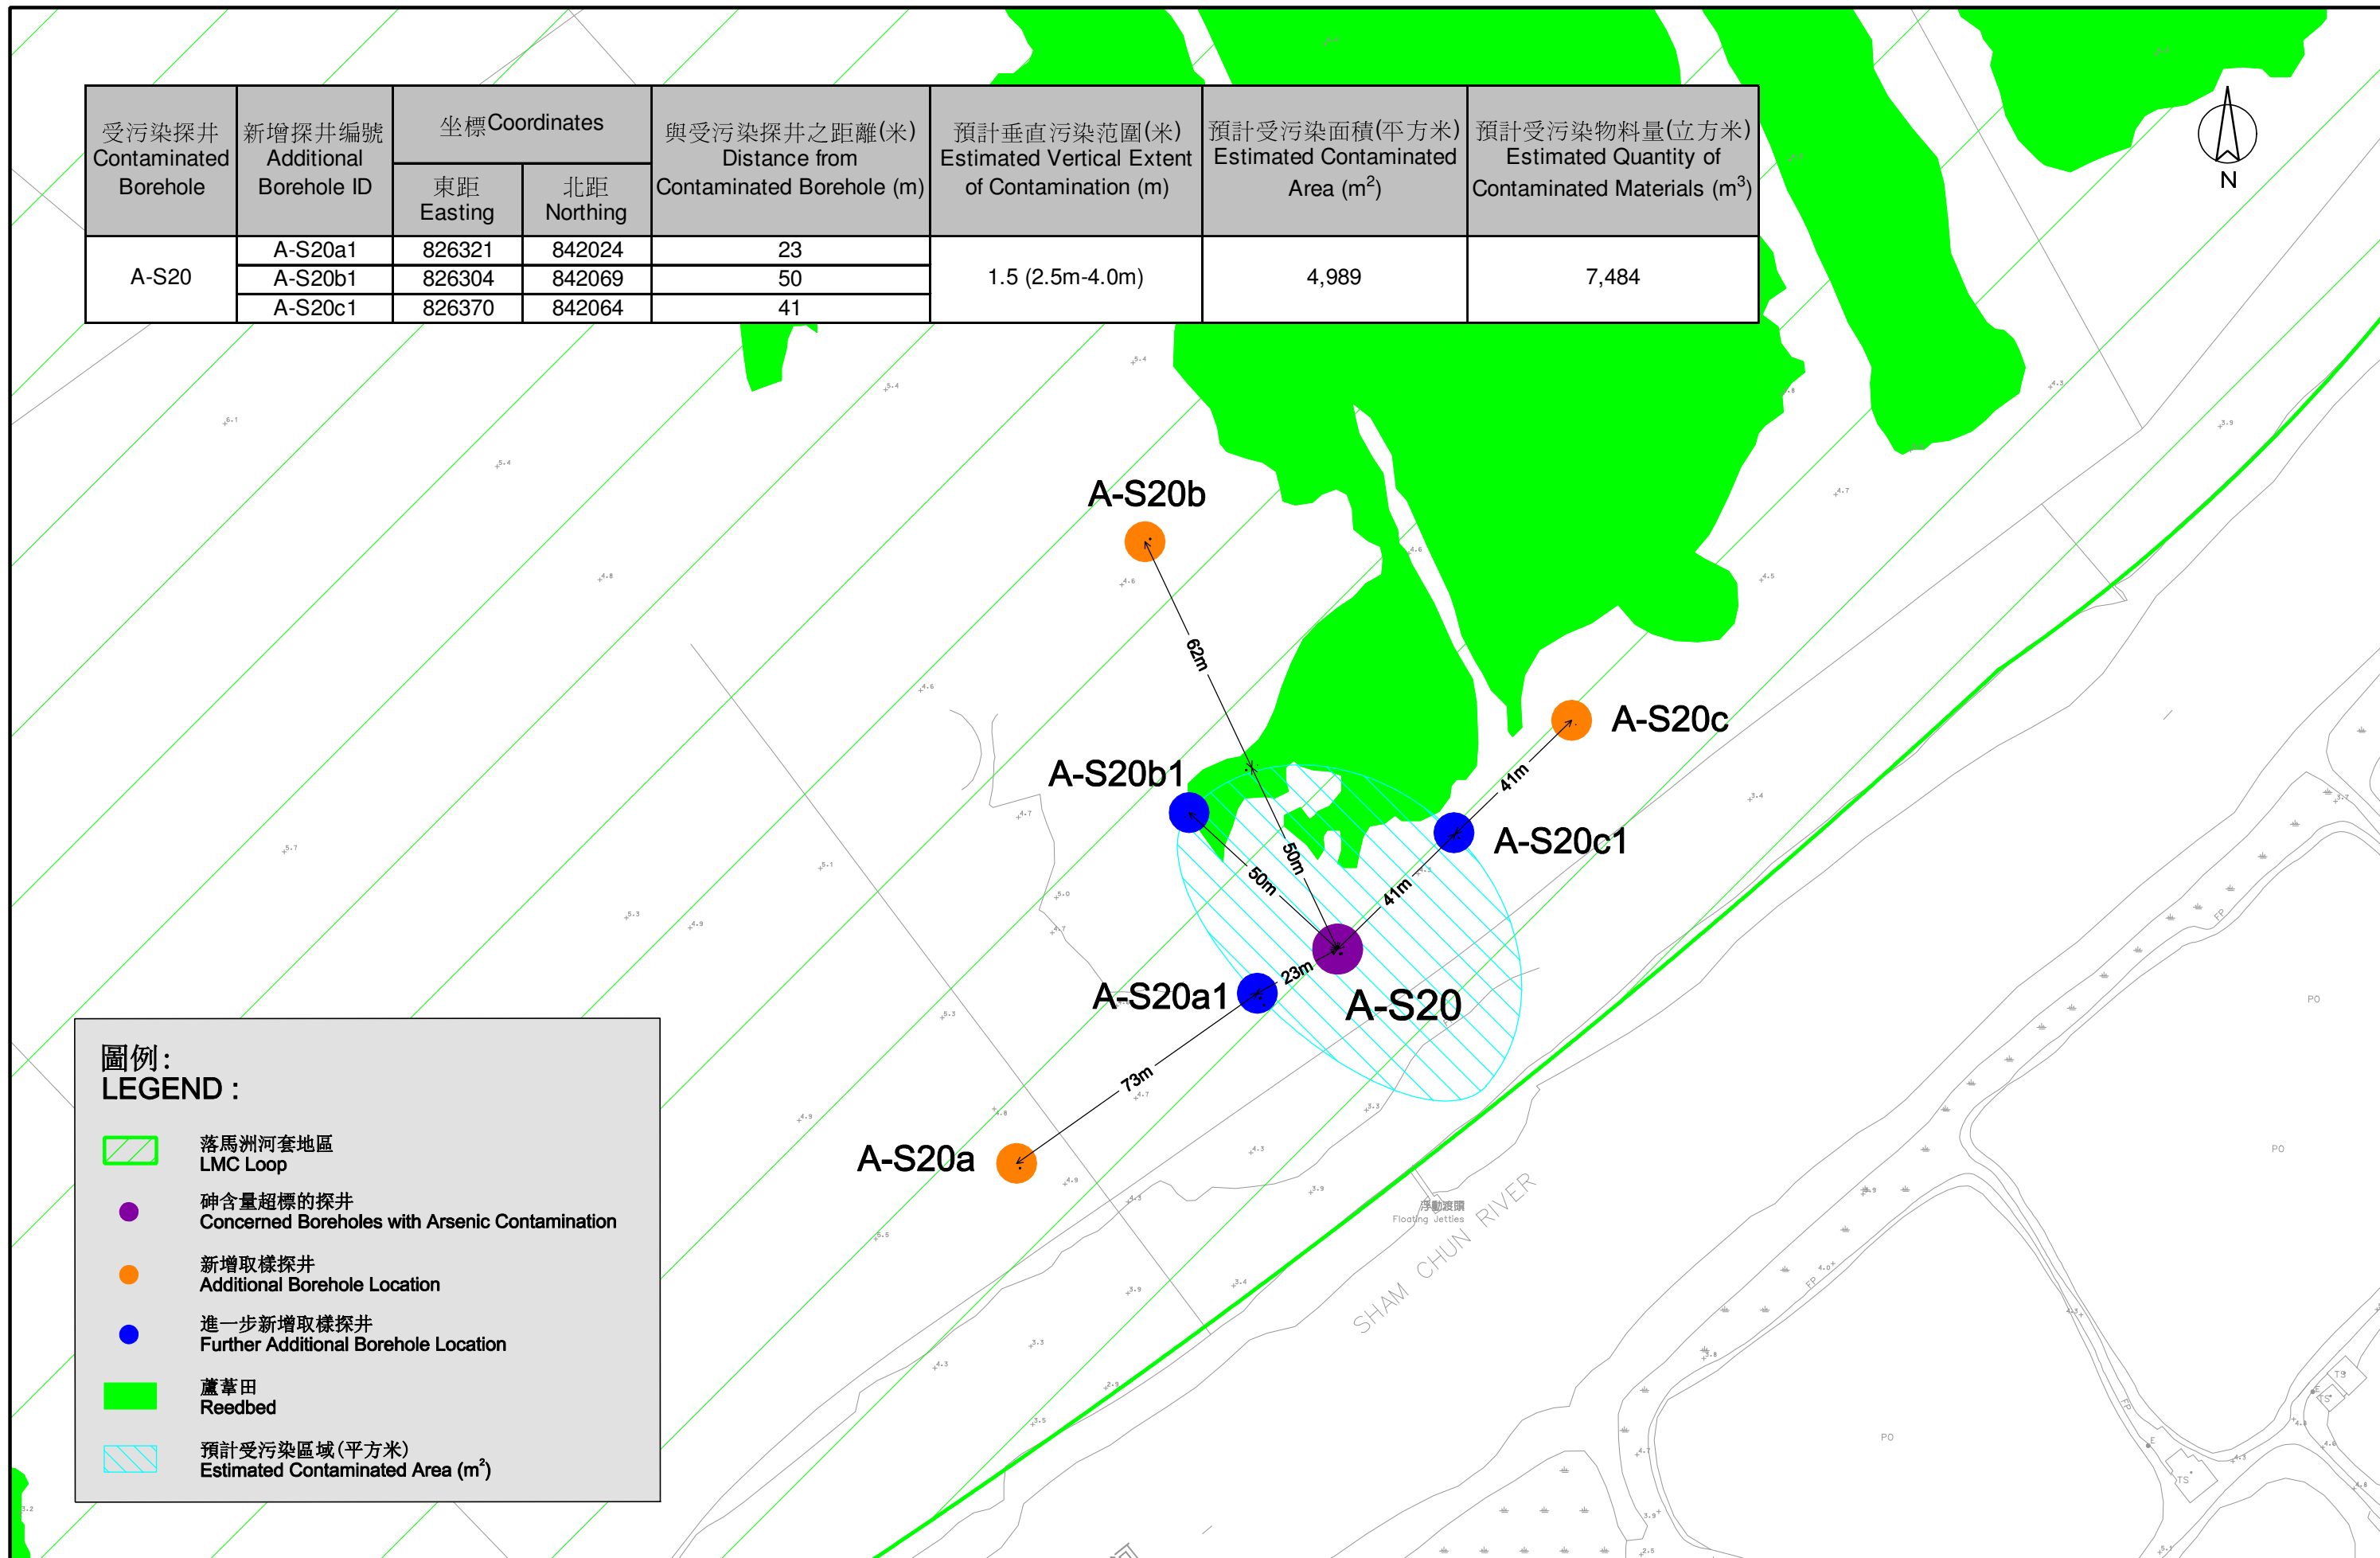
受污染探井 Contaminated Borehole	新增探井編號 Additional Borehole ID	坐標 Coordinates		與受污染探井之距離(米) Distance from Contaminated Borehole (m)	預計垂直污染範圍(米) Estimated Vertical Extent of Contamination (m)	預計受污染面積(平方米) Estimated Contaminated Area (m ²)	預計受污染物料量(立方米) Estimated Quantity of Contaminated Materials (m ³)
		東距 Easting	北距 Northing				
A-S20	A-S20a1	826321	842024	23	1.5 (2.5m-4.0m)	4,989	7,484
	A-S20b1	826304	842069	50			
	A-S20c1	826370	842064	41

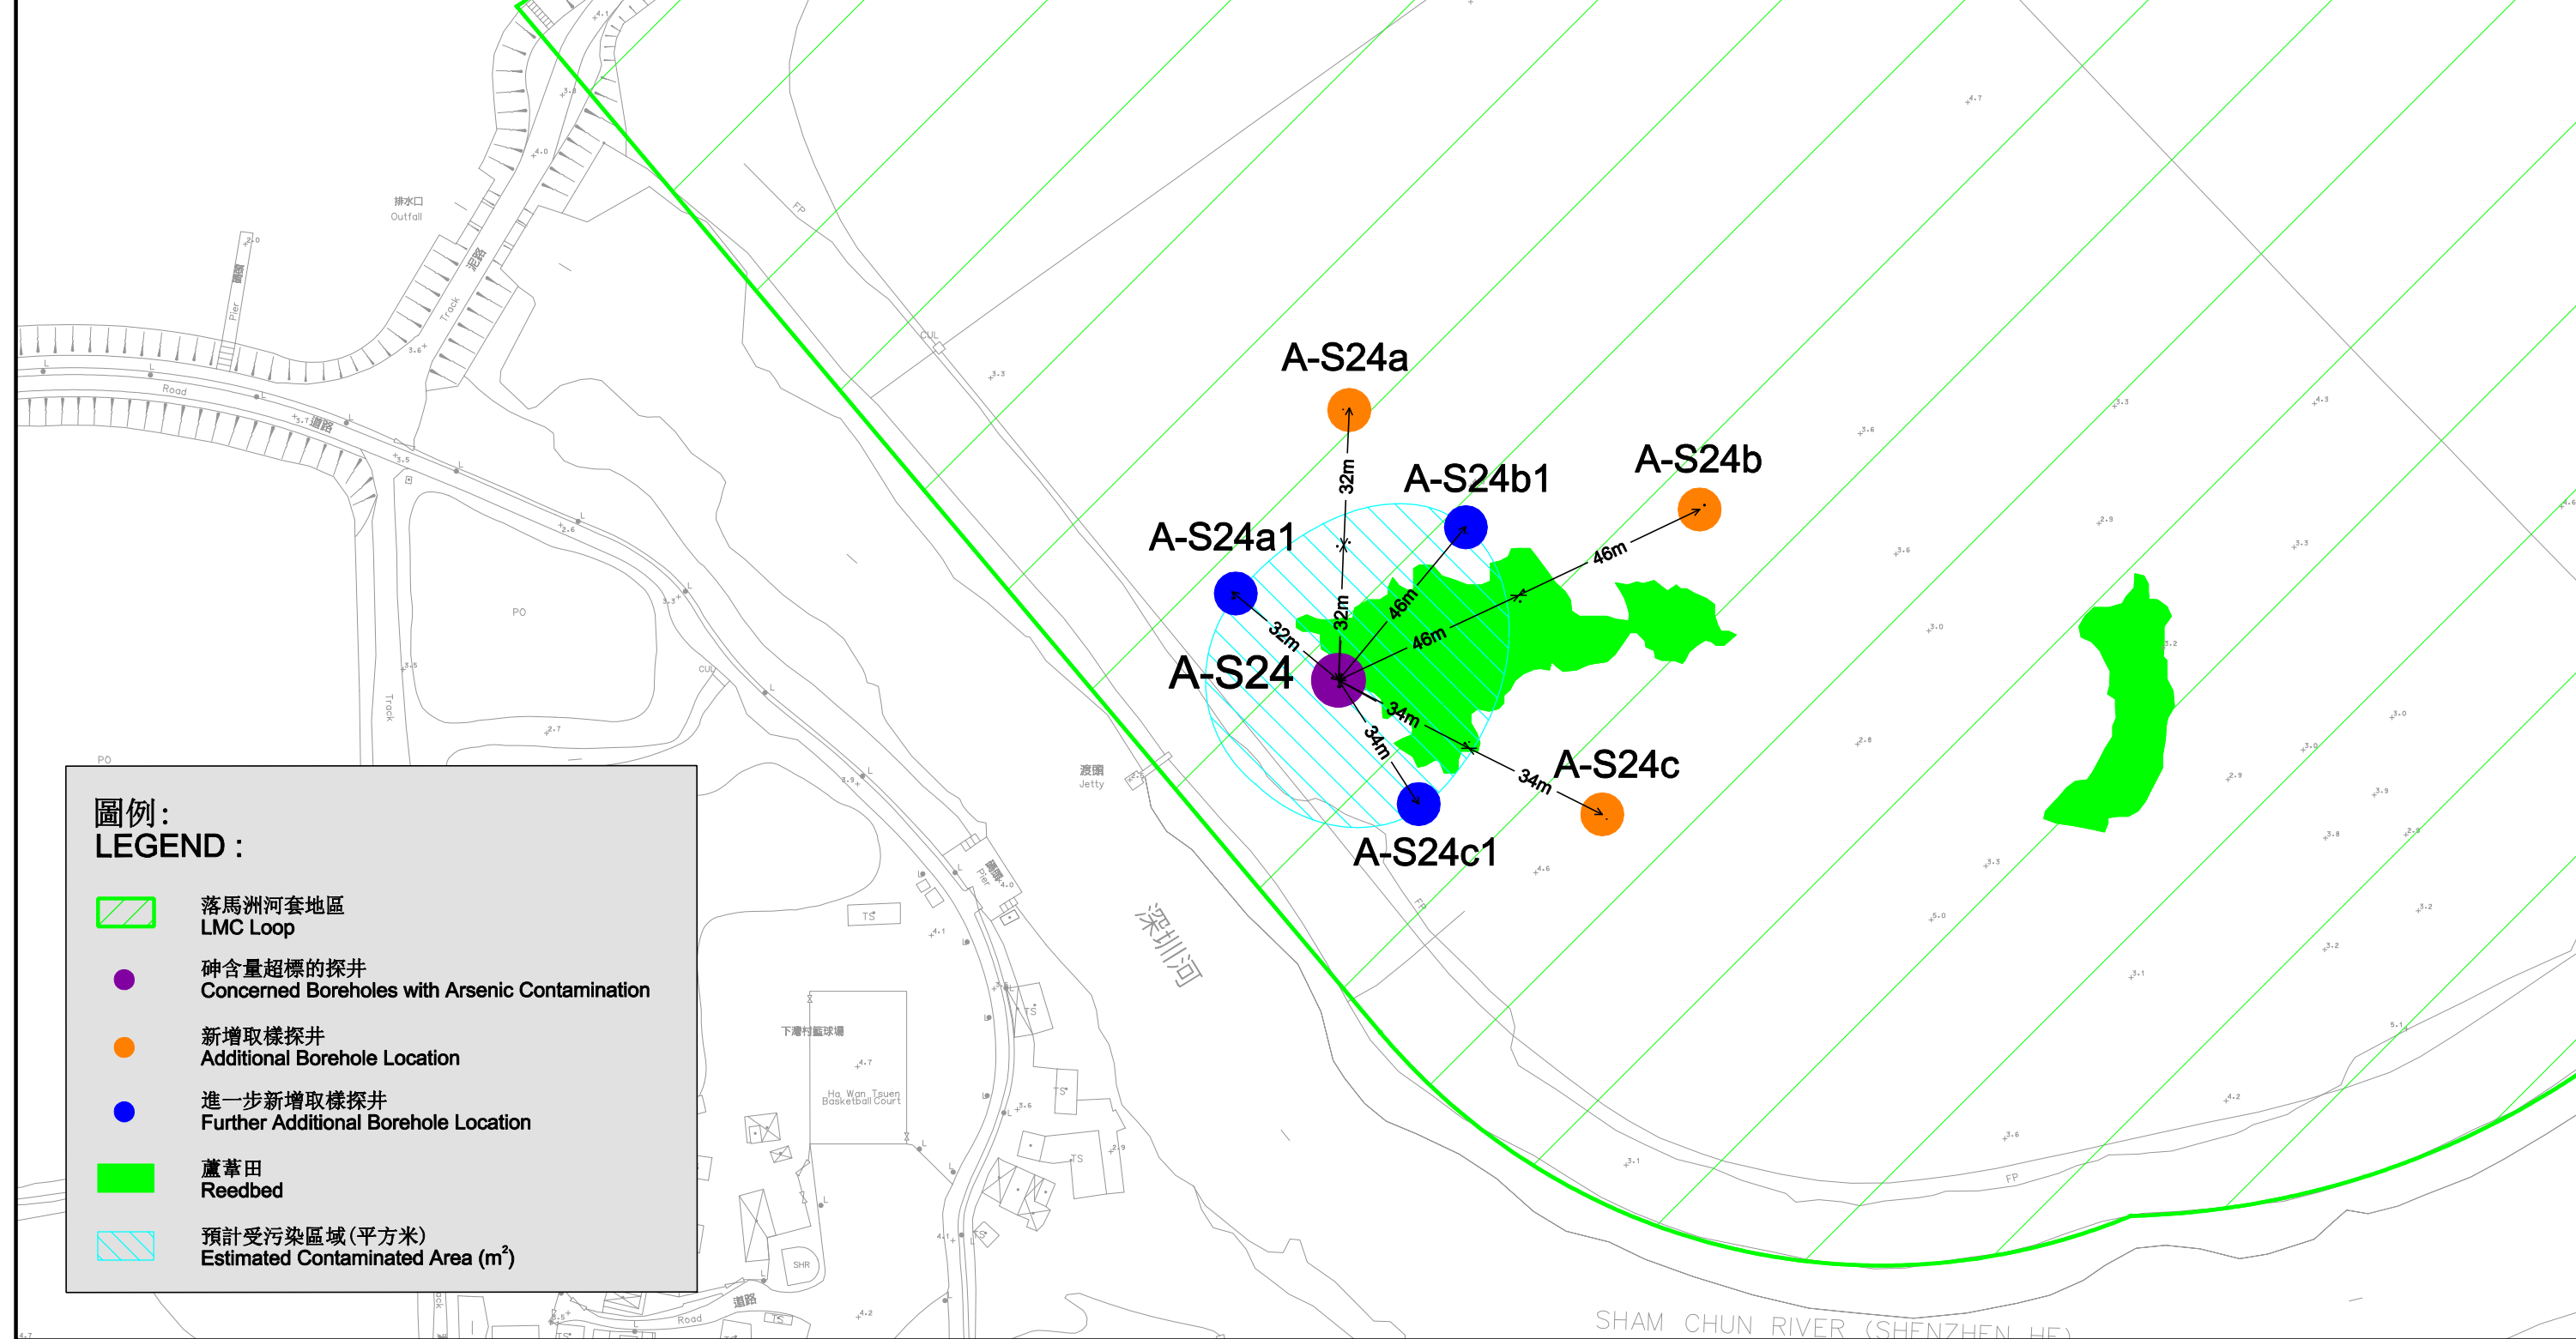
受污染探井 Contaminated Borehole	新增探井編號 Additional Borehole ID	坐標 Coordinates		與受污染探井之距離(米) Distance from Contaminated Borehole (m)	預計垂直污染範圍(米) Estimated Vertical Extent of Contamination (m)	預計受污染面積(平方米) Estimated Contaminated Area (m ²)	預計受污染物料量(立方米) Estimated Quantity of Contaminated Materials (m ³)
		東距 Easting	北距 Northing				
A-S24	A-S24a1	825798	841907	32	1.5 (2.5m-4.0m)	4,001	6,002
	A-S24b1	825851	841923	46			
	A-S24c1	825841	841857	34

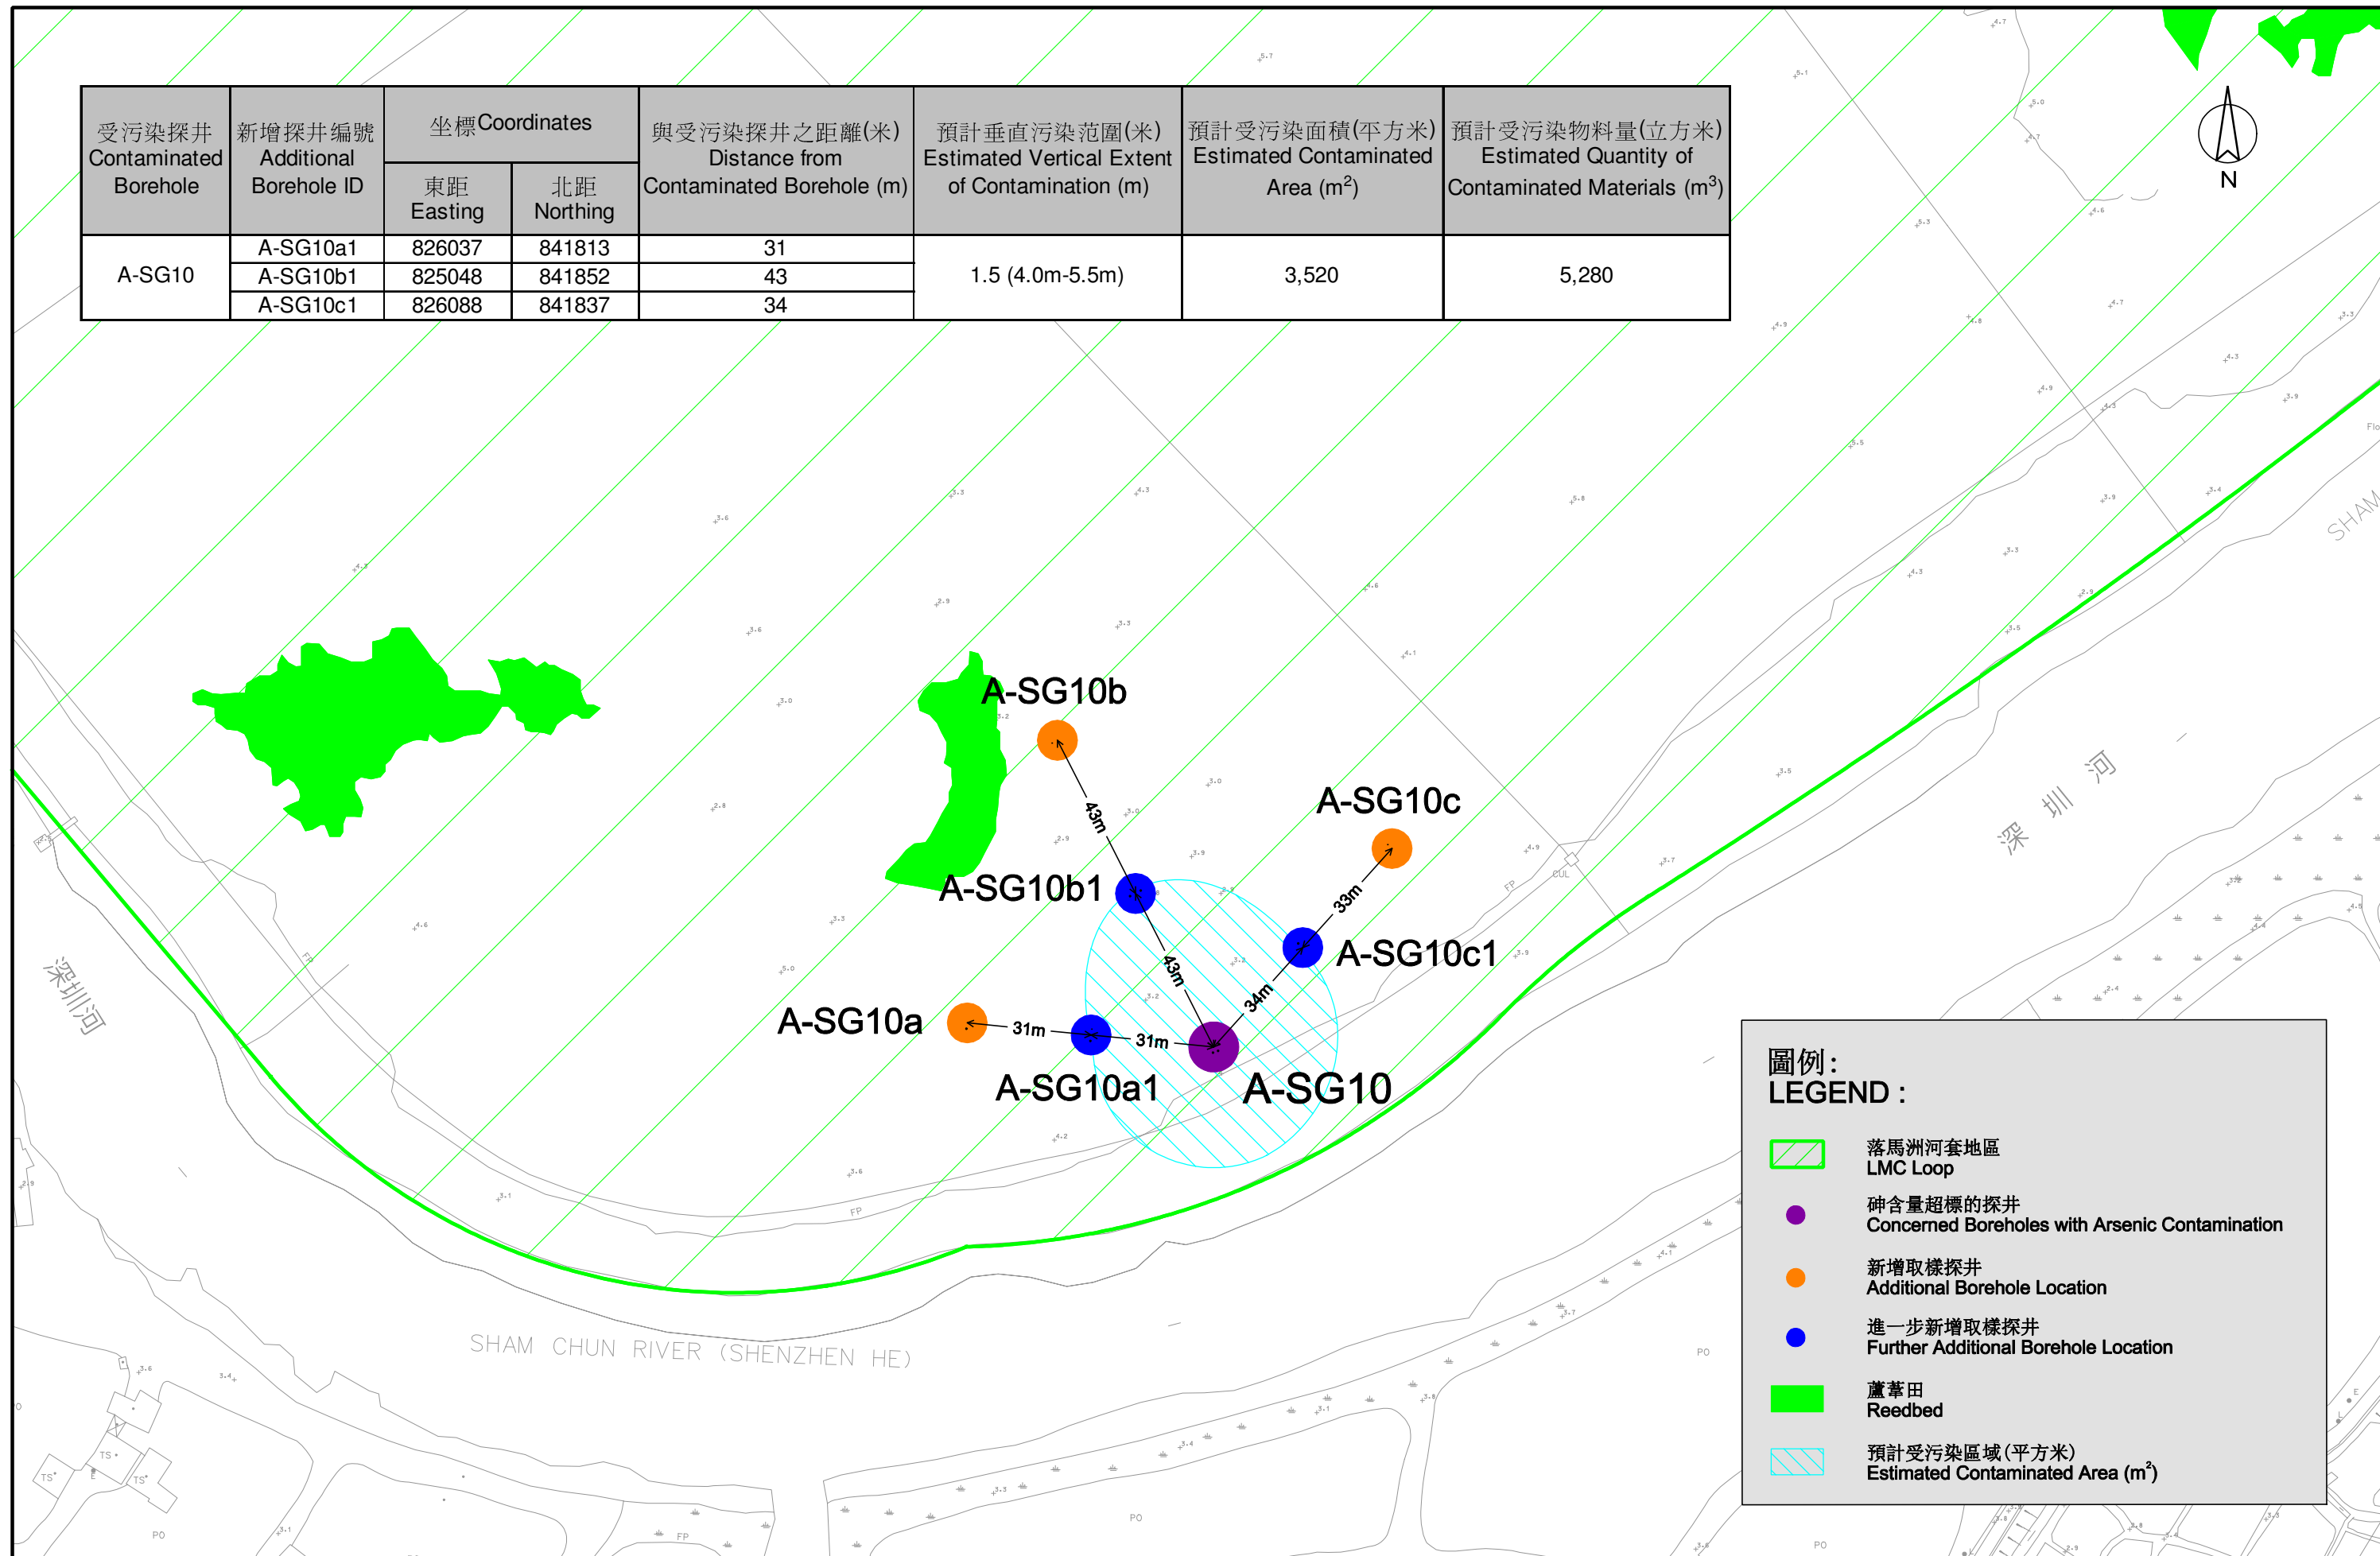
受污染探井 Contaminated Borehole	新增探井編號 Additional Borehole ID	坐標Coordinates		與受污染探井之距離(米) Distance from Contaminated Borehole (m)	預計垂直污染範圍(米) Estimated Vertical Extent of Contamination (m)	預計受污染面積(平方米) Estimated Contaminated Area (m ²)	預計受污染物料量(立方米) Estimated Quantity of Contaminated Materials (m ³)
		東距 Easting	北距 Northing				
A-SG10	A-SG10a1	826037	841813	31	1.5 (4.0m-5.5m)	3,520	5,280
	A-SG10b1	825048	841852	43			
	A-SG10c1	826088	841837	34
