| Title: Landscape and Visual Mitigation Measure - Photomontage (Sheet 5 of 6) | Drawn by: DK Checked by: TO |
| Project: Residential cum Passive Recreational Development within "Recreation" ("REC") Zone and Residential (Group C)" Zone at Various Lots in DD 104, Yuen Long, N.T | Rev.: - Date: DEC 2013 |

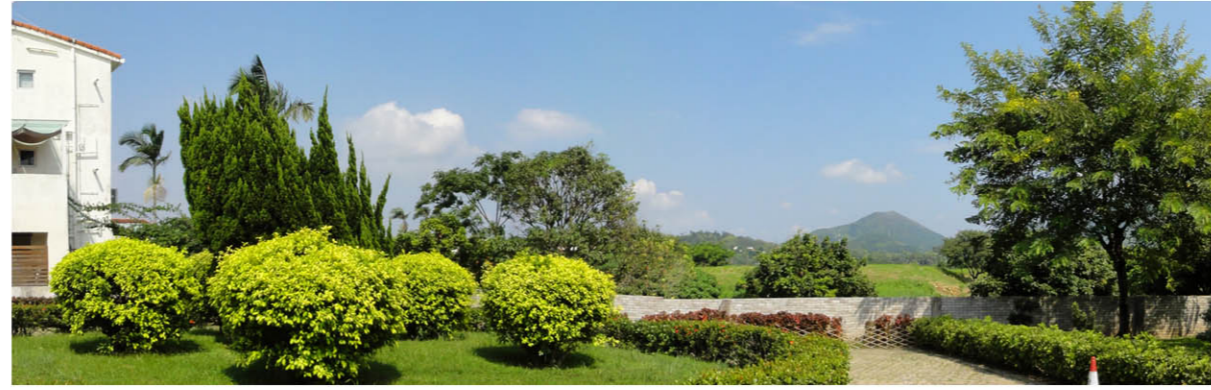
V13 – VIEW FROM NORTHERN FAIRVIEW PARK (VSR NO. R1) - EXISTING SITUATION

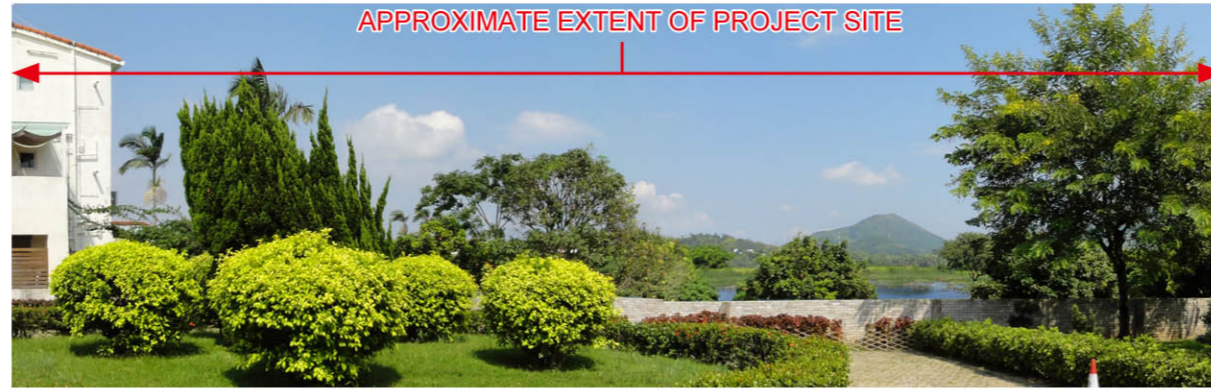
V13 – VIEW FROM NORTHERN FAIRVIEW PARK (VSR NO. R1) - DAY 1 WITHOUT MITIGATION

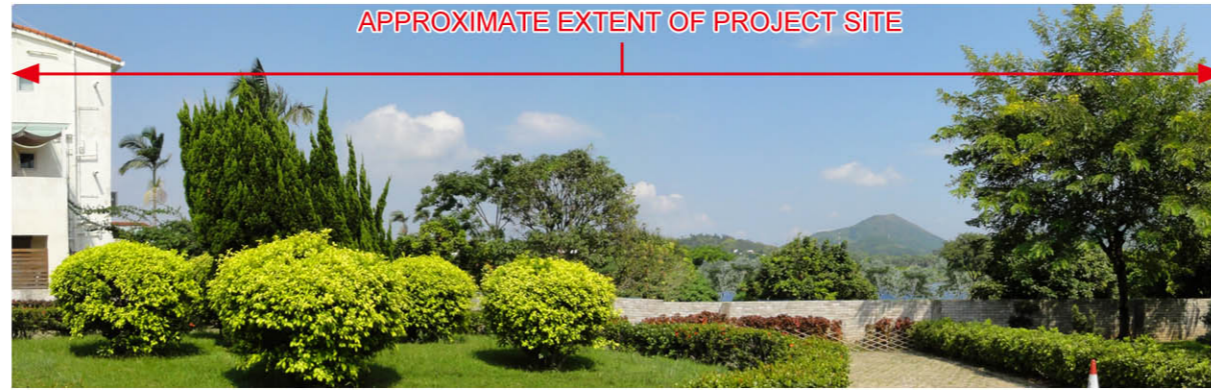
V13 – VIEW FROM NORTHERN FAIRVIEW PARK (VSR NO. R1) - DAY 1 WITH MITIGATION

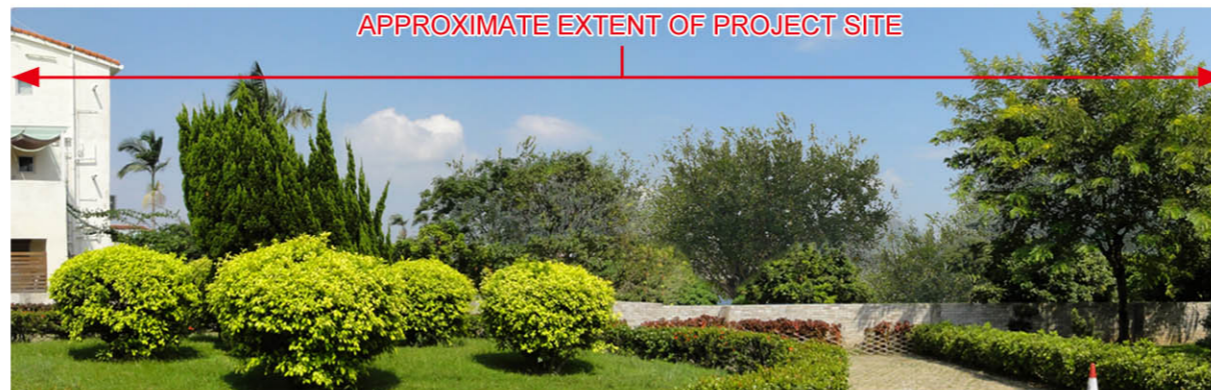
V13 – VIEW FROM NORTHERN FAIRVIEW PARK (VSR NO. R1) - YEAR 10 WITH MITIGATION
