Survey Date:	18/03/2014		1	Map No:	MWC	01
BH Item No.	MWC01	Declared Monument	Ye	es	4	lo
Name of BH	Tung Chung Battery	AMO Announced	4	2	3	No- Grade
Village/Town/ Location	Rocky Lion Hill, Ma Wan Chung	Grading	Propose	d Monum	ent	
District	Tung Chung, Lantau Island	Gov. Historic Sites	Yes No			
Building Type	Battery	Land	Leaseholder Current Us			
Date of Construction	Completed in 1817	Condition	Gover	nment	Pu	blic
Present Use	Preserved Heritage	Current Condition	In U	Jse	Aban	doned
Elements	Building Materials		Building	Methods	•	
Wall	Granite Blocks	Built	by Laying	Granite E	Blocks	
Additional Building Description (Optional)	Remains of Tung Chung Battery include a likely utilized as a gun emplacement.	an L-shaped wall	all and corner platform which was mos			
Historical /Cultural Information (Optional)	monuments). It is located on a prominent of the battery were rediscovered in 1980 to Battery was completed in 1817 with the put threatened the coasts and seas of souther in the Guangdong Annals, which recounted Lion Hill" — the literal translation of Shek States	peneath thick folia urpose of protecting on China. The consection and how two forts of the.	ge. Const ng Tung C struction o

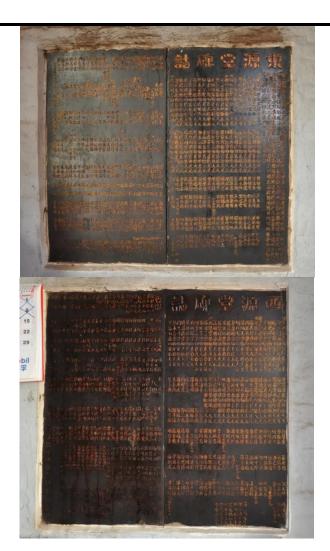
Survey Date: 18/03/2014 Map No: STT01 Declared BH Item No. STT01 Yes No Monument No-Name of BH Hau Wong Temple, Tung Chung 1 2 3 **AMO** Grade **Announced** Village/Town Grading Sha Tsui Tau **Proposed Monument** Name Gov. Historic District Tung Chung, Lantau Island Yes Nο Sites **Building Type** Leaseholder Temple **Current User** Land Date of Condition was Built at least by 1765 CTC* Local Villagers Construction Current **Present Use** Temple In Use **Abandoned** Condition **Elements Building Materials Building Methods** Glazed Roof Tile with Shiwan Ceramic concave, Cylindrical Tile Combined - Liuli Glazed Roof Tile Decoration on the Main Ridge Tiles Tile End Liuli Glazed Tiles with Drippers Dragon Fish Ends + Shiwan Ceramic Ridge Type Decoration include Dragon Fish with N/A Phoenix ends" Wall Granite Foundation + Grey Bricks Painted Brick Line Recessed Entrance + Rectangular Opening Type + Timber + Granite Door Flush Door+ Rectangular Block Door Drum Hau Wong temple is a grade 2 historic building and lies within the Sha Tsui Tau Site of Additional Archaeological Interest, within 100m of Tung Chung bay and the outlet of the Tung Chung River. Building It is a two halls-three bays structure with a Forecourt. The temple has been renovated several Description times since its establishment. Two tablets built in interior walls record two times of renovation and (Optional) the names of the donors. An inscription of a bronze bell within the temple suggests that the temple was built at least by Historical 1765 and is the largest Hau Wong temple on Lantau island. The temple is used to worship of /Cultural Yuen Liangjie and a ceremony is held on the forecourt on the 18th of the eighth month in the Information Lunar calendar every year with activities such as Chinese operas and gatherings in the open area (Optional) of the temple, to celebrate the birthday of Hau Wong. Representative Photo(s) Façade

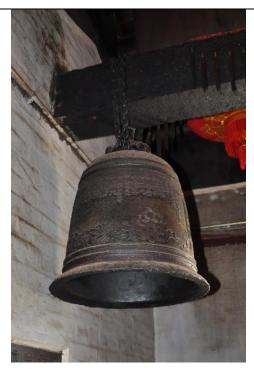
Tablets in Hau Wong Temple (Tung Chung)

Bell in Hau Wong Temple (Tung Chung), Qing Dynasity

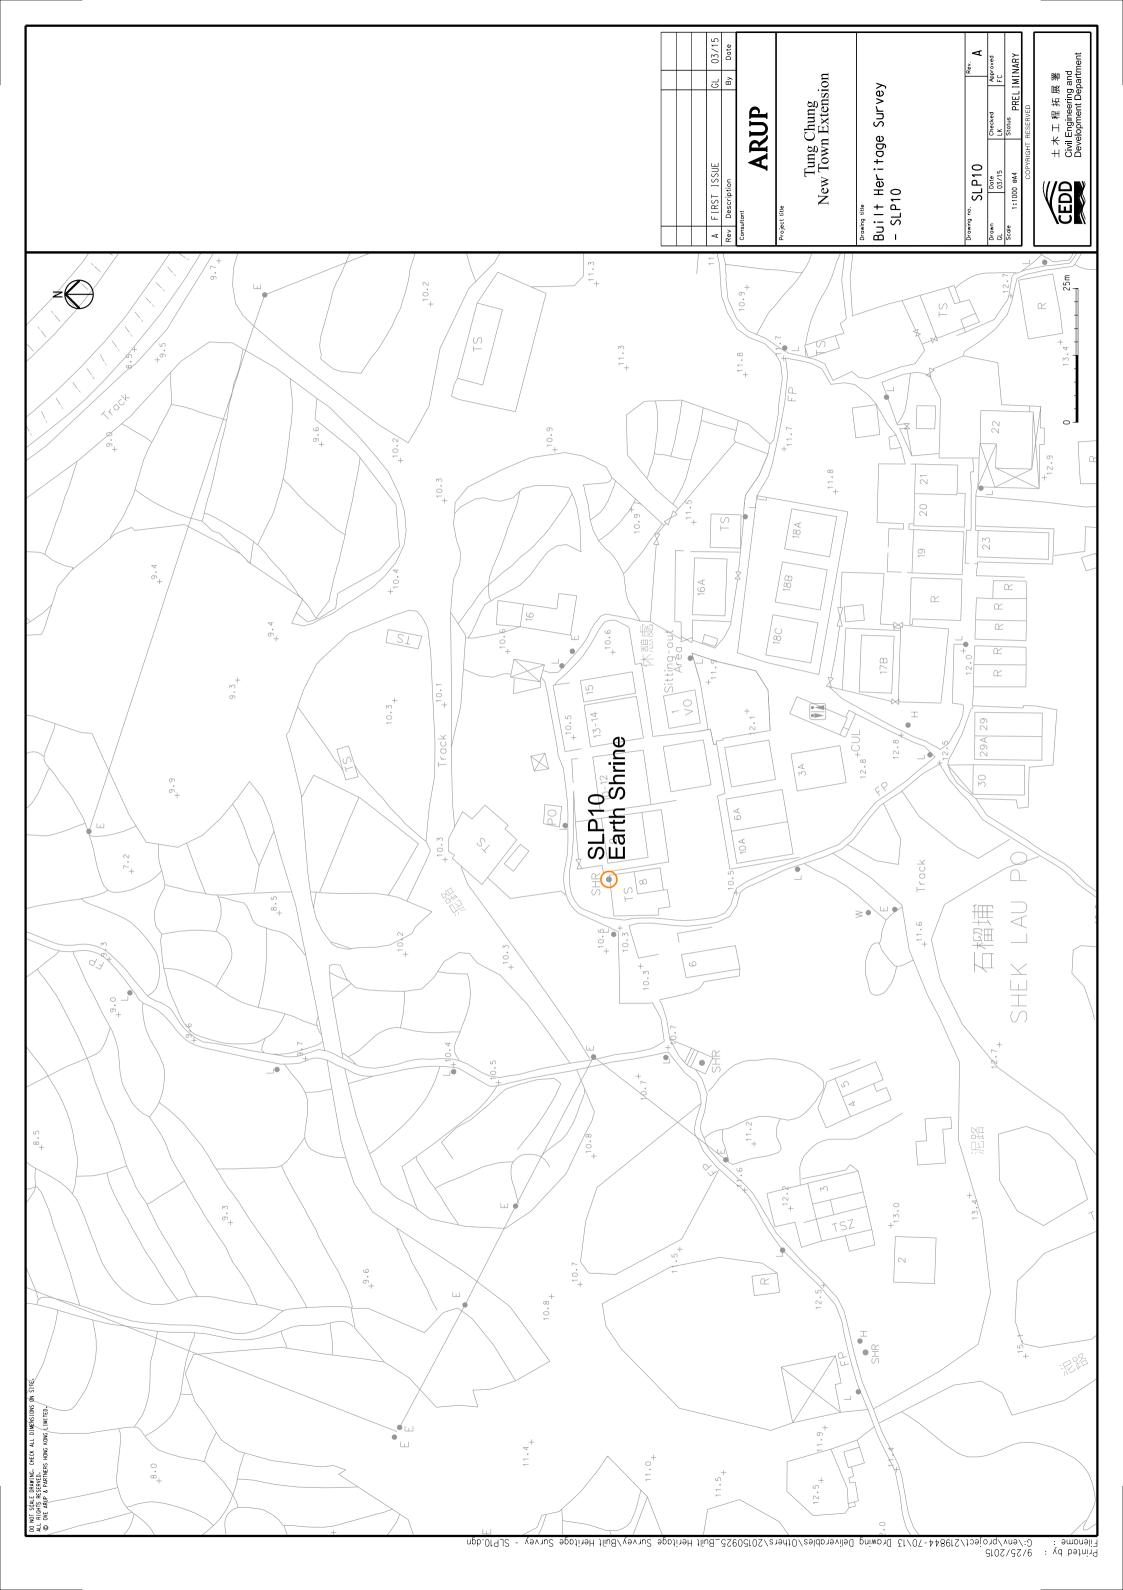
Survey Date:	18/03/2	014			Map No:	SLP	010
BH Item No.	SLP010		Declared Monument	¥	'es		No
Name of BH	Earth Shr	ine	AMO Announced	1	2	3	No Grade
Village/Town Name	Shek Lau	Po	Grading	Propos	ed Monum	nent	
District	Tung Chu	ng, Lantau Island	Gov. Historic Sites	¥	′es		No
Building Type	Earth Shr	ine	Land	Lease	eholder	Curre	ent User
Date of Construction	Not Know	'n	Condition	Pri	vate	Local	Villagers
Present Use	Storage		Current Condition	In	Use	Abar	ndoned
Elements		Building Materials		Build	ing Metho	ods	
Earth Gods	St	one with Shell Decoration	Fi	xed with	Concrete	on Altar	
Altar		Concrete	Built into R		atform + Pa ite Colours		h Red &
Gravestone	avestone Stone + Paint Fixed with Co						
Additional Building Description (Optional) Historical /Cultural	The earth character are "清顯	arth shrine with a relocated graves god stone is decorated with seas s, however, most of them have bee :誥封六品二十世祖孝王公" (from items are put on the altar.	shells. On the en weathered.	gravesto The reco	ne, there a	are carve emaining	d Chinese characters

Information (Optional)							
	I	Representative I	Photo(s)				
Façade							
Other View(s) / Detail(s) (Optional): 1. Earth god (left) 2. Relocated Gravestone (right)				September 19 Comments of the C	A popular at mis resulted		
Recorded by Kathy ChanDate 18/03/2014Checked by Anthony SiuDate 18/03/2014							2014

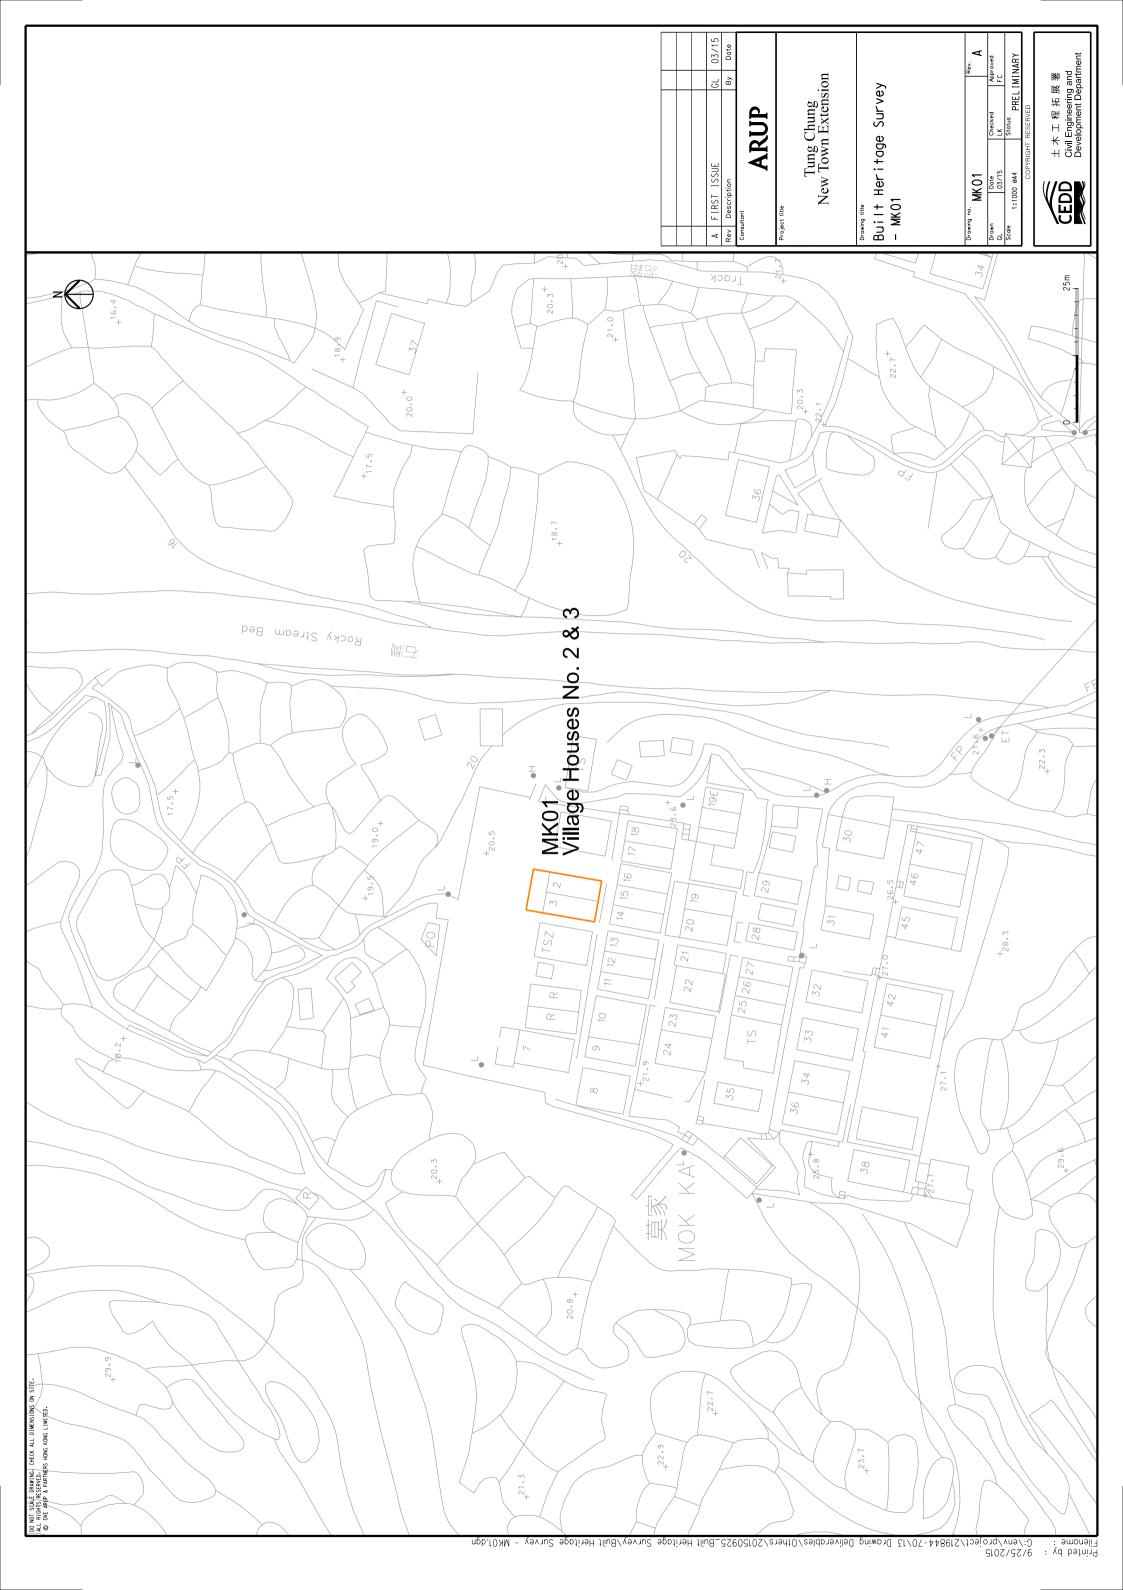
MK01 Survey Date: 19/01/2014 Map No: Declared BH Item No. Yes MK01 No Monument No Name of BH Village Houses No.2 & 3 1 2 3 AMO Grade **Announced** Village/Town Grading Mok Ka Proposed Monument Name Gov. **District Historic** Yes No Tung Chung, Lantau Island **Sites Building** Residential House Leaseholder **Current User Type** Land Date of Condition Not Known Private Local Villagers Construction Current **Present Use** Residential House In Use **Abandoned** Condition **Elements Building Materials Building Methods** Roof Tile **Grey Tile** Concave, Cylindrical Tile Combined Grey Cylindrical Tile Tile End Without Drippers No.3: Red Brick + Lime Lime Finish On Red Brick Wall No.2: Granite Block Mortar Fills In Gaps Between Granite Blocks Door Metal + Glass Additional They are one-room-one hall type building with a shared courtyard. They are situated next to the **Building Description** modern ancestral hall building Mok Yu Sang Ancestral Hall (莫裕生堂). (Optional) Historical /Cultural Information (Optional) Representative Photo(s) Façade Other View(s) Detail(s) (Optional): Recorded by Chris Day Date 19/01/2014 Checked by Anthony Siu Date 18/03/2014

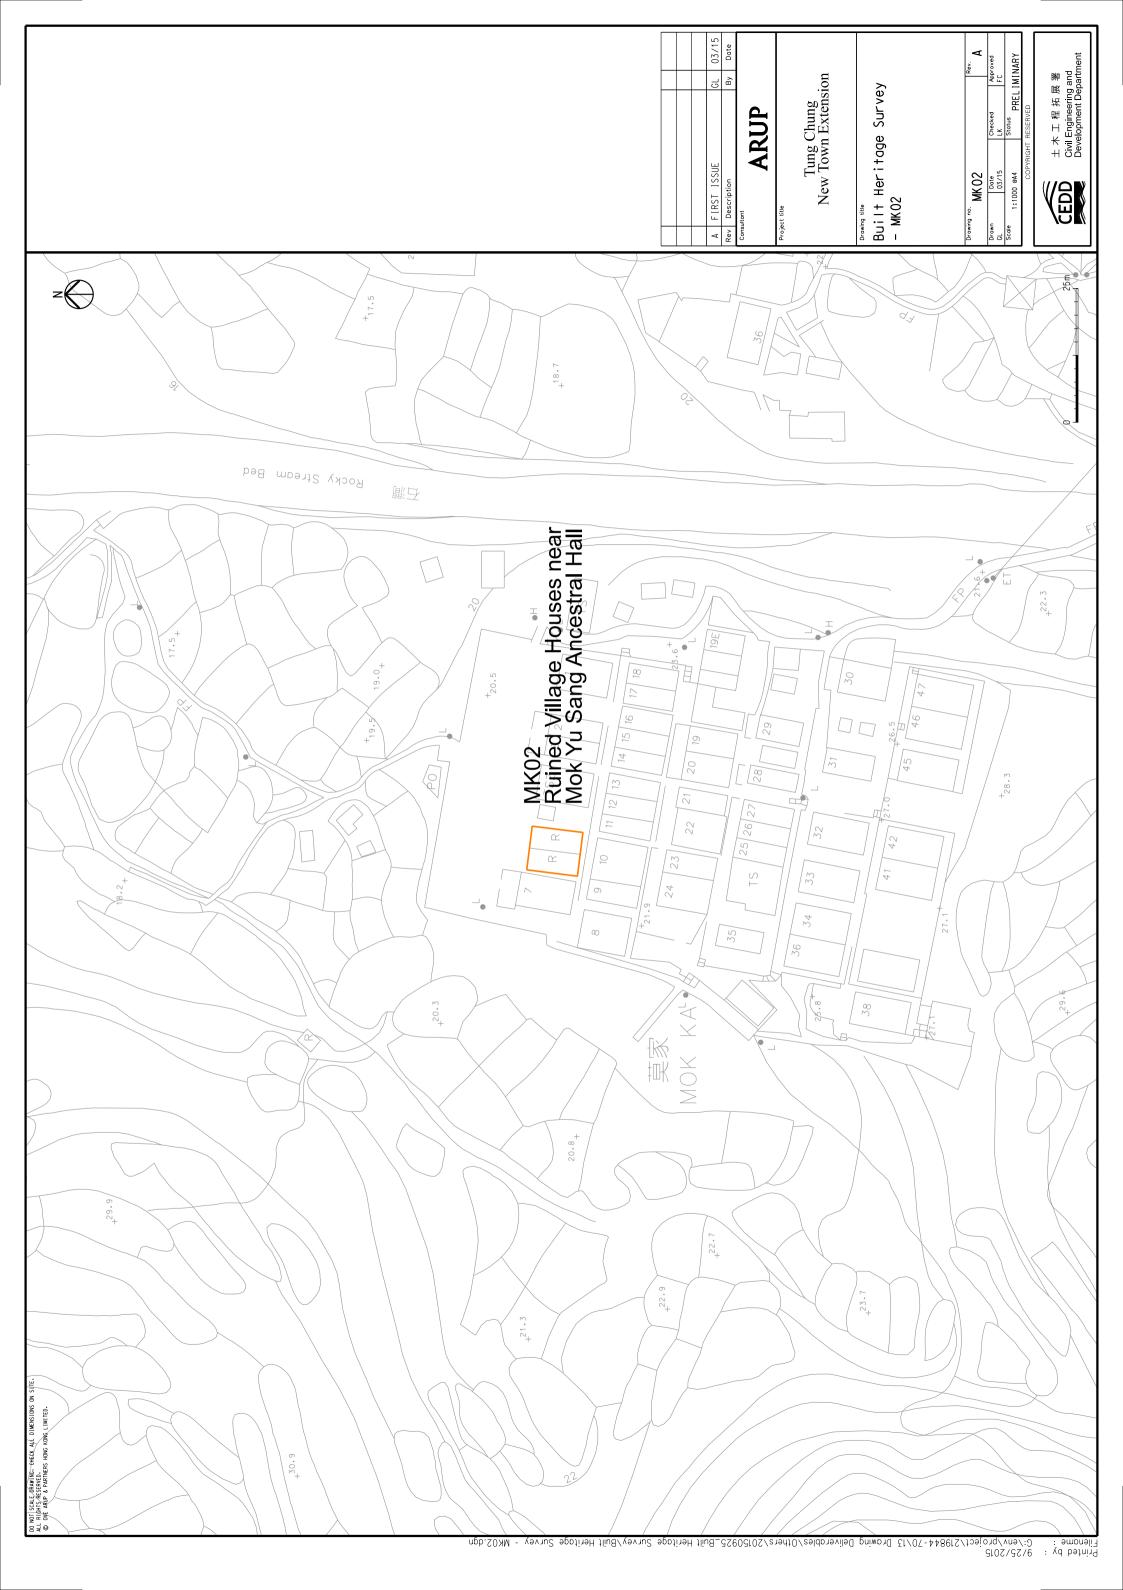
Survey Date:	19/01/2	014	_	1	Map No:	MK0	2
Name of BH	BH Item No.	MK02			¥	'es	1	No
Mame District Tung Chung, Lantau Island Building Type Residential House Land Construction Present Use Residential House Leaseholder Current Condition Private Local Villager Current Condition Residential House Current Condition Residential House Elements Building Materials Building Methods Roof Tile Grey Tile Grey Tile Concave, Cylindrical Tile Combined Tile End Grey Cylindrical Tile Without Drippers Wall Stone + Brick + Concrete Concrete Finish On Stone And Brick Wall Door Timber Rectangular Door Opening Type + Flush Door - Rectangular Block Door Drum Additional Building Description (Optional) Representative Photo(s) Façade Other View(s) / Detail(s) (Optional): Cother View(s) / Detail(s) (Optional):	Name of BH			_	4	2	3	No Grade
District Tung Chung, Lantau Island Historic Sites Yee No		Mok Ka		Grading	Propose	ed Monum	nent

Roof Tile Grey Tile Concave, Cylindrical Tile Combined Tile End Grey Cylindrical Tile Without Drippers Wall Stone + Brick + Concrete Concrete Finish On Stone And Brick Wall Door Timber Rectangular Door Opening Type + Flush Door Rectangular Block Door Drum Additional Building Description (Optional) Historical / Cultural Information (Optional) Representative Photo(s) Façade Other View(s) / Detail(s) (Optional):	Present Use	Residenti	al House		In l	Use	Abar	ndoned
Tile End Grey Cylindrical Tile Without Drippers Wall Stone + Brick + Concrete Concrete Finish On Stone And Brick Wall Door Timber Rectangular Door Opening Type + Flush Door Rectangular Block Door Drum Additional Building Description (Optional) Historical / Cultural Information (Optional) Representative Photo(s) Façade Other View(s) / Detail(s) (Optional):	Elements		Building Materials		Buildi	ng Metho	ods	
Wall Door Timber Rectangular Door Opening Type + Flush Door Rectangular Block Door Drum Additional Building Description (Optional) Historical /Cultural Information (Optional) Representative Photo(s) Façade Other View(s) / Detail(s) (Optional):	Roof Tile		Grey Tile	Conc	ave, Cylir	ndrical Tile	e Combine	ed

Door Timber Rectangular Door Opening Type + Flush Door Rectangular Block Door Drum Additional Building Description (Optional) Historical /Cultural Information (Optional) Representative Photo(s) Façade Other View(s) / Detail(s) (Optional):	Tile End		Grey Cylindrical Tile		Witho	out Drippe	ers	
Additional Building Description (Optional) Historical (Optional) Representative Photo(s) Façade Other View(s) / Detail(s) (Optional): Rectangular Block Door Drum Rectangular Block Door Drum Rectangular Block Door Drum	Wall	S	Stone + Brick + Concrete	Concret	e Finish C	On Stone	And Brick	Wall
Building Description (Optional) Historical /Cultural Information (Optional) Representative Photo(s) Façade Other View(s) / Detail(s) (Optional):	Door		Timber					n Door +
Information (Optional) Representative Photo(s) Façade Other View(s) / Detail(s) (Optional):	Building Description (Optional)							
Façade Other View(s) / Detail(s) (Optional):	Information

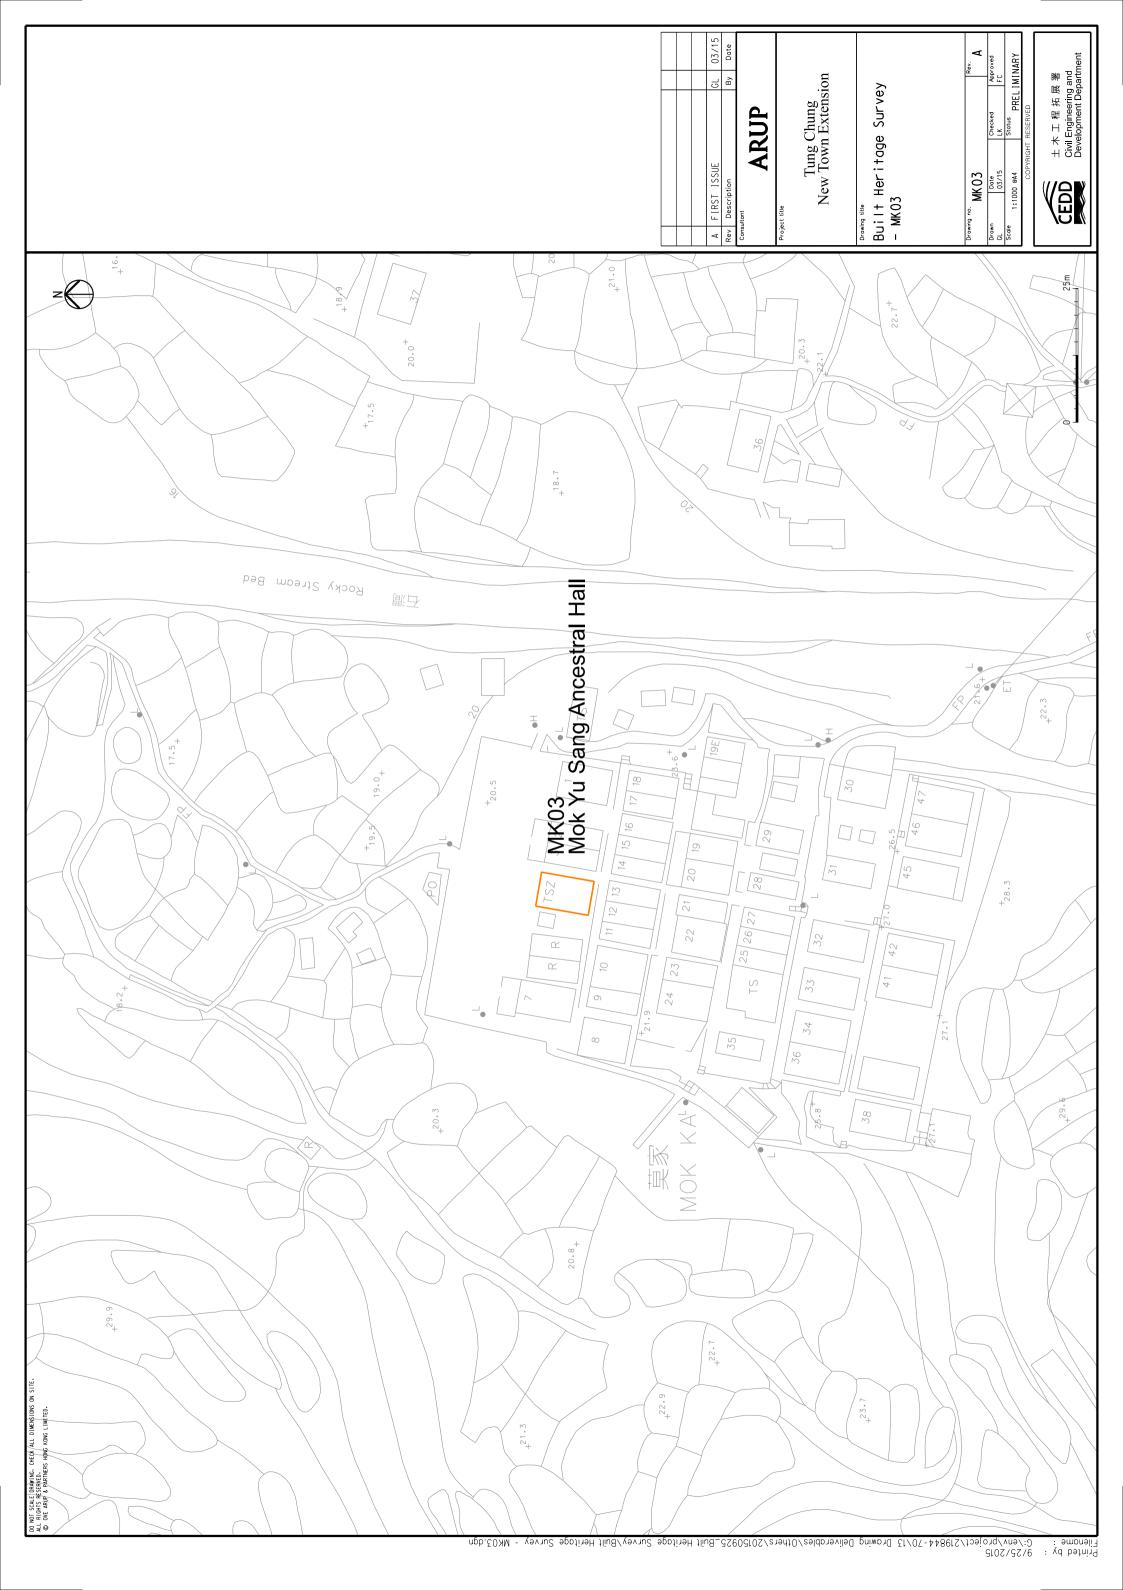
MK03 Survey Date: 19/01/2014 Map No: Declared BH Item No. MK03 Yes No **Monument** No Name of BH Mok Yu Sang Ancestral Hall (莫裕生堂) 4 2 3 **AMO** Grade Announced Village/Town Grading Mok Ka **Proposed Monument** Name Gov. Historic **District** Tung Chung, Lantau Island Yes No **Sites Building Type** Ancestral Hall Leaseholder **Current User** Land Date of Condition Private Local Villagers Not Known Construction Current **Present Use** Residential House In Use **Abandoned** Condition **Elements Building Materials Building Methods** NA Roof Tile NA NA NA Tile End NA NA Wall NA NA Door Additional **Building** It is a modern building. **Description** (Optional) **Historical** /Cultural Information (Optional) Representative Photo(s) Façade Other View(s) / Detail(s) (Optional): Recorded by Chris Day Date 19/01/2014 Checked by Anthony Siu Date 18/03/2014

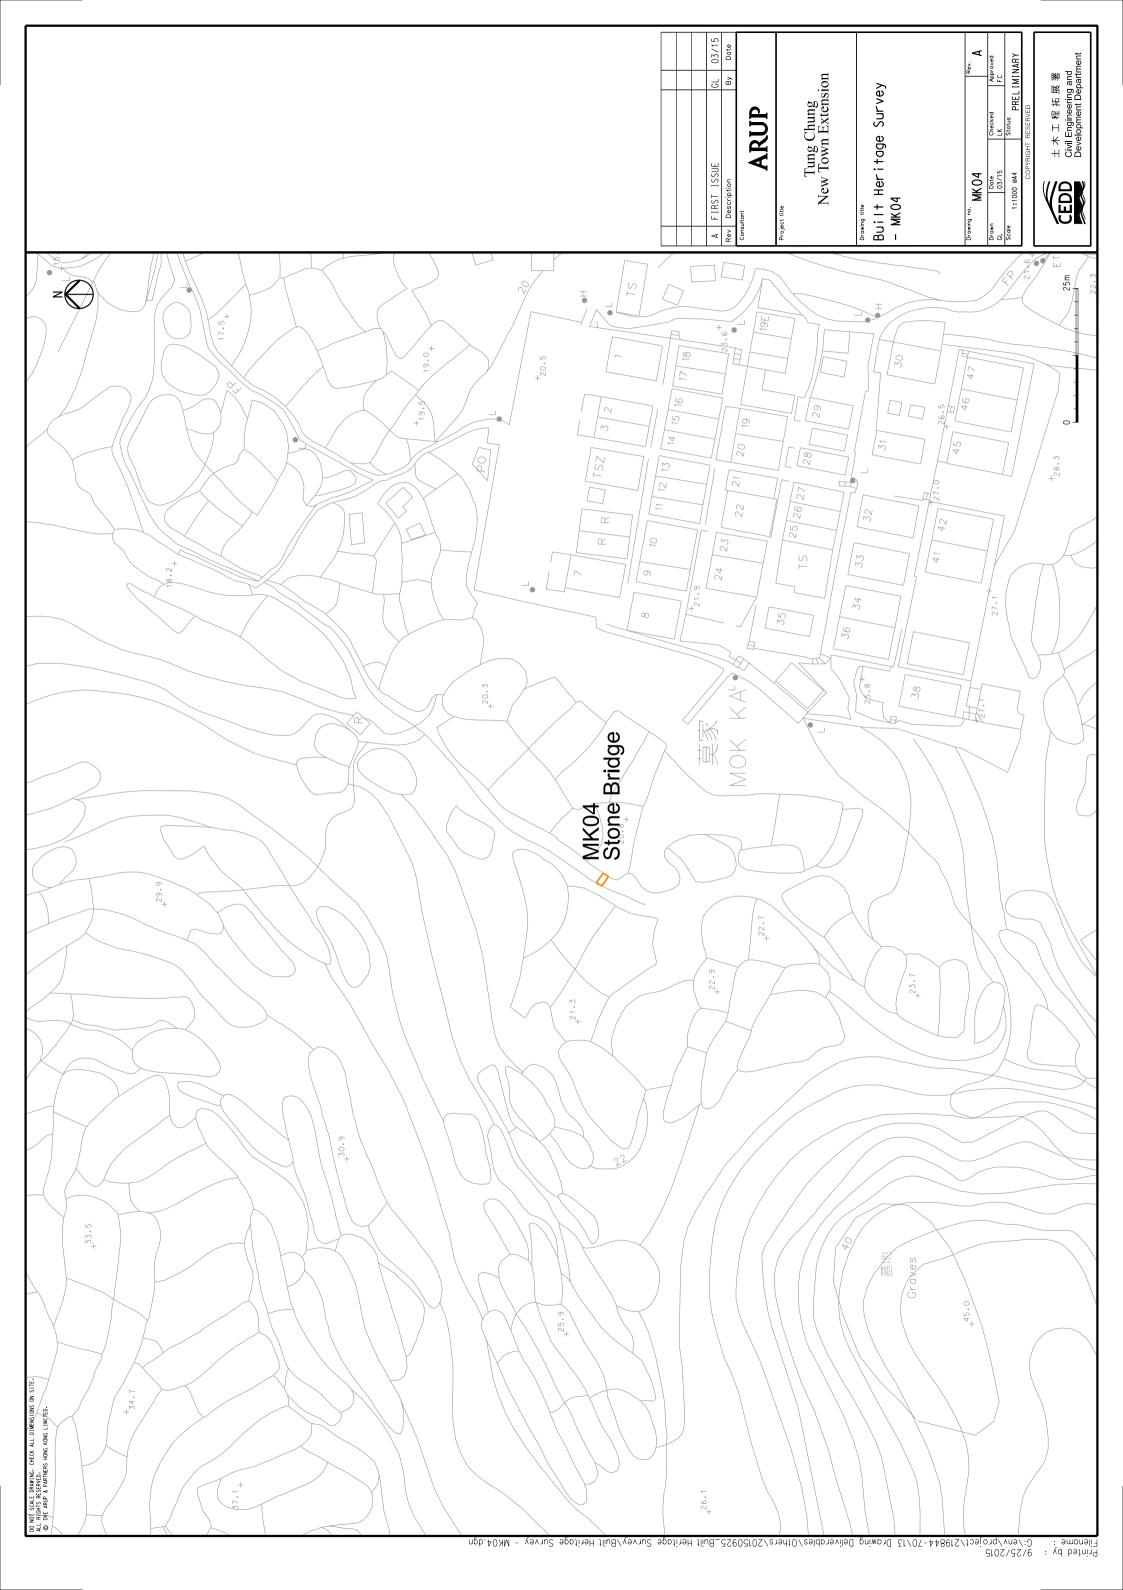
Survey Date:	19/01/2	014		_		Map No:	MK0	4					
BH Item No.	MK04			Declared Monument									
Name of BH	Stone Brid	dge		AMO Announced	4	2	3	No Grade					
Village/Town Name	Mok Ka			Grading	Propose	ed Monui	ment						
District	Tung Chu	ng, Lantau Island		Gov. Historic Sites	¥	'es	1	No					
Building Type	Bridge			Land	Lease	holder	Curre	nt User					
Date of Construction	Not Know	n		Condition	Pri	vate	Local	Villagers					
Present Use	Bridge			Current Condition	In	Use	Abar	idoned					
Elements		Building Materials			Buildi	ing Meth	ods						
Bridge		Stone		Laying across Stream in single span									
Step		Stone		Layii	ng at Eac	h Side o	f the Bridge	Э					
Additional Building Description (Optional)													
Historical /Cultural Information (Optional)													
		Repre	esentative I	Photo(s)									
Façade													
Other View(s) / Detail(s) (Optional):													
Recorded by Ch	ris Day	Date 19/01/2014		Checked by	Anthony	Siu D a	ate 18/03/2	2014

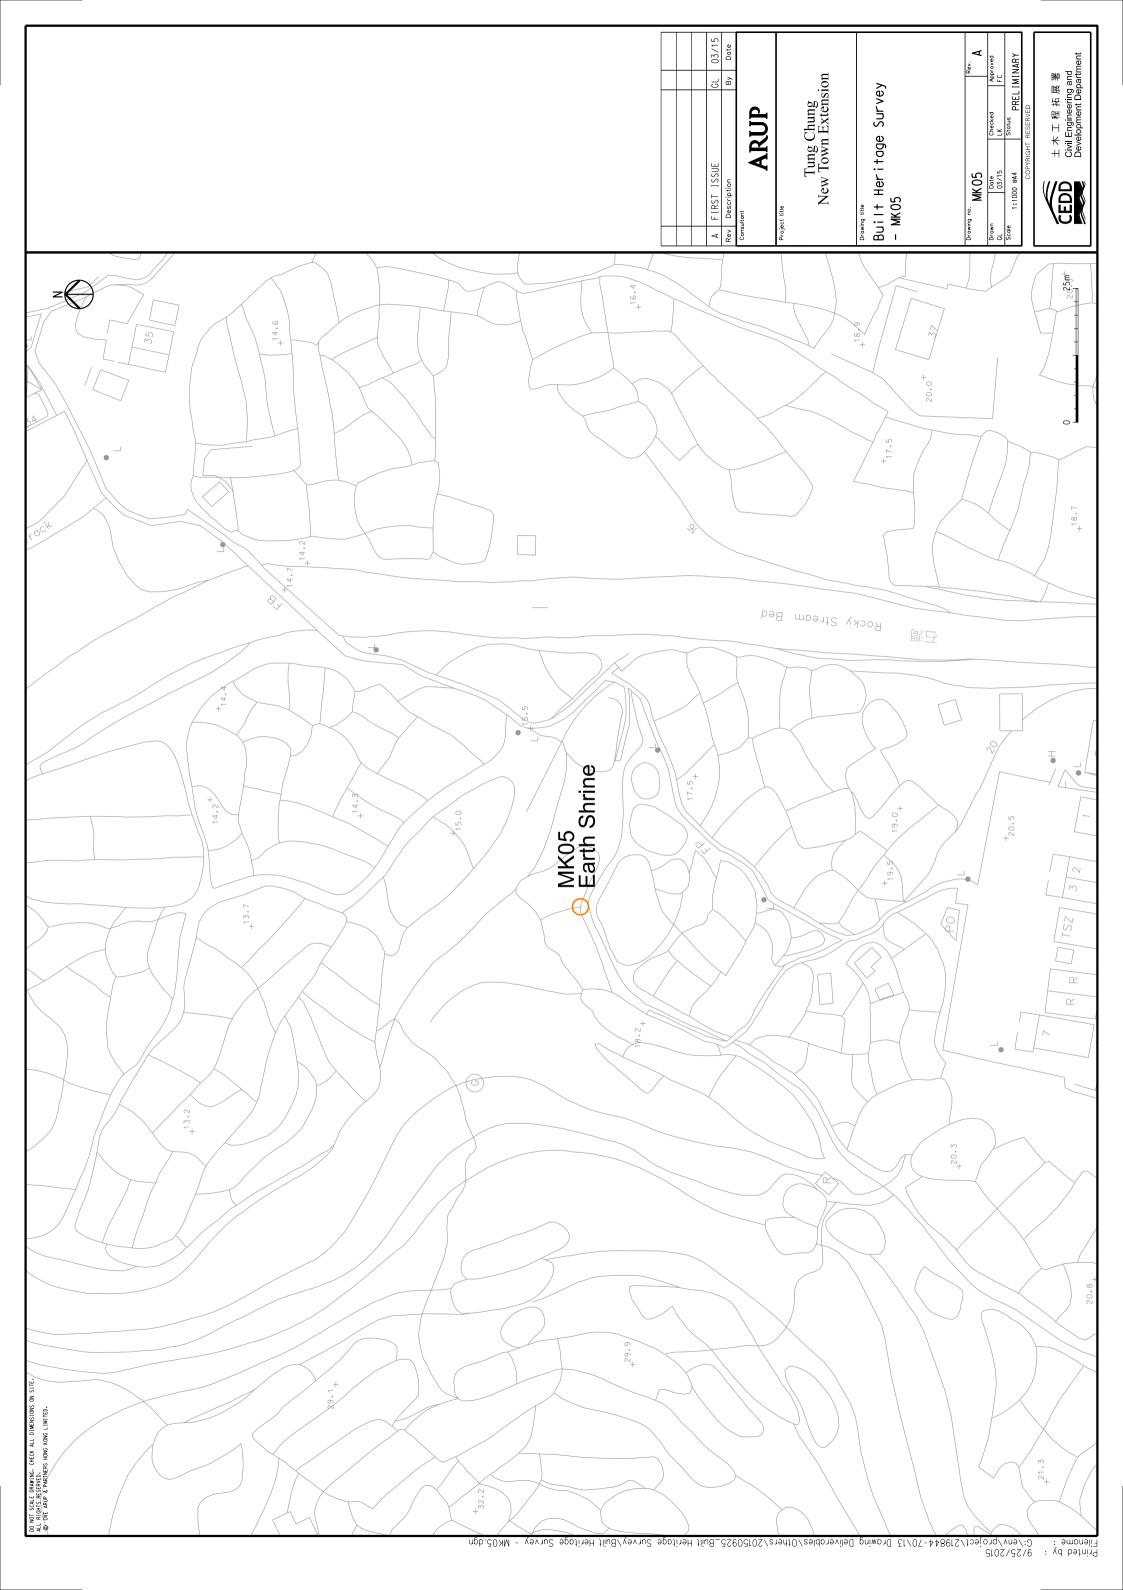
Survey Date:	19/01/2	014		I	Map No:	MK0	5				
BH Item No.	MK05		Declared Monument	Yes No							
Name of BH	Earth Shr	ine	AMO Announced	1	2	3	No Grade				
Village/Town Name	Mok Ka		Grading	Propos	ed Monu	ment					
District	Tung Chu	ing, Lantau Island	Gov. Historic Sites	¥	'es	1	No				
Building Type	Earth Shr	ine	Land	Lease	holder	Curre	nt User				
Date of Construction	Not Know	'n	Condition	Pri	vate	Local	/illagers				
Present Use	Earth Shr	ine	Current Condition	In	Use	Aban	doned				
Elements		Building Materials		Build	ing Meth	nods					
Door Shape Frame		Concrete	Molded And I		n Altar + Writing	Carved an	d Painted				
Couplet		Concrete Molded And Elected Besides Door Shape Fra Carved and Painted on Concrete Tablets									
Altar		Concrete		Built Ir	nto Arm-(Chair					
Earth God		Stone		Pla	ce on Alt	ar					
Additional Building Description (Optional)											
Historical /Cultural Information (Optional)

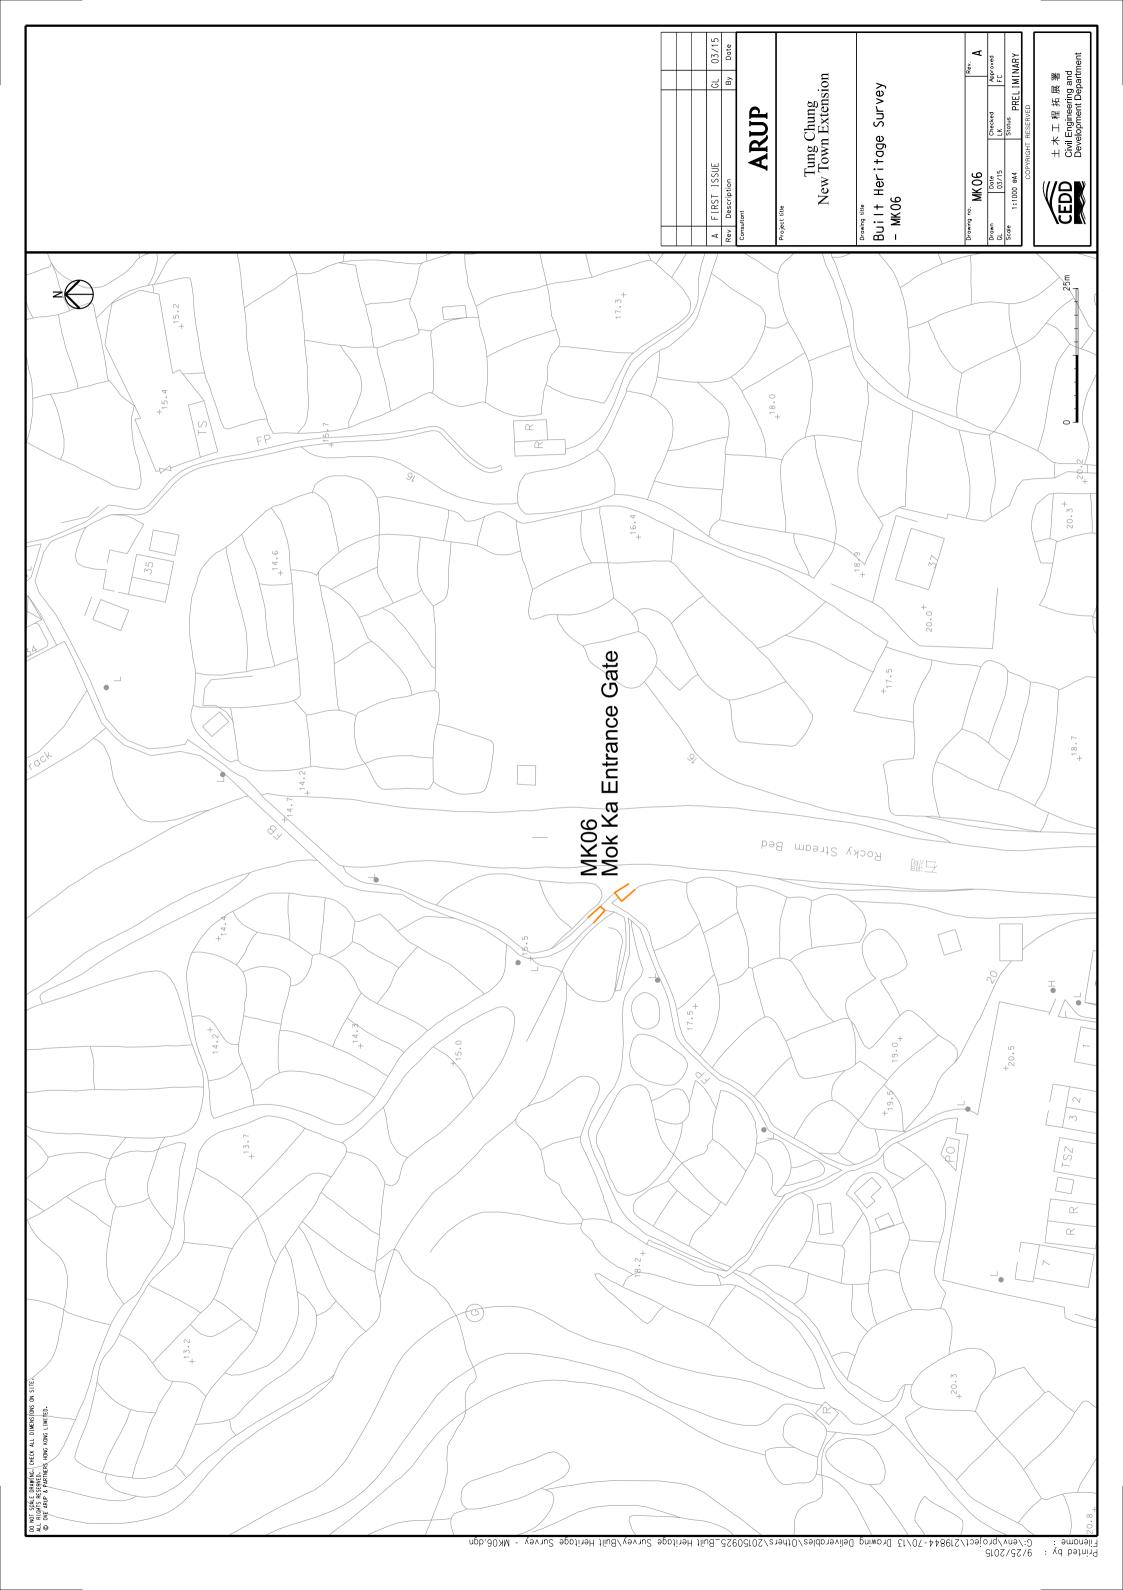
Survey Date:	19/01/2	014	_		Map No:	MK0	6					
BH Item No.	MK06		Declared Monument	Yes No								
Name of BH	Mok Ka E	ntrance Gate	AMO Announced	4	2	3	No Grade					
Village/Town Name	Mok Ka		Grading	Propose	ed Monur	ment						
District	Tung Chu	ng, Lantau Island	Gov. Historic Sites	¥	'es	1	No					
Building Type	Entrance	Gate	Land	Lease	holder	Curre	nt User					
Date of Construction	Not Know	n	Condition	Pri	vate	Local	Villagers					
Present Use	Entrance	Gate	Current Condition	In	Use	Abar	idoned					
Elements		Building Materials		Buildi	ing Meth	ods						
Gate		Concrete		Concr	ete Finish	hing						
Wall		Stone+ Mortar	Fille	ed Mortar	in betwe	en Stones						
Couplet	t Paint Carved and Painted on Concrete											
Additional Building Description (Optional) Historical												
/Cultural Information (Optional)												
	I	Representative	Photo(s)									
Façade												
Other View(s) / Detail(s) (Optional):

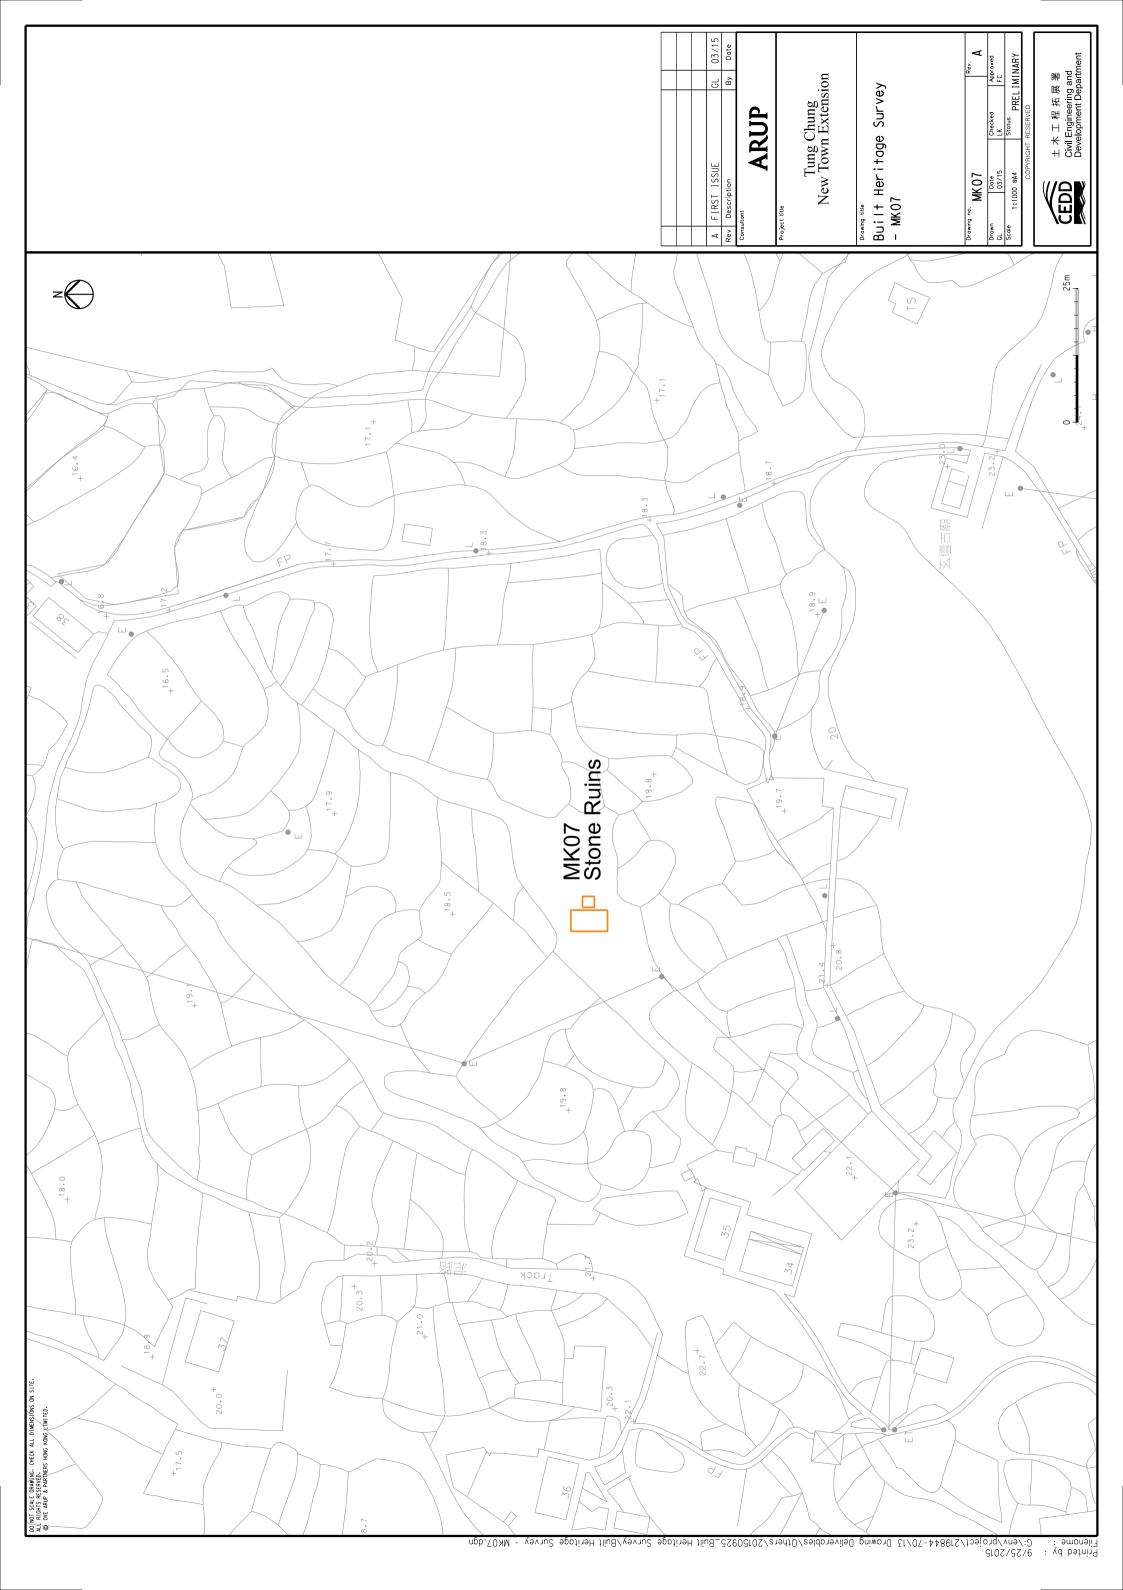
Construction Present Use Abandoned Current Condition In-Uee Abandoned Elements Building Materials Wall Stone Laying Additional Building Description (Optional) Historical /Cultural information (Optional) Representative Photo(s) Façade Other View(s) / Detail(s) (Optional):		Not Know	n	Land	Lease	holder	Curre	nt User	
Elements Building Materials Building Methods Wall Stone Laying Additional Building Description (Optional) Historical / Cultural Information (Optional) Representative Photo(s) Façade Other View(s) / Detail(s) (Optional):		Not Know	n		Pri	vate	Local	Villagers	
Wall Stone Laying Additional Building Description (Optional) Historical / Cultural Information (Optional) Façade Other View(s) / Detail(s) (Optional):	Present Use	Abandone	ed		ln-	Use	Aban	ndoned	
Additional Building Description (Optional) Historical / Cultural Information (Optional) Façade Other View(s) / Detail(s) (Optional): They are short stone walls built into rectangular shape.	Elements		Building Materials		Buildi	ng Metl	hods

Building Description (Optional) Historical /Cultural Information (Optional) Façade Other View(s) / Detail(s) (Optional): They are short stone walls built into rectangular shape. Other View(s) / Detail(s) (Optional):	Wall		Stone			Laying			
Cultural Information (Optional) Representative Photo(s) Façade Other View(s) / Detail(s) (Optional):	Building Description (Optional)	They are	short stone walls built into rectang	gular shape.					
Façade Other View(s) / Detail(s) (Optional):	/Cultural Information								
Other View(s) / Detail(s) (Optional):			Representative	Photo(s)			F 75 F W	THEORY	
Detail(s) (Optional):	Façade								
	Detail(s)	40000				ANT		and the second	
		ris Day	Date 19/01/2014	Checked by	hecked by Anthony Siu Date 18/03/2014

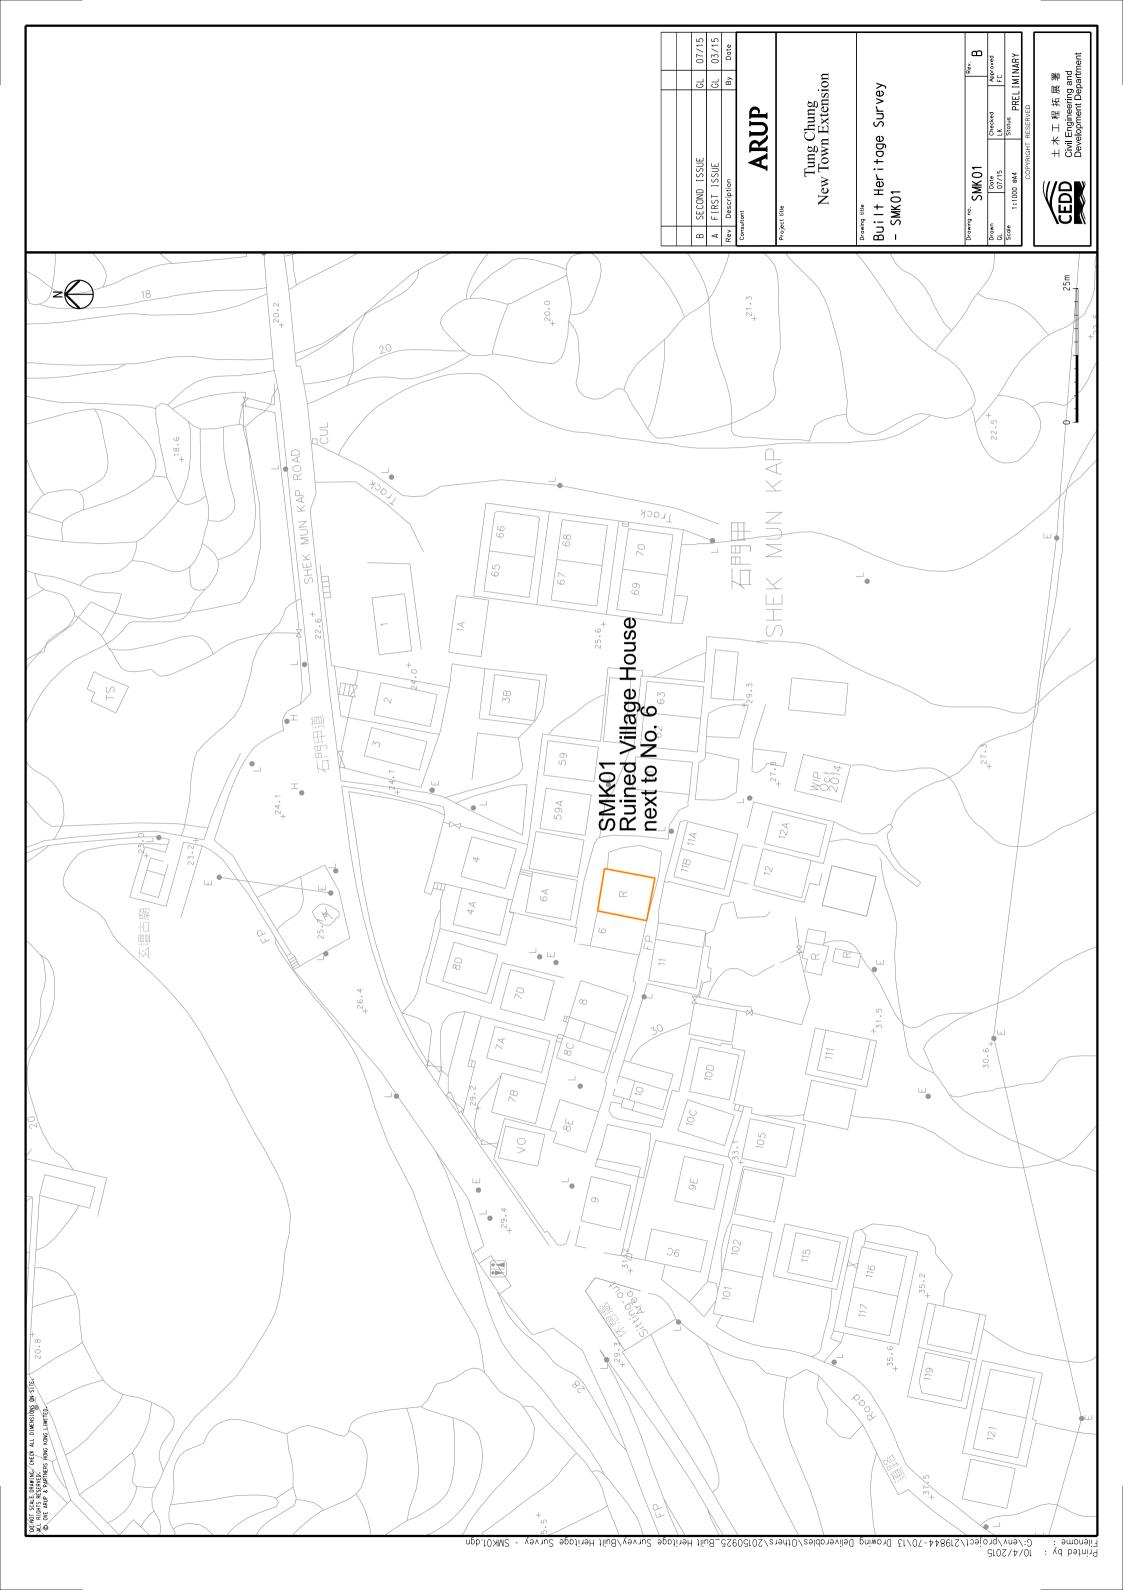
Name of BH Ruined village House Next to No. 6 Name of BH Ruined village House Next to No. 6 Name of BH Ruined village House Next to No. 6 AMO Announced Grading Preposed Montment Private No	Survey Date:	18/03/2	014			Map No	o: SMK	(01					
Village/Town Name Shek Mun Kap Shek Mun Ka	BH Item No.	SMK01			Yes No								
Village/Town Name Shek Mun Kap Grading Proposed Monument District Tung Chung, Lantau Island Historic Sites No Building Type Residential House Land Condition Leaseholder Current User Date of Construction Not Known Condition Private No Present Use Residential House Current Condition Abandoned Elements Building Materials Building Methods Roof Tile Grey Tile Concave, Cylindrical Tile Combined Tile End Grey Cylindrical Tile Without Drippers Wall Granite Block Mortar Fill In Gaps Between Granite Blocks Door Timber Rectangular Door Opening Type + Flush Door Additional Building Description (Optional) """ Historical / (Cultural Information (Optional) """ Façade Façade Other View(s) / Detail(s) (Optional):	Name of BH	Ruined vil	llage House Next to No. 6	_	4	2	3

Roof Tile Grey Tile Concave, Cylindrical Tile Combined Tile End Grey Cylindrical Tile Without Drippers Wall Granite Block Mortar Fill In Gaps Between Granite Blocks Door Timber Rectangular Door Opening Type + Flush Door Additional Building Description (Optional) Historical /Cultural Information (Optional) Representative Photo(s) Façade Other View(s) / Detail(s) (Optional):	Present Use	Residentia	al House		- In	use	Abaı	ndoned					
Tile End Grey Cylindrical Tile Without Drippers Wall Granite Block Mortar Fill In Gaps Between Granite Blocks Door Timber Rectangular Door Opening Type + Flush Door Additional Building Description (Optional) Historical /Cultural Information (Optional) Representative Photo(s) Façade Other View(s) / Detail(s) (Optional):	Elements		Building Materials		Build	ing Met	hods						
Wall Granite Block Mortar Fill In Gaps Between Granite Blocks Door Timber Rectangular Door Opening Type + Flush Door Additional Building Description (Optional) Historical / Cultural Information (Optional) Representative Photo(s) Façade Other View(s) / Detail(s) (Optional):	Roof Tile		Grey Tile	Conc	ave, Cyli	ndrical T	Γile Combin	ed
