Survey Date:	18/03/2014		1	Map No:	MWC	01
BH Item No.	MWC01	Declared Monument	Ye	es	4	lo
Name of BH	Tung Chung Battery	AMO Announced	4	2	3	No- Grade
Village/Town/ Location	Rocky Lion Hill, Ma Wan Chung	Grading	Propose	d Monum	ent	
District	Tung Chung, Lantau Island	Gov. Historic Sites	Yes No			
Building Type	Battery	Land	Leaseholder Current Us			
Date of Construction	Completed in 1817	Condition	Gover	nment	Pu	blic
Present Use	Preserved Heritage	Current Condition	In U	Jse	Aban	doned
Elements	Building Materials		Building	Methods	•	
Wall	Granite Blocks	Built	by Laying	Granite E	Blocks	
Additional Building Description (Optional)	Remains of Tung Chung Battery include a likely utilized as a gun emplacement.	an L-shaped wall	all and corner platform which was mos			
Historical /Cultural Information (Optional)	monuments). It is located on a prominent of the battery were rediscovered in 1980 to Battery was completed in 1817 with the put threatened the coasts and seas of souther in the Guangdong Annals, which recounted Lion Hill" — the literal translation of Shek States	peneath thick folia urpose of protecting on China. The consection and how two forts of the.	ge. Const ng Tung C struction o

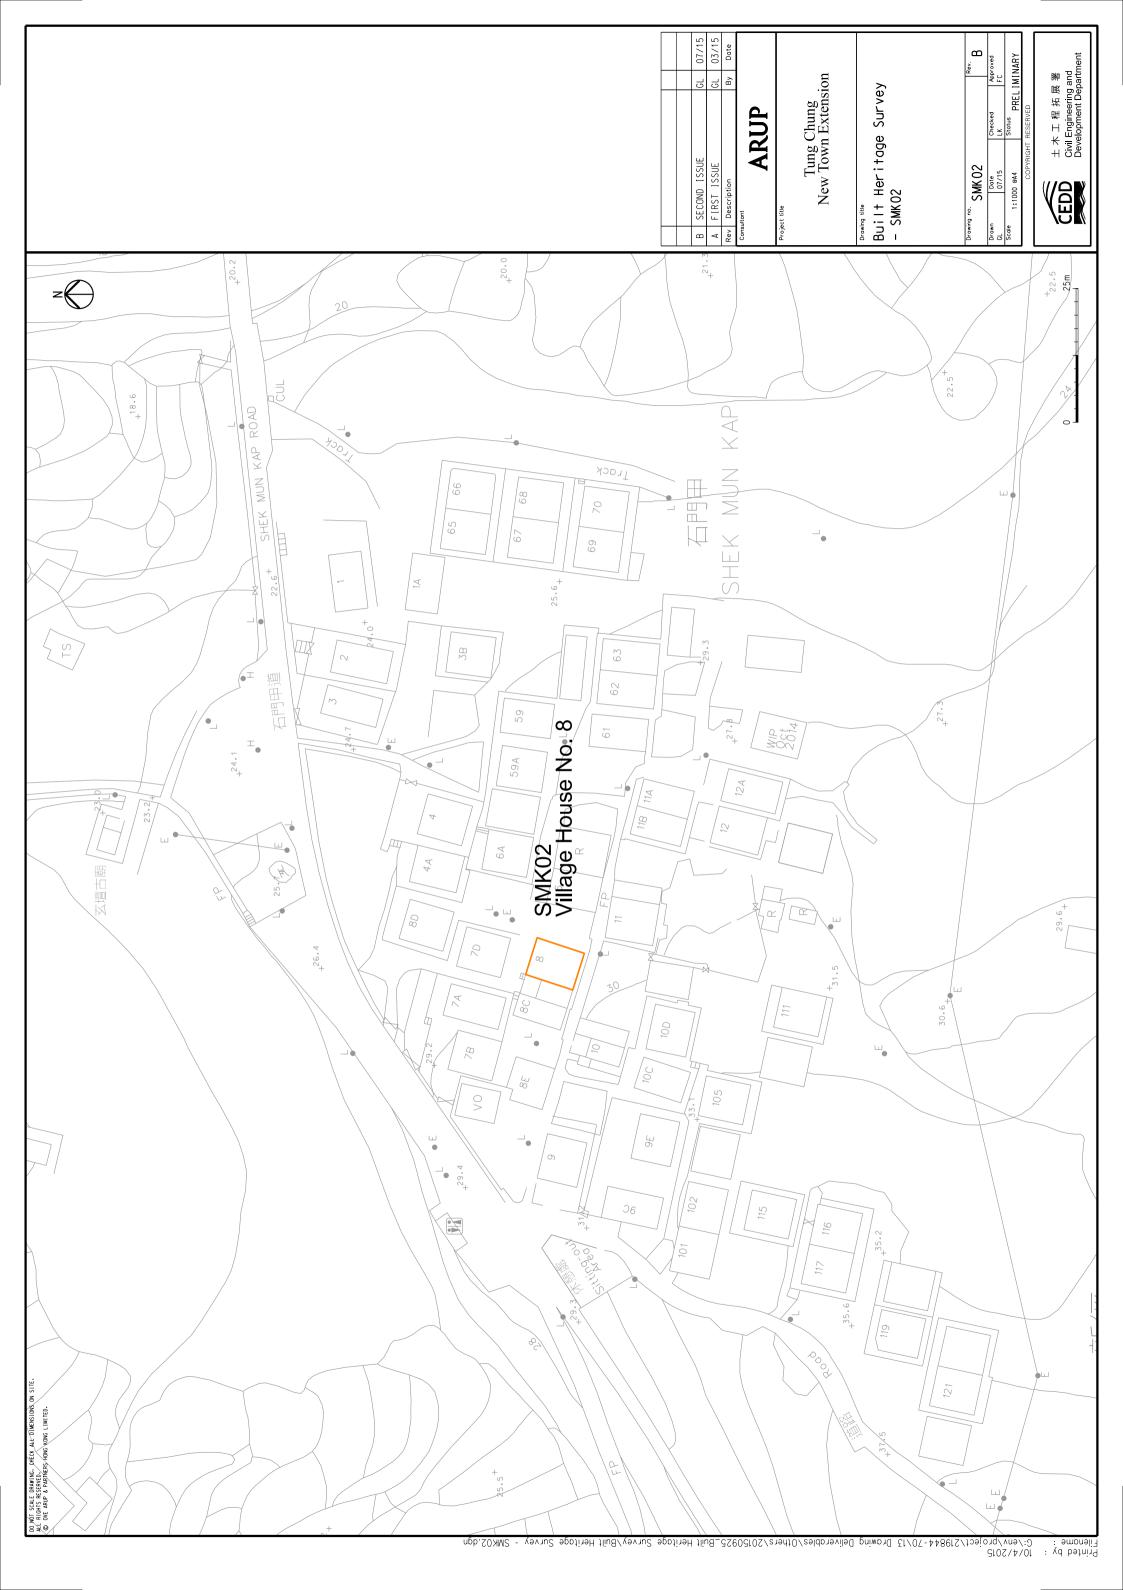
Survey Date:	18/03/2	014	_		Map No:	SMK	02			
BH Item No.	SMK02		Declared Monument	Yes No						
Name of BH	Village Ho	ouse No. 8	AMO Announced	4	2	3	No Grade			
Village/Town Name	Shek Mur	п Кар	Grading	Propos	ed Monur	ment				
District	Tung Chu	ing, Lantau Island	Gov. Historic Sites	¥	'es	1	No			
Building Type	Residentia	al House	Land	Lease	holder	Curre	nt User			
Date of Construction	Not Know	'n	Condition	Pri	vate	Local '	Villagers			
Present Use	Residentia		Current Condition		Use		ndoned			
Elements		Building Materials		Buildi	ing Meth	ods				
Roof Tile		Grey Tile	Conc	ave, Cylii	ndrical Til	e Combine	ed			
Tile End		Grey Cylindrical Tile		With	out Dripp	ers				
Wall	G	Granite Block + Concrete	Concrete F	rete Fill In Gaps Between Granite Bloo						
Door		Timber	Rectangula	ctangular Door Opening Type + Flush D						
Additional Building Description (Optional)		age house with a balcony and flast made of metal and glass and is the				ched roof	Rear Hall.

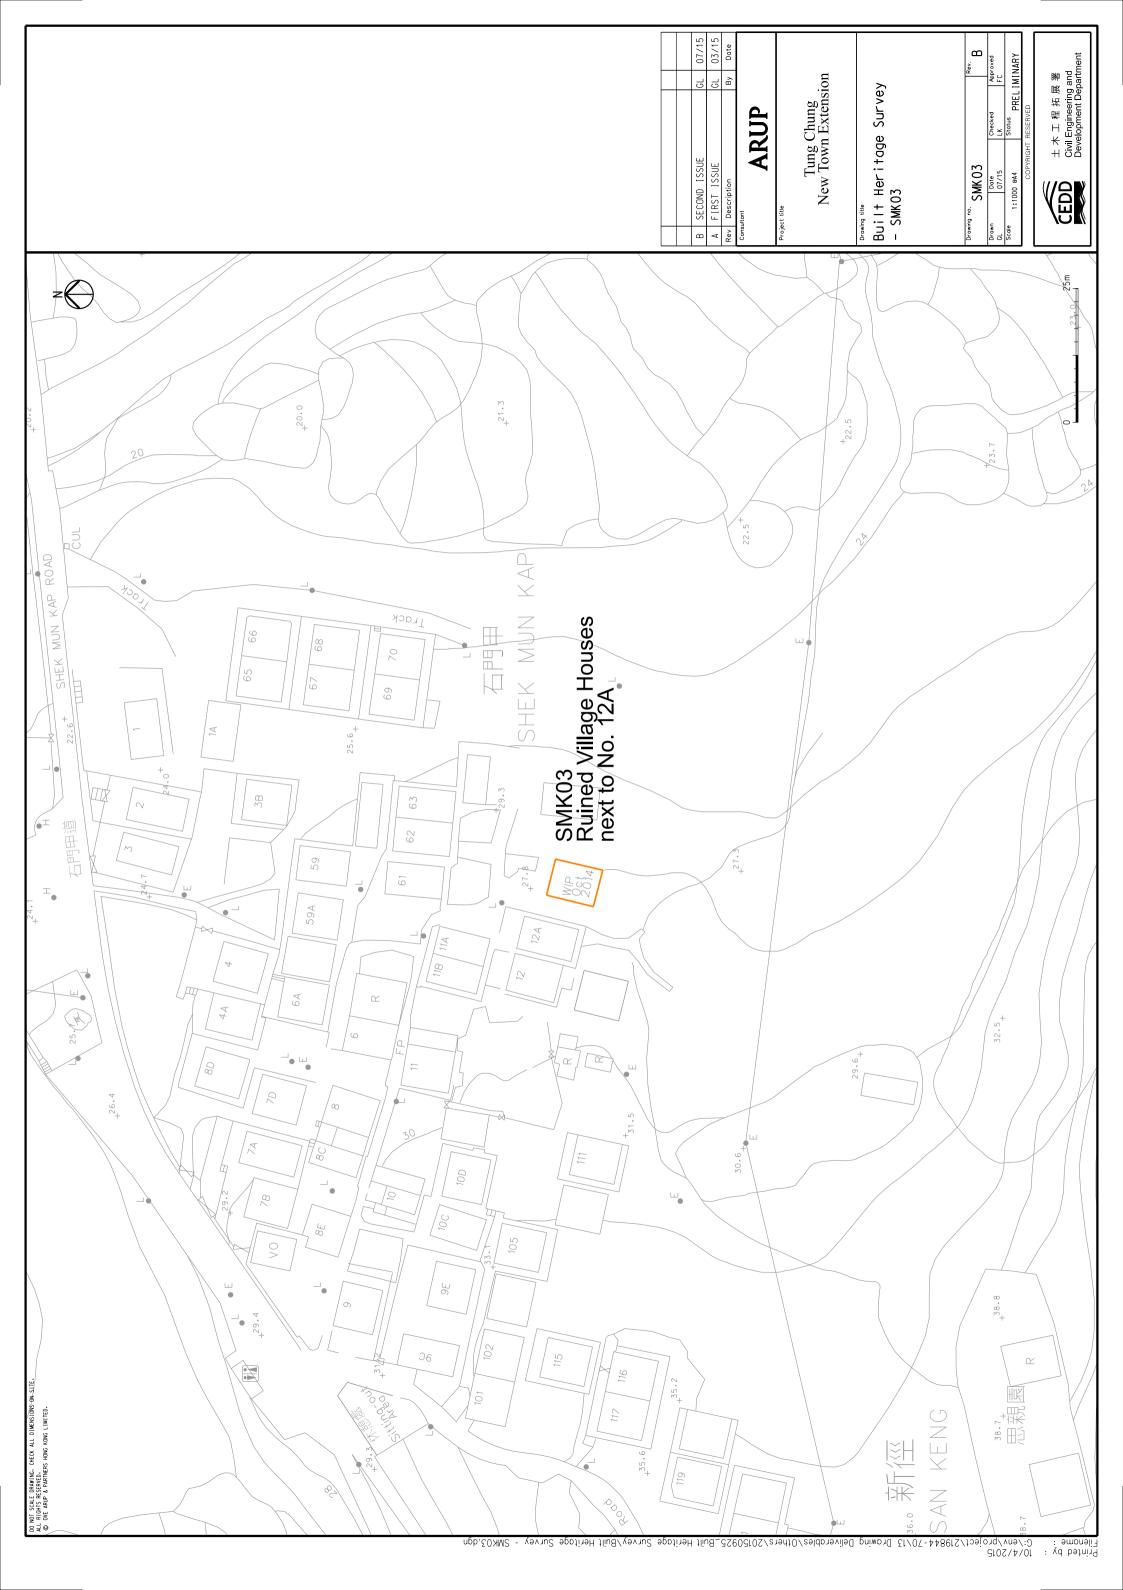
Survey Date:	18/03/	2014	-		Map No:	SMK	03			
BH Item No.	SMK03		Declared Monument	Yes No						
Name of BH	Ruined \	/illage Houses near No. 12 A	AMO Announced	4	2	3	No Grade			
Village/Town Name	Shek Mu	n Kap	Grading	Propose	ed Monumer	nt				
District	Tung Ch	ung, Lantau Island	Gov. Historic Sites	2	Yes		No			
Building Type	Resident	ial House	Land	Leas	eholder	Curr	ent User			
Date of Construction	Not Know	wn	Condition	Pr	rivate		No			
Present Use	Vacant		Current Condition	In) use	Aba	ındoned			
Elements		Building Materials		Buildir	ng Methods	\$				
Not observable	due to ass	ess problem								
Additional Building Description (Optional)										
Historical /Cultural Information (Optional)										
Façade		Representativ								
Other View(s) / Detail(s) (Optional):		ANDON								
Recorded by Chan	Kathy	Date 18/03/2014	Checked by A	nthony Si	u Date	18/03/20)14

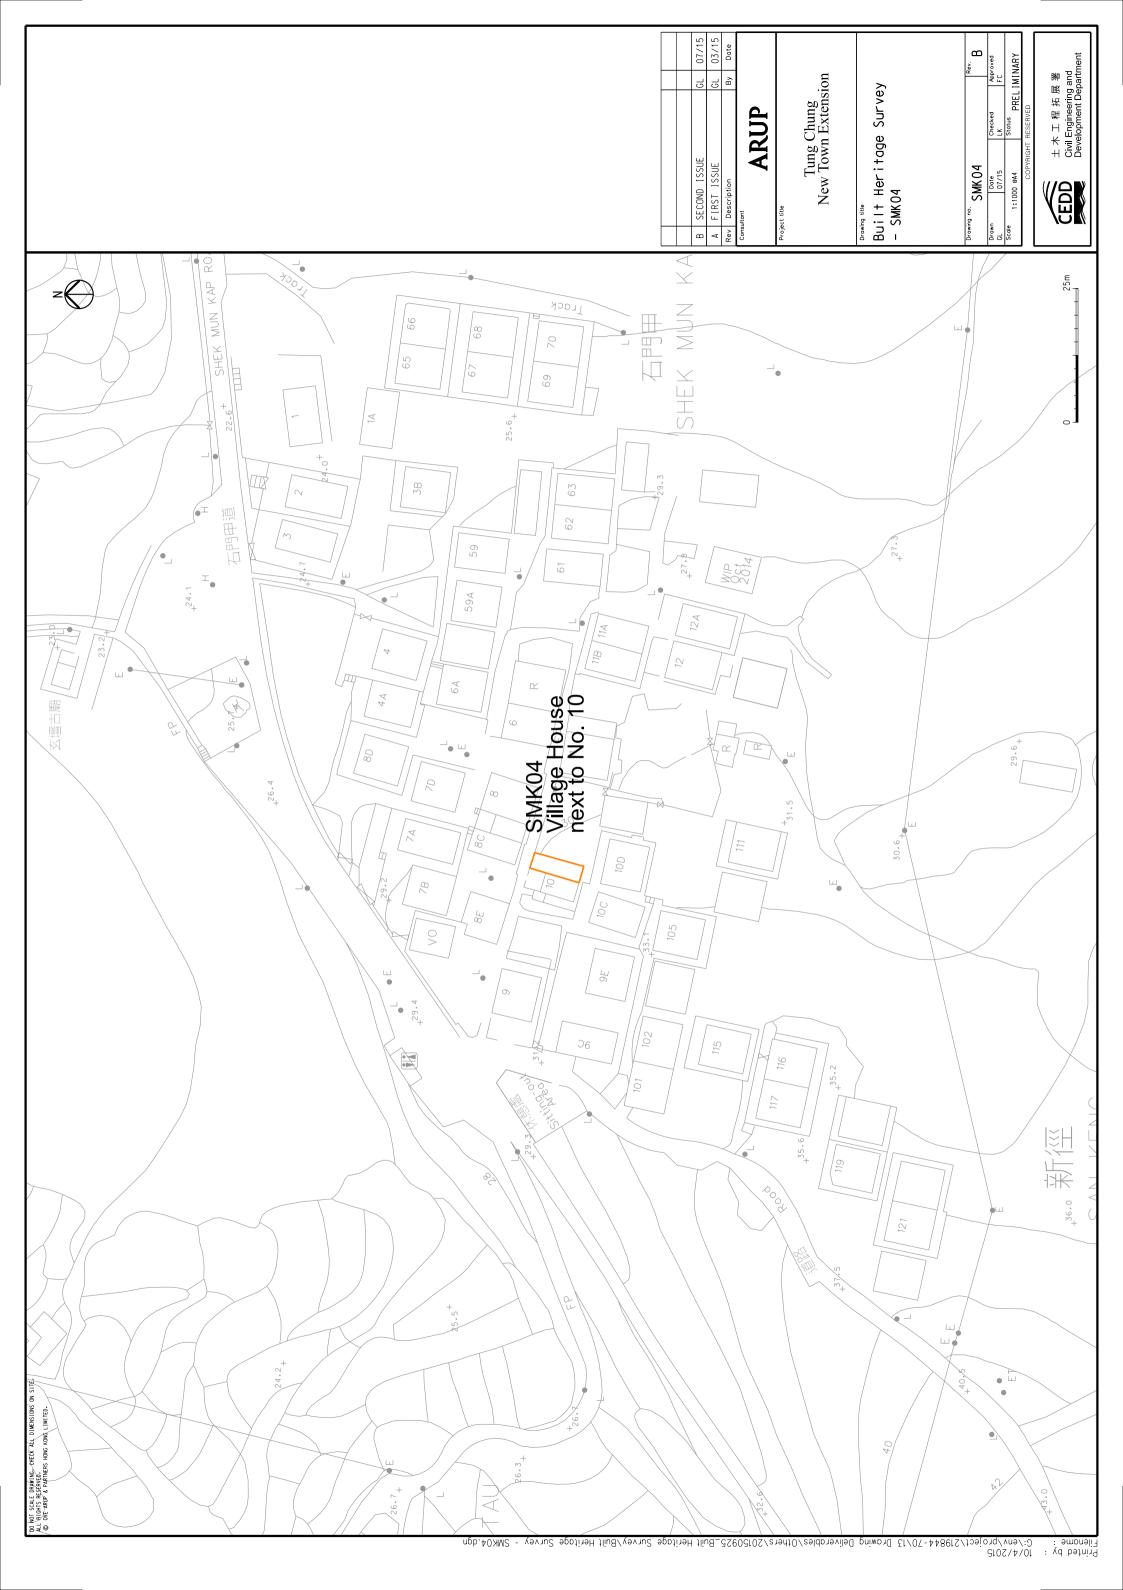
18/03/2014 SMK04 Survey Date: Map No: **Declared** BH Item No. SMK04 No Yes **Monument** No Name of BH Village house Next to No. 10 4 2 3 **AMO** Grade Announced Village/Town Grading Shek Mun Kap **Proposed Monument** Name Gov. **District Historic** Yes No Tung Chung, Lantau Island **Sites Building Type** Leaseholder **Current User** Residential house Land Date of Condition Not Known Private Local Villagers Construction Current **Present Use** Residential house In Use **Abandoned** Condition **Elements Building Materials Building Methods** Roof Tile Concave, Cylindrical Tile Combined **Grey Tile** Tile End Grey Cylindrical Tile Without Drippers Wall Granite Block + Concrete Concrete Fill in Gaps Between Granite Blocks Door Timber Rectangular Door Opening Type + Flush Door Additional It is a village house with a balcony and flat-rooted First Hall adjoining a pitched roof Rear Hall. **Building** Description Window is made of metal and glass and is with a concrete window canopy. (Optional) Historical /Cultural Information (Optional) Representative Photo(s) Façade No enough space to photograph façade view Other View(s) / Detail(s) (Optional): Date 18/03/2014 Recorded by Kathy Chan Checked by Anthony Siu Date 18/03/2014

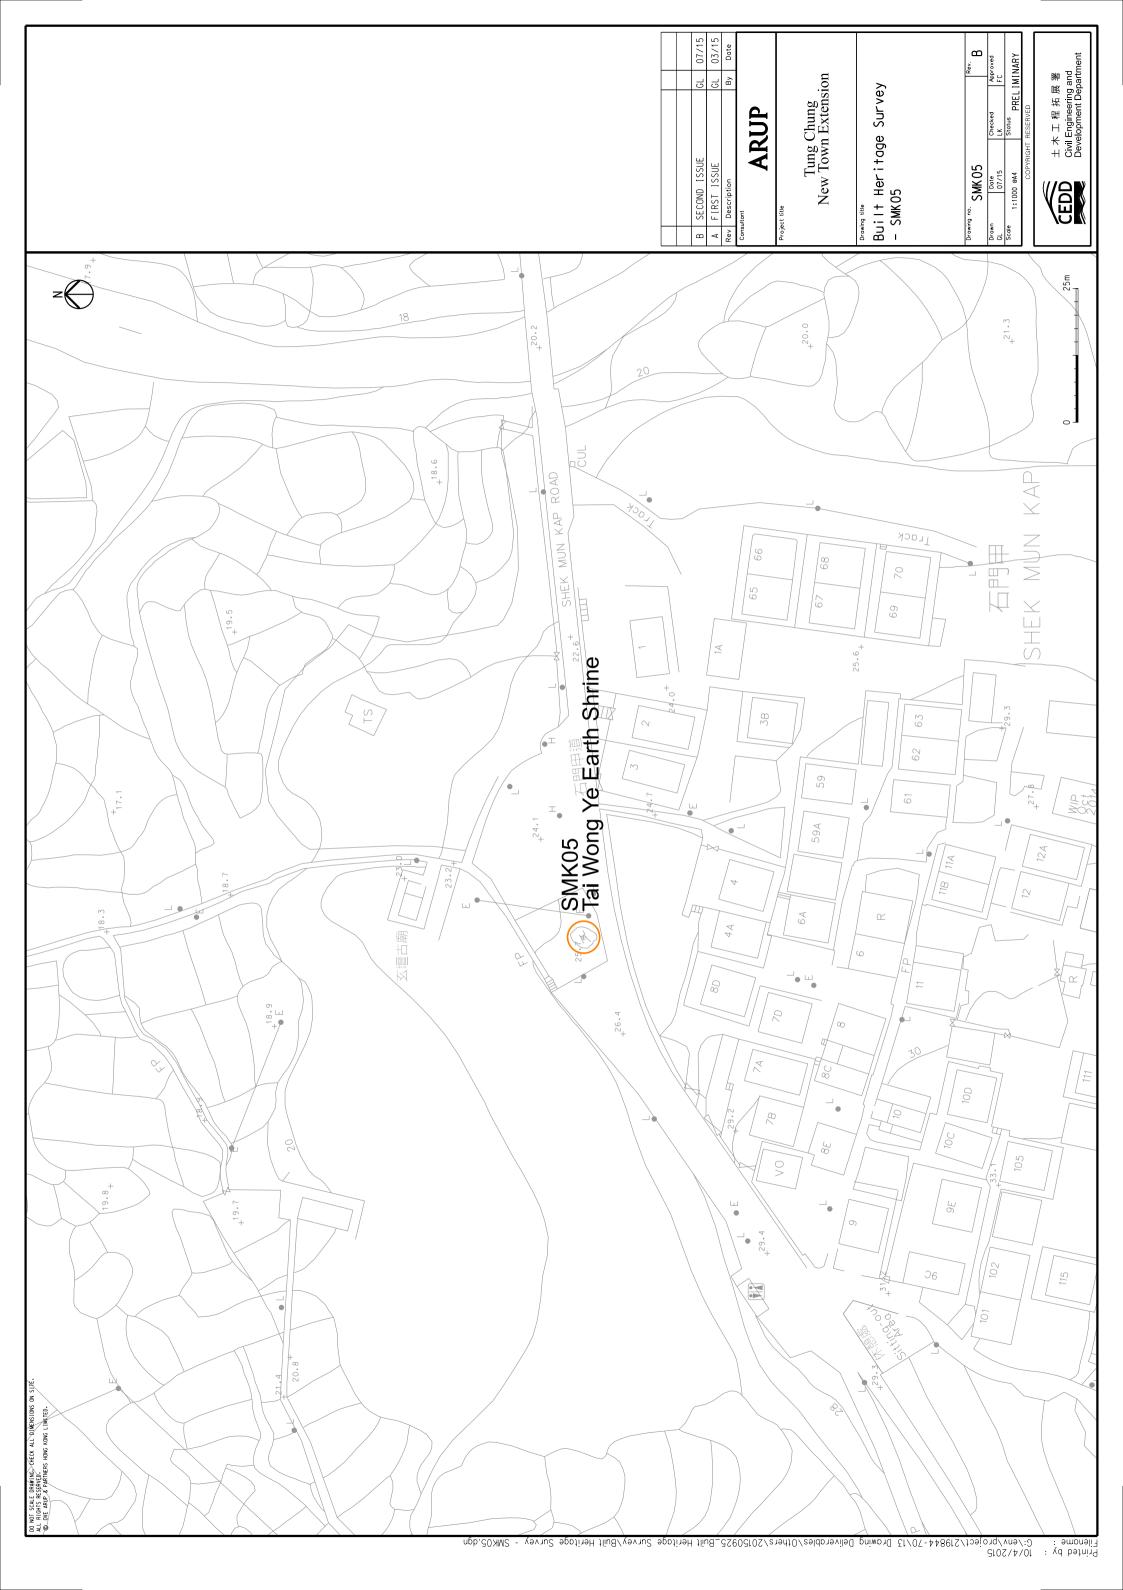
Survey Date:	18/03/2	<u>014 </u>		Ī	Map No	o: <u>Sl</u>	ИK	05			
BH Item No.	SMK05		Declared Monument								
Name of BH	Tai Wong	Ye (大王爺) Earth Shrine	AMO Announced	4	2	3		No Grade			
Village/Town Name	Shek Mur	ı Кар	Grading	Propos	ed Mon	nument					
District	Tung Chu	ng, Lantau Island	Gov. Historic Sites	¥	'es		I	No			
Building Type	Earth Shr	ine	Land	Lease	holder	r Cu	rre	nt User			
Date of Construction	Not Know	n	Condition	Pri	vate	Loc	al '	Villagers			
Present Use	Earth Shr	ine	Current Condition	In	Use	Al	ar	idoned			
Elements		Building Materials		Buildi	ing Me	thods					
Huge Rock		Stone		in	Situ Ro	ock					
Earth Gods		Stone with Ribbon		Plac	ed on A	Altar					
Door Gods		Painting on Paper		Glued	l to Alta	ır Wall					
Couplet		Stone	Ca	rved And	Painte	d on Table	ets				
Altar		Concrete + Stone				d Platforr luge Rock		A Wall			
Additional Building Description (Optional) Historical /Cultural Information (Optional)

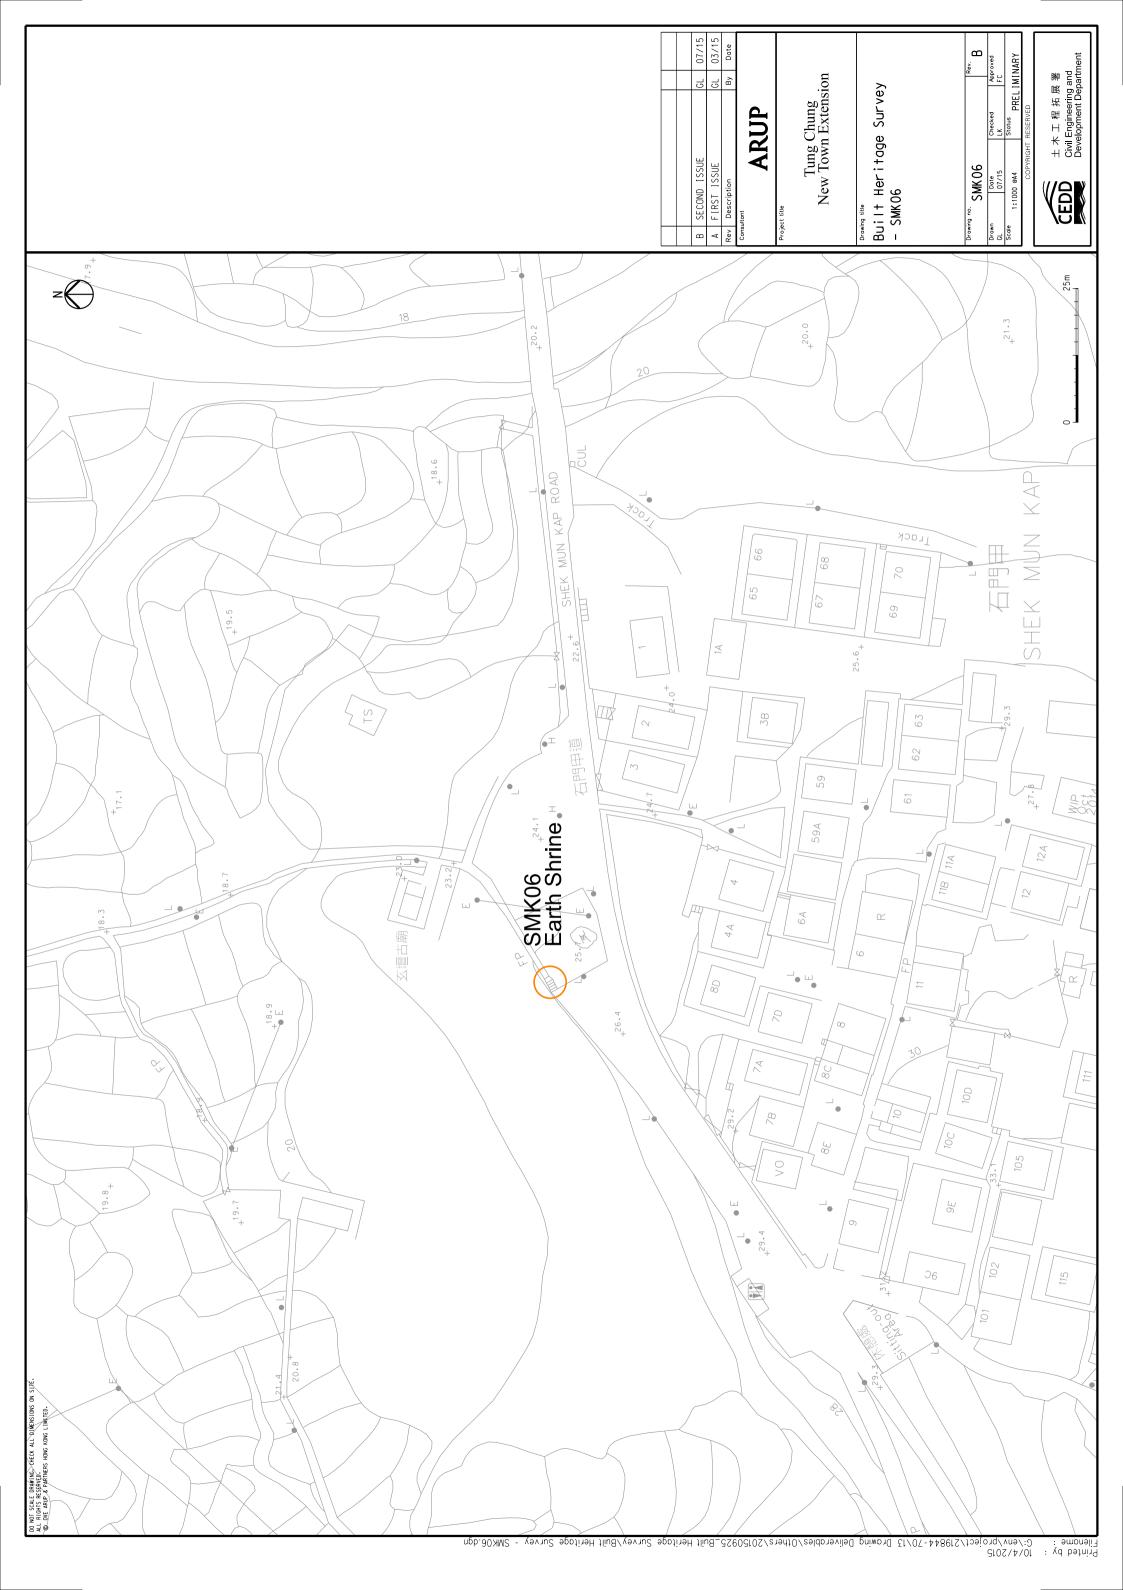
Survey Date:							06			
BH Item No.	SMK06		Declared Monument	Yes		No				
Name of BH	Earth Shri	ne	AMO Announced	4	2	3	No Grade			
Village/Town Name	Shek Mun	Кар	Grading	Propose	ed Monur	ment				
District	Tung Chu	ng, Lantau Island	Gov. Historic Sites	Yes I			No			
Building Type	Earth Shri	ne	Land	Leaseholder Currei			nt User			
Date of Construction	Not Know	n	Condition	Private		Local	Local Villagers			
Present Use	Earth Shri	ne	Current Condition	In Use		Abandoned				
Elements		Building Materials		Buildi	ng Meth	ods				
Earth God		Stone with Ribbon		Placed on Altar						
Door Shape Frame	5	Stone Tablet + Concrete		Built on Altar						
Altar Platform	5	Stone Tablet + Concrete	В	Built into a Raised Platform						
Additional Building Description (Optional) Historical /Cultural Information (Optional)										
		Representat	tive Photo(s)	No.						
Façade Other View(s) /										
Detail(s) (Optional):	Abor Ole and	Data 40/00/0044	Charlett	A	c: <u>-</u>	10/00/2	004.4

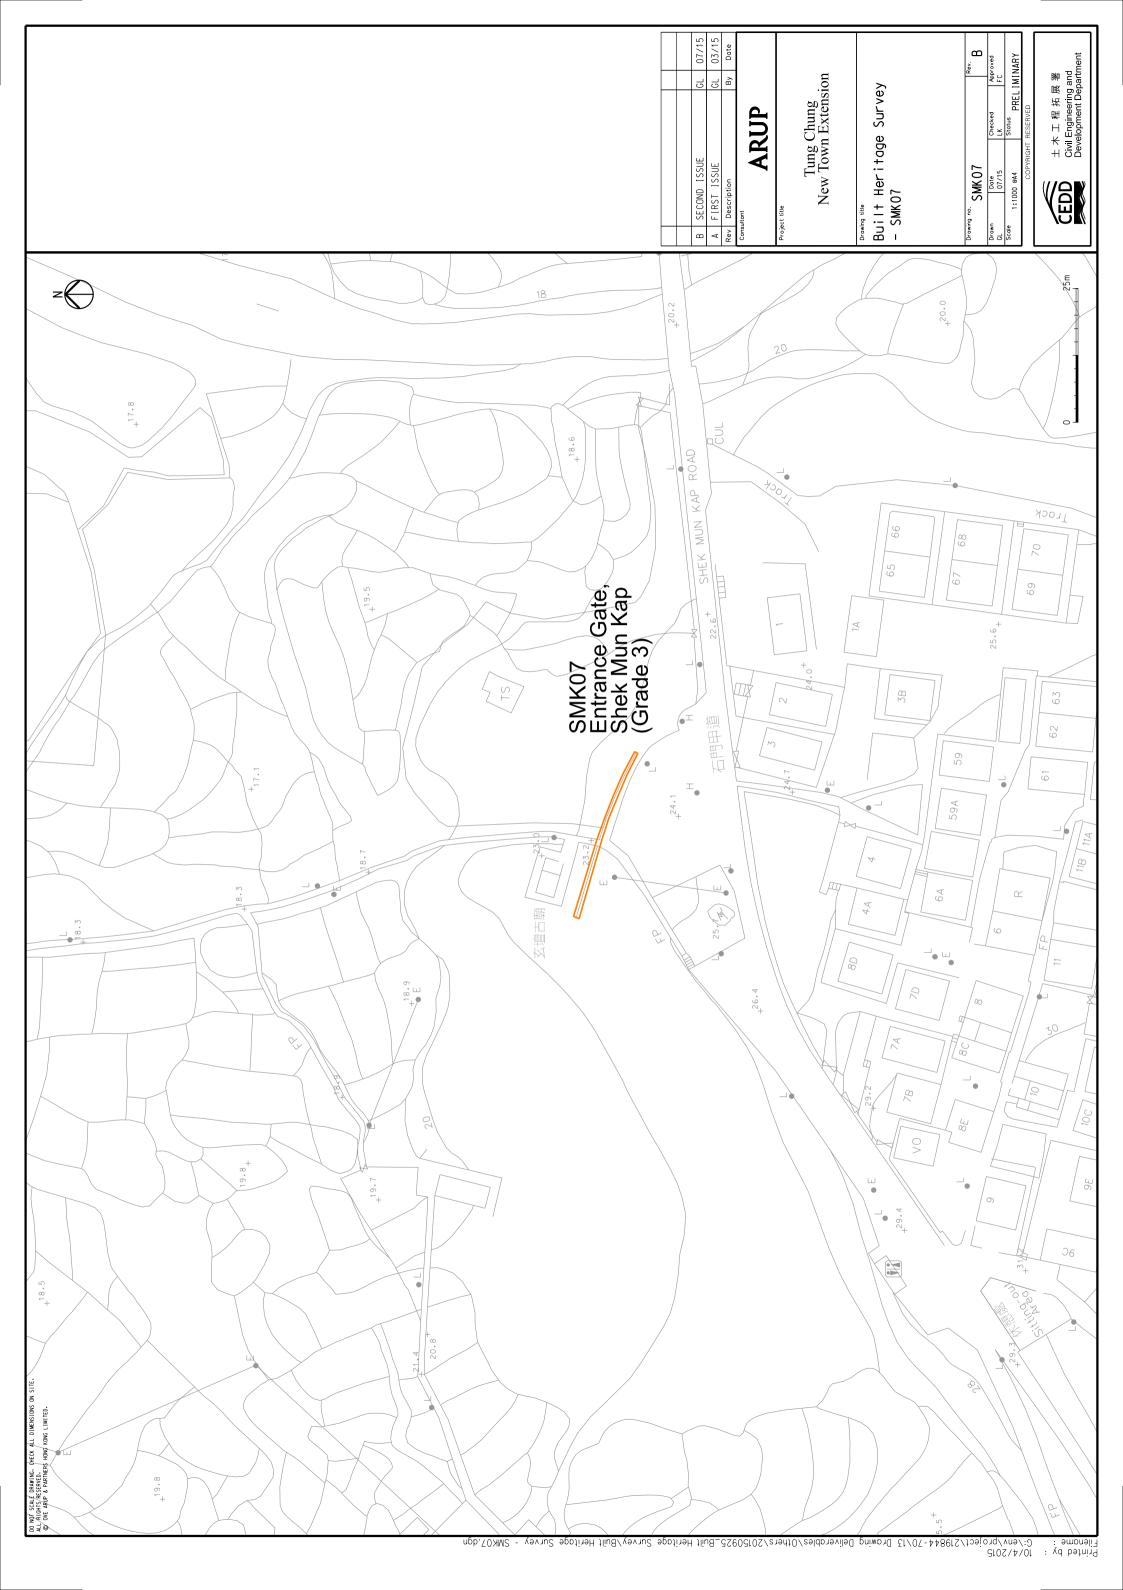
Survey Date:	18/03/2014				Map No: SMK07				
BH Item No.	SMK07		Declared Monument	Yes		1	No		
Name of BH	Entrance	Gate, Shek Mun Kap	AMO Announced	4	2	3	No - Grade		
Village/Town Name	Shek Mur	n Кар	Grading	Propose	ed Monu	ment	nt		
District	Tung Chu	ing, Lantau Island	Gov. Historic Sites	Yes		1	No		
Building Type	Entrance	Gate	Land	Leaseholder Current			nt User		
Date of Construction	Probably	Built around 1880	Condition	Private		Local \	Local Villagers		
Present Use	Entrance	Gate	Current Condition	In Use		Aban	Abandoned		
Elements		Building Materials		Building Methods					
Gate	S	tone + Mortar (?) + Lime	Rectang	gular Ope	ning Typ	oe +Lime Fi	nish		
Name Broad		Mortar (?)		Molded + Painted					
Couplet		Stone Tablets		Carved + Painted					
Wall	Stone + Mortar Mortar Fills in Gaps Between Stone Blocks						llocks		
Additional Building Description (Optional) Historical /Cultural	The entrance gate was confirmed a Grade 3 historic building on 31 Aug 2010. It has been renovated by repainting the surface and replacing the couplet into tablet form. The entrance gate was built for <i>fung shui</i> and defence purposes. They protected the villagers

Information (Optional)	from the attack of pirates and bandits (AMO's 1444 Historic Building Appraisal).								
	T	Representati	ve Photo(s)		2000	F & MK - 1/2			
Façade Other View(s) /									
Detail(s) (Optional):									
Recorded by Ka	thy Chan	Date 18/03/2014	Checked by	Anthony	Siu D	Date 18/03/2014

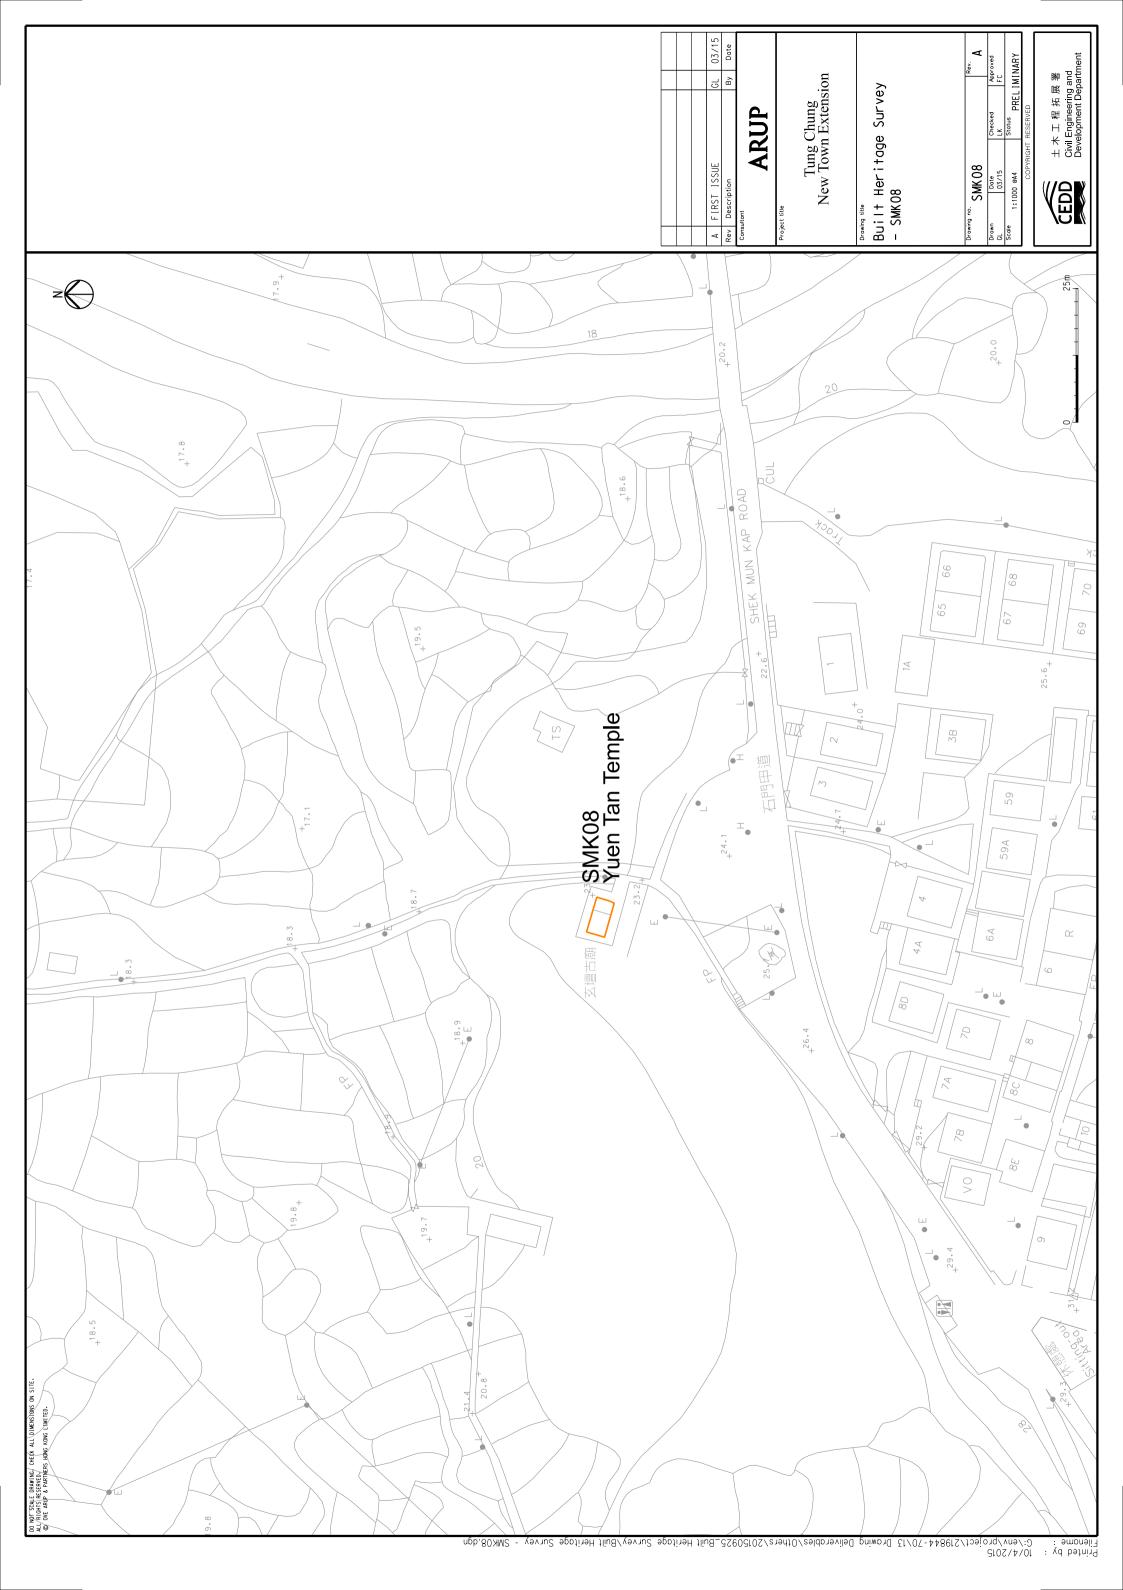
Survey Date:	18/03/2014				Map No: <u>SMK08</u>							
BH Item No.	SMK08			Declared Monument	Yes		No					
Name of BH	Yuen Tan	Temple (玄壇古廟)		AMO Announced	4	2	3	No Grade				
Village/Town Name	Shek Mun	Кар		Grading	Proposed Monument							
District	Tung Chu	ng, Lantau Island		Gov. Historic Sites	Yes No			No				
Building Type	Temple			Land	Leaseholder Current U			nt User				
Date of Construction	Not Know	n, Renovated in 200	0	Condition	Private		Local	Local Villagers				
Present Use	Temple			Current Condition	In Use		Abandoned					
Elements		Building Materials	S		Building Methods							
Roof Tile		Grey Tile + Red Tile	е	Concave, Cylindrical Combined								
Tile End		Cylindrical Tile			Witho	ut Drippi	ngs					
Wall		Concrete		Concrete Finish					Concrete Fir			
Door		Timber + Granite		Recessed Entrance + Rectangular Opening Type + Flush Door								
Additional Building Description (Optional) Historical

/Cultural Information (Optional)	The present temple was a later rebuilt (in 2000) as the village experienced several outbreaks of plagues (AMO's 1444 Historic Building Appraisal). The temple serves Fuhu Yuen Tan (伏虎玄壇).											
(Optional)		Ren	resentative F	Photo(s)								
Façade												
Other View(s) / Detail(s) (Optional): Fuhu Yuen Tan (伏虎玄壇).												
Recorded by Ka	thy Chan	Date 18/03/2014		Checked by	Anthony	Siu D a	Date 18/03/2014
