Existing View of the Existing Tai O STW

View of the Proposed Tai O STW Upgrading - without visual mitigation measures

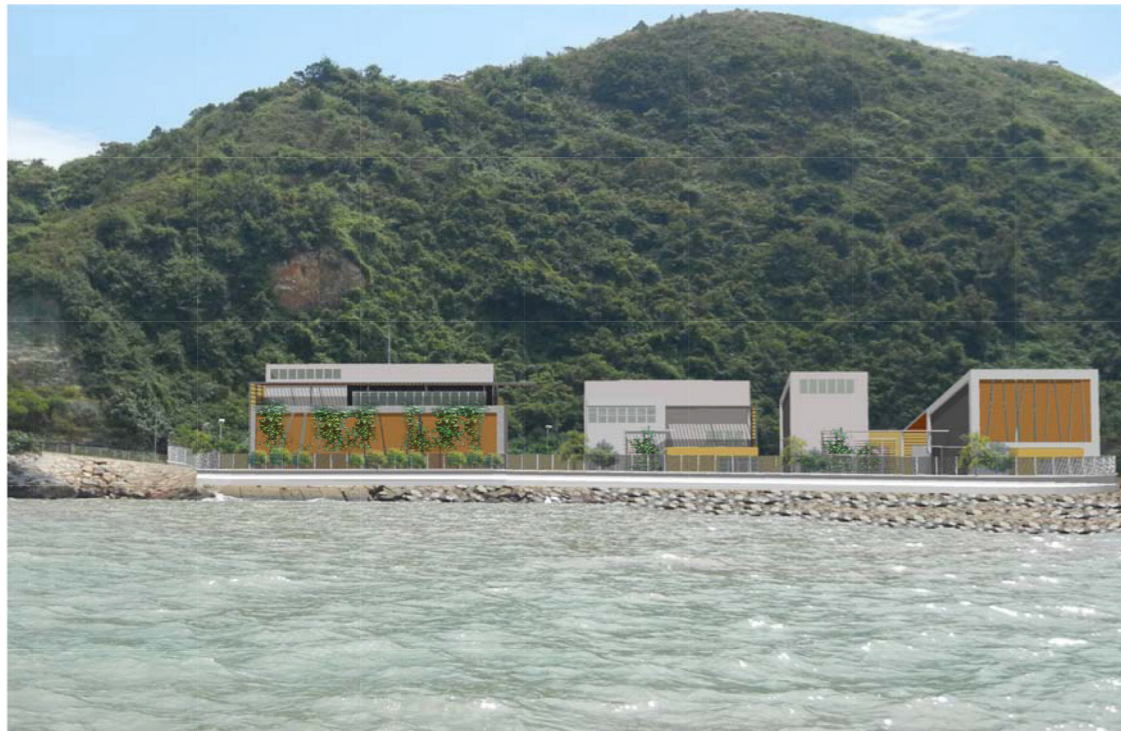
View of the Proposed Tai O STW Upgrading - with visual mitigation measures - Day 1

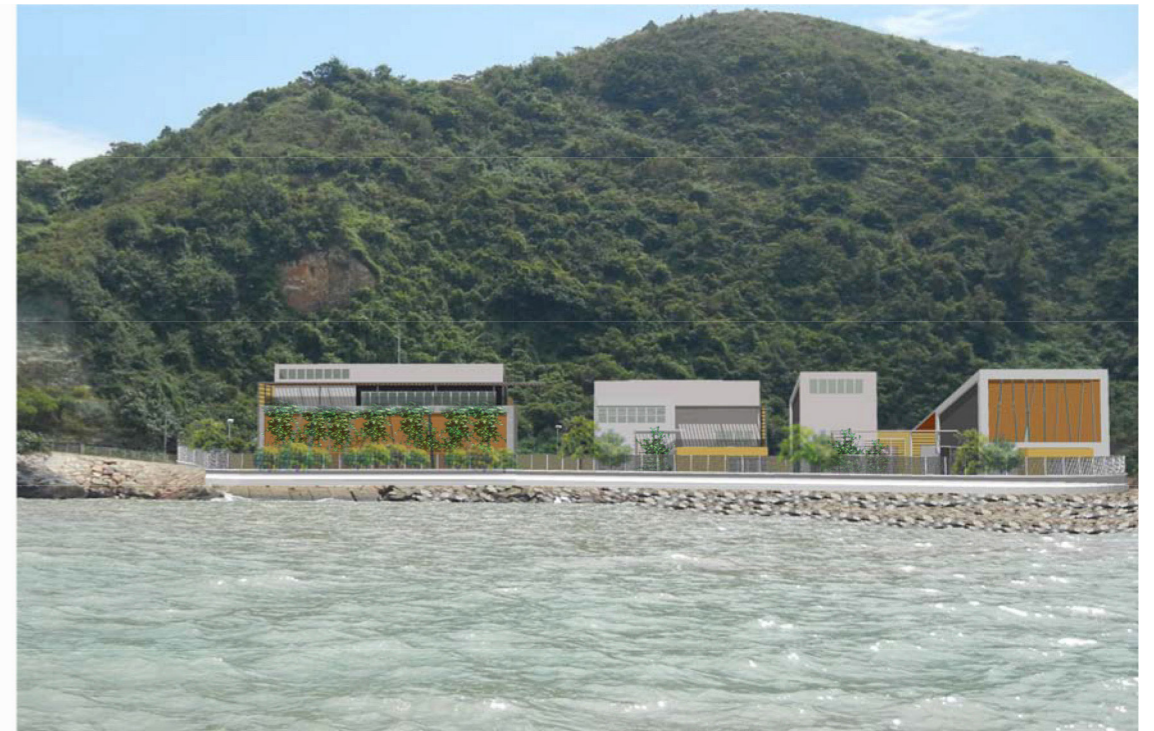
View of the Proposed Tai O STW Upgrading - with visual mitigation measures - Year 10
