FIGURE 11-5-7: PHOTOMONTAGE 06 : KEY VIEWPOINT VP06 FROM FUTURE RESIDENTIAL AT NORTHWEST OF MPSC

PROJECT: Kai Tak Multi-purpose Sports Complex

DRAWING NO:
Figure 11-5-7

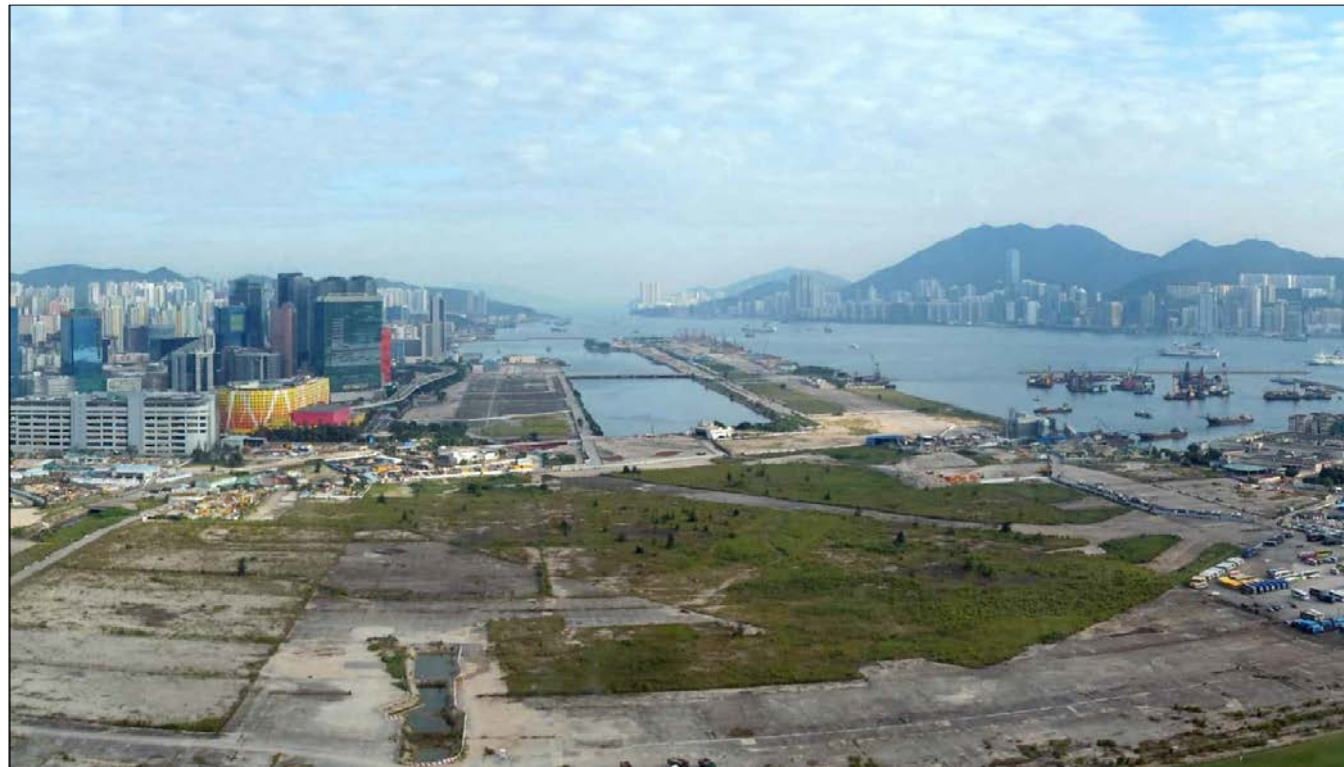
EXISTING CONDITION

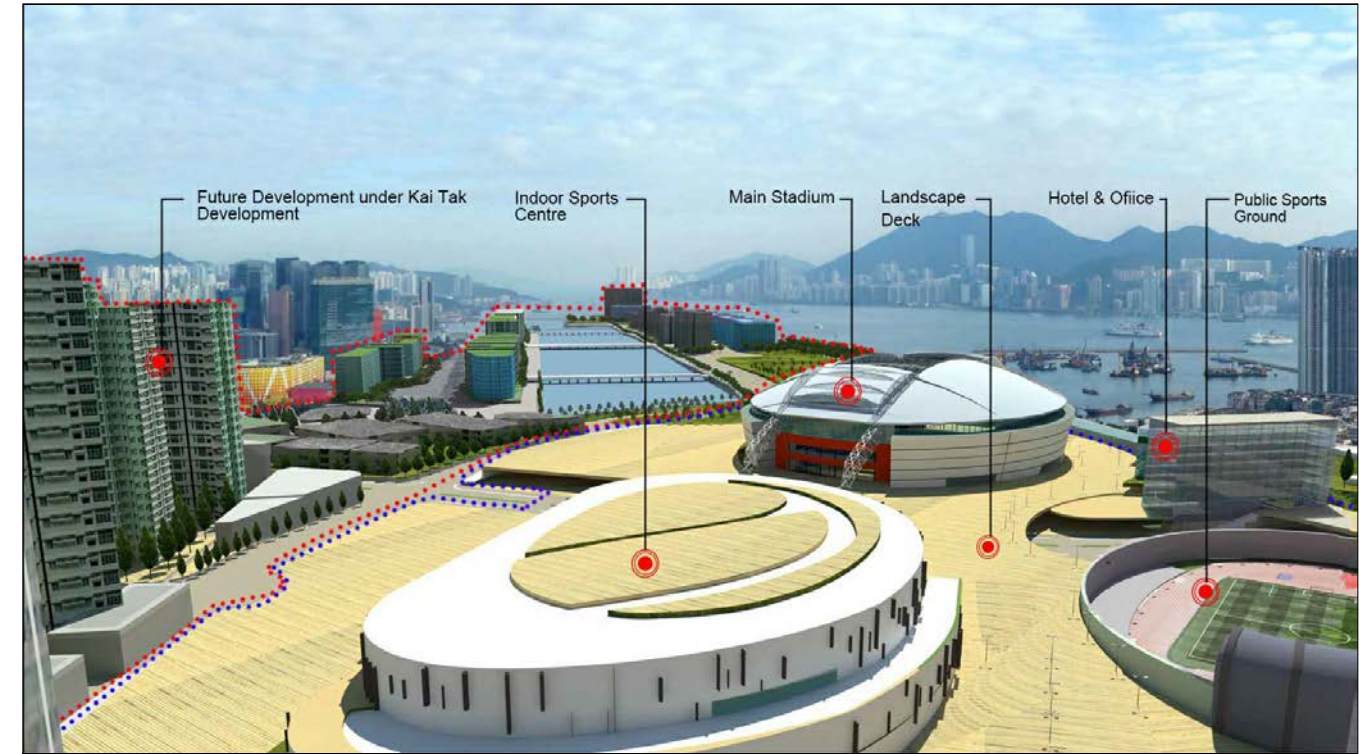
DAY 1 WITHOUT MITIGATION MEASURES

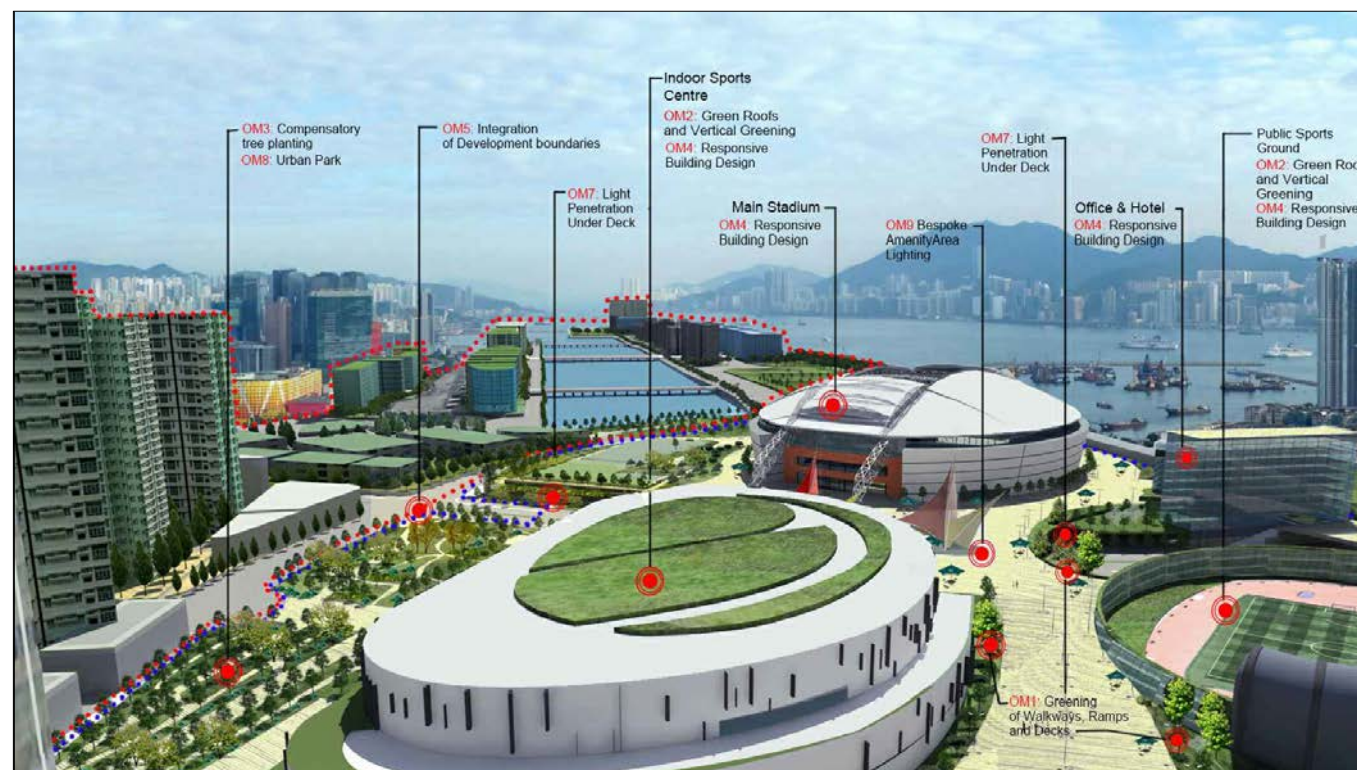
DAY 1 WITH MITIGATION MEASURES

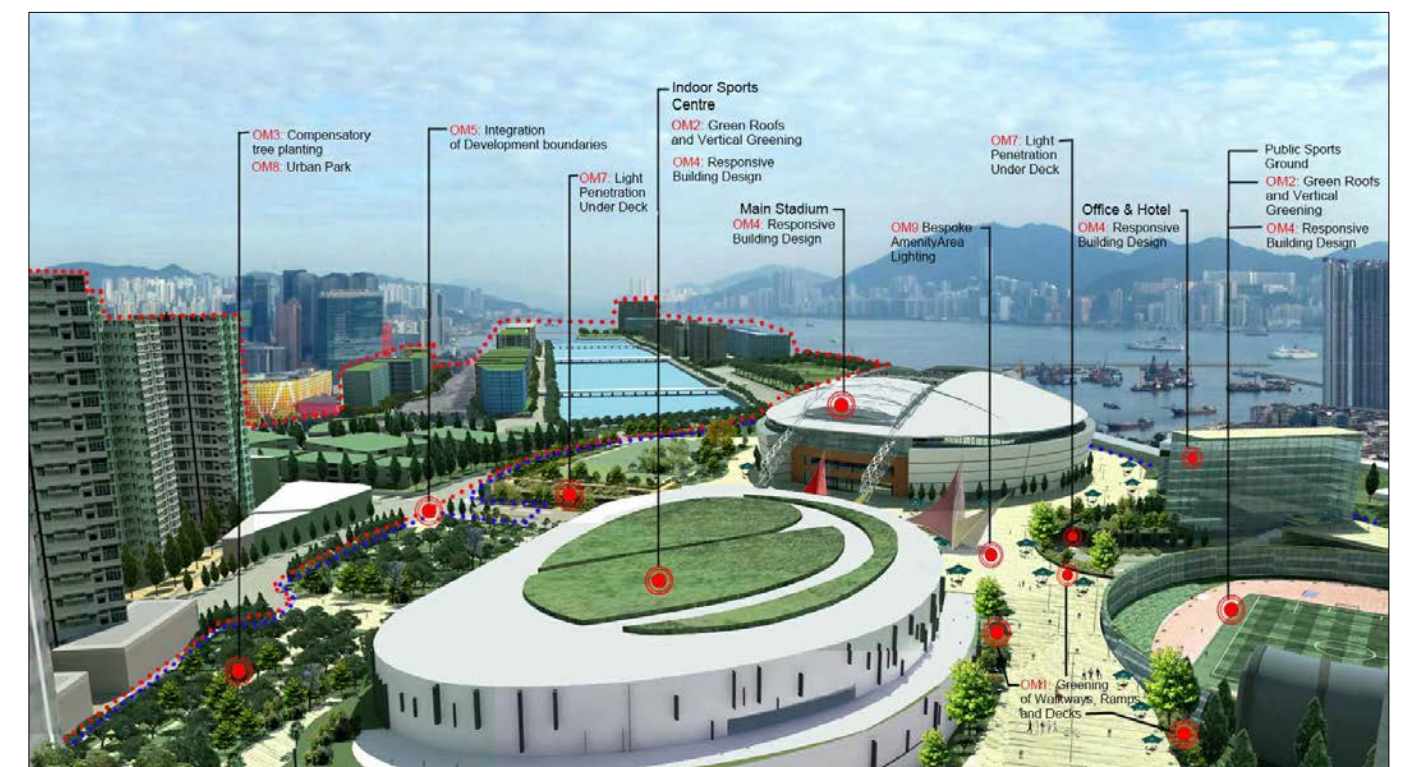
10 YEAR WITH MITIGATION MEASURES
