Agreement No. CE 3/2015 (DS) Yuen Long Effluent Polishing Plant – Investigation, Design and Construction Water Level, Depth Averaged Current Velocity and Direction at DM2 in Dry Season Model results – Red: Base Case; Dashed Blue: Repeat Model Run	Dry Season	Nov 2018
	Appendix 5.8 – 01	
AECOM	/GPP/	Spchk.ssn

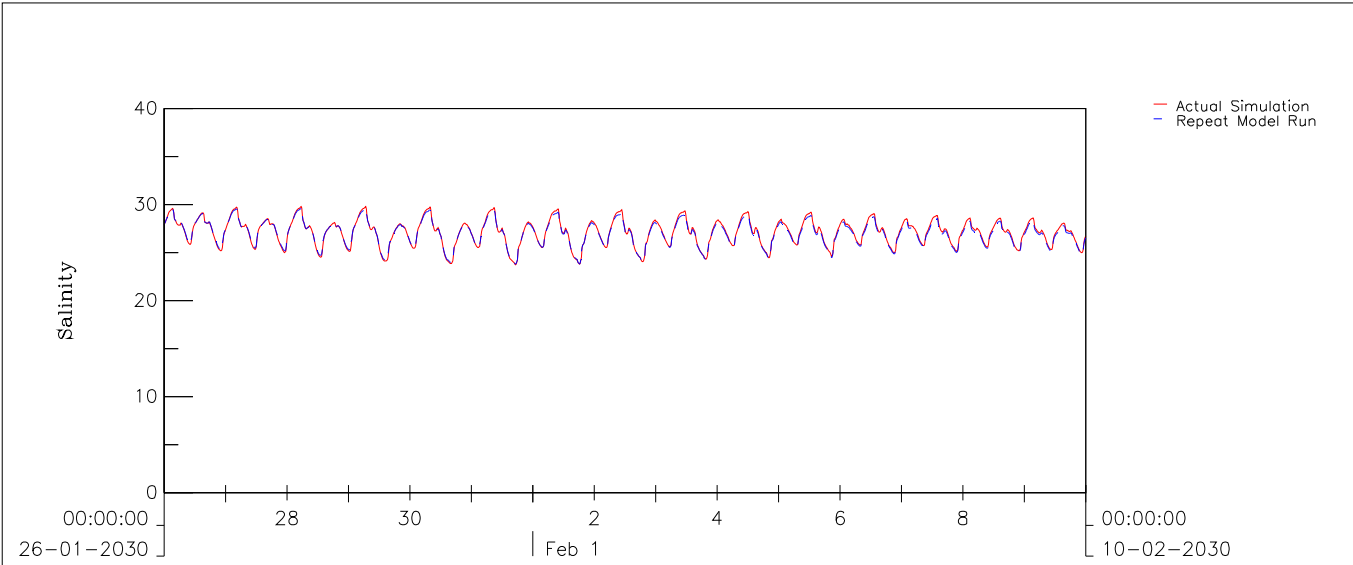
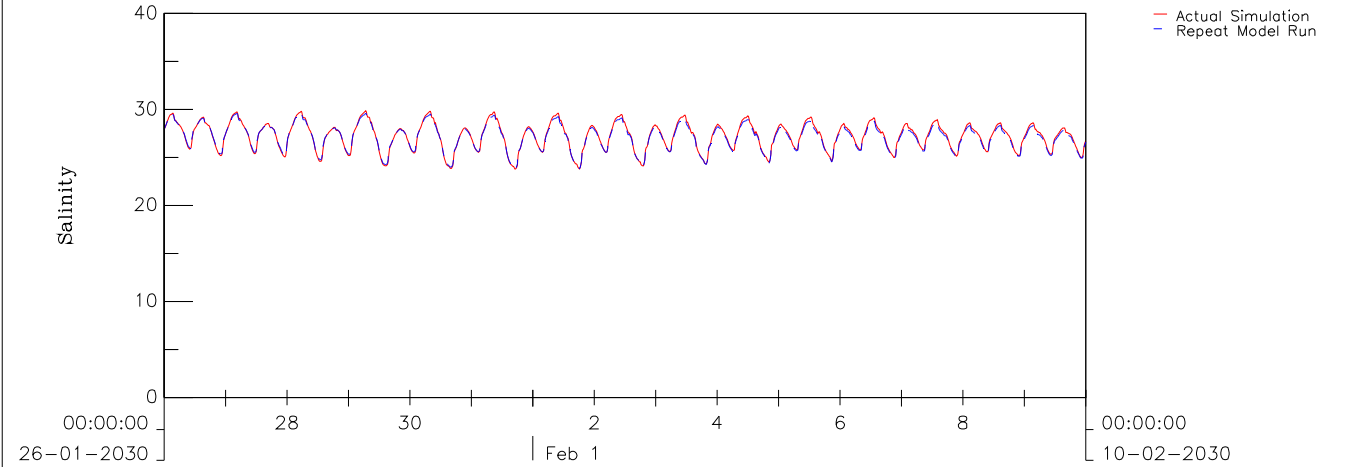
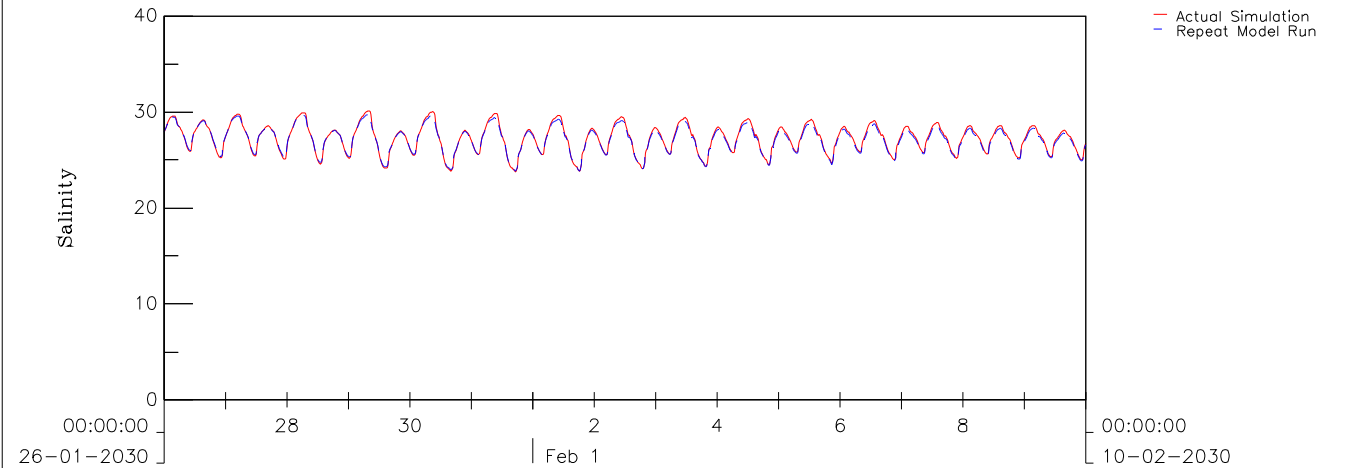
Agreement No. CE 3/2015 (DS) Yuen Long Effluent Polishing Plant – Investigation, Design and Construction Surface, Mid-Depth and Bottom Salinity at DM2 in Dry Season Model results – Red: Base Case; Dashed Blue: Repeat Model Run	Dry Season	Nov 2018
	Appendix 5.8 – 02	
AECOM	/GPP/	Spchk.ssn

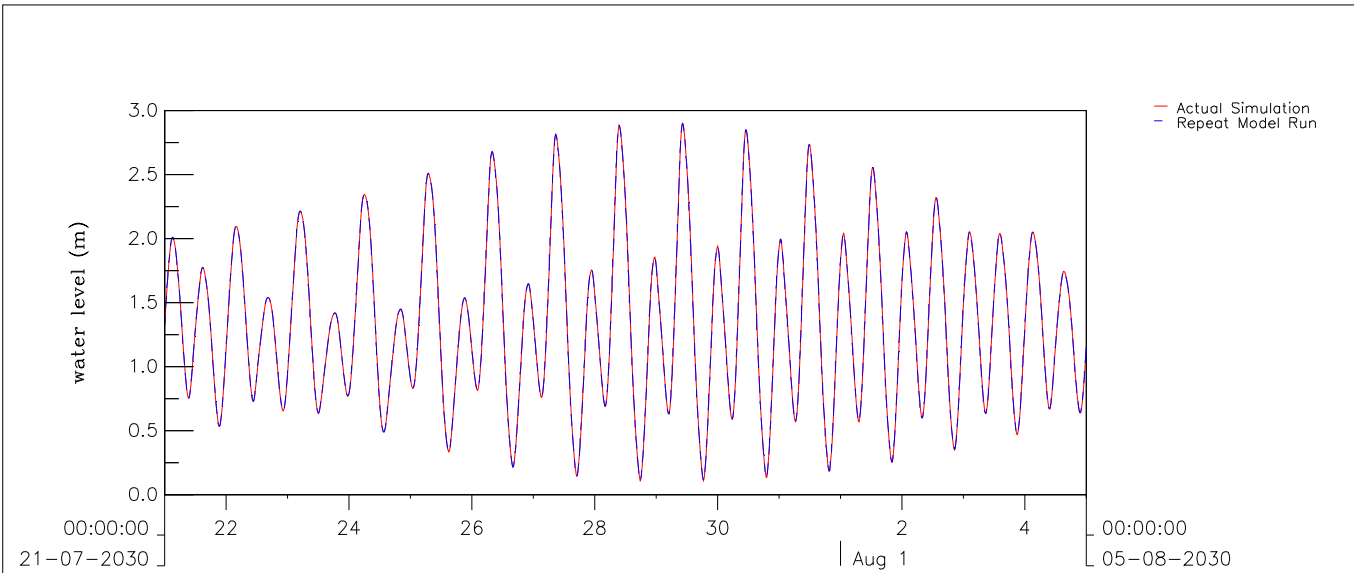
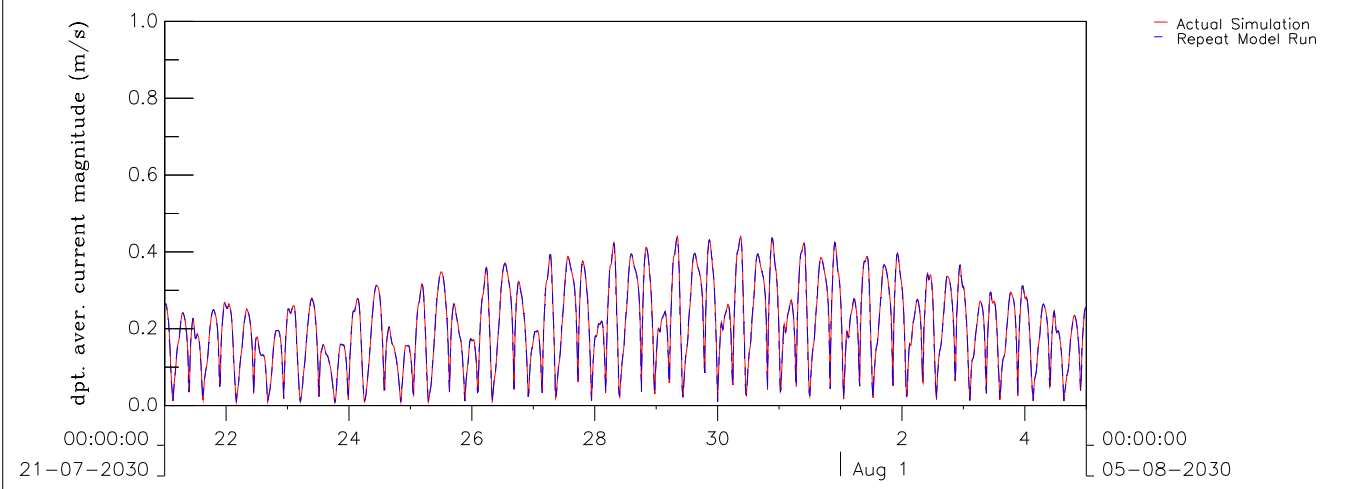
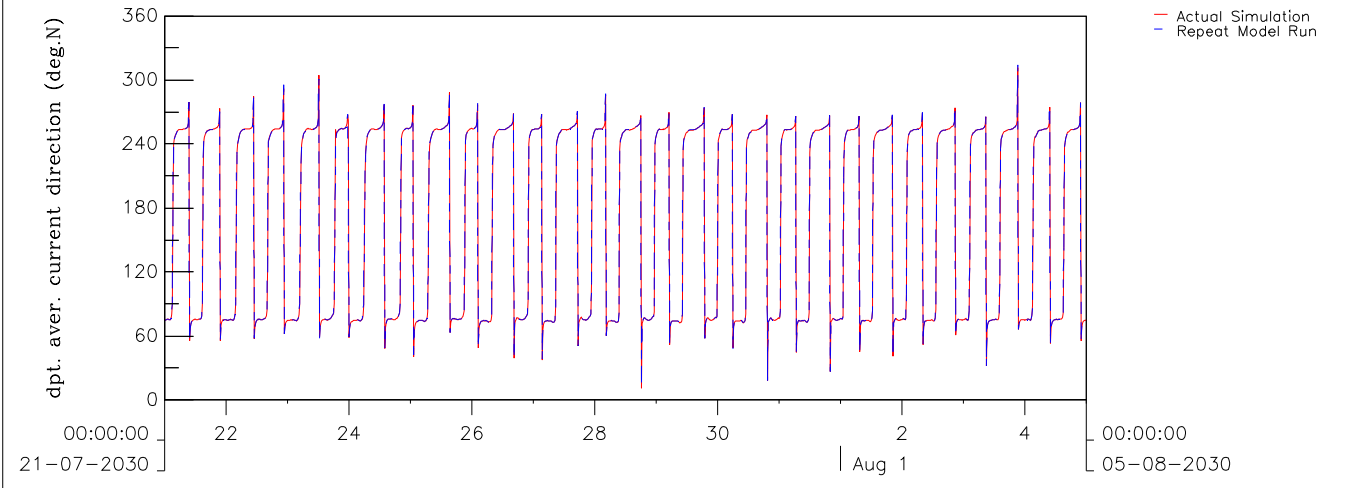
Agreement No. CE 3/2015 (DS) Yuen Long Effluent Polishing Plant – Investigation, Design and Construction Water Level, Depth Averaged Current Velocity and Direction at DM2 in Wet Season Model results – Red: Base Case; Dashed Blue: Repeat Model Run	Wet Season	Nov 2018
	Appendix 5.8 – 03	
AECOM	/GPP/	Spchk.ssn

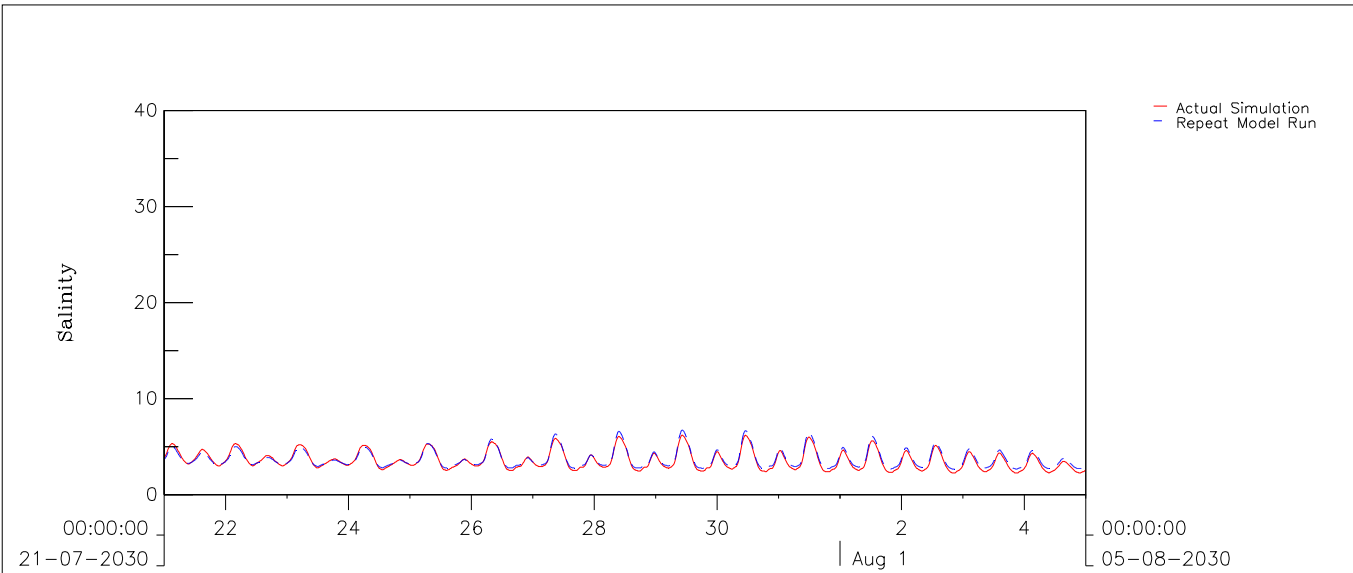
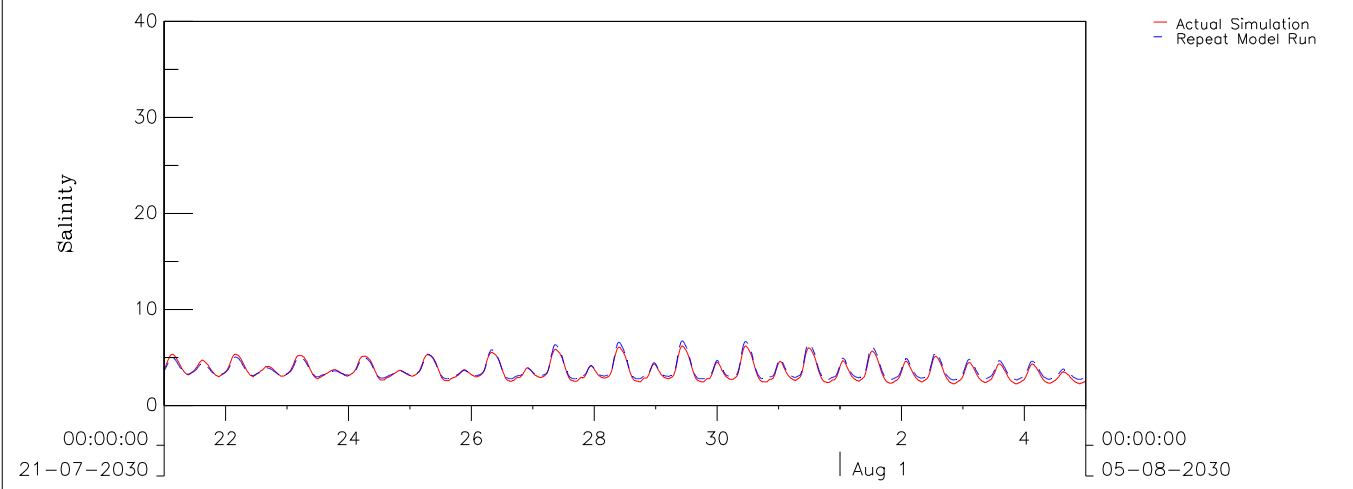
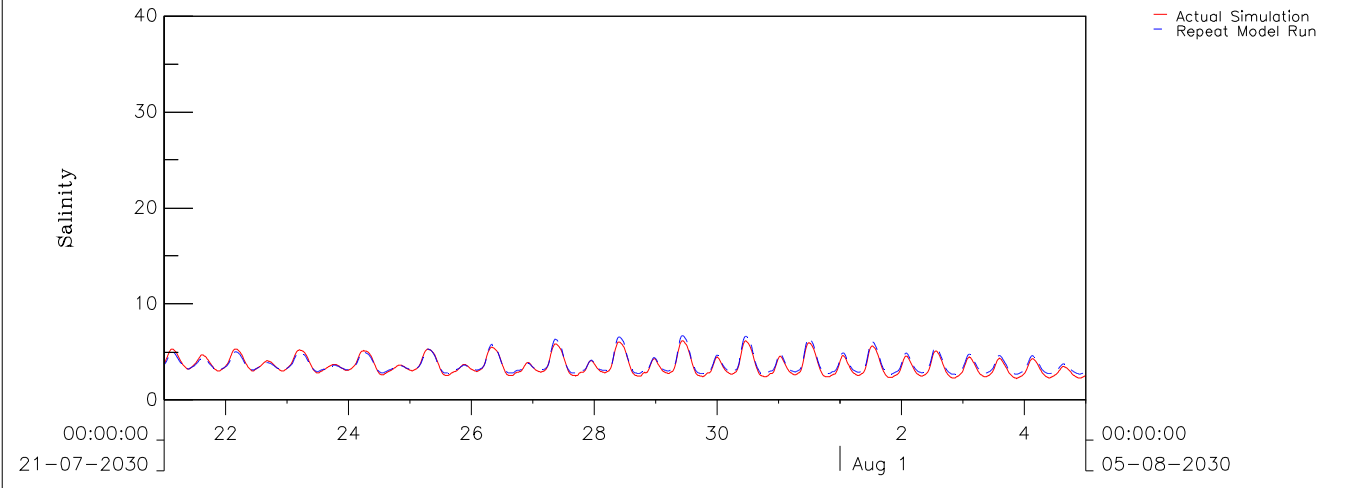
Agreement No. CE 3/2015 (DS) Yuen Long Effluent Polishing Plant – Investigation, Design and Construction Surface, Mid-Depth and Bottom Salinity at DM2 in Wet Season Model results – Red: Base Case; Dashed Blue: Repeat Model Run	Wet Season	Nov 2018
	Appendix 5.8 – 04	
AECOM	/GPP/	Spchk.ssn

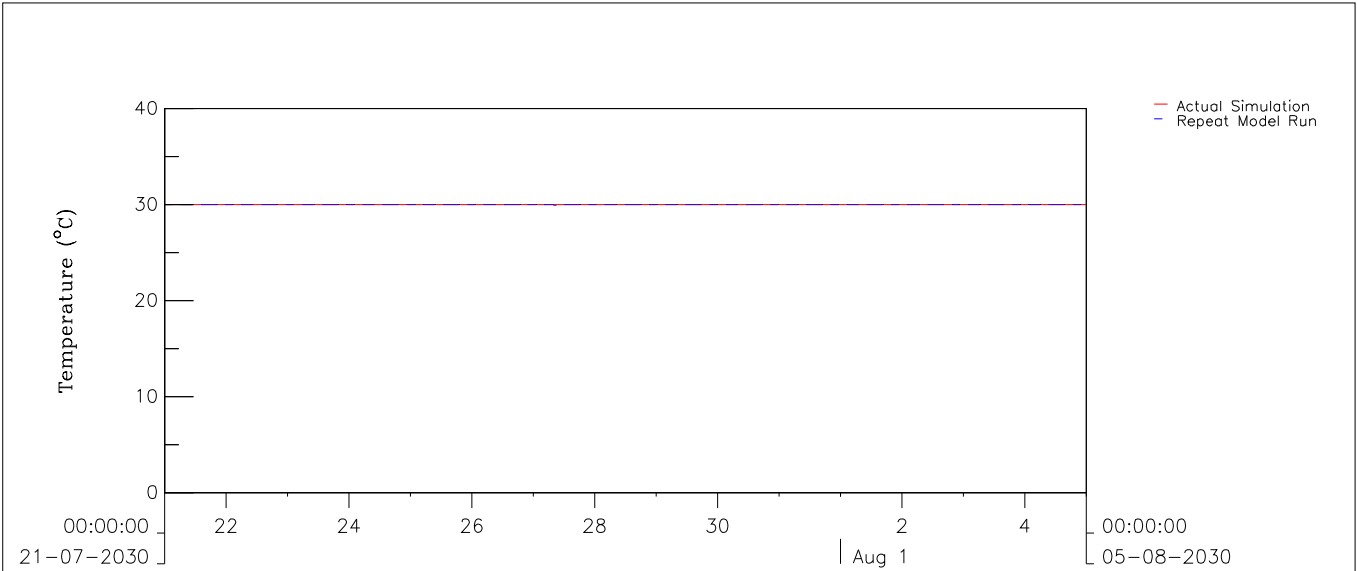
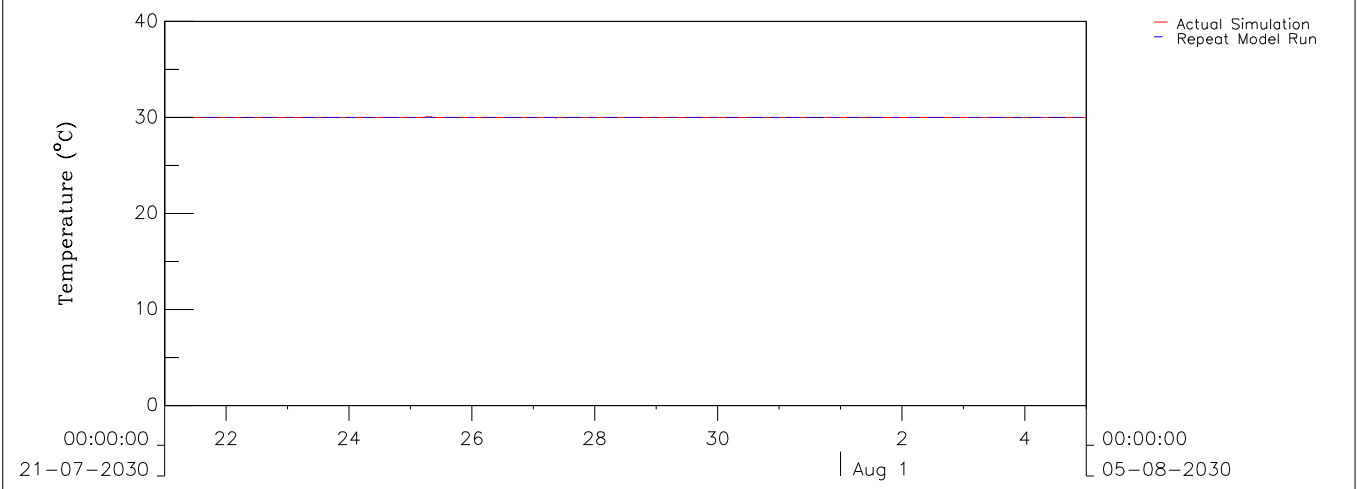
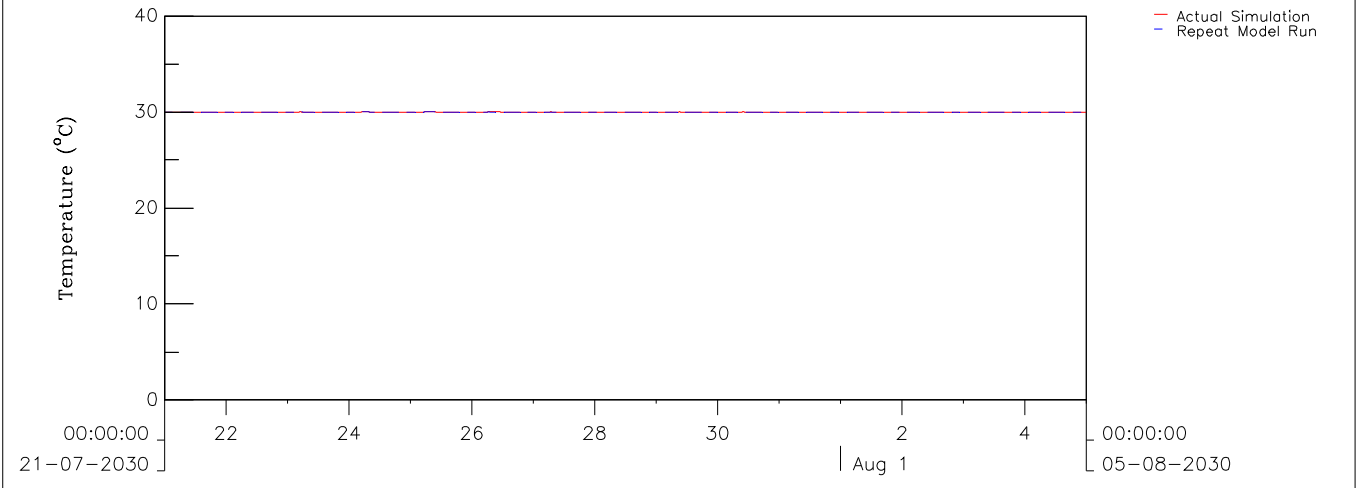
Agreement No. CE 3/2015 (DS) Yuen Long Effluent Polishing Plant – Investigation, Design and Construction Surface, Mid-Depth and Bottom Temperature at DM2 in Wet Season Model results – Red: Base Case; Dashed Blue: Repeat Model Run	Wet Season	Nov 2018
	Appendix 5.8 – 05	
AECOM	/GPP/	Spchk.ssn

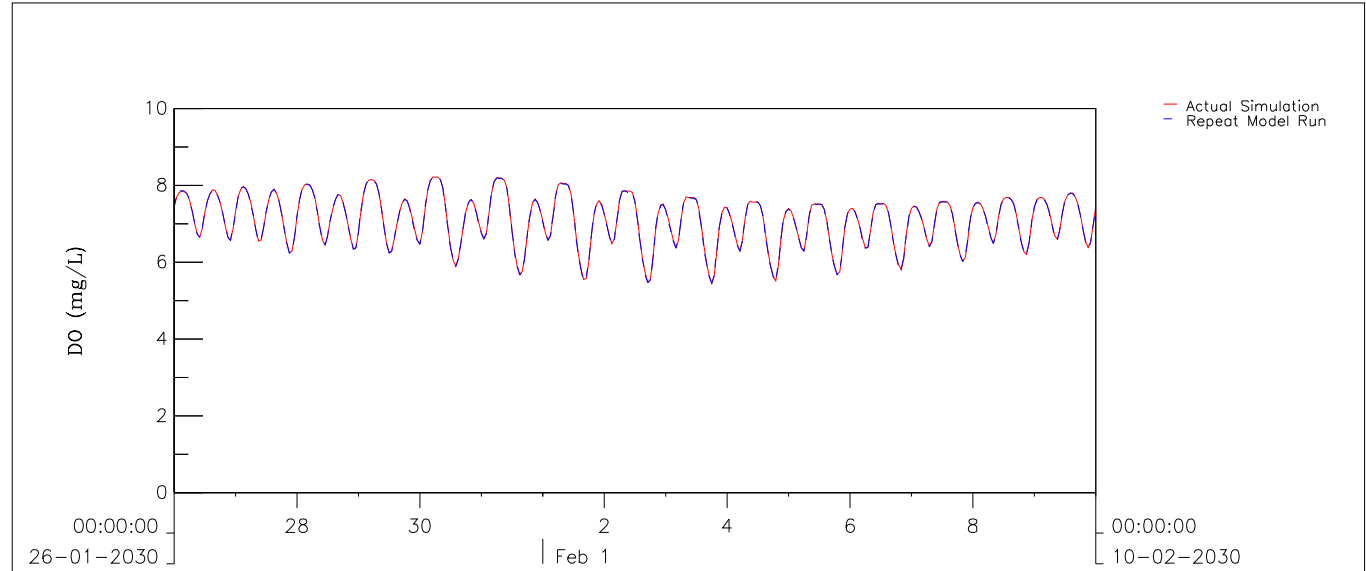
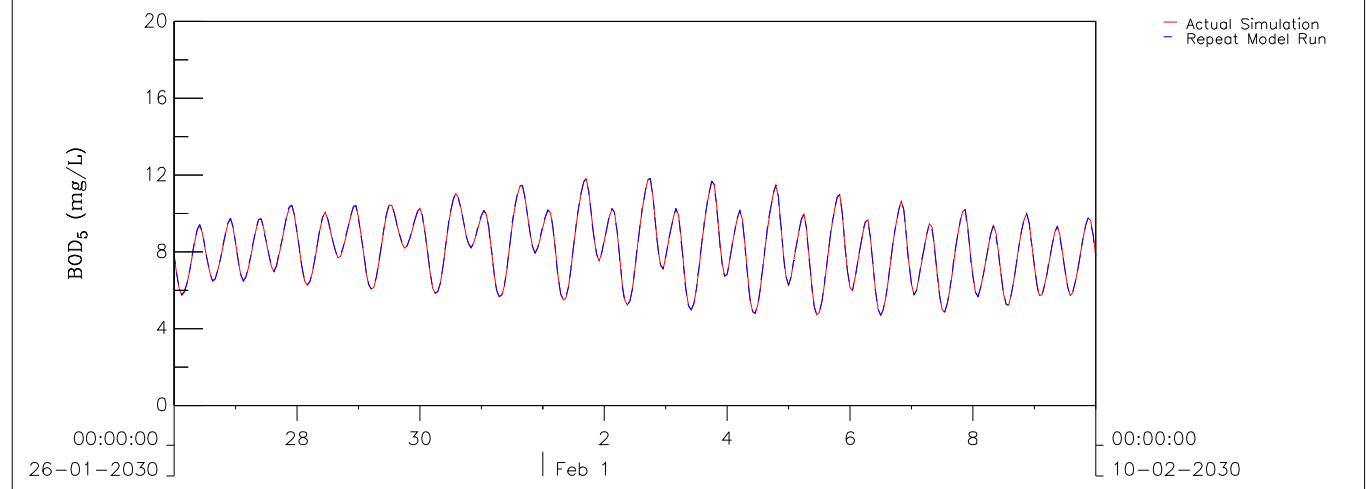
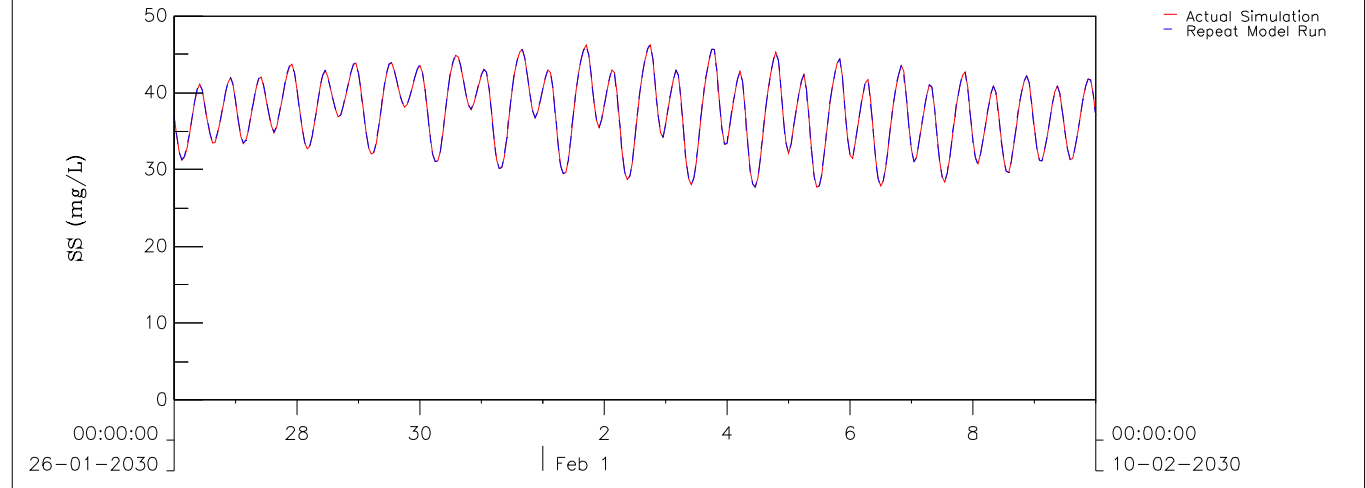
Agreement No. CE 3/2015 (DS) Yuen Long Effluent Polishing Plant – Investigation, Design and Construction Depth Averaged DO, BOD <sub>5</sub> and SS at DM2 in Dry Season Model results – Red: Base Case; Dashed Blue: Repeat Model Run	Dry Season	Nov 2018
	Appendix 5.8 – 06	
AECOM	/GPP/	Spchk.ssn

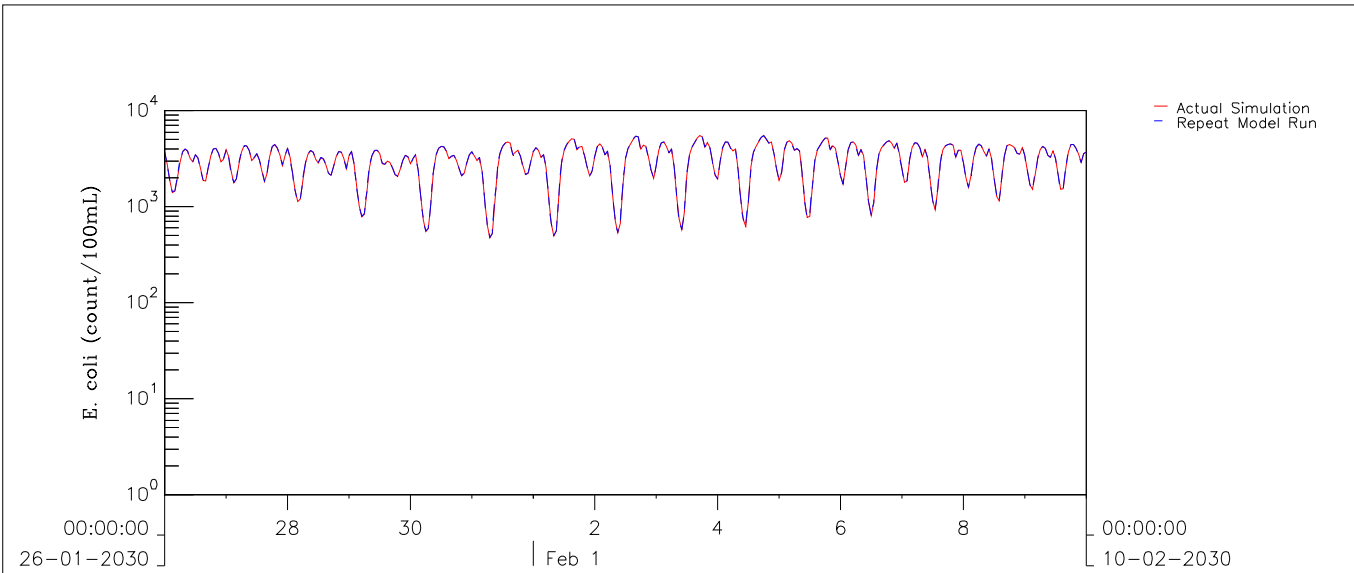
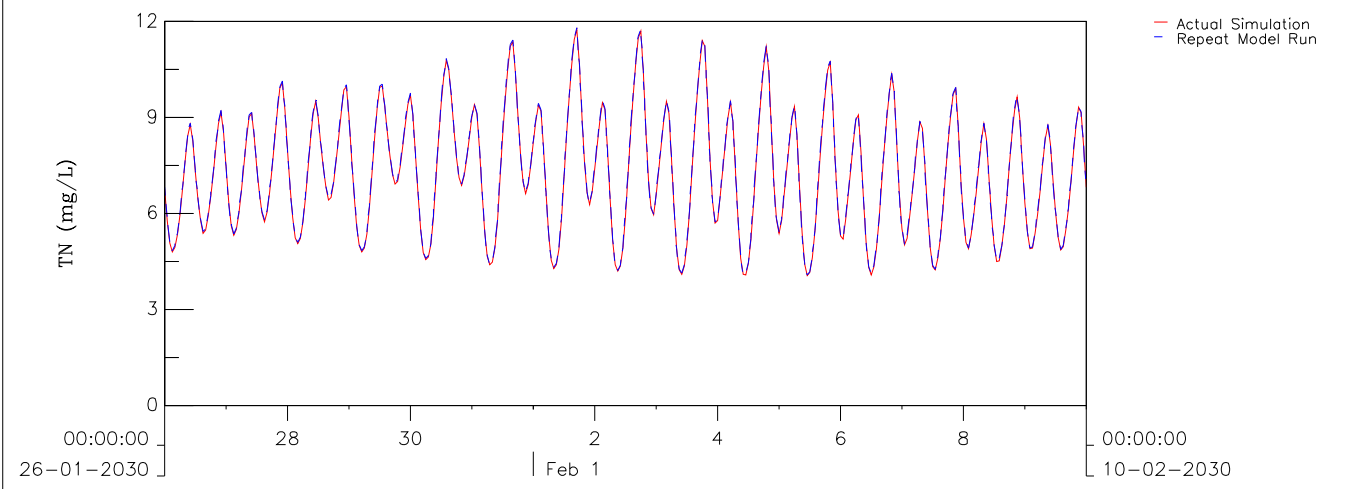
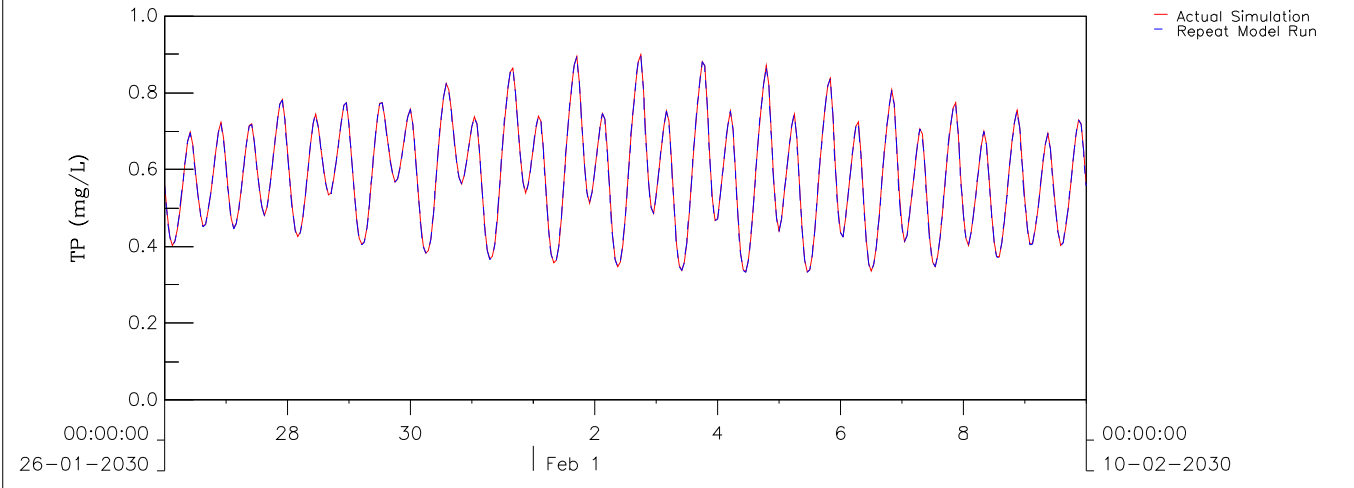
Agreement No. CE 3/2015 (DS) Yuen Long Effluent Polishing Plant – Investigation, Design and Construction Depth Averaged E. coli, TN and TP at DM2 in Dry Season Model results – Red: Base Case; Dashed Blue: Repeat Model Run	Dry Season	Nov 2018
	Appendix 5.8 – 07	
AECOM	/GPP/	Spchk.ssn

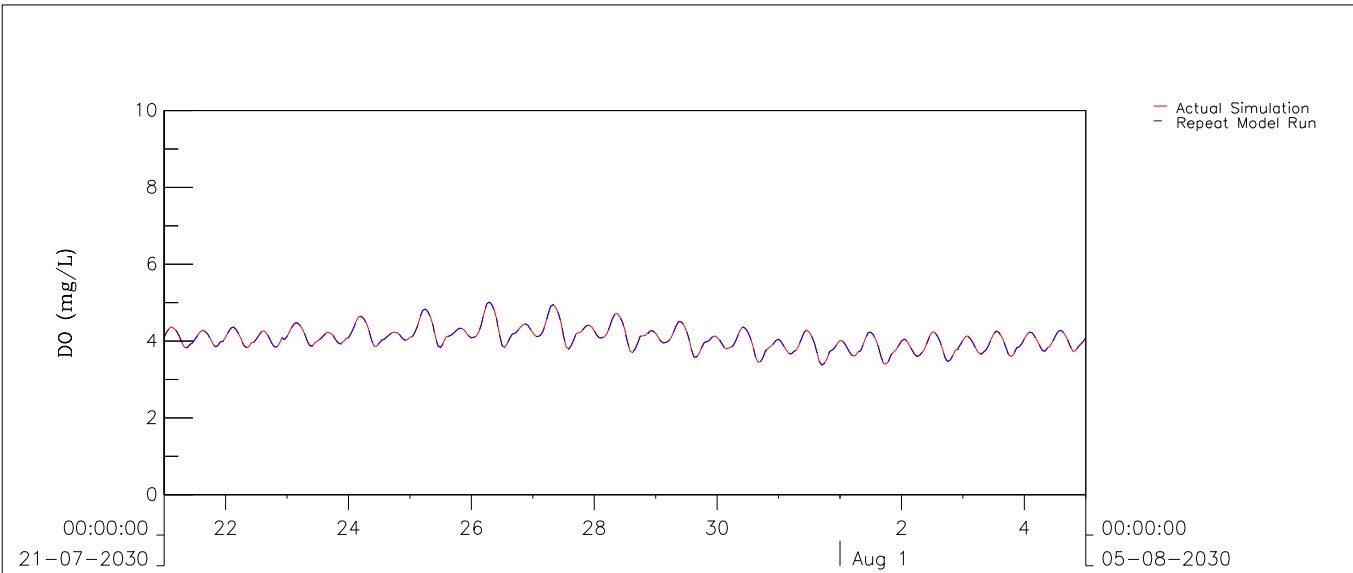
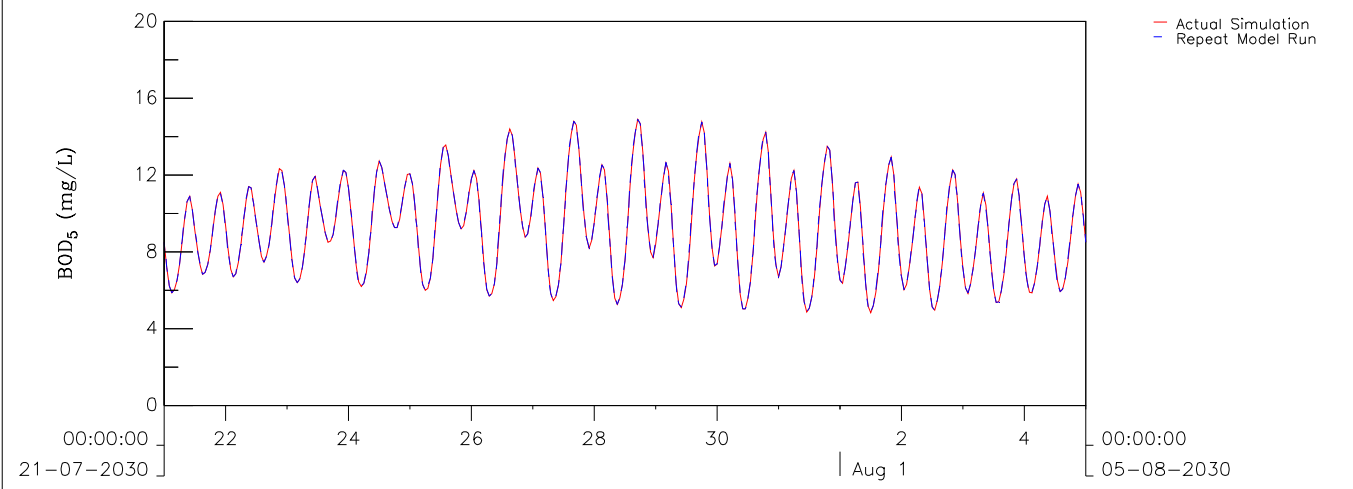
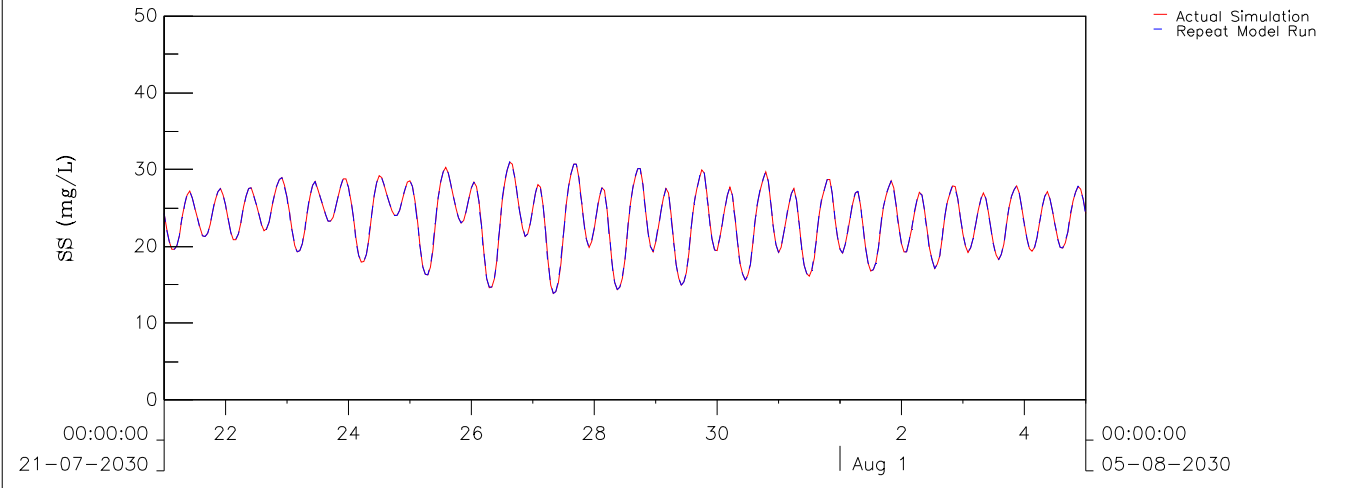
Agreement No. CE 3/2015 (DS) Yuen Long Effluent Polishing Plant – Investigation, Design and Construction Depth Averaged DO, BOD <sub>5</sub> and SS at DM2 in Wet Season Model results – Red: Base Case; Dashed Blue: Repeat Model Run	Wet Season	Nov 2018
	Appendix 5.8 – 08	
AECOM	/GPP/	Spchk.ssn

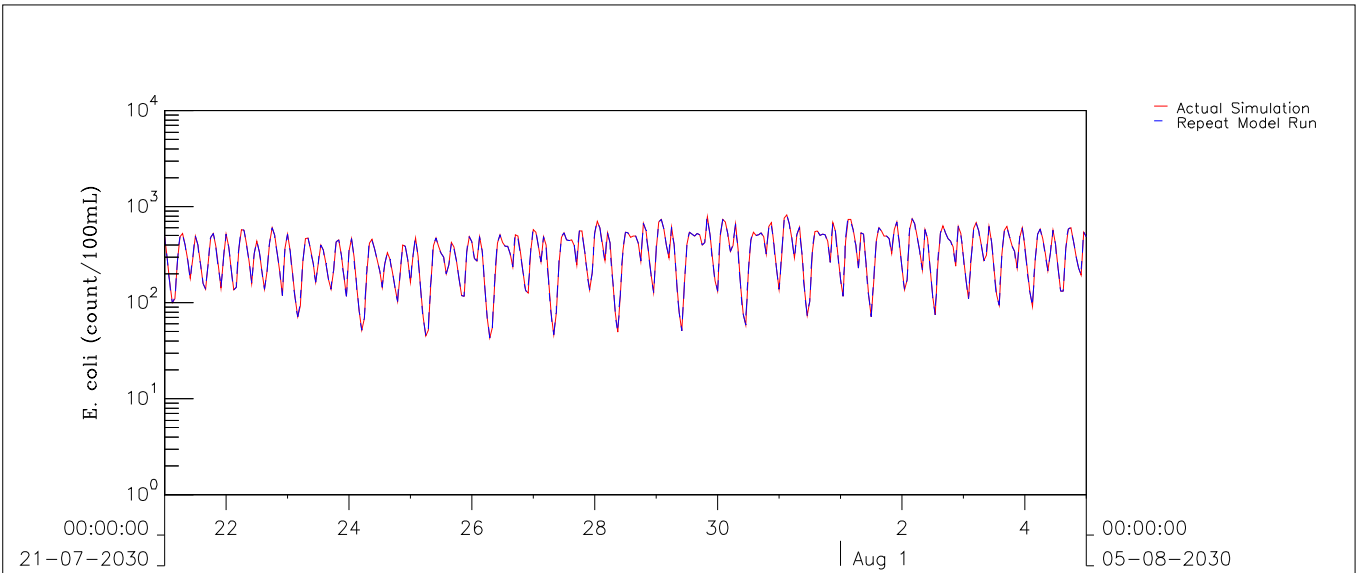
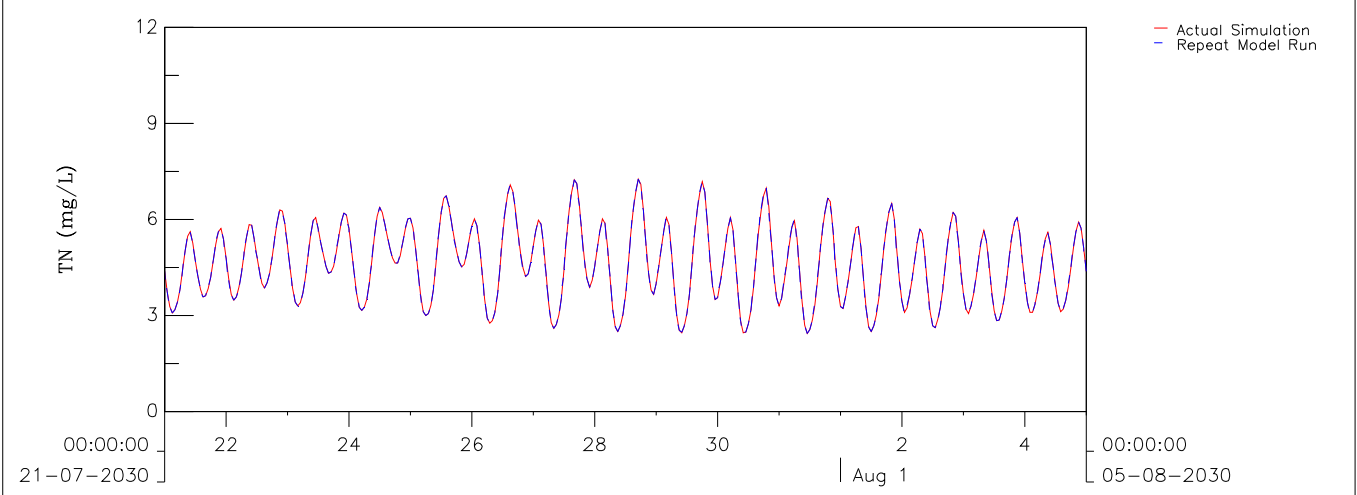
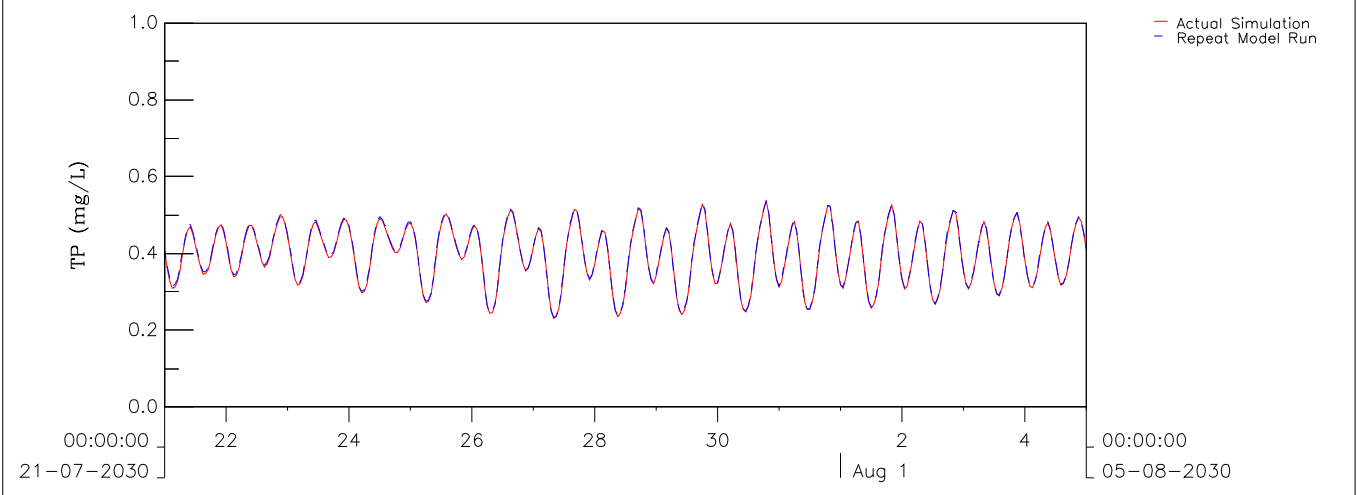
Agreement No. CE 3/2015 (DS) Yuen Long Effluent Polishing Plant – Investigation, Design and Construction Depth Averaged E. coli, TN and TP at DM2 in Wet Season Model results – Red: Base Case; Dashed Blue: Repeat Model Run	Wet Season	Nov 2018
	Appendix 5.8 – 09	
AECOM	/GPP/	Spchk.ssn
