CE 76/2017 (HY)  
 Upgrading of Remaining Sections of Kam Tin Road and Lam Kam Road

Drawing title  
**Visual Impacts**

Drawing number  
**Figure 9.10A**

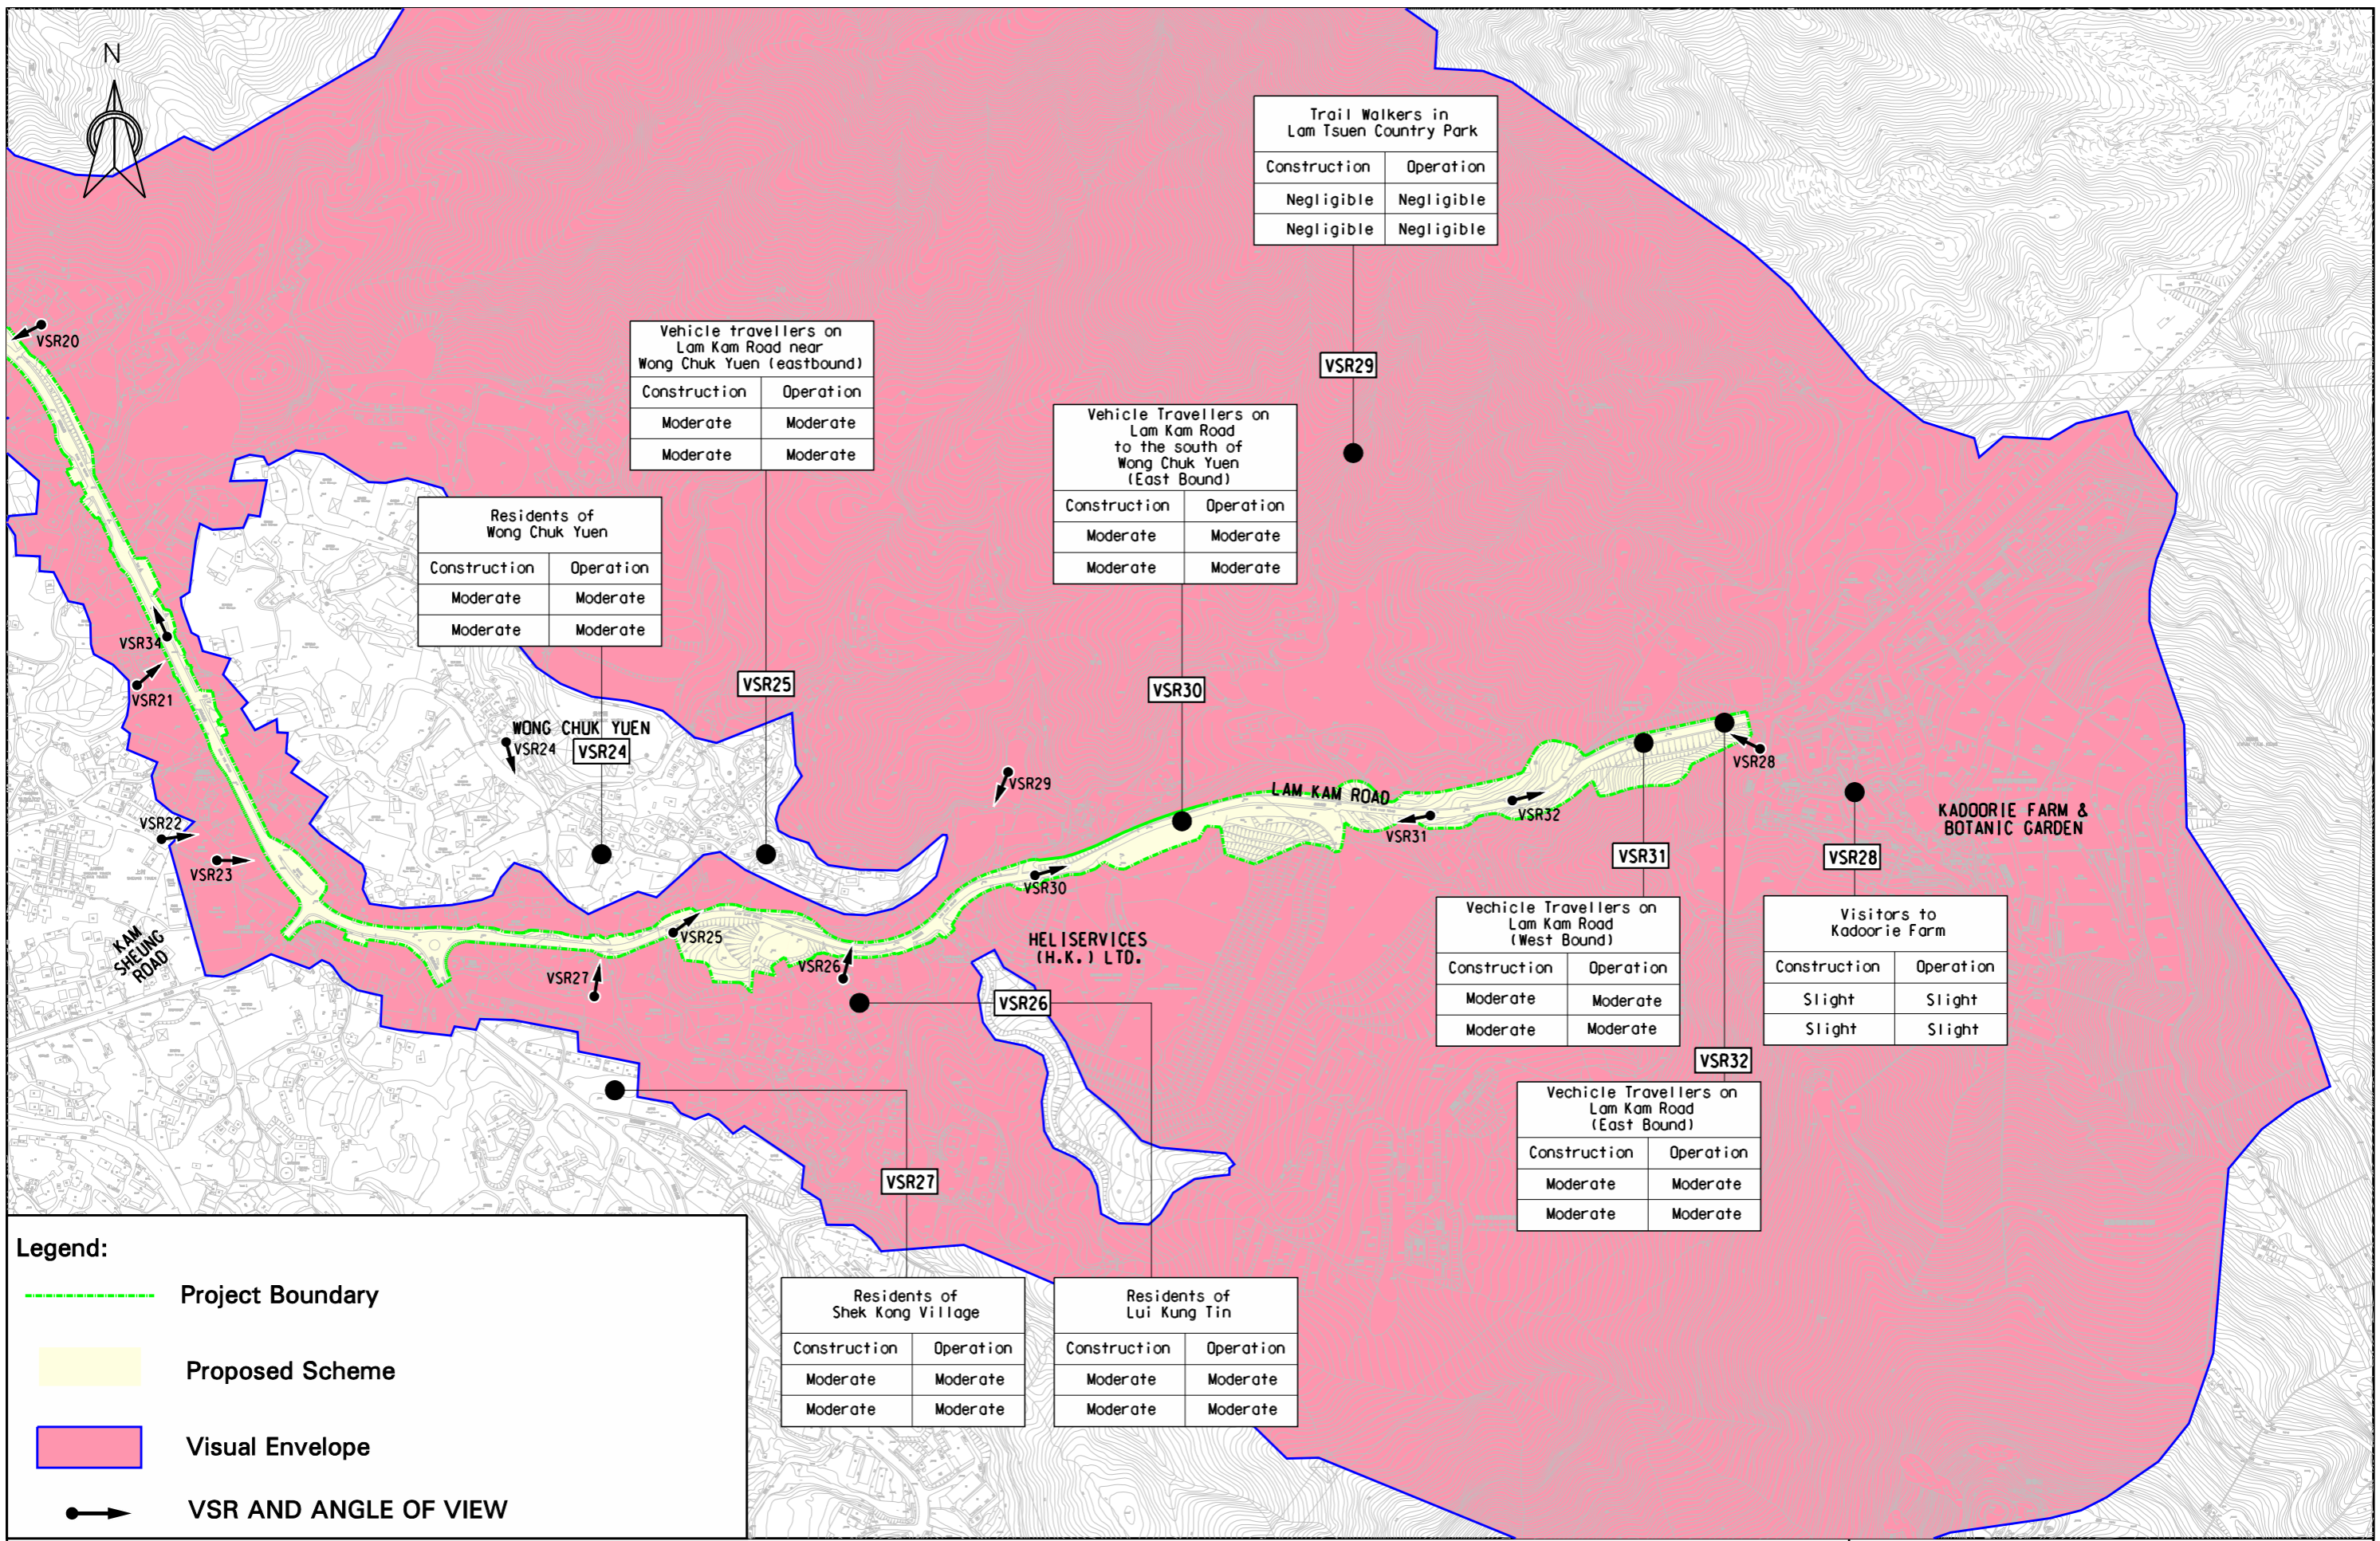
Drawing title		
<b>Visual Impact</b>		
(Sheet 3 of 3)		
Drawing number	Scale	Rev
<b>Figure 9.10C</b>	1 : 6000 @A3

Trail Walkers in Lam Tsuen Country Park	
Construction	Operation
Negligible	Negligible
Negligible	Negligible

Vehicle travellers on Lam Kam Road near Wong Chuk Yuen (eastbound)	
Construction	Operation
Moderate	Moderate
Moderate	Moderate

Residents of Wong Chuk Yuen	
Construction	Operation
Moderate	Moderate
Moderate	Moderate

Vehicle Travellers on Lam Kam Road to the south of Wong Chuk Yuen (East Bound)	
Construction	Operation
Moderate	Moderate
Moderate	Moderate

Vehicle Travellers on Lam Kam Road (West Bound)	
Construction	Operation
Moderate	Moderate
Moderate	Moderate

Visitors to Kadoorie Farm	
Construction	Operation
Slight	Slight
Slight	Slight

Vehicle Travellers on Lam Kam Road (East Bound)	
Construction	Operation
Moderate	Moderate
Moderate	Moderate

Residents of Shek Kong Village	
Construction	Operation
Moderate	Moderate
Moderate	Moderate

Residents of Lui Kung Tin	
Construction	Operation
Moderate	Moderate
Moderate	Moderate
