APPENDIX 11.2
IMAGE OF PROCESSED MAGNETIC
INTENSITY OVER THE SURVEY AREA

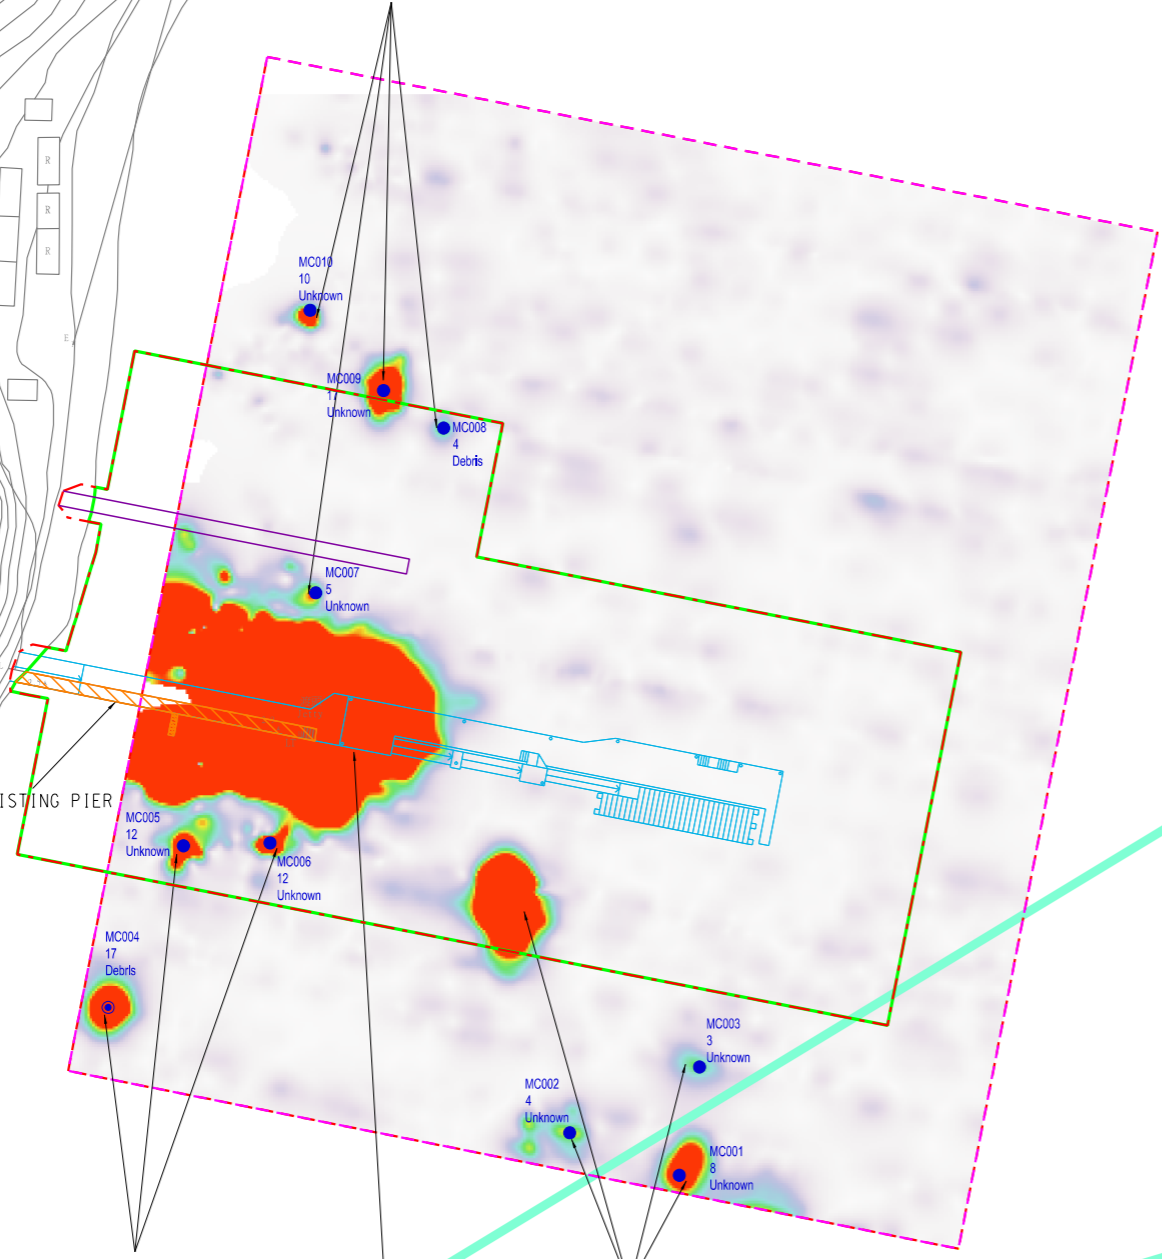
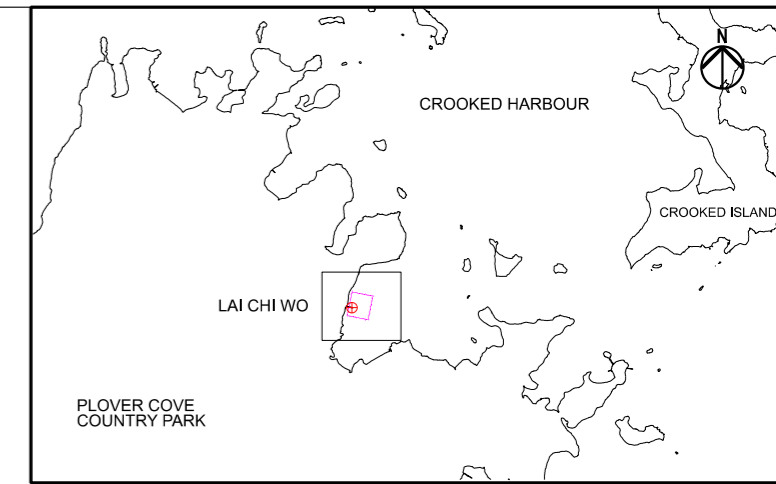
HIGH MAGNETIC VARIATIONS DUE
TO DEBRIS OR UNKNOWN OBJECTS

HIGH MAGNETIC VARIATIONS DUE TO
DEBRIS OR UNKNOWN OBJECTS

MAJOR MAGNETIC VARIATION CAUSED BY THE
PIER STRUCTURE, MOORED BOATS AND DEBRIS

EXISTING PIER

QUASI-ANALYTICAL SIGNAL (nT/m)
