Project Title:
Agreement No. CE 22/2013 (DS)
Drainage Improvement Works in Yuen Long, Stage 1
Investigation, Design and Construction

Figure Title:
Water Sensitive Receivers
At Tai Wo

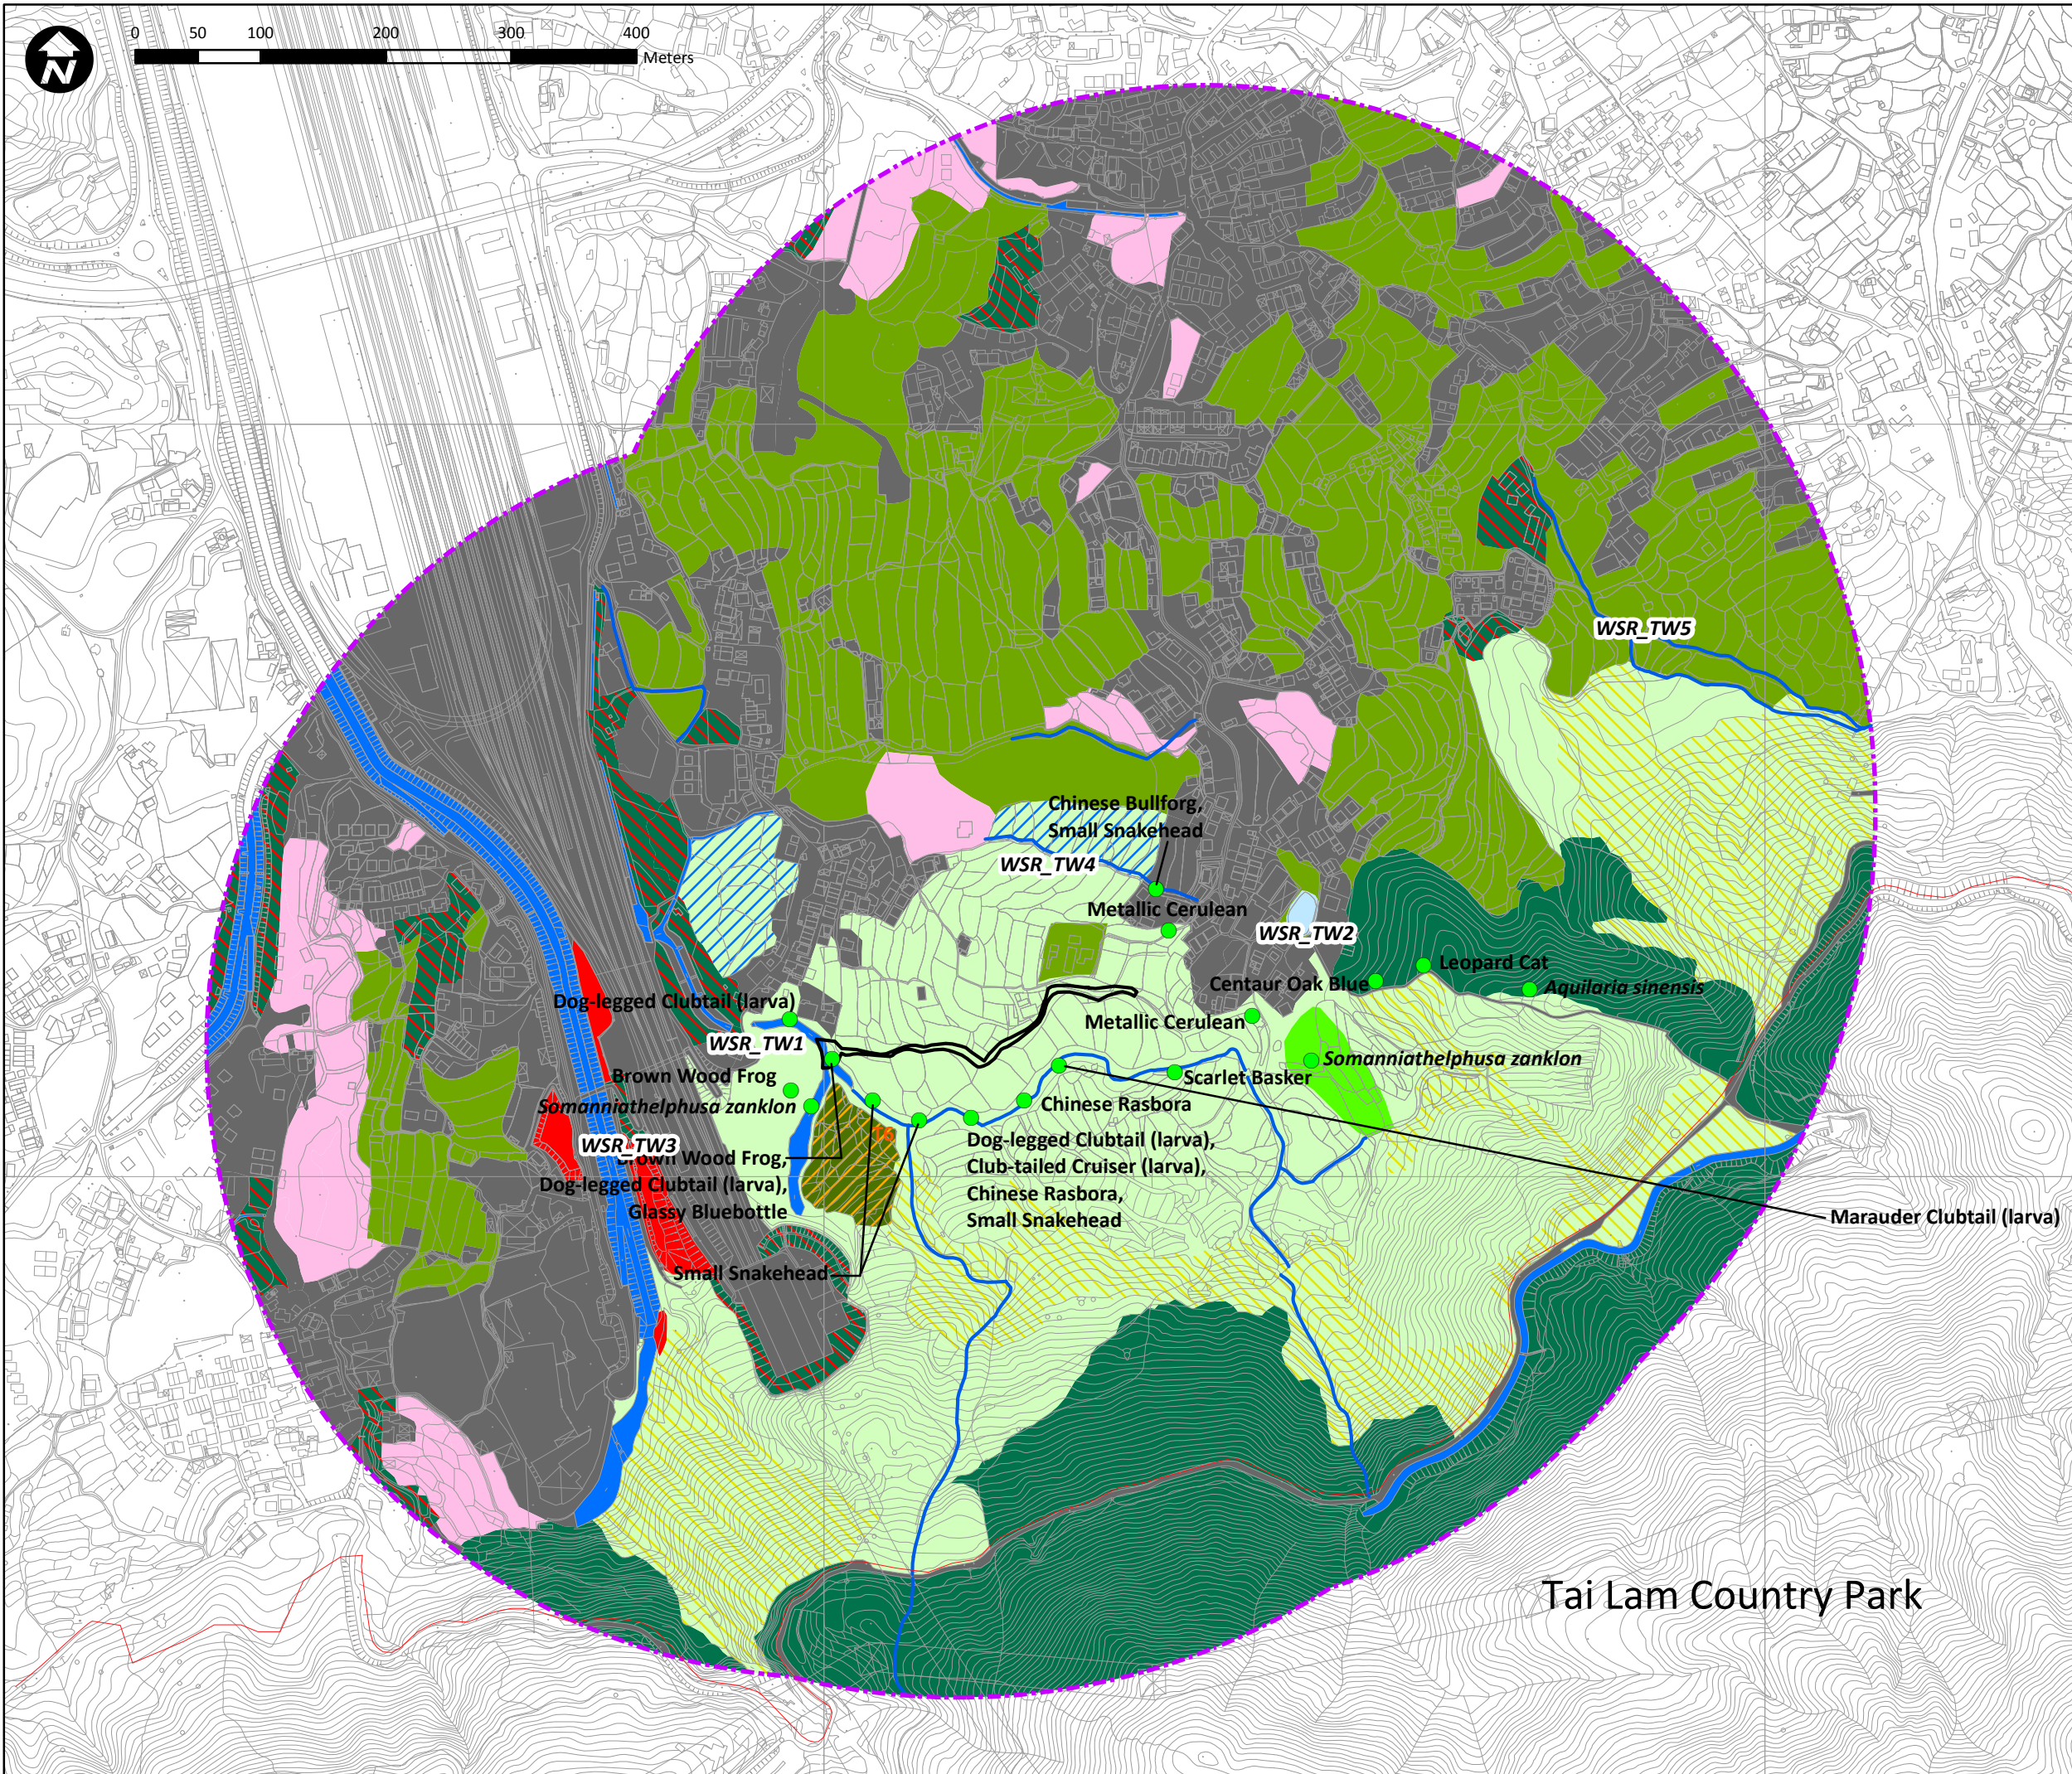
Drawn by:	ST	Scale:	1:5,003 on A3
Checked By:	EL	Date:	Sep 2019
Approved by:	JC		
Figure Number:	Figure 6.2		Revision: 2

- Species of Conservation Concern
- 500m Study Area
- Work Limit Boundary
- Agricultural Land
- Pond
- Marsh
- Mitigation Wetland
- Watercourse
- Seasonally Wet Grassland
- Grassland
- Grassland/Shrubland
- Secondary Woodland
- Orchard
- Plantation
- Waste Ground
- Urban/Residential Area
- Tai Lam Country Park Boundary

Chinese Bullfrog, Small Snakehead
 WSR_TW4
 Metallic Cerulean
 WSR_TW2
 Leopard Cat
 Centaur Oak Blue
 Aquilaria sinensis
 Somanniathelphusa zanklon
 Scarlet Basker
 WSR_TW1
 Dog-legged Clubtail (larva)
 Brown Wood Frog
 Somanniathelphusa zanklon
 WSR_TW3
 Brown Wood Frog,
 Dog-legged Clubtail (larva),
 Glassy Bluebottle
 Small Snakehead
 Dog-legged Clubtail (larva),
 Club-tailed Cruiser (larva),
 Chinese Rasbora,
 Small Snakehead
 Chinese Rasbora
 Marauder Clubtail (larva)
