EIA Report Volume I: Main Text

Mai Po Nature Reserve Infrastructure Upgrade Project

Revision 7.3 – Final
Prepared for World Wide Fund For Nature Hong Kong
20 October 2021

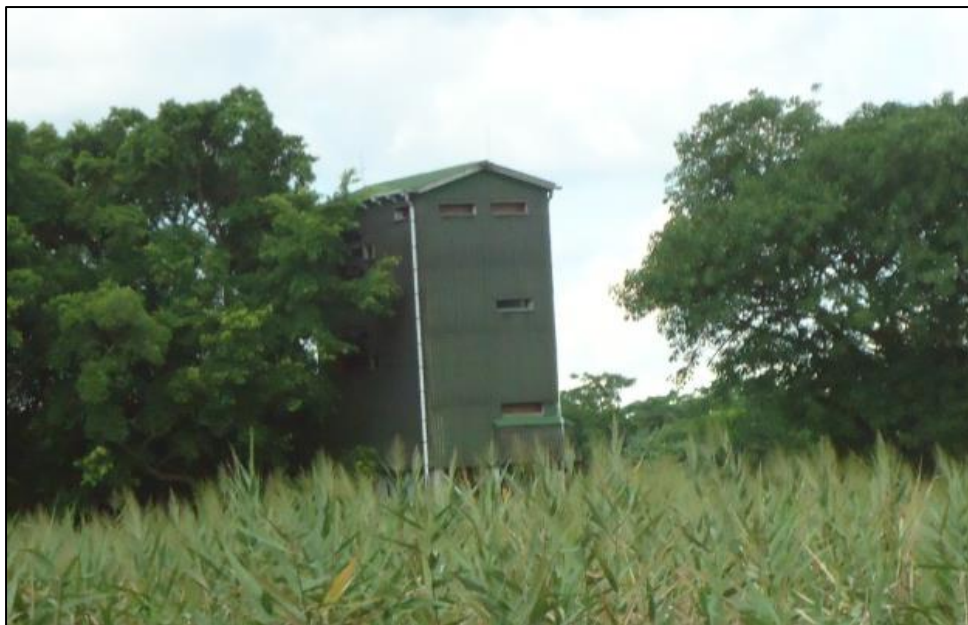
Photograph 2-1 Existing Tower Hide 1

- 2.2.13 **This Element has been removed from the Project.** TH1 is an existing tower hide located at gei wai 8a. The tower hide was intended to be partially demolished and extended in order to facilitate separate groups of public, school visitors, and researchers. Researchers have greater space needs due to their extensive equipment, and on average they utilise the hides for a longer period of time than school and public visitor groups. The Project Proponent wants to ensure that research work can continue in hides undisturbed, while also raising public awareness and education of the importance of wetlands and their conservation. The tower hide was planned as a three-storey structure expansion. It was found that to provide the expansion the footing may cause an adverse impact on nearby trees and roots, and therefore the Project Proponent did not proceed with this element. Instead, a new location near to gei wai 8a was conceived where such impacts could be avoided, to be delivered as TH1E.

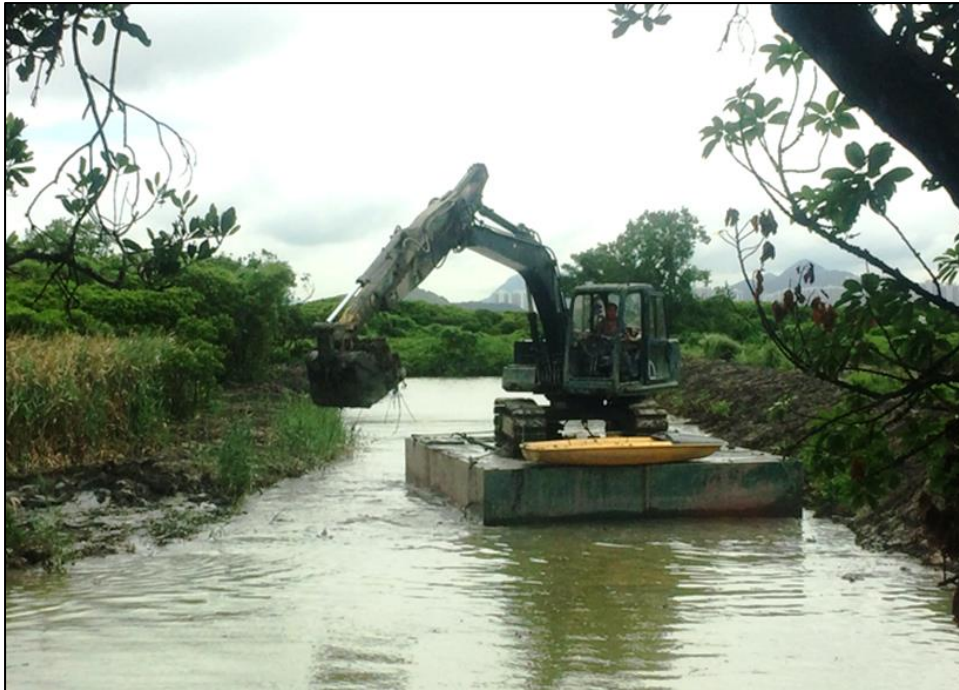
Photograph 2-2 Desilting Channel (from Pontoon)

2.3.10 Each year, specific gei wai within MPNR are drained in accordance with the planned schedule set out in the five-year *MPNR Management Plan* – this activity has been part of the management of MPNR for decades and is not related to the Project. When drained, the gei wai will be as shown in **Photograph 2-5 to Photograph 2-7** – large mud pits with dredging and digging of material by machine carried out over several months during the summer.
