Project Title
Upgrading of Tai Po Sewage Treatment Works - Investigation

Figure Title
Photomontage for VP1

Drawing No. **Figure 7.10** Revision **-**

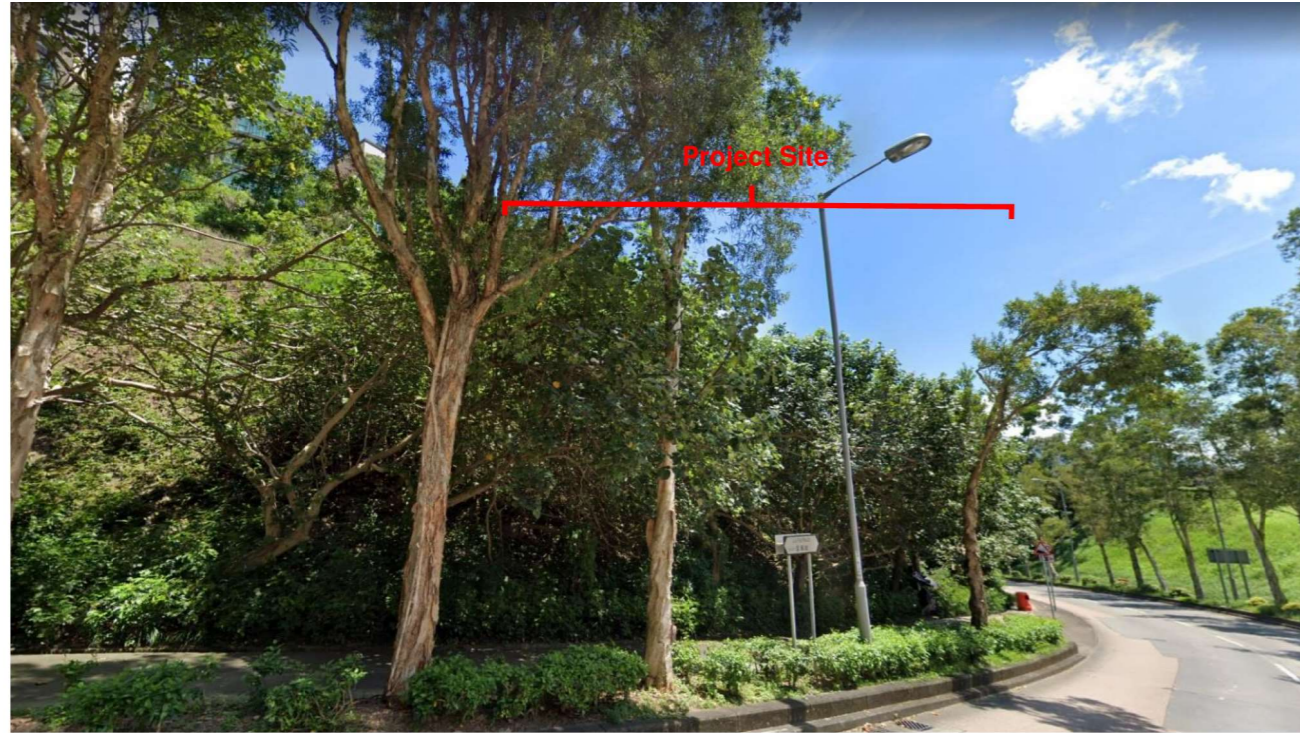
Existing Condition

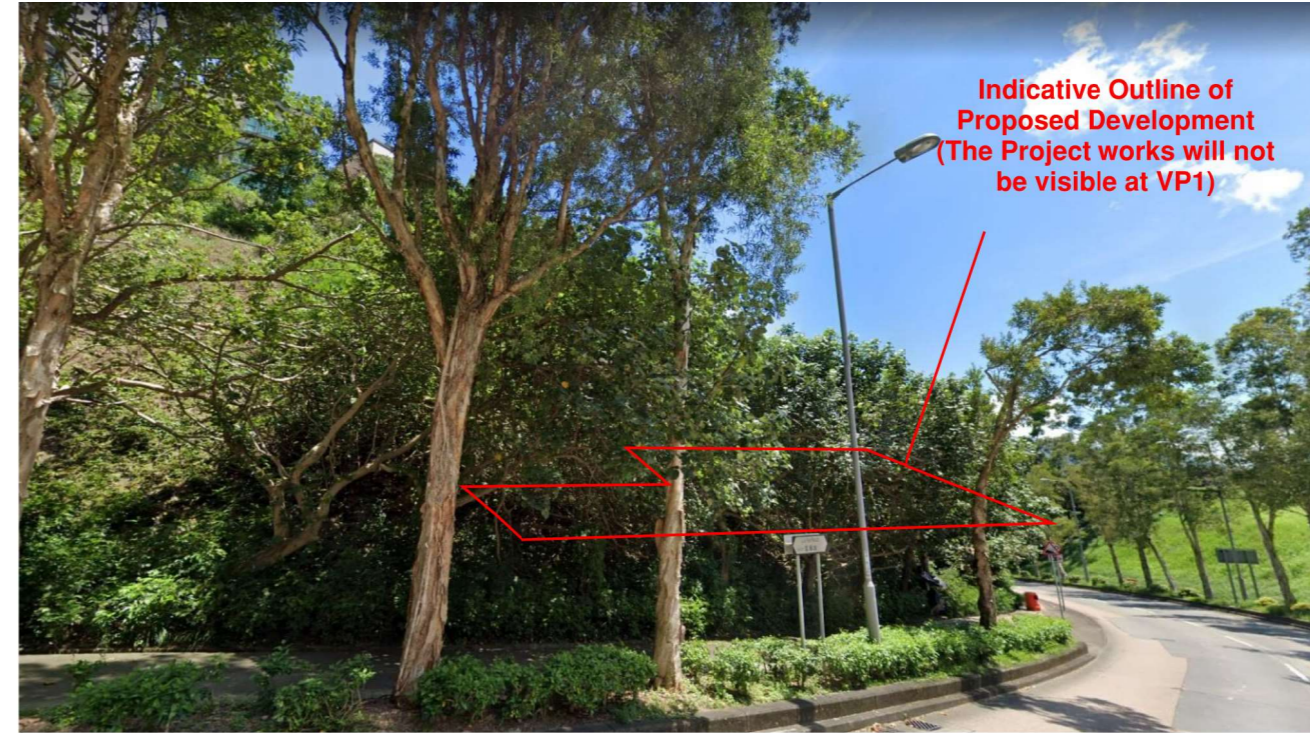
Day 1 of Operation without Mitigation Measure

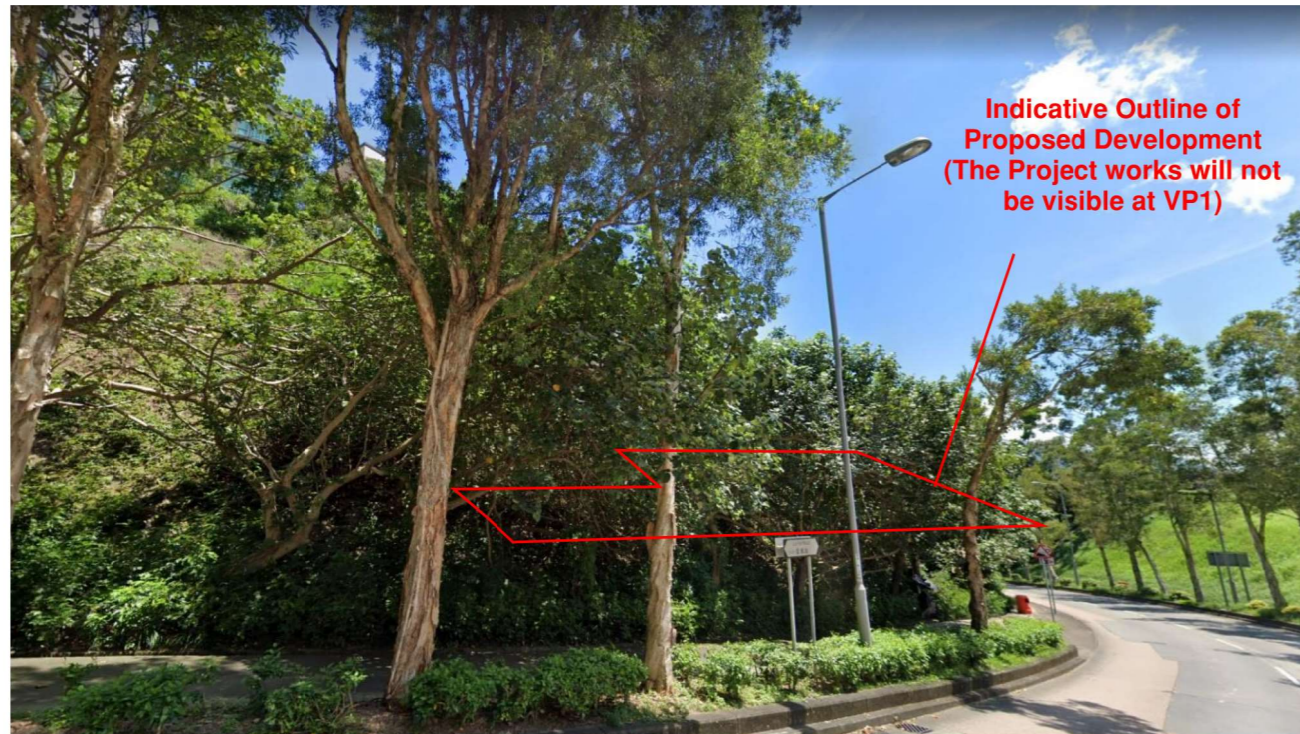
Day 1 of Operation with Mitigation Measure

- OM1 – Infill Planting
- OM2 – Tree Planting along Site Boundary
- OM3 – Green Roof / Vertical Greening
- OM4 – Responsive Design of Building

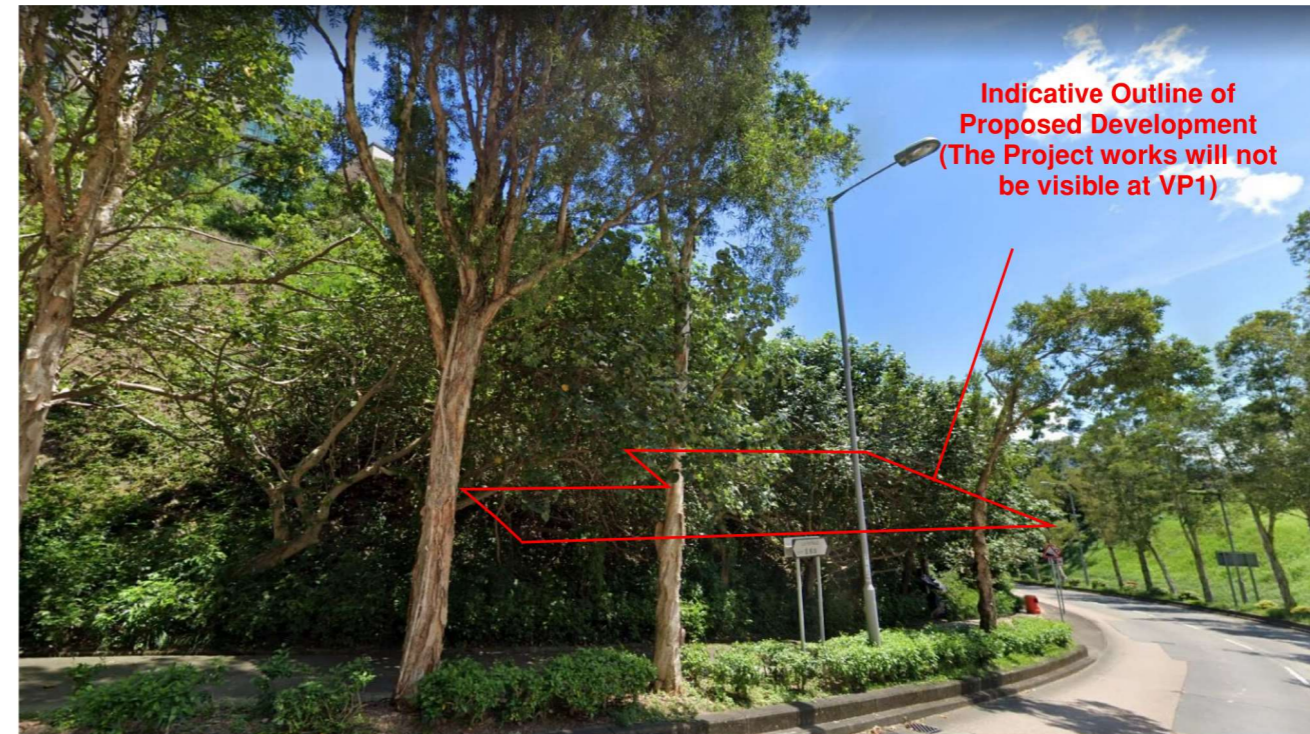
Year 10 of Operation with Mitigation Measure
