Project Title
Upgrading of Tai Po Sewage Treatment Works - Investigation

Figure Title
Photomontage for VP2

Drawing No. **Figure 7.11** Revision **-**

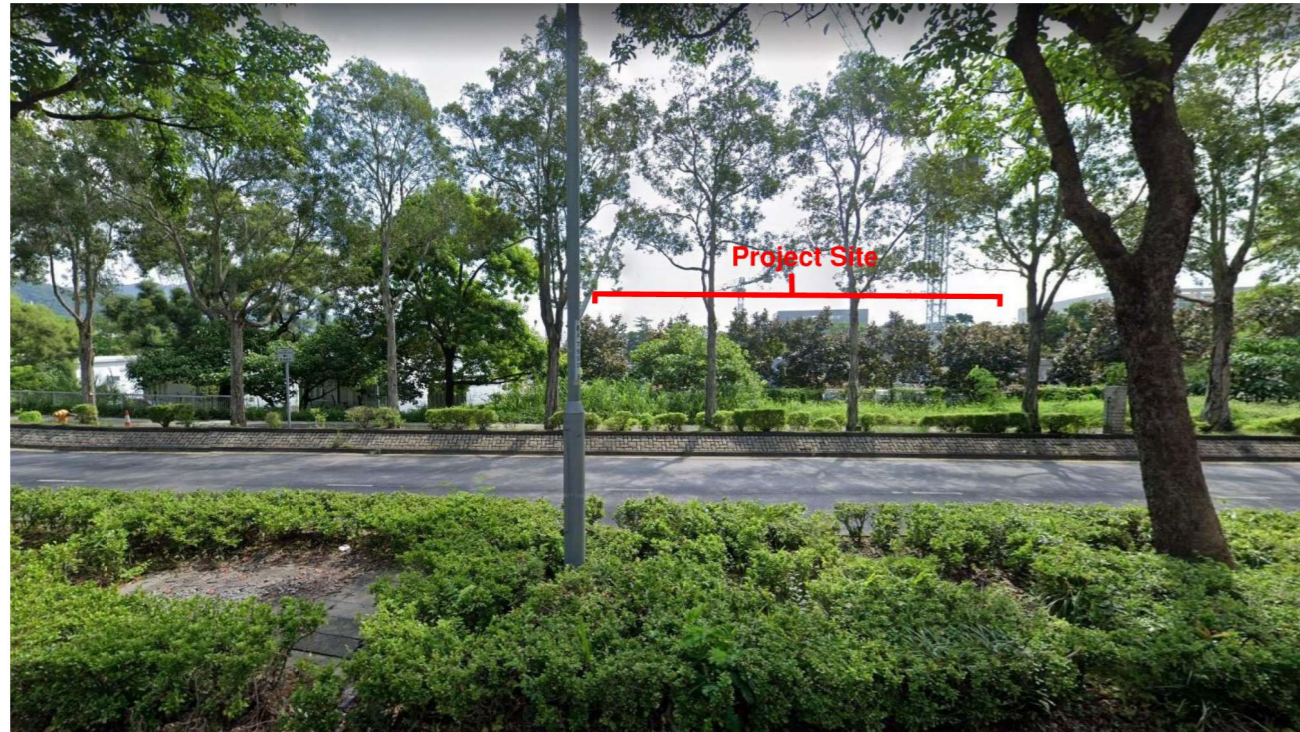
Existing Condition

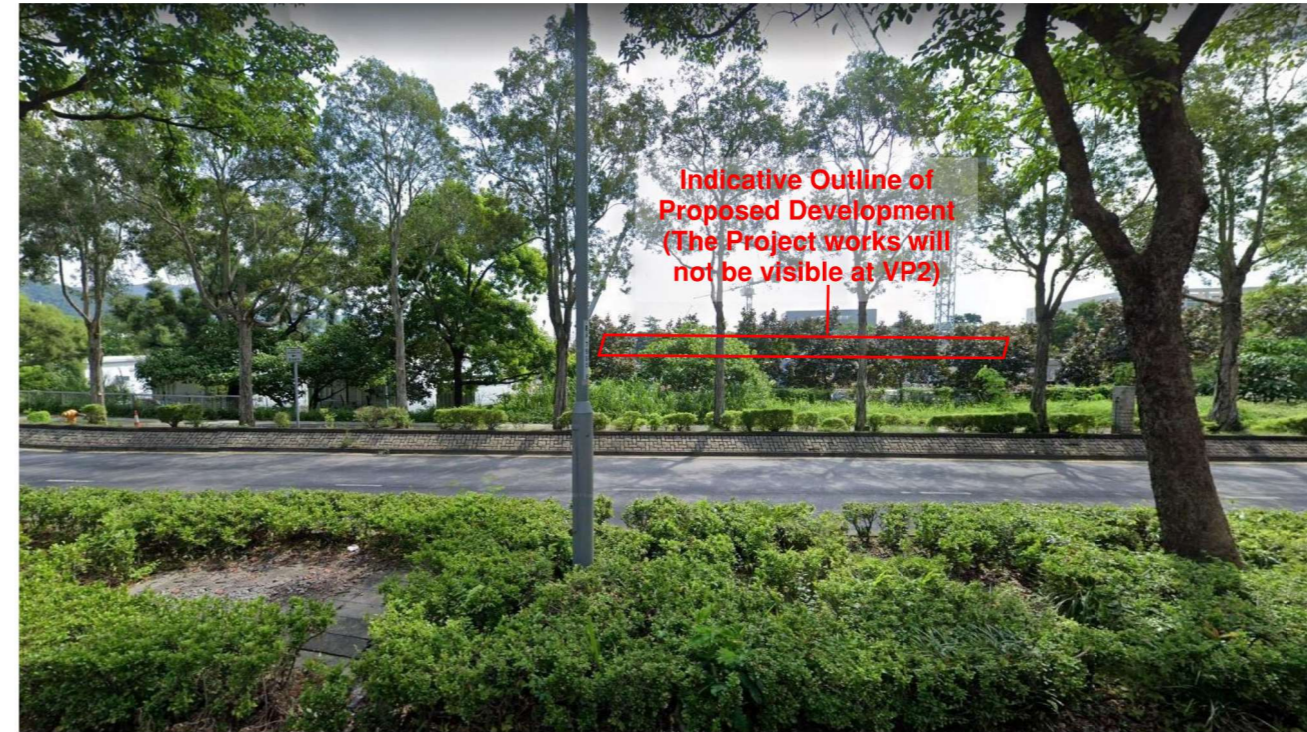
Day 1 of Operation without Mitigation Measure

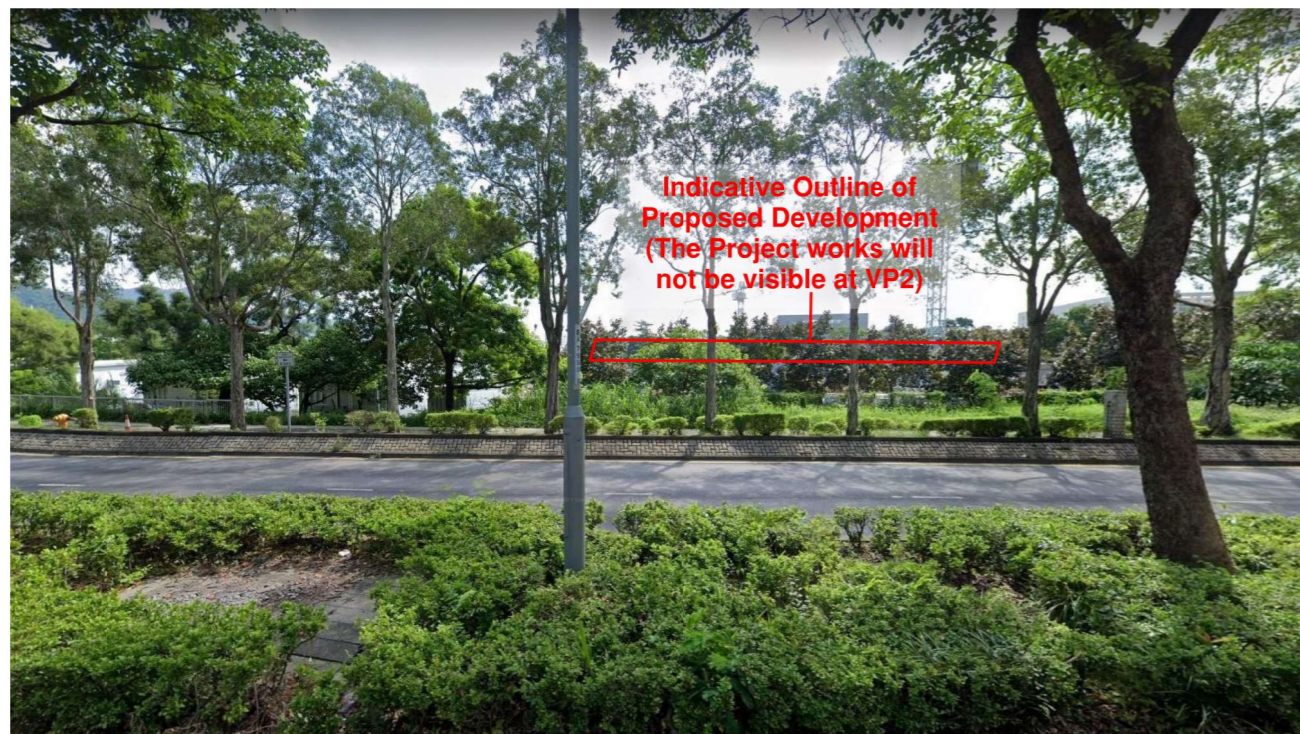
Day 1 of Operation with Mitigation Measure

- OM1 – Infill Planting
- OM2 – Tree Planting along Site Boundary
- OM3 – Green Roof / Vertical Greening
- OM4 – Responsive Design of Building

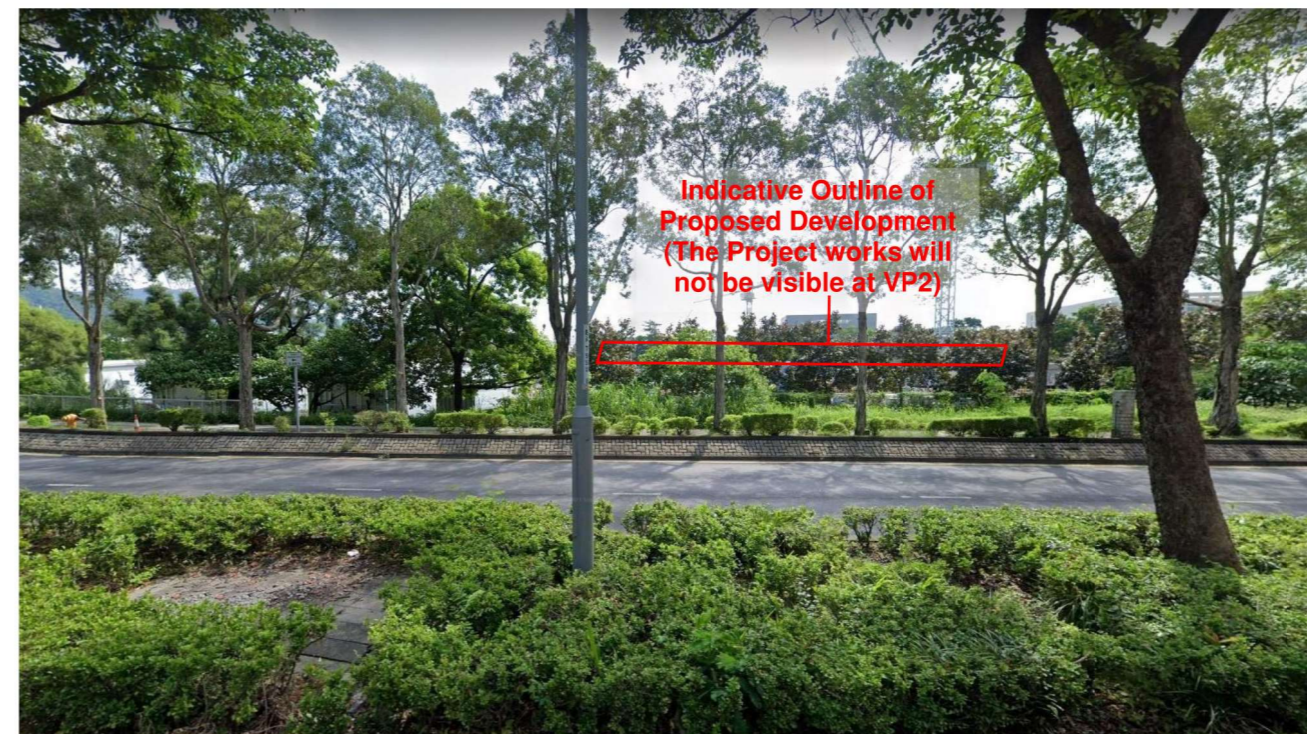
Year 10 of Operation with Mitigation Measure
