Agreement No. **CE 50/2019 (DS)**

Project Title
Upgrading of Tai Po Sewage Treatment Works - Investigation

Figure Title
Photomontage for VP5

Drawing No. **Figure 7.14** Revision **-**

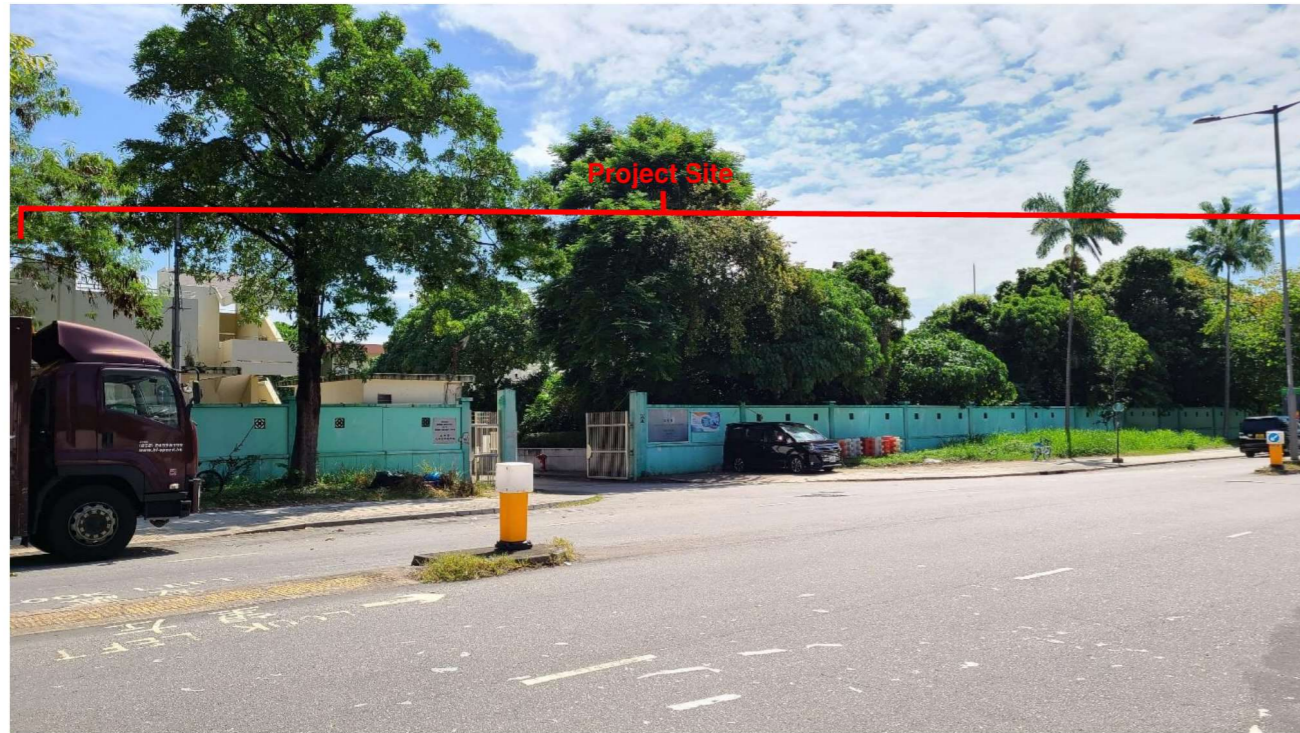
Existing Condition

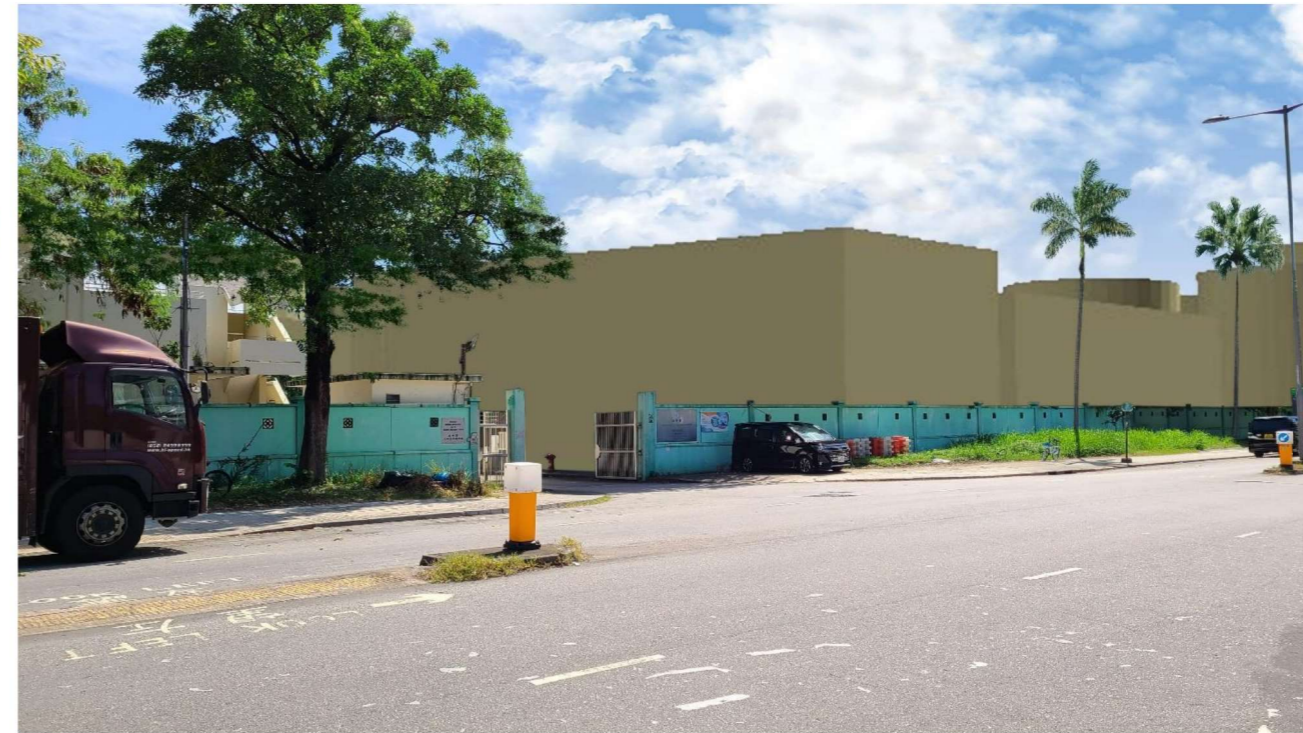
Day 1 of Operation without Mitigation Measure

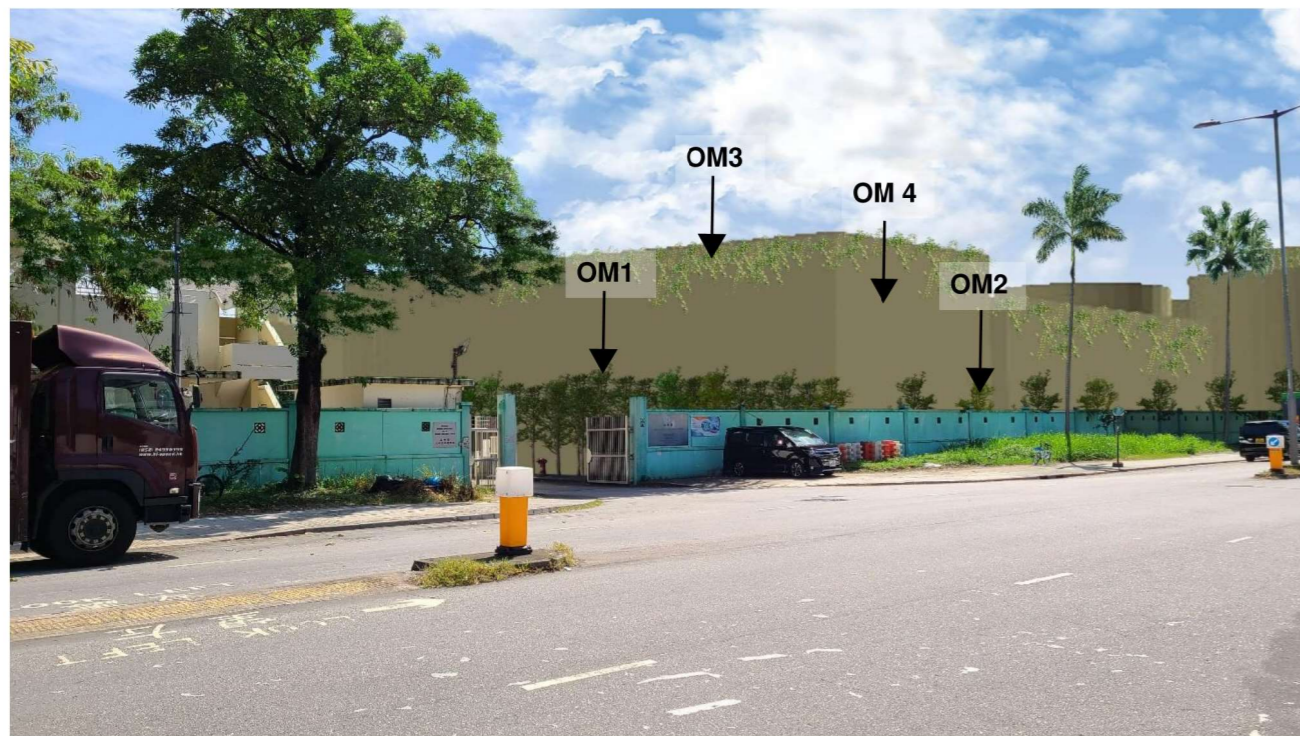
Day 1 of Operation with Mitigation Measure

- OM1 – Infill Planting
- OM2 – Tree Planting along Site Boundary
- OM3 – Green Roof / Vertical Greening
- OM4 – Responsive Design of Building

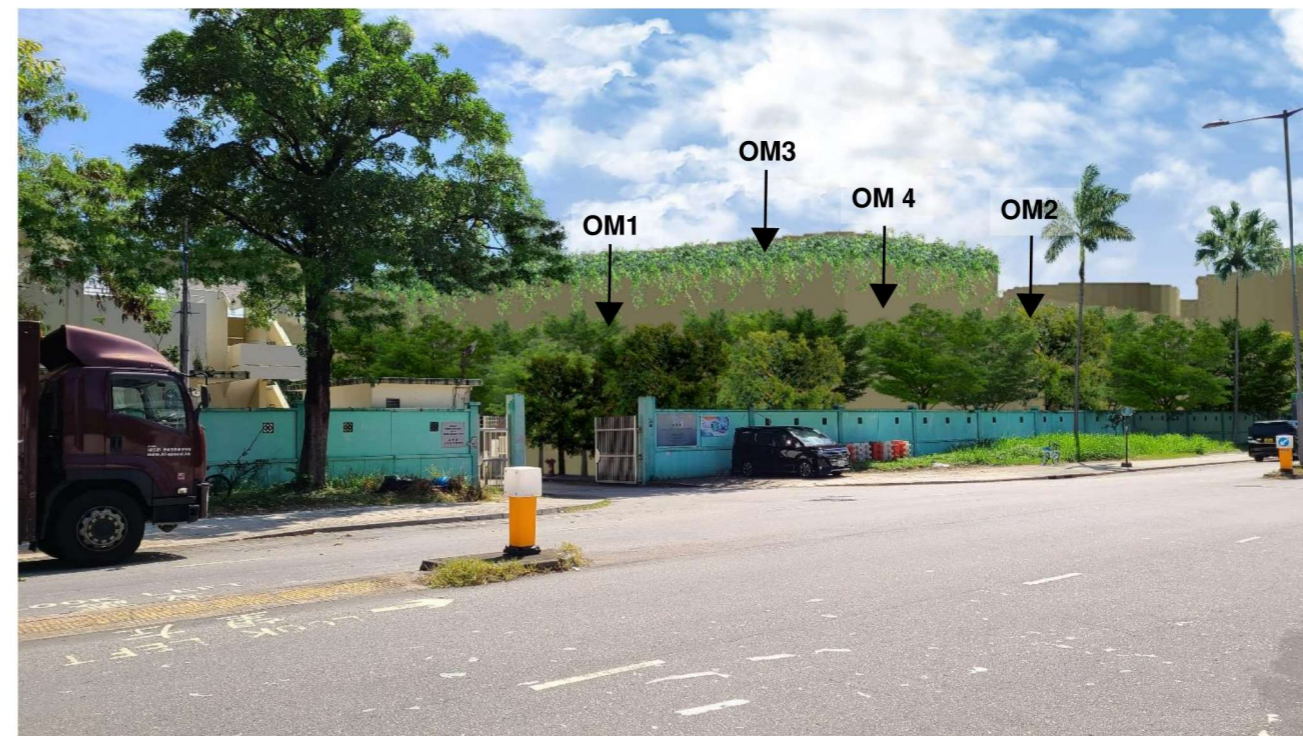
Year 10 of Operation with Mitigation Measure
