Project Title
Upgrading of Tai Po Sewage Treatment Works - Investigation

Figure Title
Photomontage for VP6

Drawing No. **Figure 7.15** Revision **-**

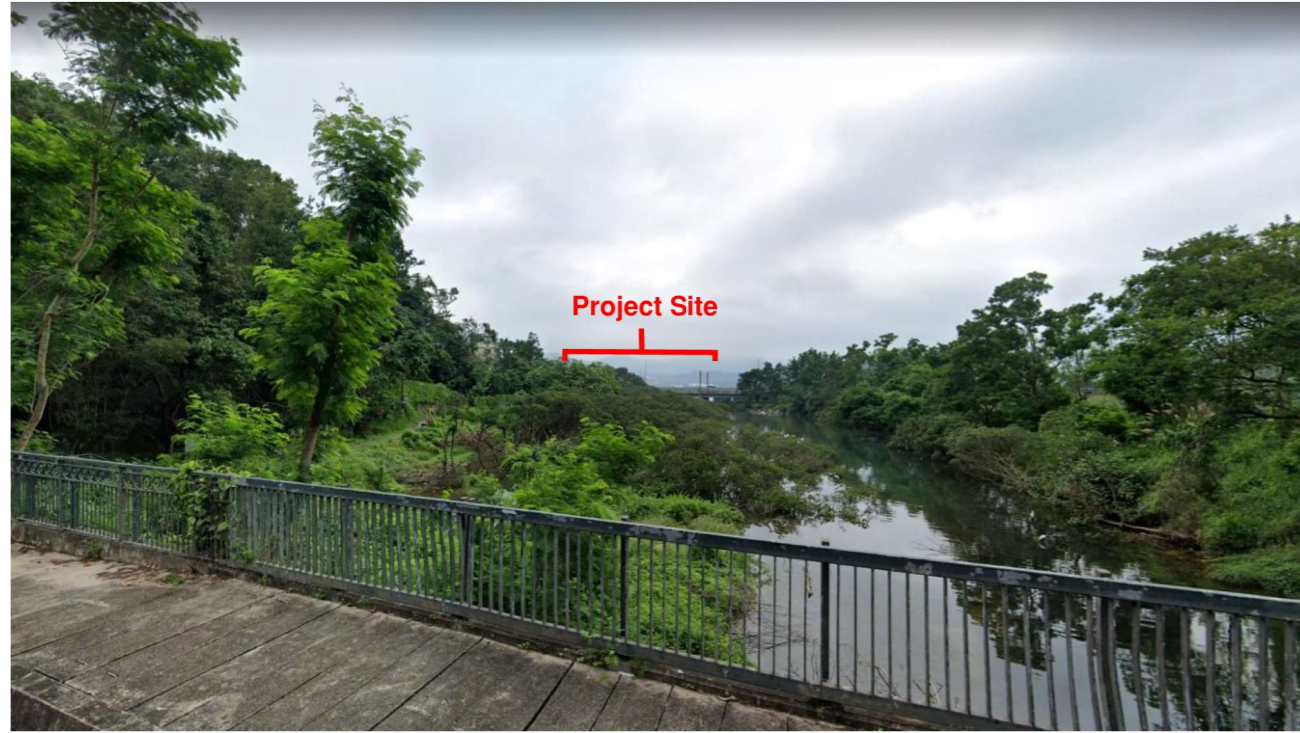
Existing Condition

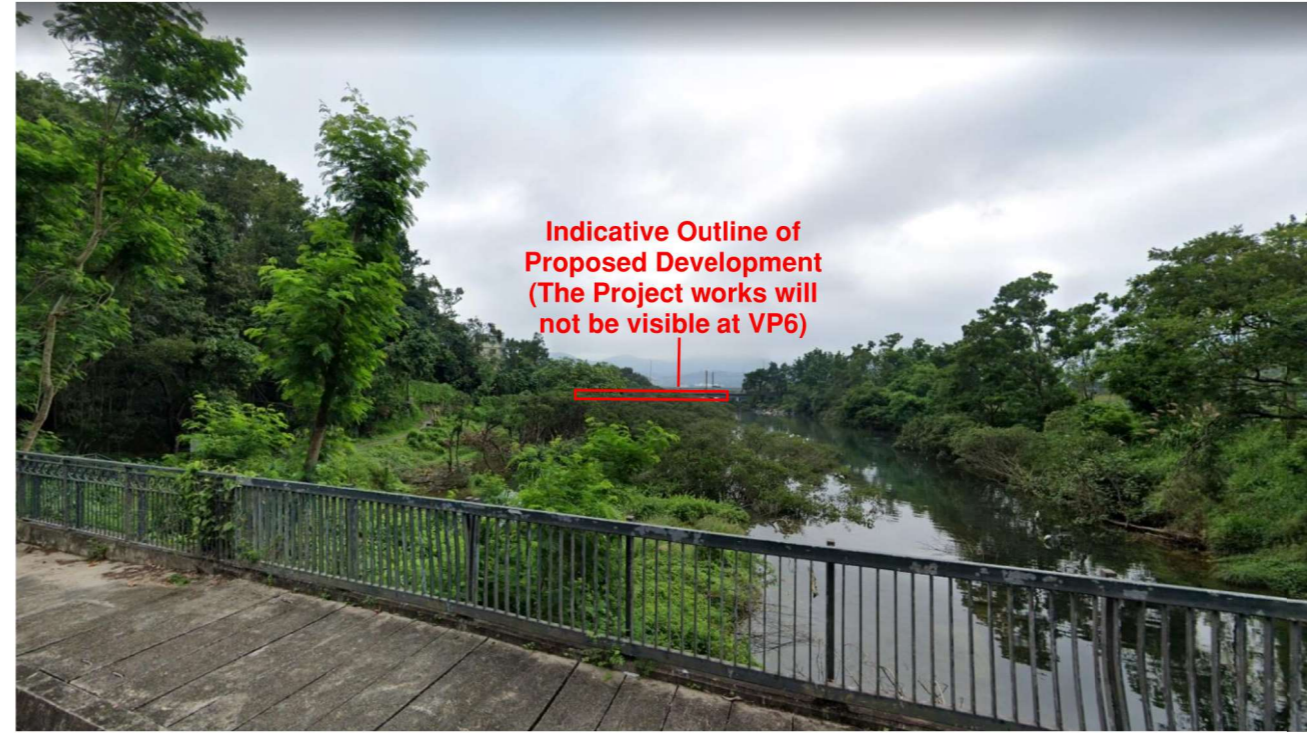
Day 1 of Operation without Mitigation Measure

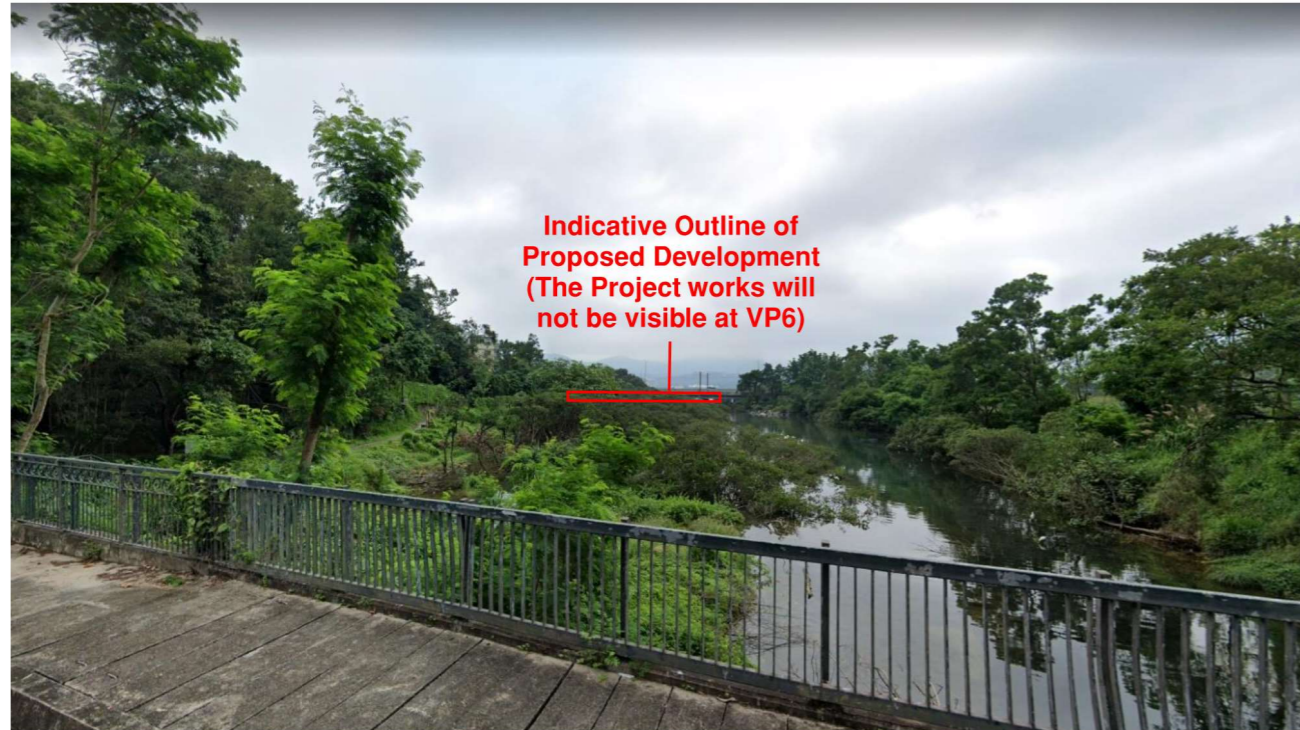
Day 1 of Operation with Mitigation Measure

- OM1 – Infill Planting
- OM2 – Tree Planting along Site Boundary
- OM3 – Green Roof / Vertical Greening
- OM4 – Responsive Design of Building

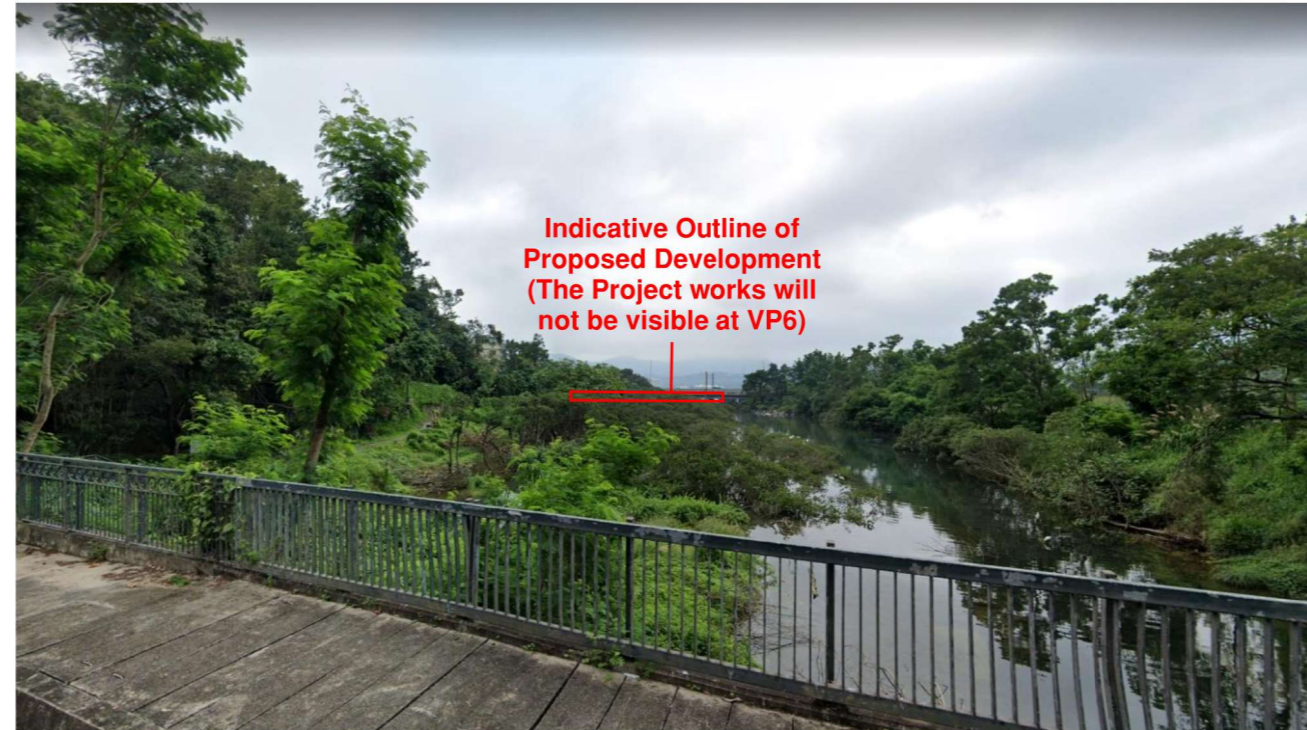
Year 10 of Operation with Mitigation Measure
