Project Title  
**Upgrading of Tai Po Sewage Treatment Works - Investigation**

Figure Title  
**Photomontage for VP7**

Drawing No. **Figure 7.16** Revision **-**

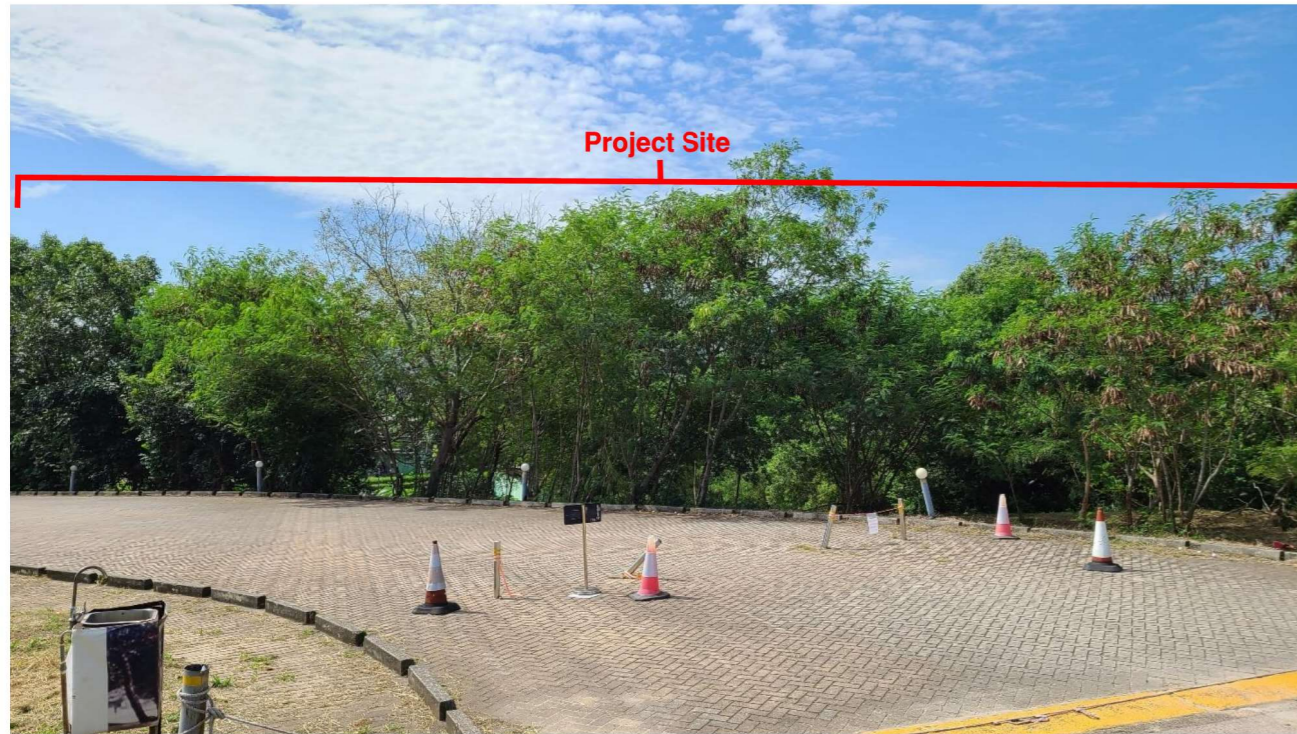
**Existing Condition**

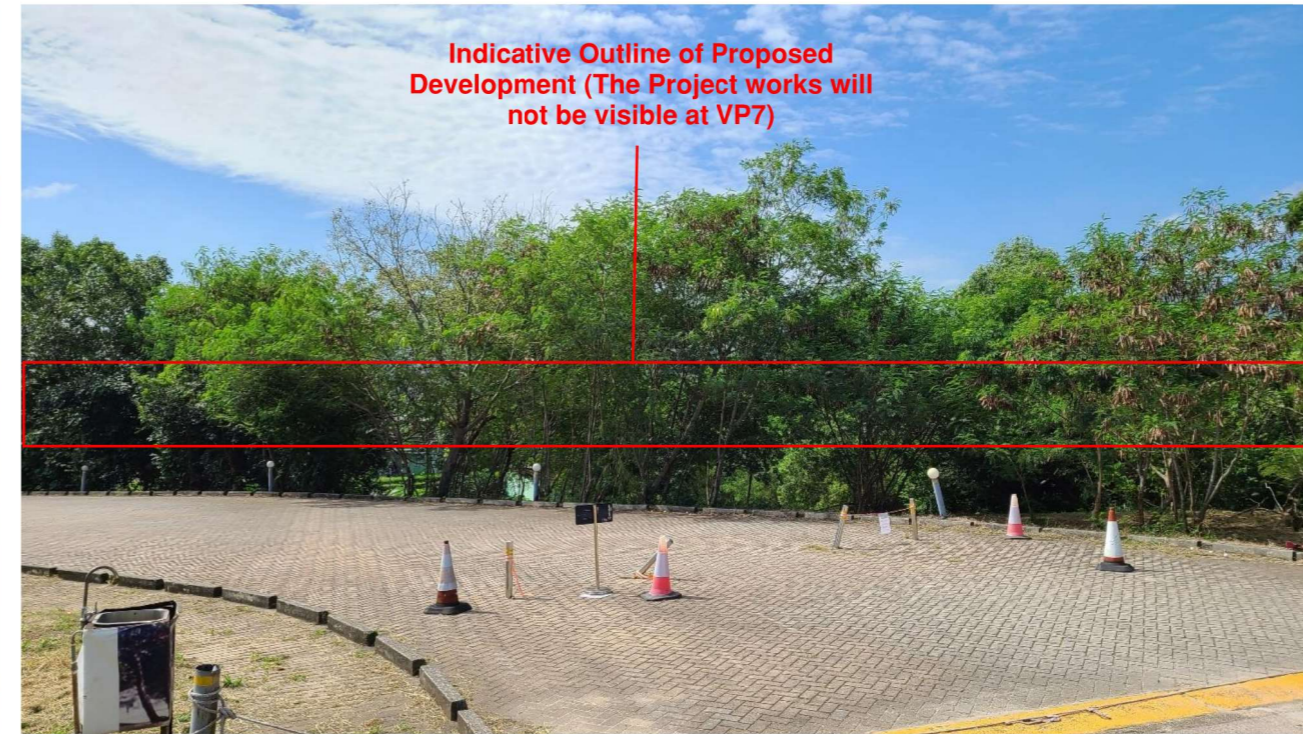
**Day 1 of Operation without Mitigation Measure**

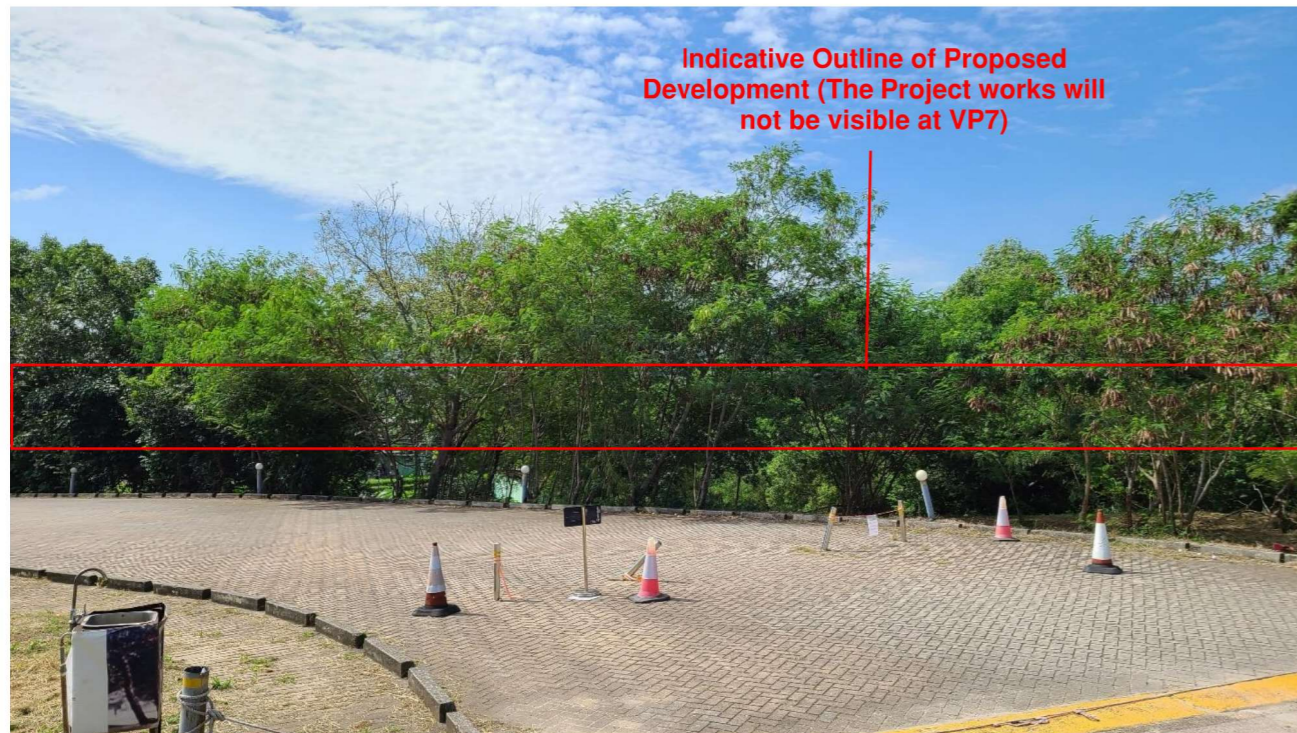
**Day 1 of Operation with Mitigation Measure**

- OM1 – Infill Planting
- OM2 – Tree Planting along Site Boundary
- OM3 – Green Roof / Vertical Greening
- OM4 – Responsive Design of Building

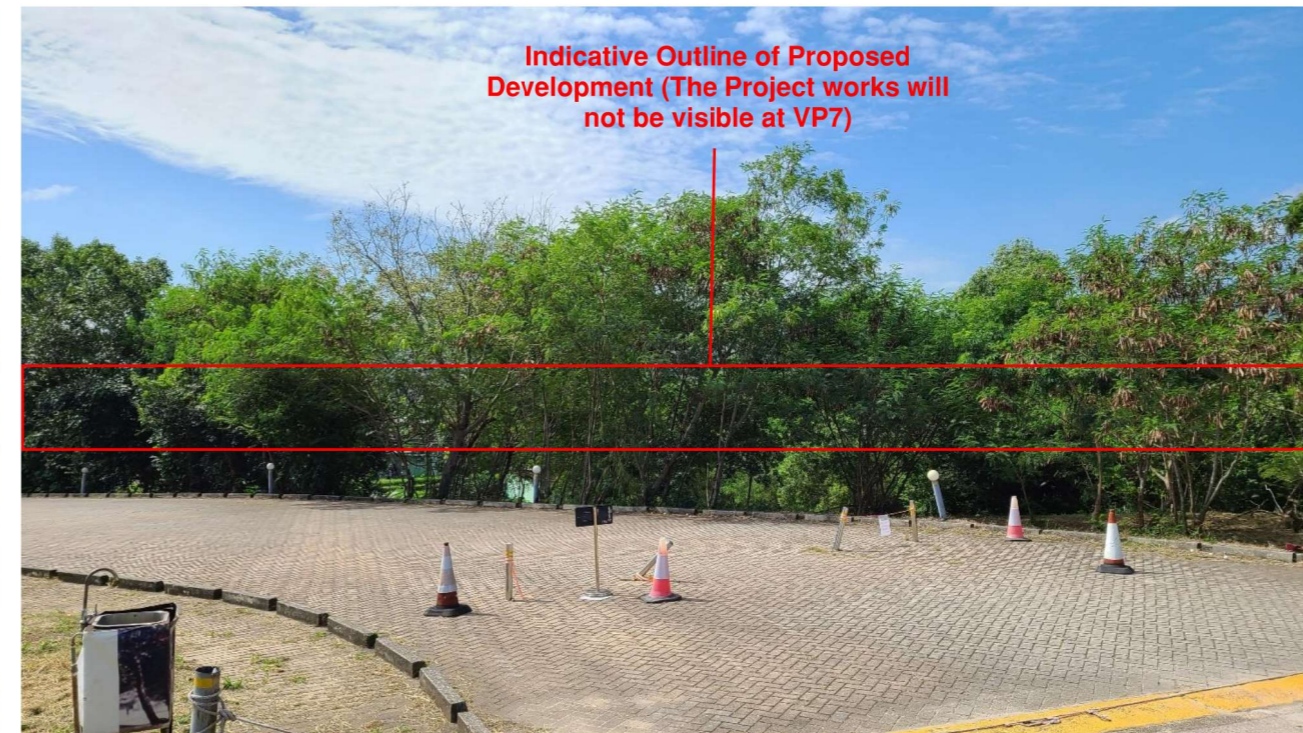
**Year 10 of Operation with Mitigation Measure**
