Project title
TRAFFIC IMPROVEMENT SCHEME IN TUEN MUN
- WIDENING AND ADDITION OF SLIP ROADS
AT LUNG FU ROAD/ TUEN MUN ROAD/
WONG CHU ROAD/ HOI WING ROAD

Drawing title
PHOTOMONTAGE VIEWPOINT 01

Drawing no.	FIGURE 9.8.1	Rev.	B
Drawn	Date	Checked	Approved
Scale	N.T.S.	Status	FOR INFORMATION

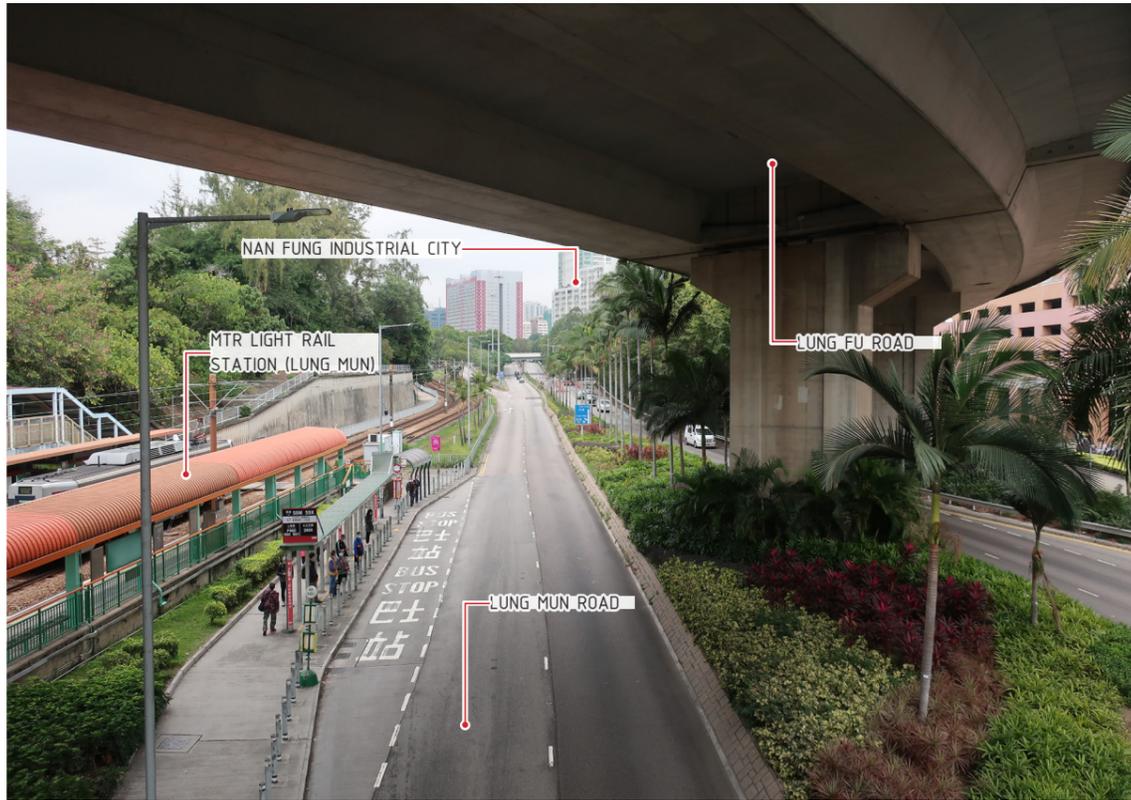
VP01 - FOOTBRIDGE ON LUNG MUN ROAD - EXISTING SITE CONDITION

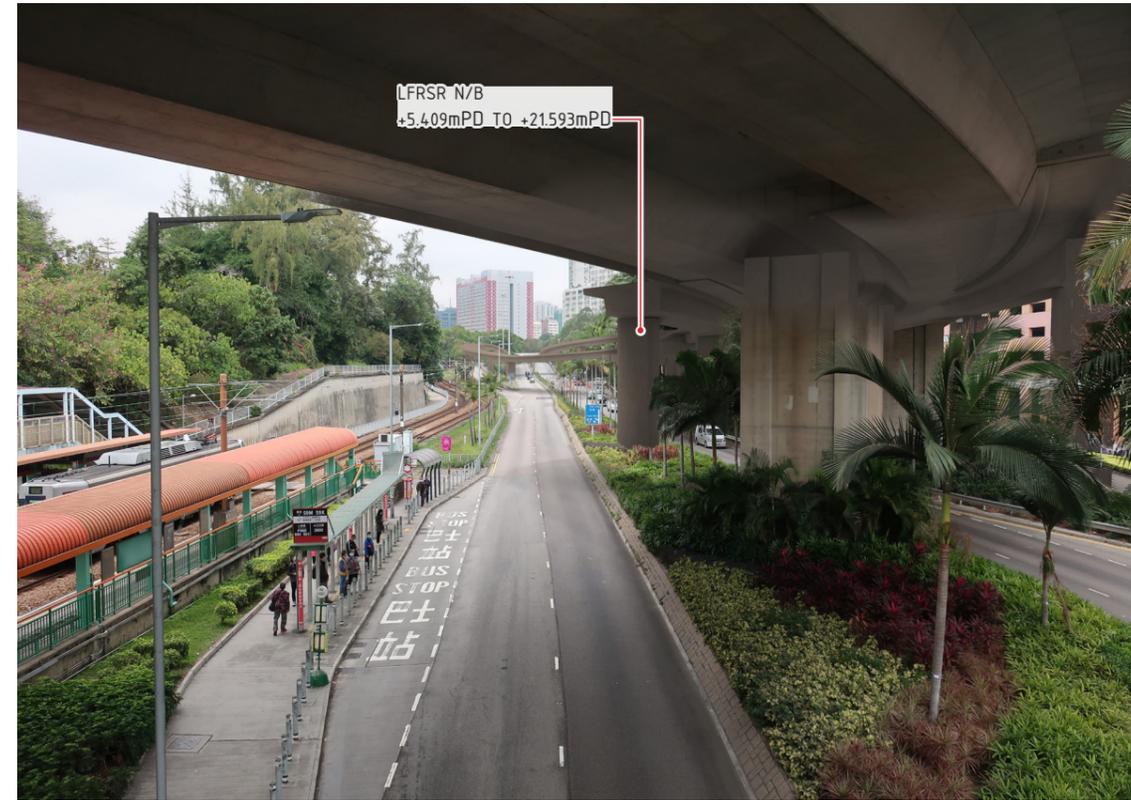
VP01 - FOOTBRIDGE ON LUNG MUN ROAD - WITHOUT MITIGATION MEASURES

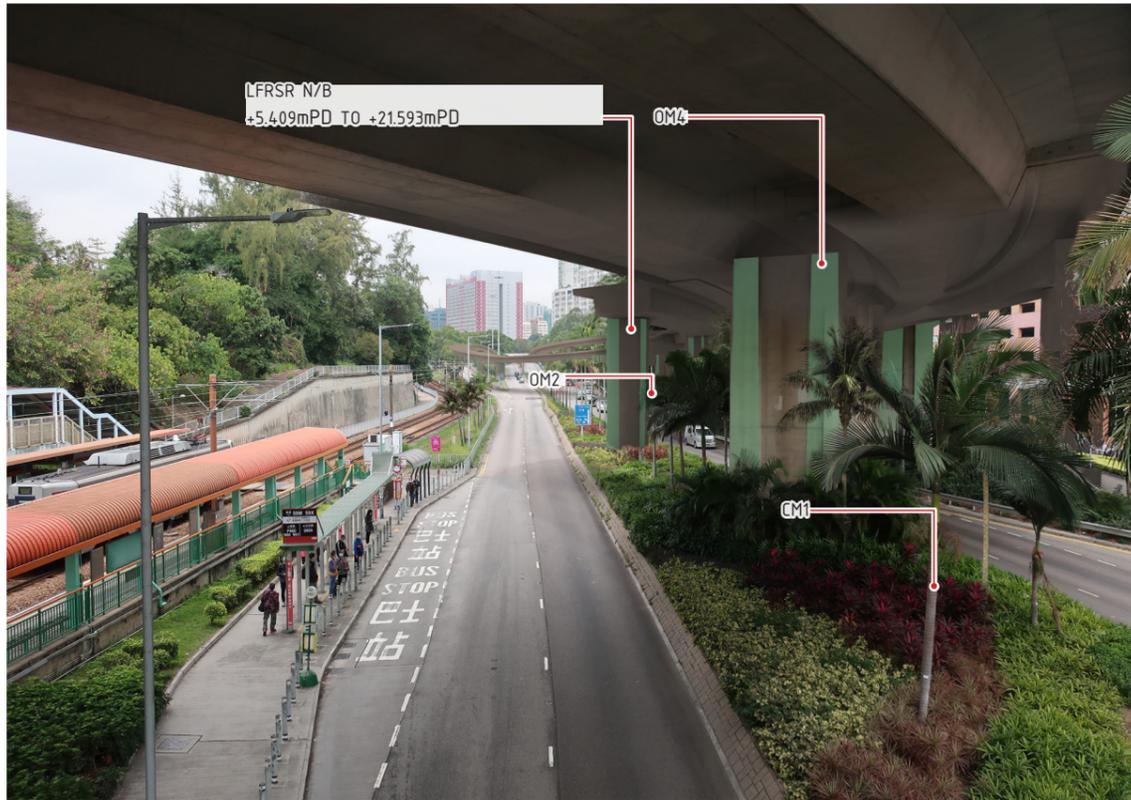
VP01 - FOOTBRIDGE ON LUNG MUN ROAD - DAY 1 WITH MITIGATION MEASURES

MITIGATION MEASURES (CONSTRUCTION PHASE)

CM1	Preservation of Existing Vegetation
CM2	Transplanting of Affected Trees
CM3	Control of Night-time Lighting Glare
CM4	Good Site Practice
CM5	Erection of Decorative Screen Hoarding

MITIGATION MEASURES (OPERATION PHASE)

OM1	Compensatory Tree Planting
OM2	Roadside Planting
OM3	Aesthetically treatment Noise Barrier
OM4	Aesthetically pleasing design

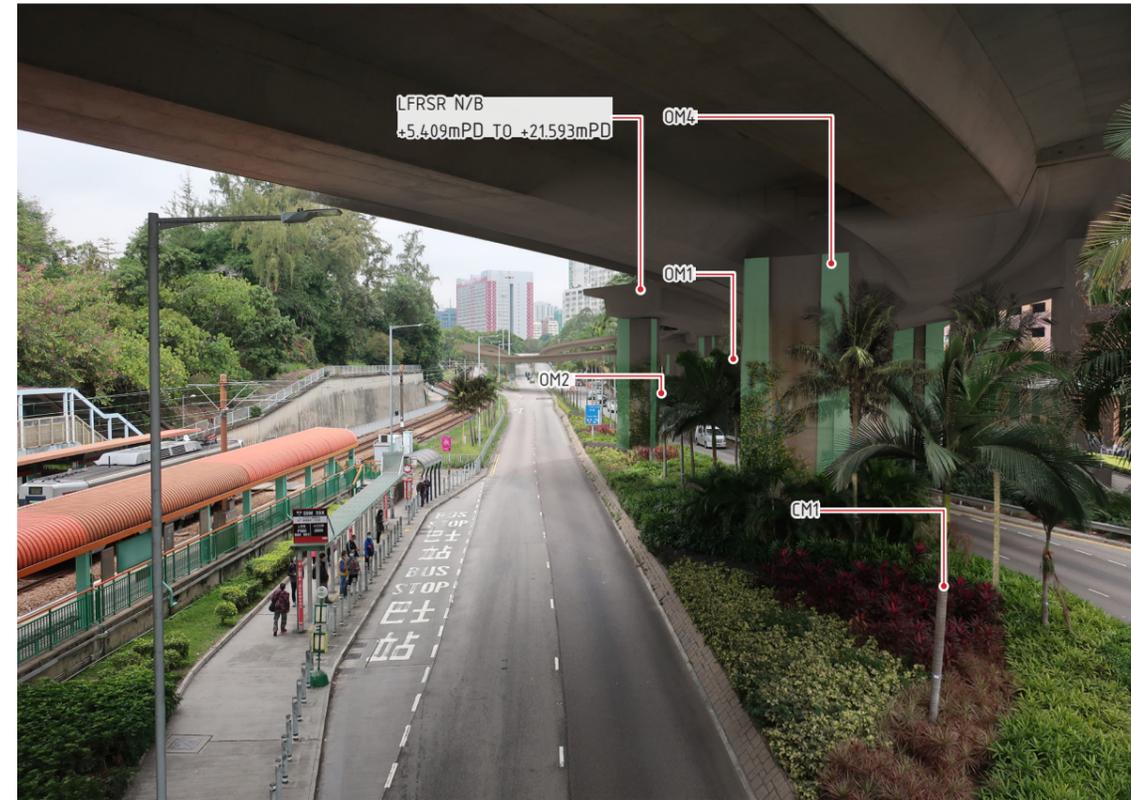
VP01 - FOOTBRIDGE ON LUNG MUN ROAD - YEAR 10 WITH MITIGATION MEASURES
